B LINE LEAK

Remediation Action Plan

NMOCD Incident No. nAPP2322146971
UL "P", Sec. 27, T17S, R35E
32.799148, -103.437051
Lea County, New Mexico

September 25, 2024

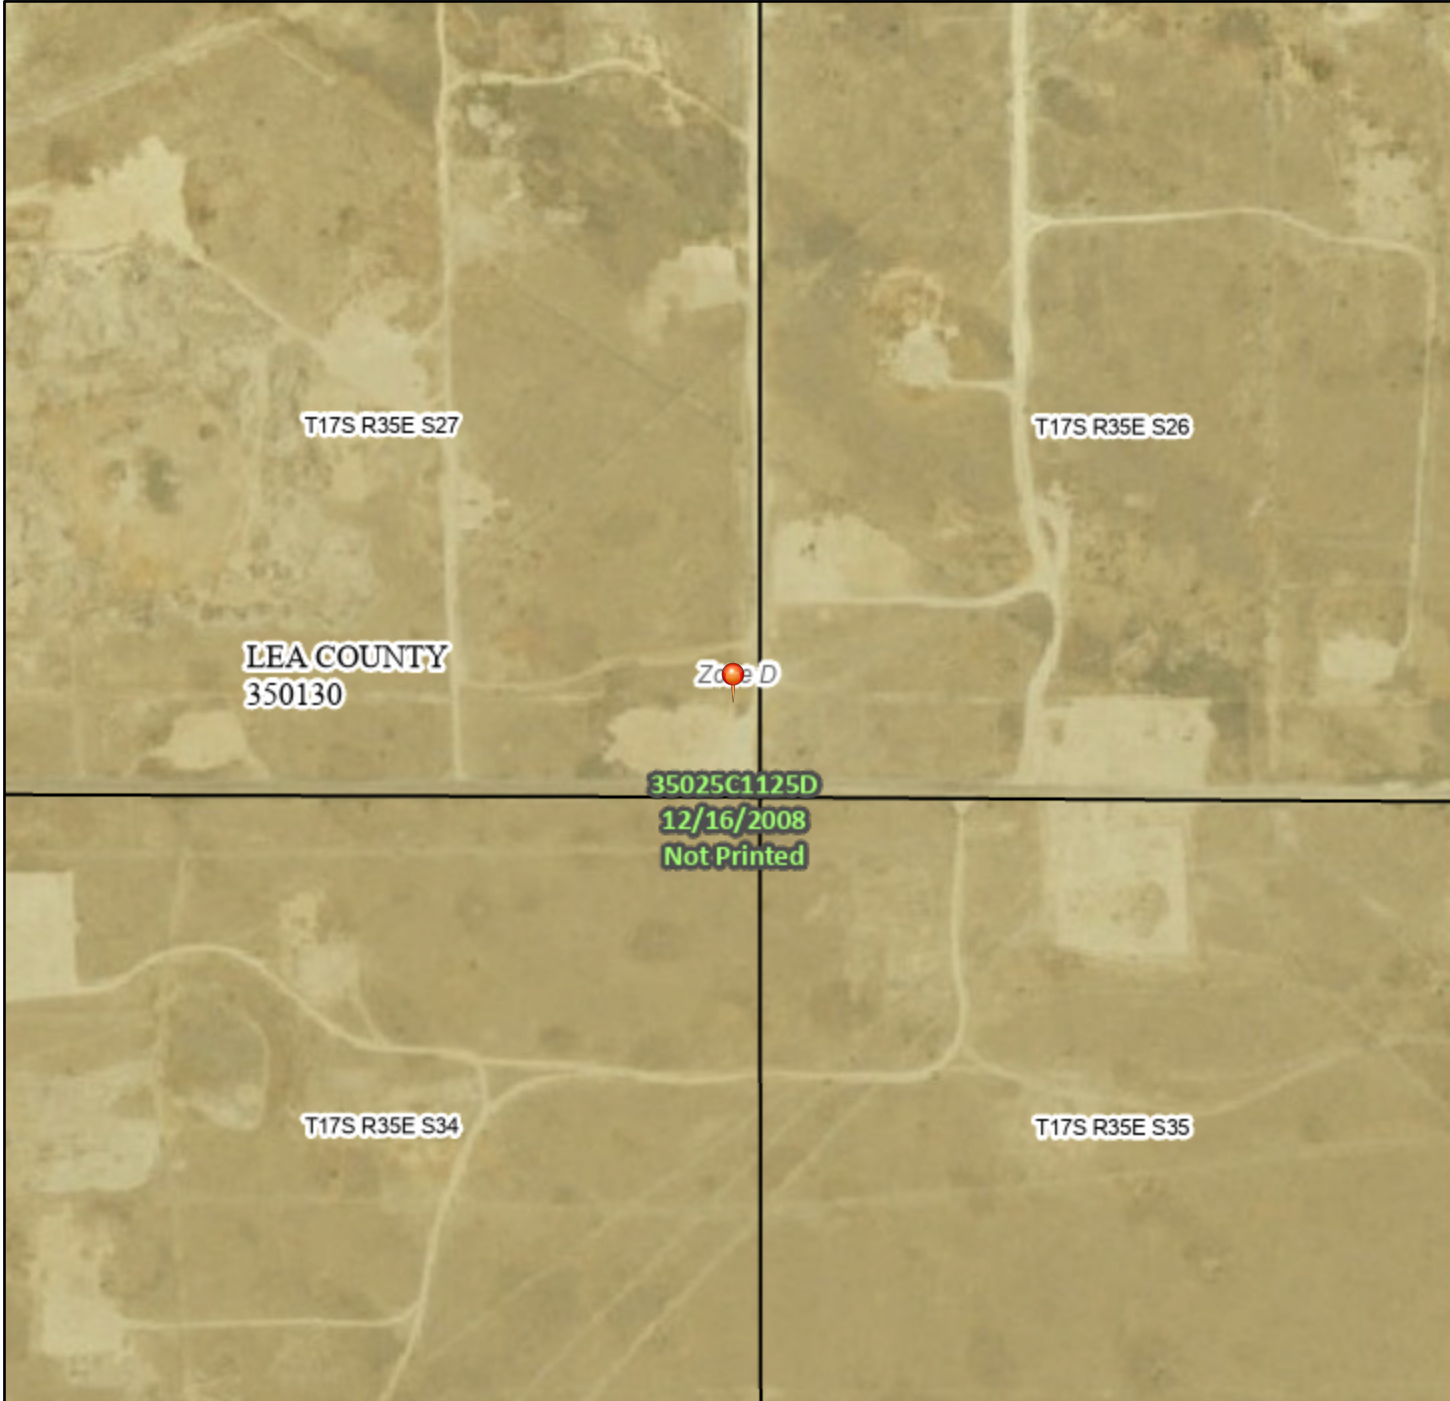
National Flood Hazard Layer FIRMette

Review of flood map data published by the Federal Emergency Management Agency (FEMA) indicates the site is not located within a 100-year floodplain. A copy of the FEMA FIRMet Map can be found attached as Figure 4.
