## A-2-3-7 EXT LINE LEAK Remediation Action Plan

NMOCD Incident No. nAPP2331222132  
UL "J", Sec. 19, T17S, R35E  
32.81748, -103.49475  
Lea County, New Mexico

September 25, 2024

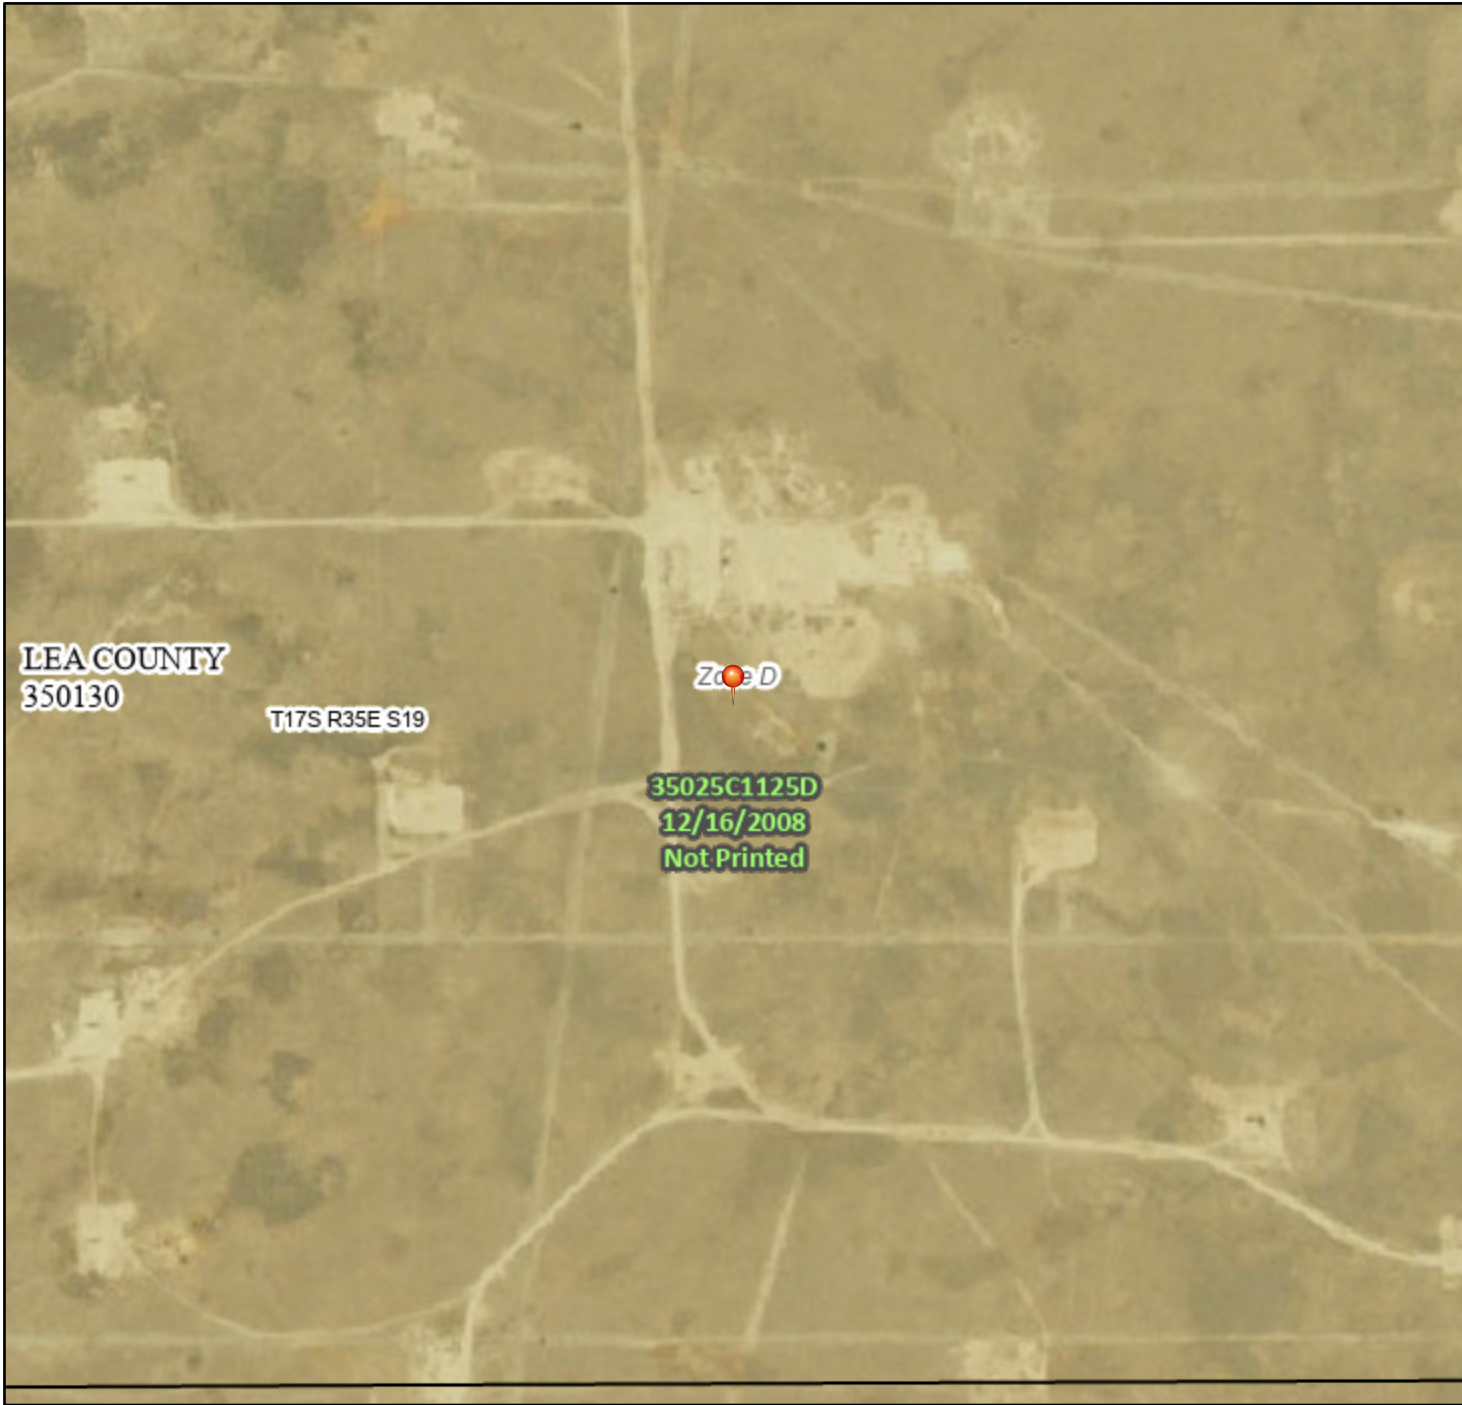
# National Flood Hazard Layer FIRMette

Review of flood map data published by the Federal Emergency Management Agency (FEMA) indicates the site is not located within a 100-year floodplain. A copy of the FEMA FIRMete Map can be found attached as Figure 4.

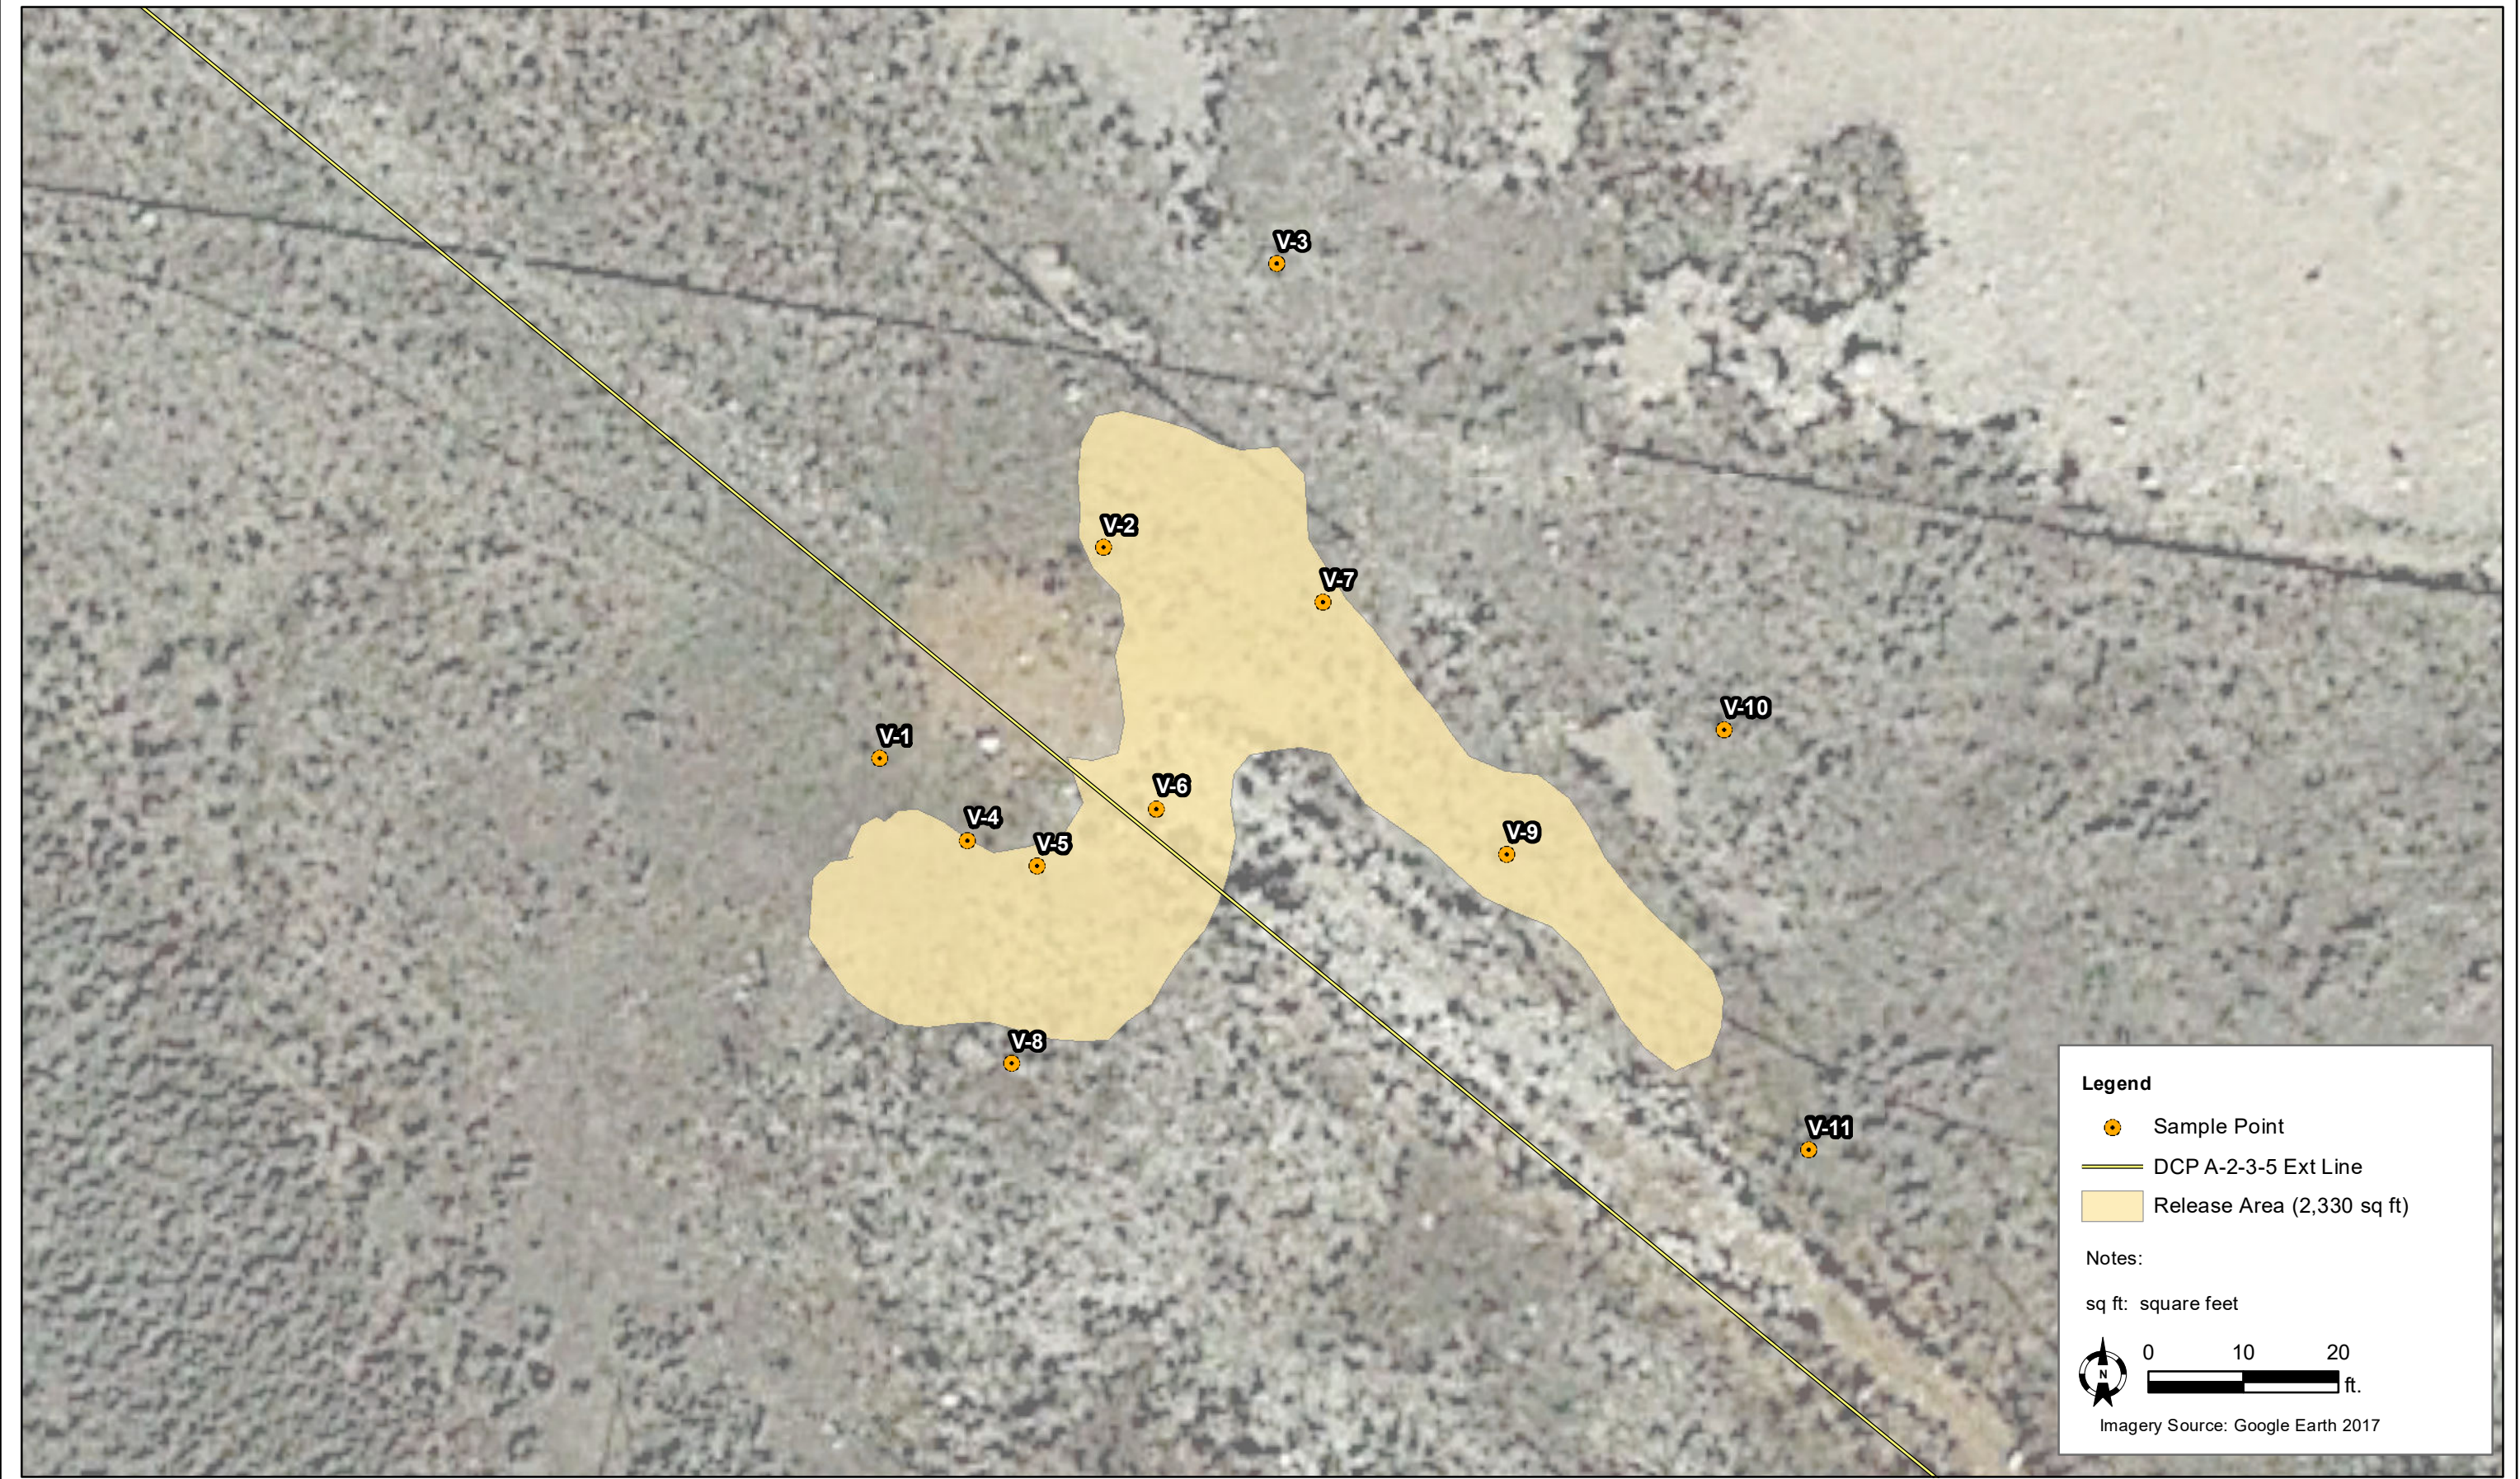
The attached Figure 5 illustrates the observed release and location of soil sample locations.
