Release Assessment and Deferral

Big Eddy Unit DI 9 35H

Vertex File Number: 24E-01314

The release occurred on December 16, 2023, due to equipment failure. The incident was reported on December 20, 2023, and involved the release of approximately 5 barrels (bbl) of produced water and 2 bbl of crude oil on the pad around the wellhead. Approximately 7 bbl of free fluid was removed during initial clean-up. Additional details relevant to the release are presented in the C-141 Report.

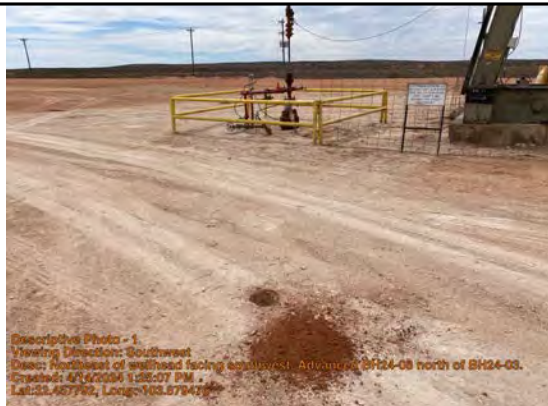
Northeast of wellhead facing southwest.
Advanced BH24-08 north of BH24-03.

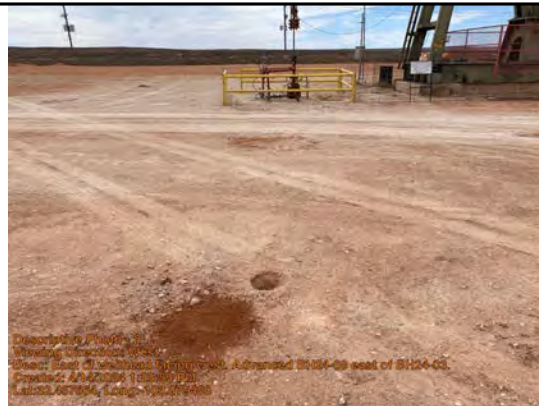
East of wellhead facing west. Advanced BH24-09 east of BH24-03.

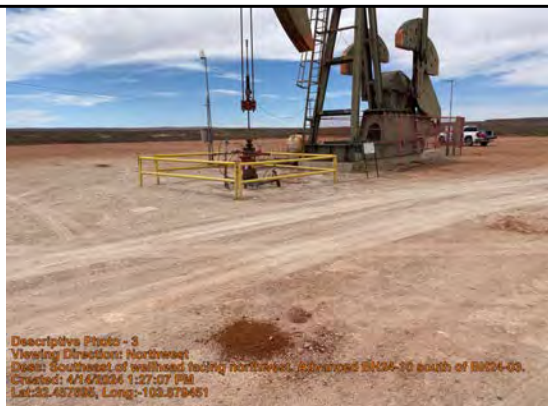
Southeast of wellhead facing northwest.
Advanced BH24-10 southeast of BH24-03.

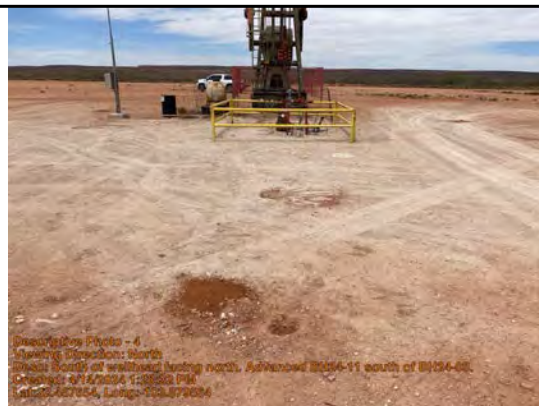
South of wellhead facing north. Advanced BH24-11 south of BH24-04.

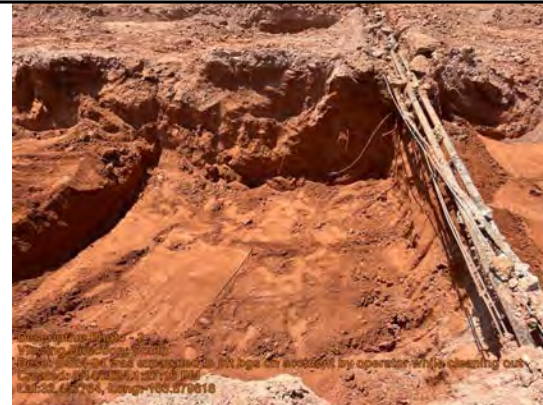
BS24-04 was excavated to 8ft bgs on accident by operator while cleaning out the area

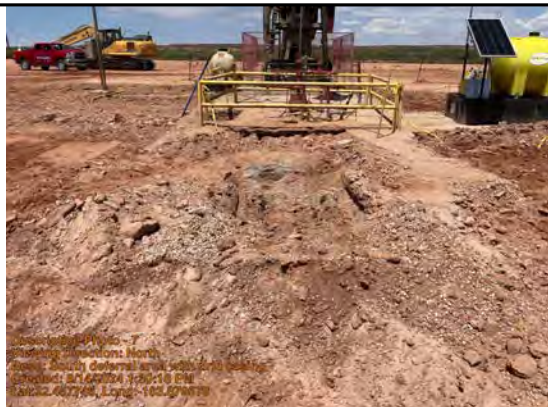
South deferral area with drill casing

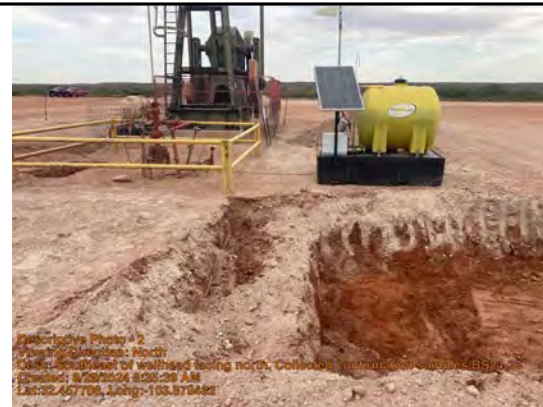
Southeast of wellhead facing north. Collected confirmation samples BS24-33 and WS24-22 from excavation to 3 feet bgs.

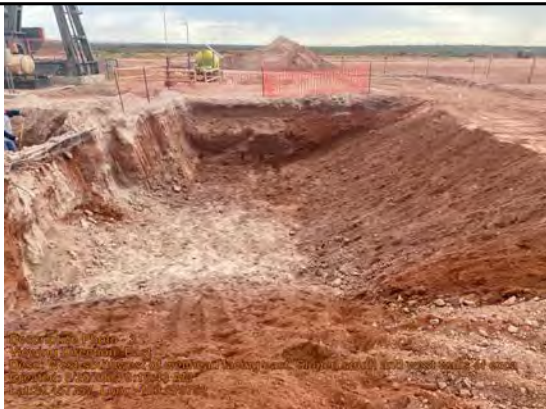
West-southwest of wellhead facing east. Sloped south and west walls of excavation to 10 feet bgs.

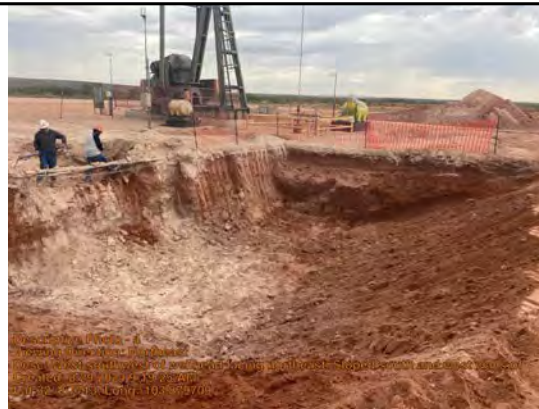
West-southwest of wellhead facing northeast. Sloped south and west walls of excavation to 10 feet bgs.

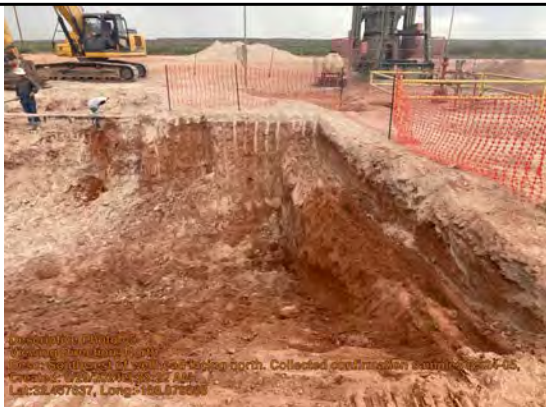
Southwest of wellhead facing north. Collected confirmation samples BS24-05, BS24-35, WS24-25, and WS24-26 from base/walls of excavation to 10 feet bgs.

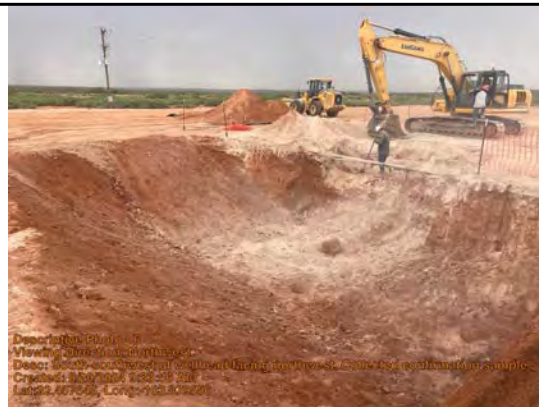
South-southwest of wellhead facing northwest. Collected confirmation samples BS24-02, BS24-05, and BS24-35 from base of excavation to 10 feet bgs.

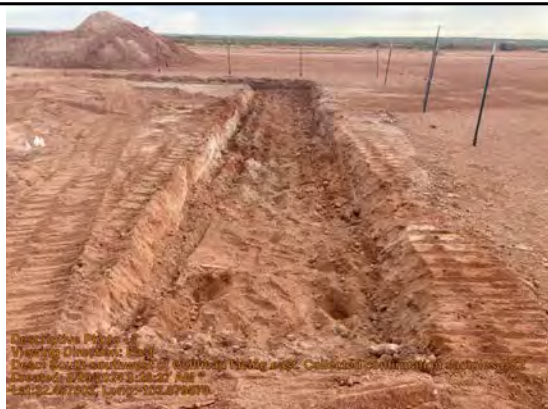
South-southwest of wellhead facing east. Collected confirmation samples BS24-29, BS24-30, BS24-32, and WS24-21 from base/wall of excavation to 1 feet bgs.

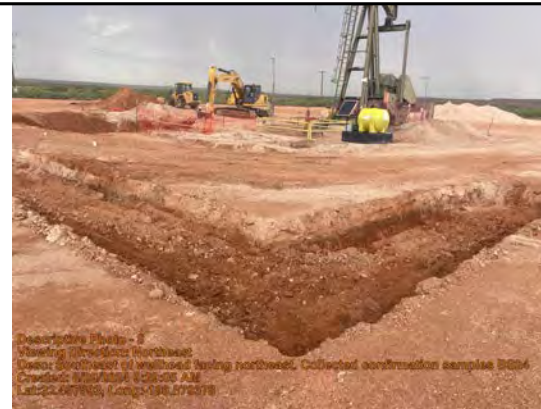
Southeast of wellhead facing northeast. Collected confirmation samples BS24-29, BS24-30, BS24-31, BS24-32, and WS24-21 from base/wall of excavation to 1 feet bgs.

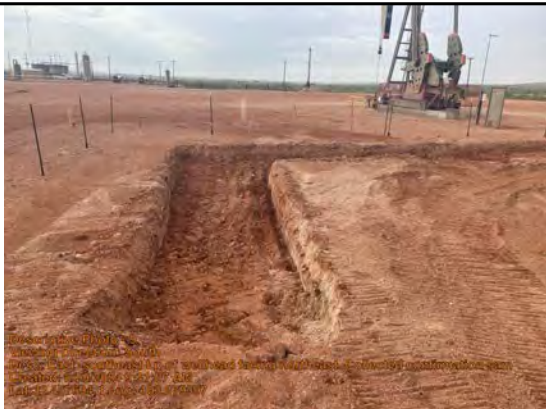
East-southeast lip of wellhead facing northeast. Collected confirmation samples BS24-30, BS24-31, BS24-32, and WS24-21 from base/wall of excavation to 1 feet bgs.

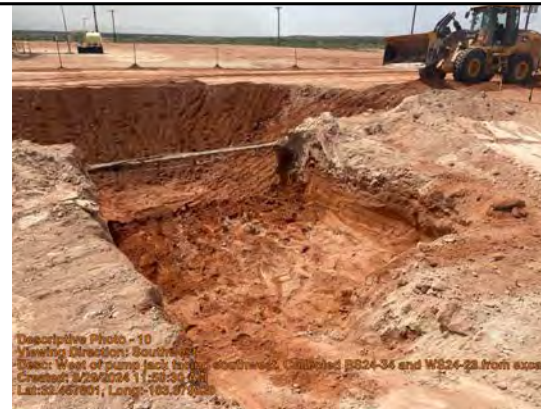
West of pump jack facing southwest. Collected BS24-34 and WS24-23 from excavation to 5 feet bgs.

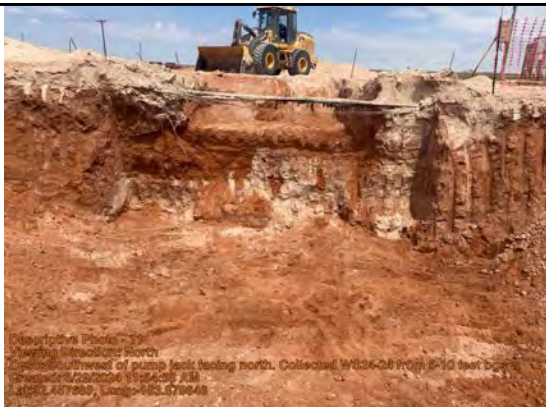
Southwest of pump jack facing north. Collected WS24-24 from 5-10 feet bgs wall between excavation depths.
