LEAK #34

Remediation Action Plan

NMOCD Incident No. nAPP2412818139
UL "C", Sec. 15, T22S, R37E
32.396100, -103.154549
Lea County, New Mexico

October 3, 2024

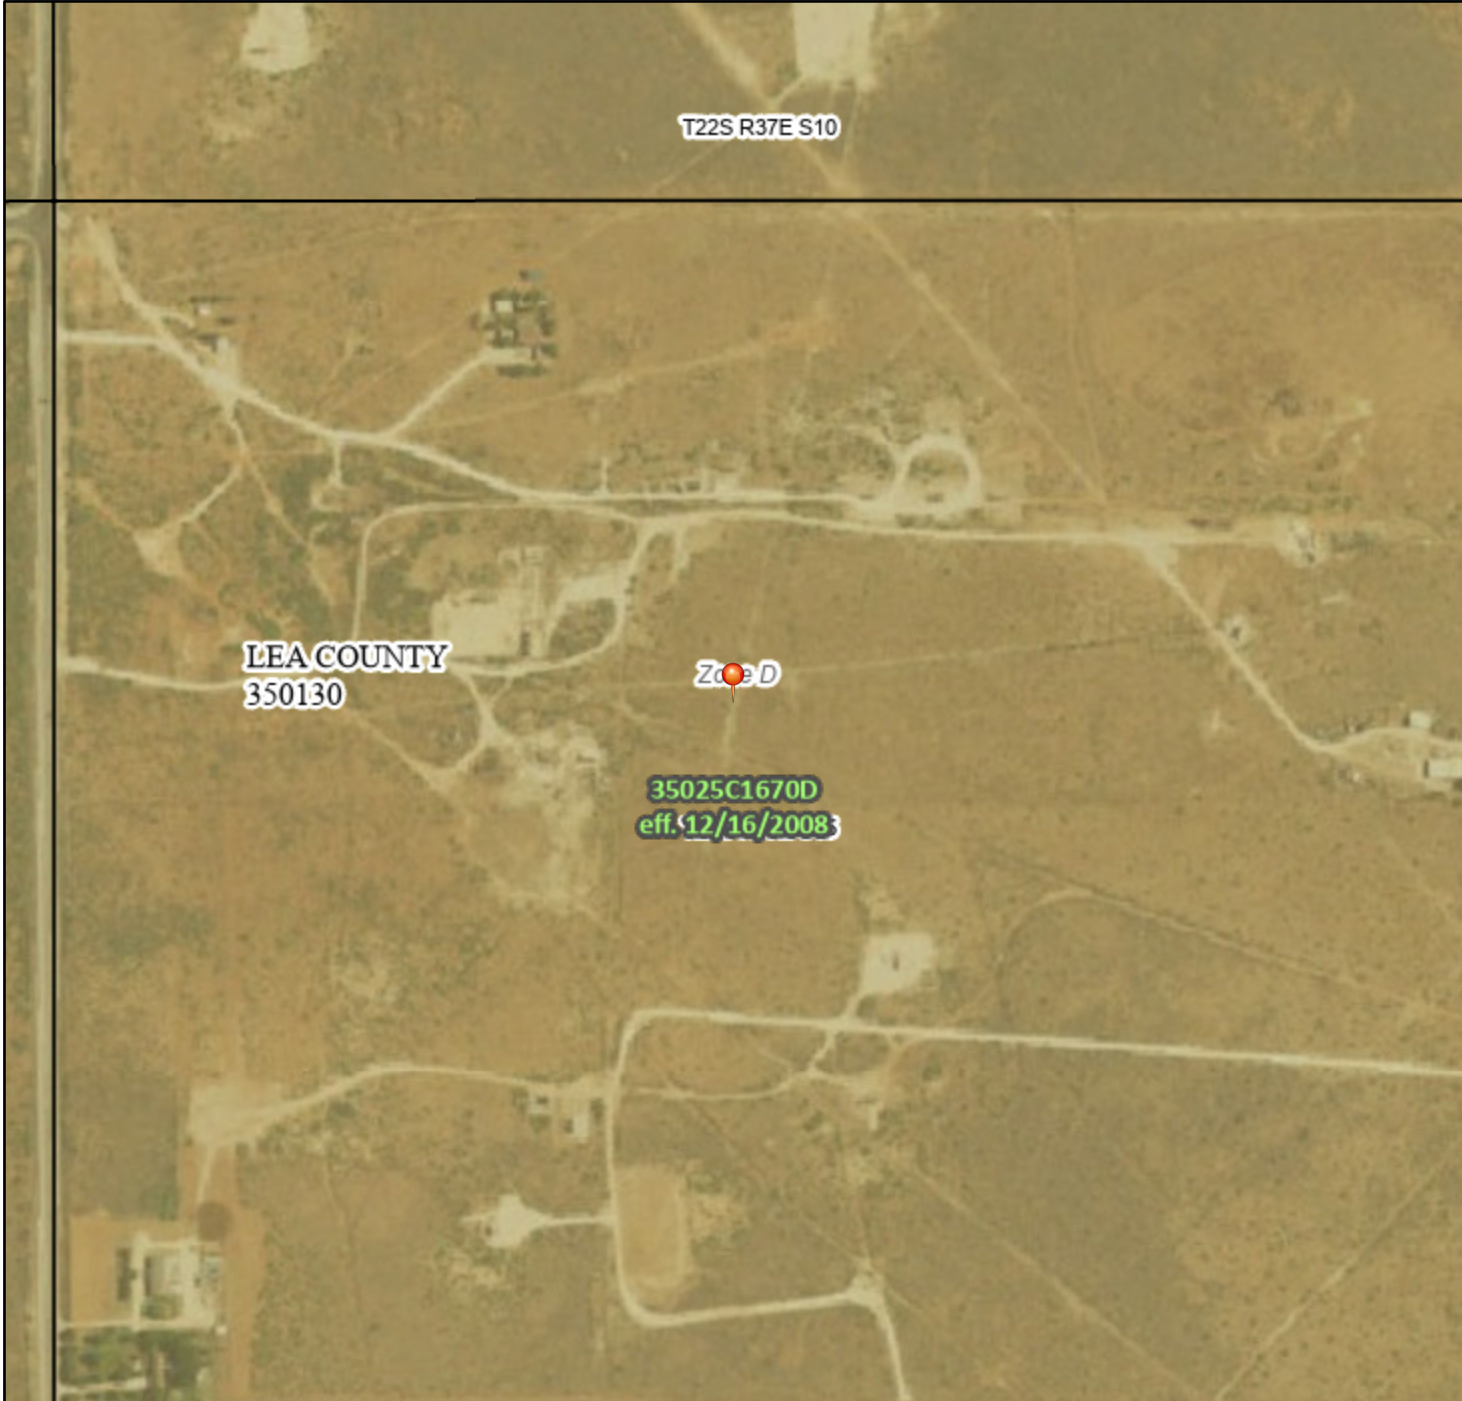
National Flood Hazard Layer FIRMette

Review of flood map data published by the Federal Emergency Management Agency (FEMA) indicates the site is not located within a 100-year floodplain. A copy of the FEMA FIRMet Map can be found attached as Figure 4.

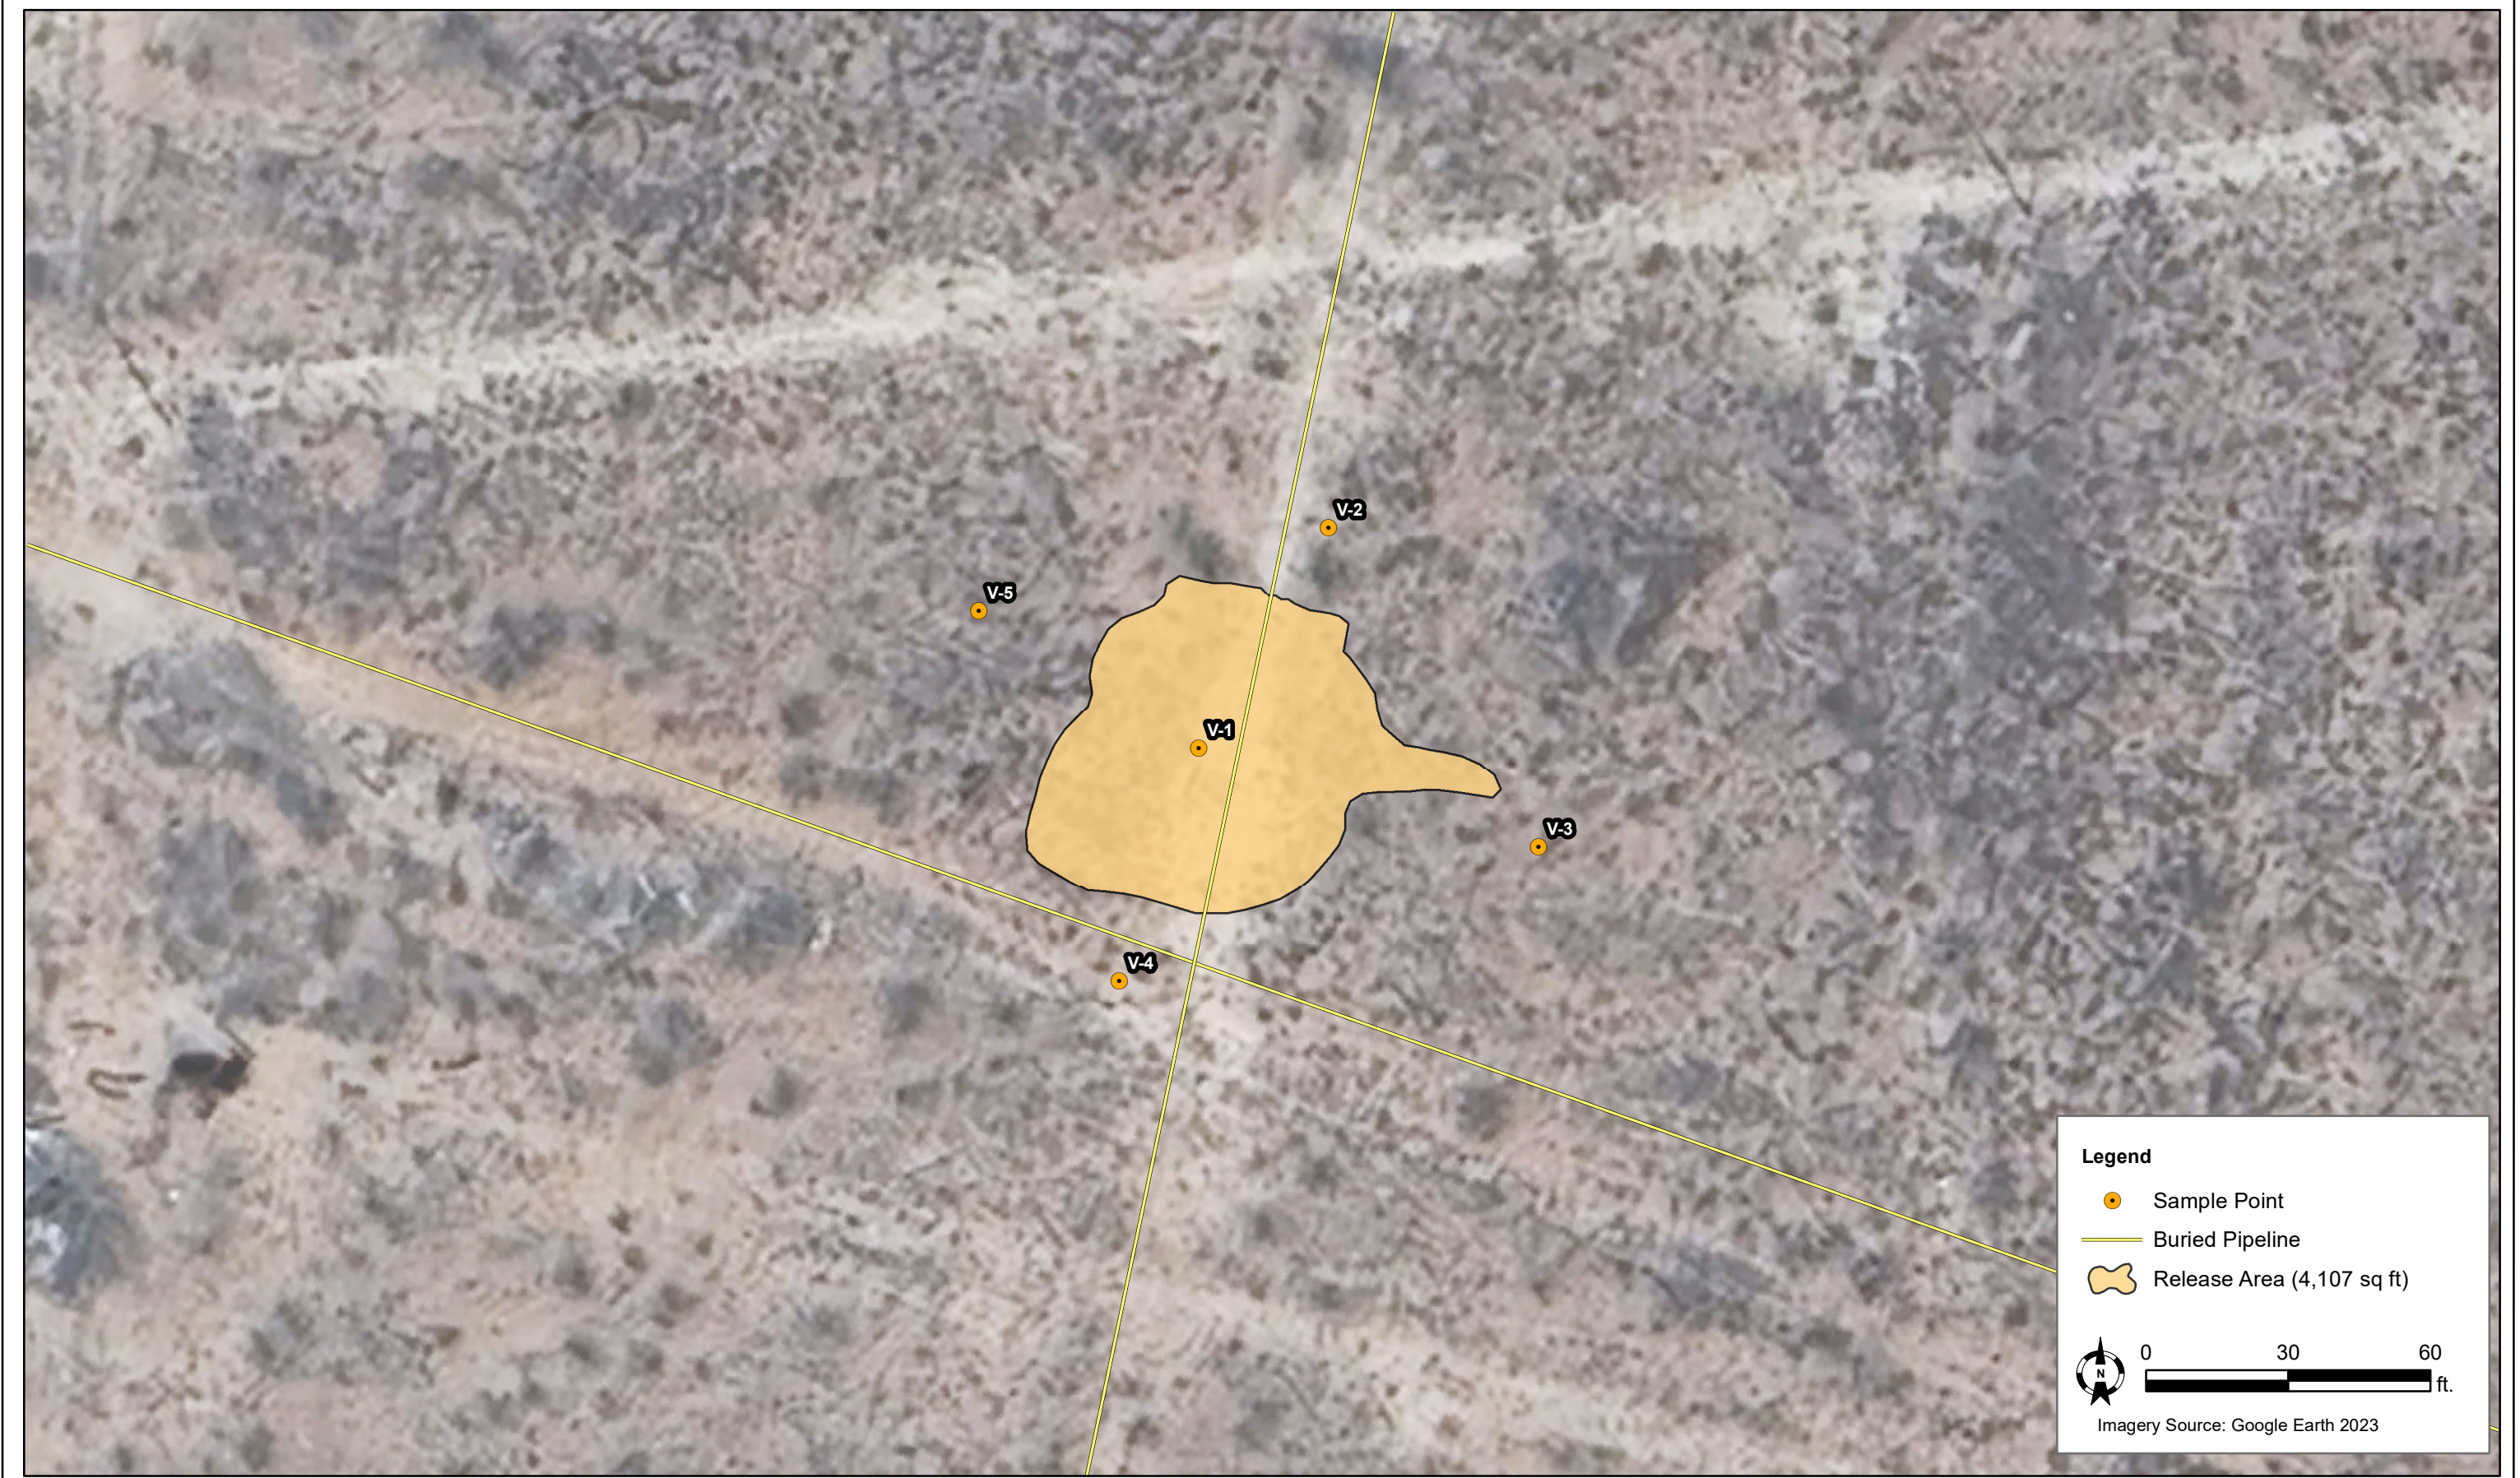
The attached Figure 5 illustrates the observed release and location of soil sample locations.
