RE: Liner Inspection and Closure Report
API No. 30-015-39641
GPS: Latitude 32.683698 Longitude -104.41176
UL- M, Section 05, Township 19S, Range 26E
NMOCD Reference No. nAPP2416454087

Spur Energy Partners (Spur) has contracted Edge Safety (Edge) to perform a liner inspection and prepare this closure report for the release of oil and produced water that happened at the Patton 5 Fee 8 Battery (Patton). On June 12, 2024, the initial C-141 was formally submitted. The corresponding release received the designation Incident ID No. nAPP2416454087 from the New Mexico Oil Conservation Division (NMOCD).

Spur Energy Partners
Patton 5 Fee 8 Battery
Site Photographs

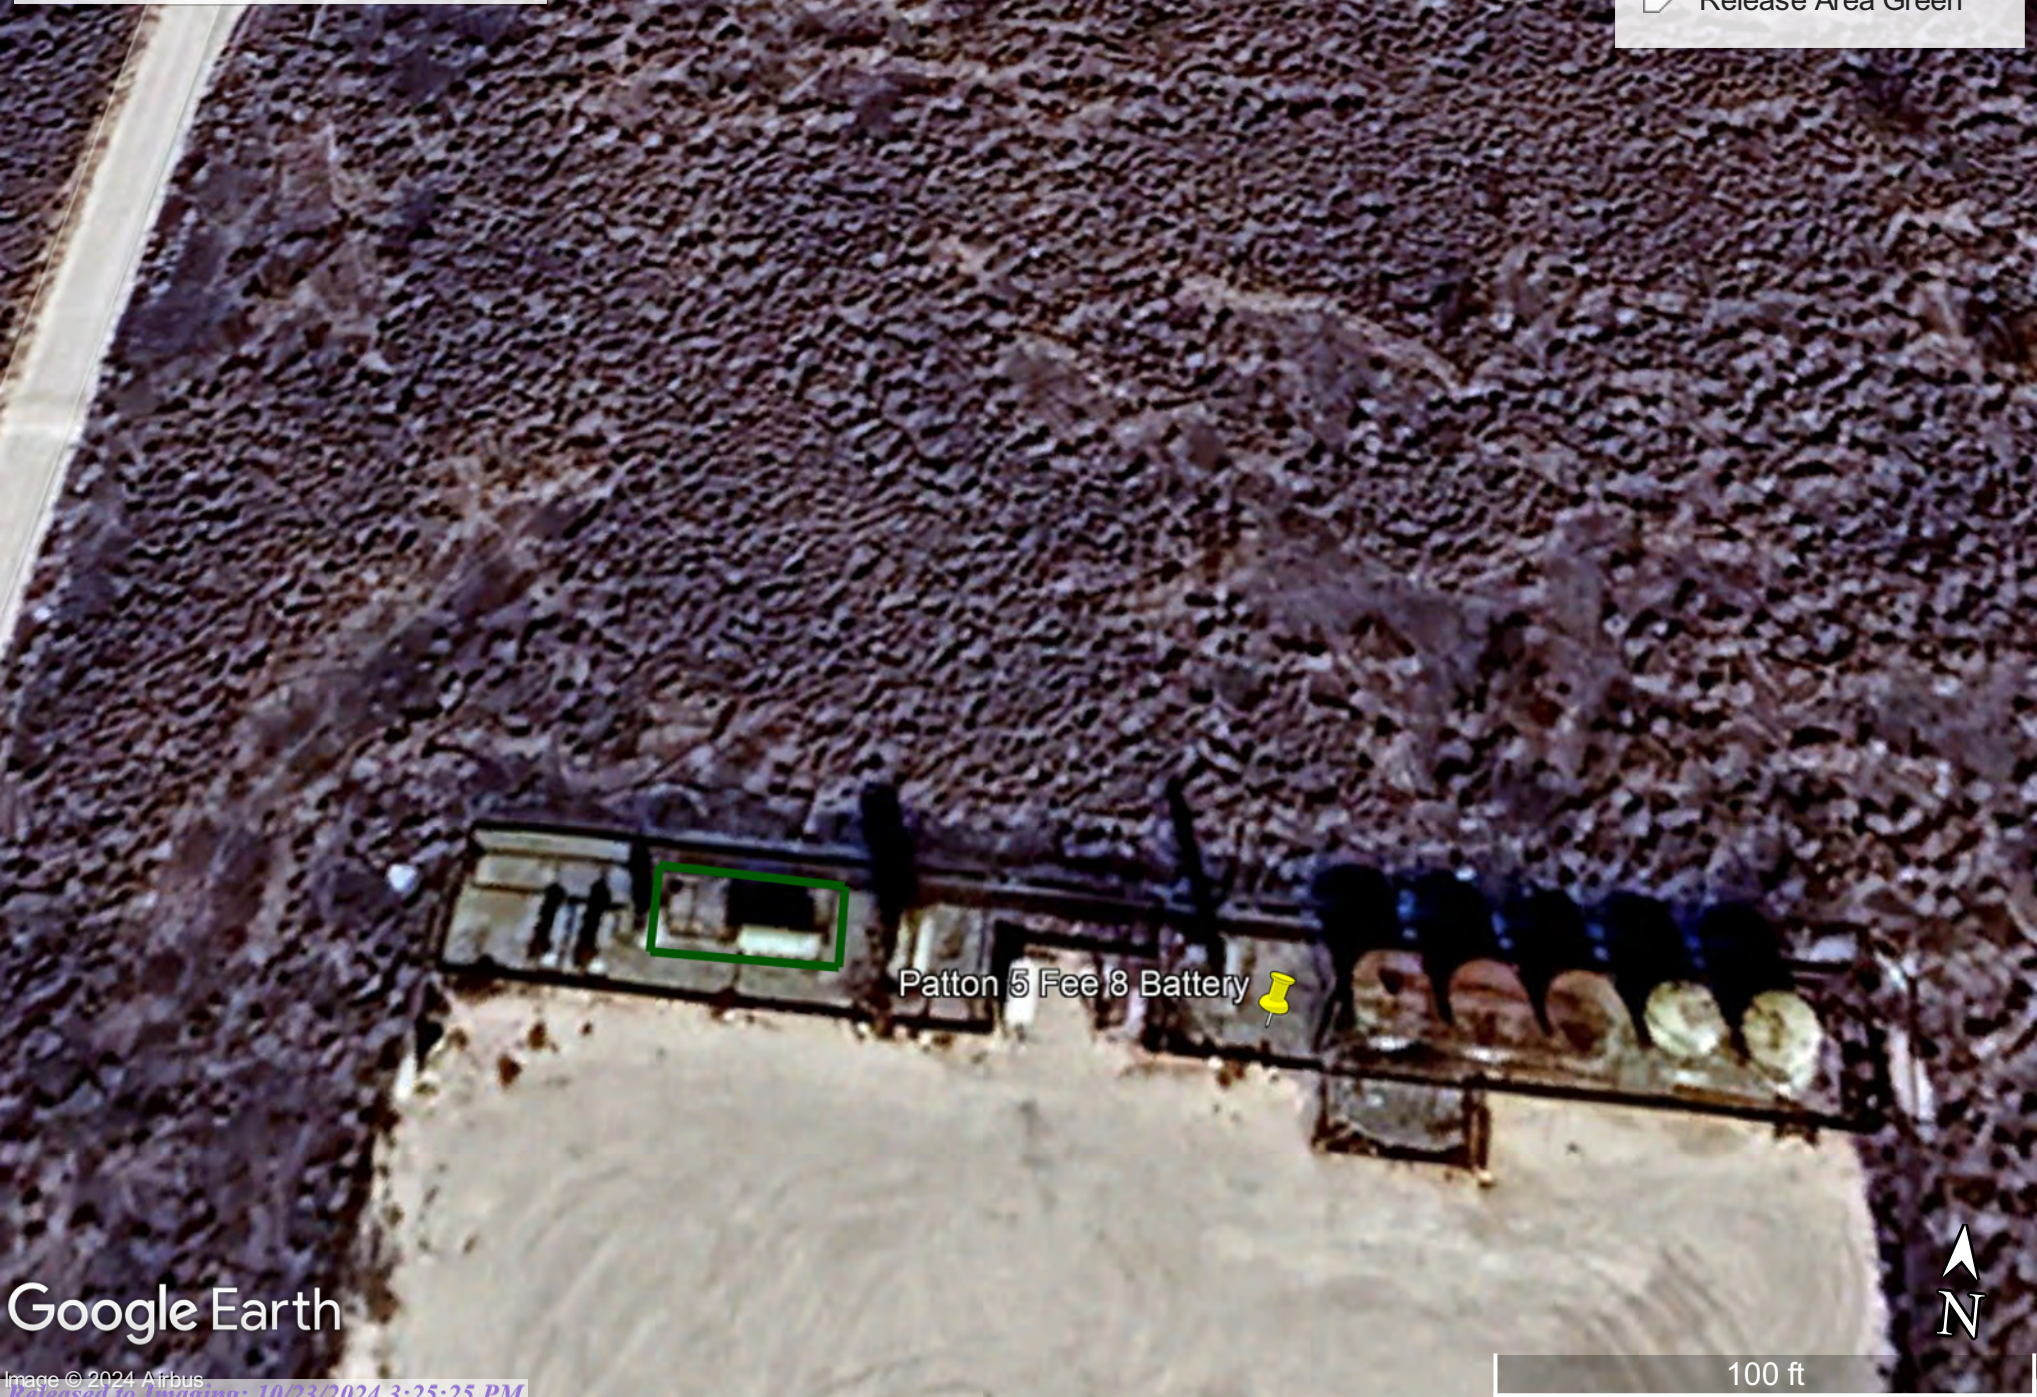
Site Map

nAPP2416454087: On June 12, 2024, the 4" check valve from the separator to the heater developed a pin hole due to internal corrosion causing a 15-barrel spill inside lined containment. The total release area measured approximately 642 square feet.

Release Area Green

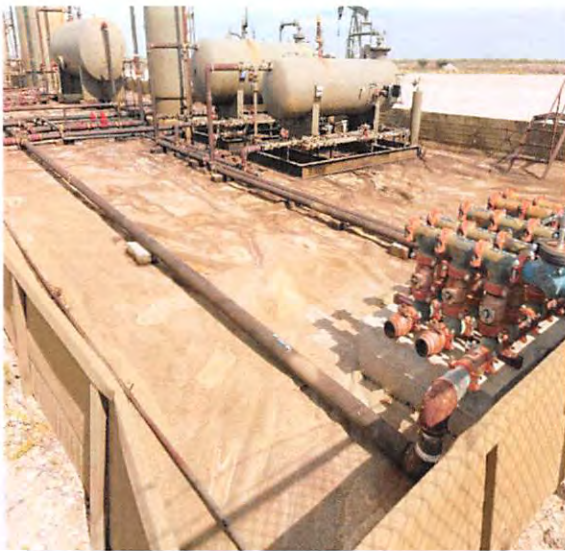
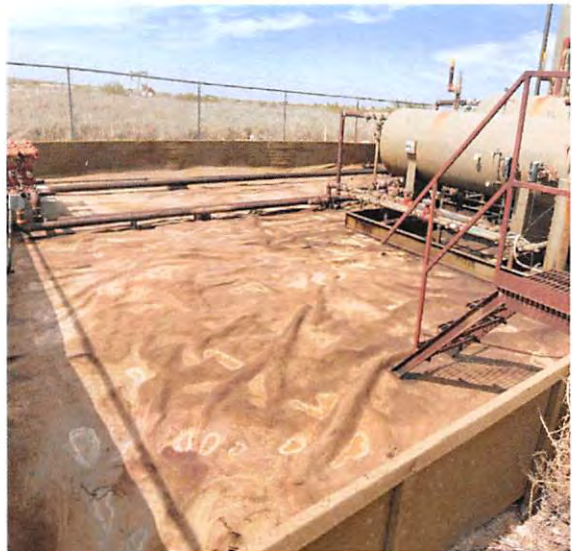
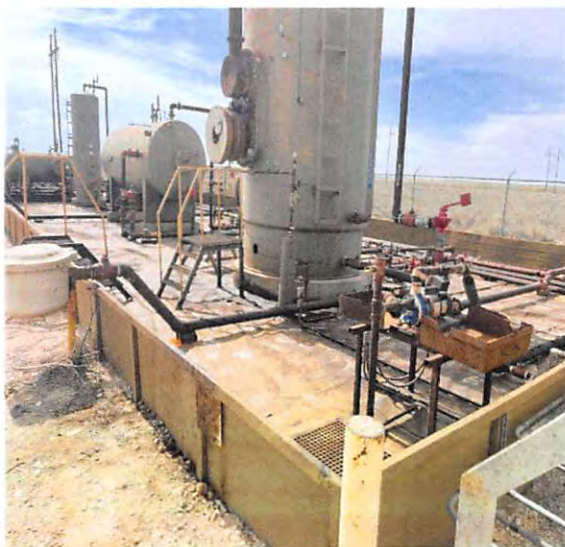
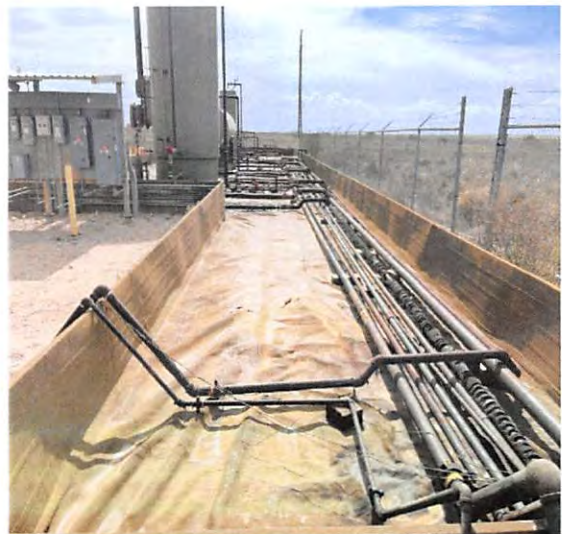
Liner Inspection:

On June 21, 2024, Edge Safety conducted a liner inspection at this location. We concluded that this liner and containment maintained its integrity and was able to retain the fluids. The liner inspection form and photographic documentation can be found in Appendix C.

Visualization	Yes	No	Comments
Is there a tear in the liner?		xx	
Are there Holes in the liner?		xx	
Is the liner retaining any fluids?		xx	
Does the liner have integrity to contain a leak?	xx

June 15, 2024 Tri-Star personnel mobilized their team to the Patton site to conduct remediation efforts within the lined containment area utilizing a Vacuum Truck and Power Washer to uphold integrity of the line. A thorough cleaning spanning 2844 square feet was completed, with approximately 15-barrels of impacted material successfully extracted. Ensuring proper disposal, all contaminated material was transported and disposed of at R360, an approved disposal facility sanctioned by NMOCD. Following this, a detailed inspection for tears and rips was conducted. Upon confirming the absence of any tears or rips, an inspection was conducted to validate the integrity of the liner.
