**Re: Remediation Work Plan
James Ranch Unit DI 1A Battery
Incident Number NAPP2421529493
Eddy County, New Mexico**

Site Receptor Map
XTO Energy, Inc
JAMES RANCH UNIT DI 1A BATTERY
Incident Number: NAPP2421529493
Unit A, Sec 21, T22S, R30E
Eddy Co, New Mexico, United States

James Ranch Unit DI 1A Battery

NAPP2421529493

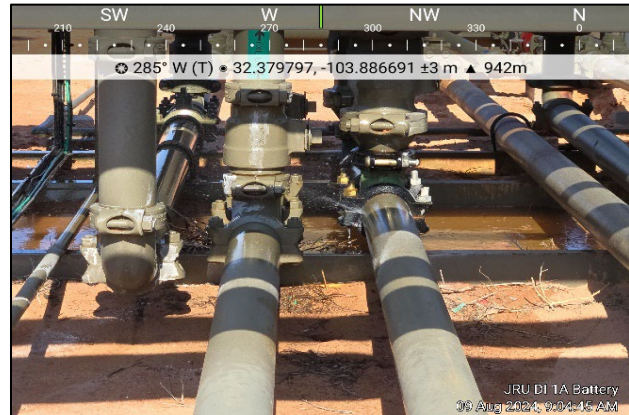
On July 26, 2024, a corrosion on a 4-inch tester joint resulted in the release of 15 barrels (bbls) of produced water onto the pad. No fluids were recovered. XTO reported the release to the New Mexico Oil Conservation Division (NMOCD) on August 9, 2024 and the release was assigned Incident Number NAPP2421529493.

Photograph: 2 Date: 8/9/2024
Description: Active leak
View: Northwest

Yes maam everything has been stopped that was a internal picture that was used. I have talked with the consultants and that will not happen again.

I talked with the Consulting company and they just used a photo we had from an internal form we use and the other photos was after. But release is stopped and everything is good. Just waiting for your approval on work plan.

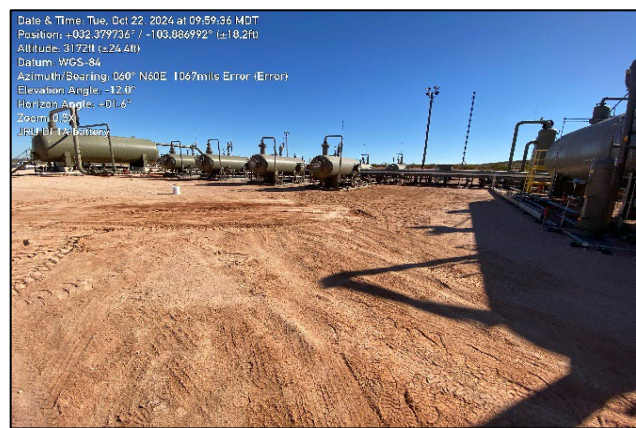
Photograph: 4 Date: 10/22/2024
Description: Remediation activities
View: Northeast
