LAGUNA SALADO SOUTH #1

PREPARED BY:
PIMA ENVIRONMENTAL SERVICES, LLC

Remediation Closure Report

Re: Remediation Closure Report
Laguna Salado South #001
API # 30-015-26407
NMOCD Incident ID nLLB0631140464
ULSTR - F - 22 - 23S - 29E 2030 FNL 1980 FWL Eddy County, NM
GPS Coordinates: Latitude 32.2922554 Longitude -103.9748001

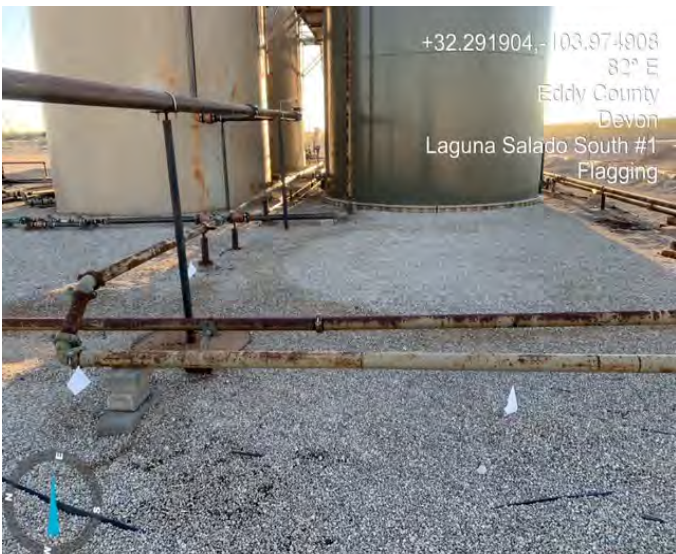
Gravel removal West

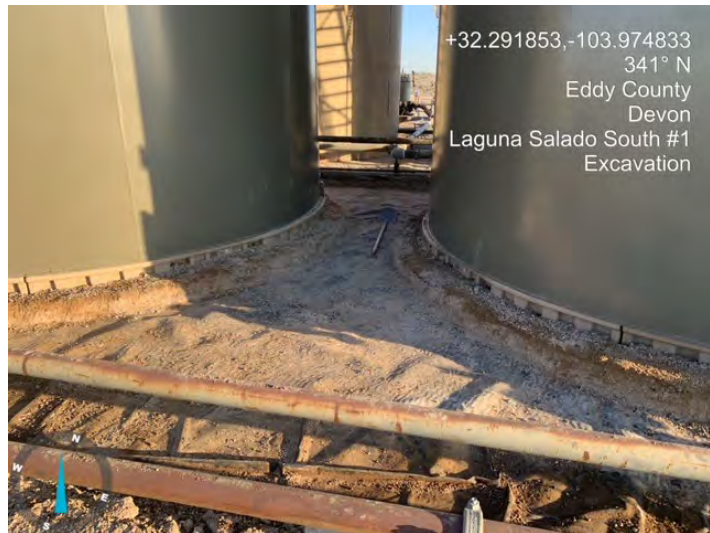
Liner inspection 4

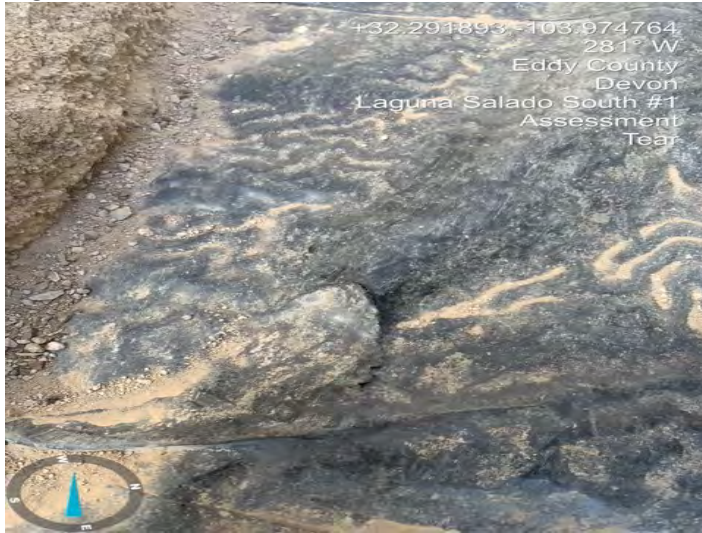
Hole in liner 1

Visualization	Yes	No	Comments
Is there a tear in the liner?	X		There are 2 tears in the liner, collect samples underneath each tear from 0 – 4 feet.
Are there holes in the liner?		X	
Is the liner retaining any fluids?		X	
Does the liner have integrity to contain a leak?		X

Comments: Liner needs repair after samples are collected from underneathInspector Name: Andrew Franco Inspector Signature: Andrew Franco

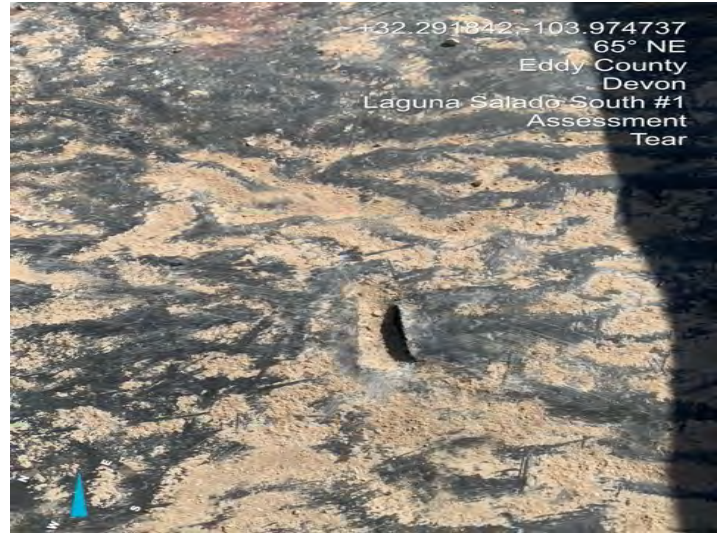
Hole in liner 2

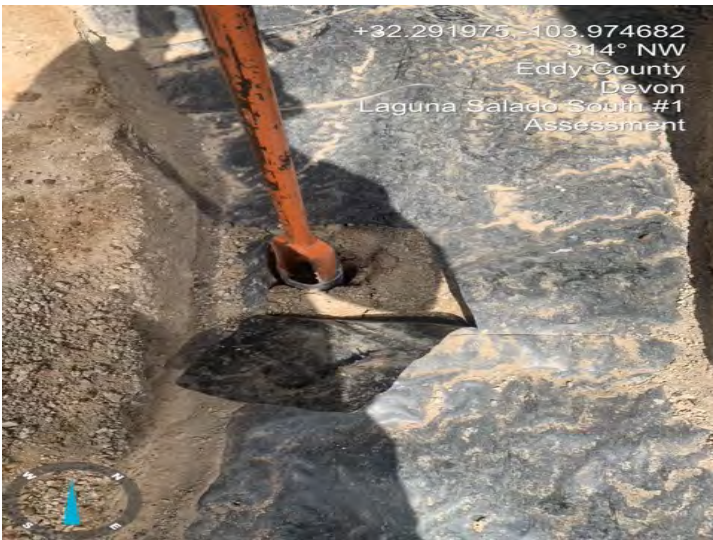
Samples from under liner

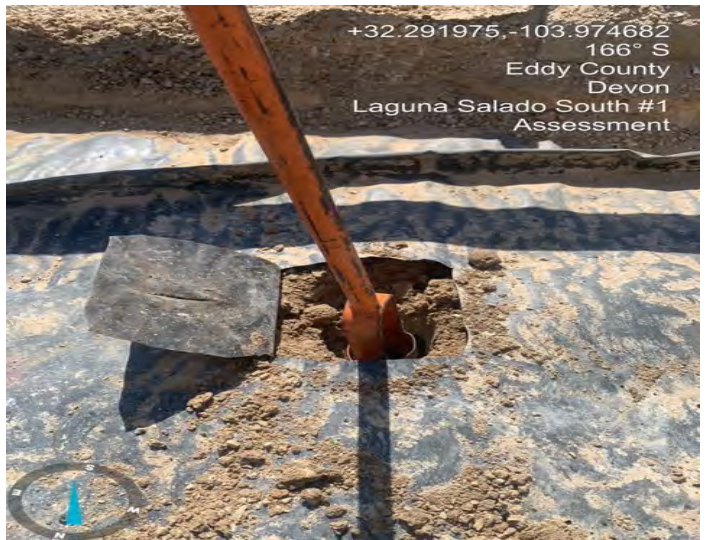
Samples from under liner

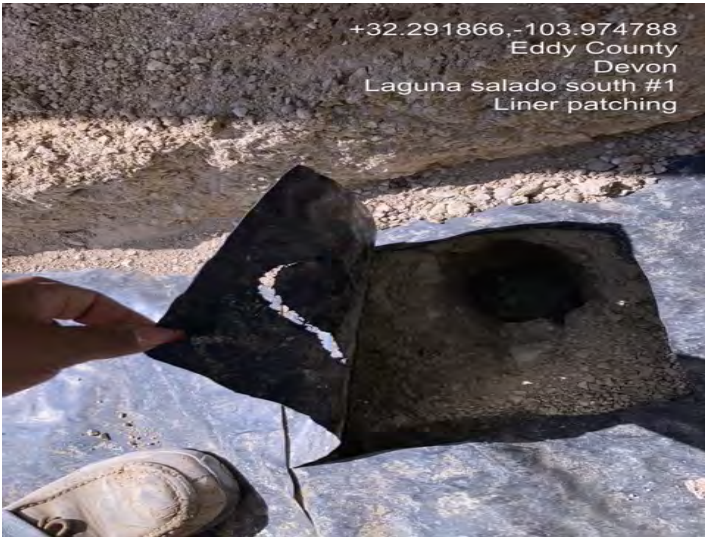
Liner patch 1

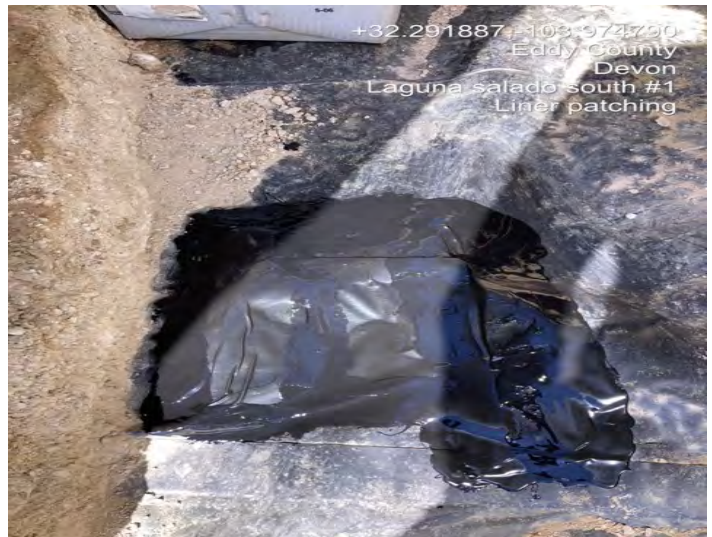
Liner patch 2

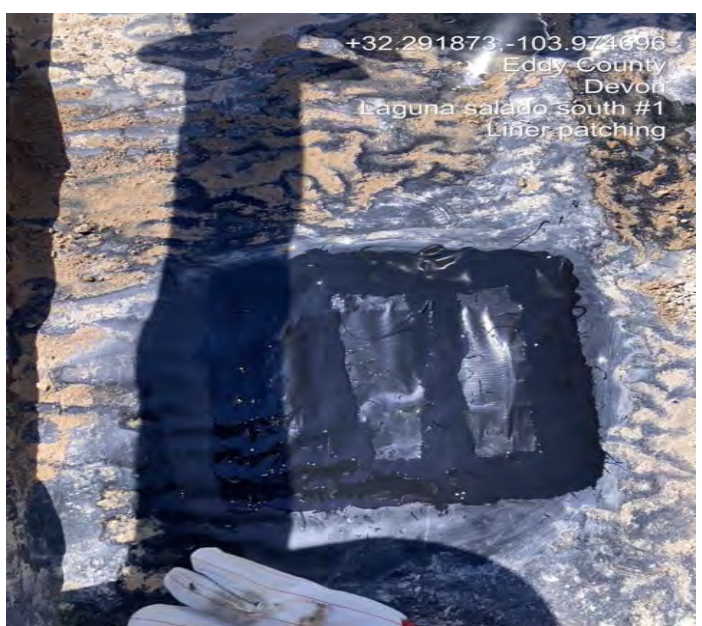
Liner patch 4

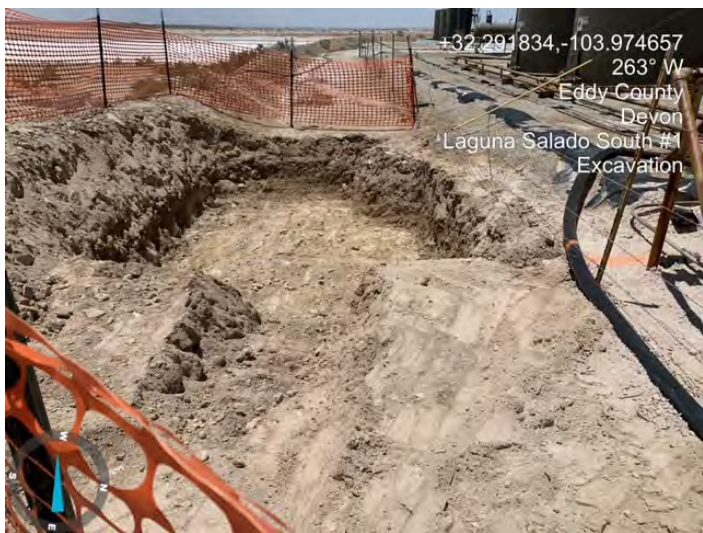
Excavation N2 area

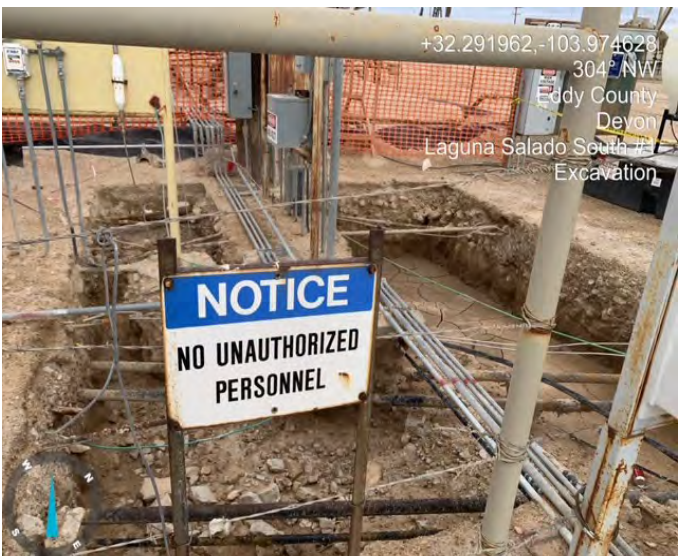
Excavation P1 area

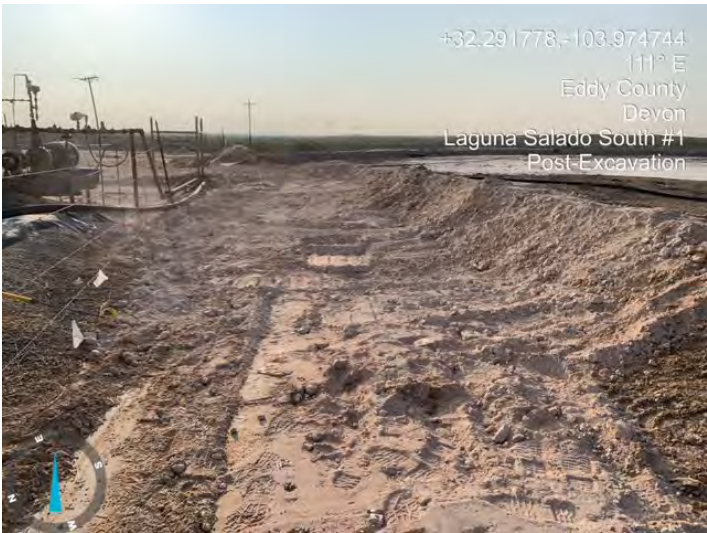
Backfill N2 area

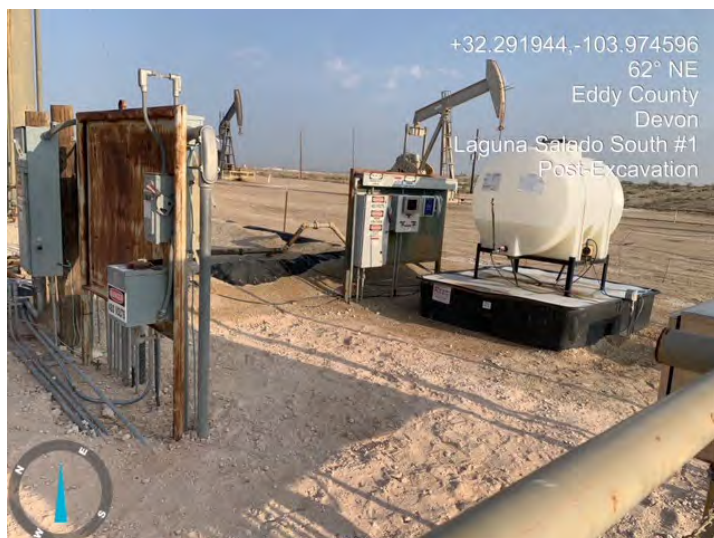
Backfill P1 area
