Remediation and Closure Report

Red Tank 3 Federal #014H R.O.W.
Incident# nAPP2412576675
Lea County, New Mexico

Subject: **Remediation and Closure Report**
Red Tank 3 Federal #014H R.O.W.
Lea County, NM

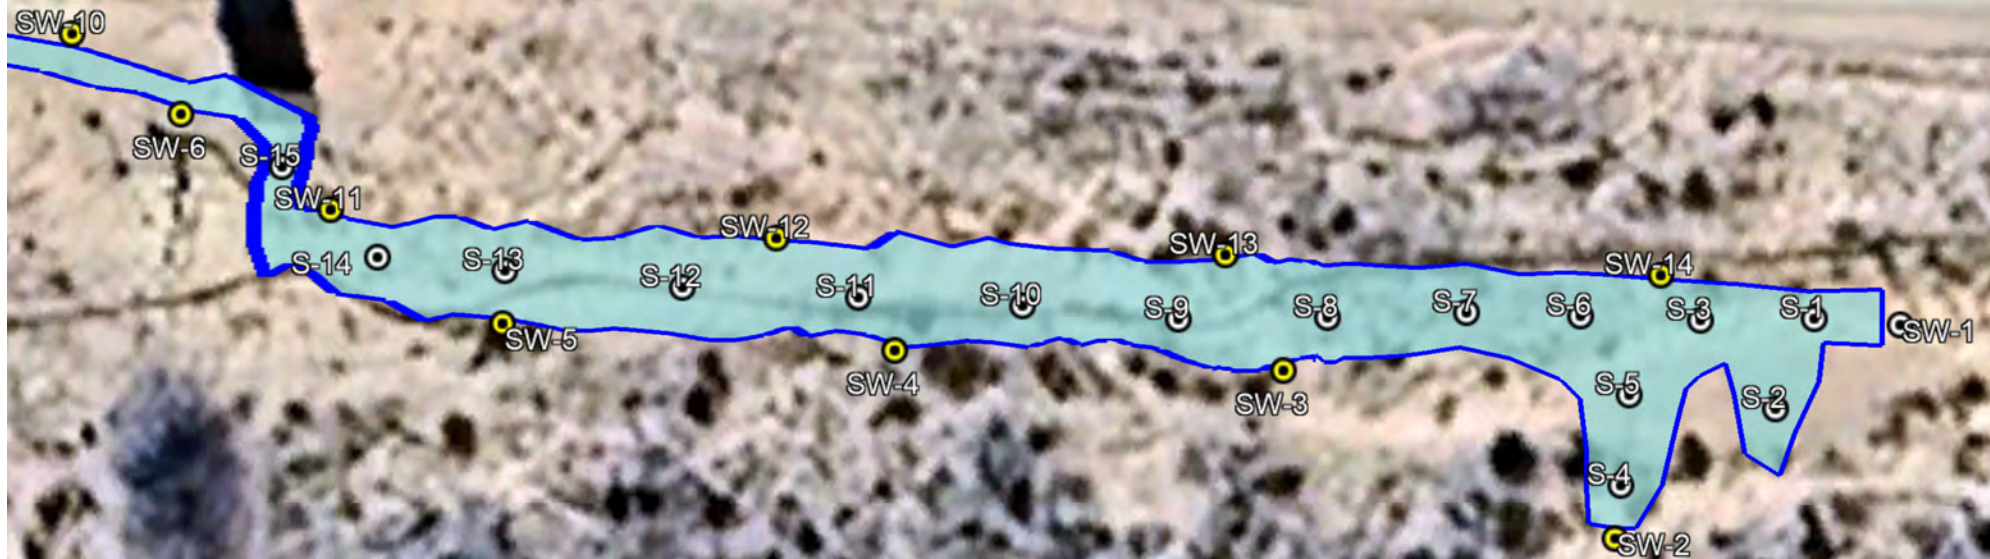
Sidewall Composite Confirmation Sample

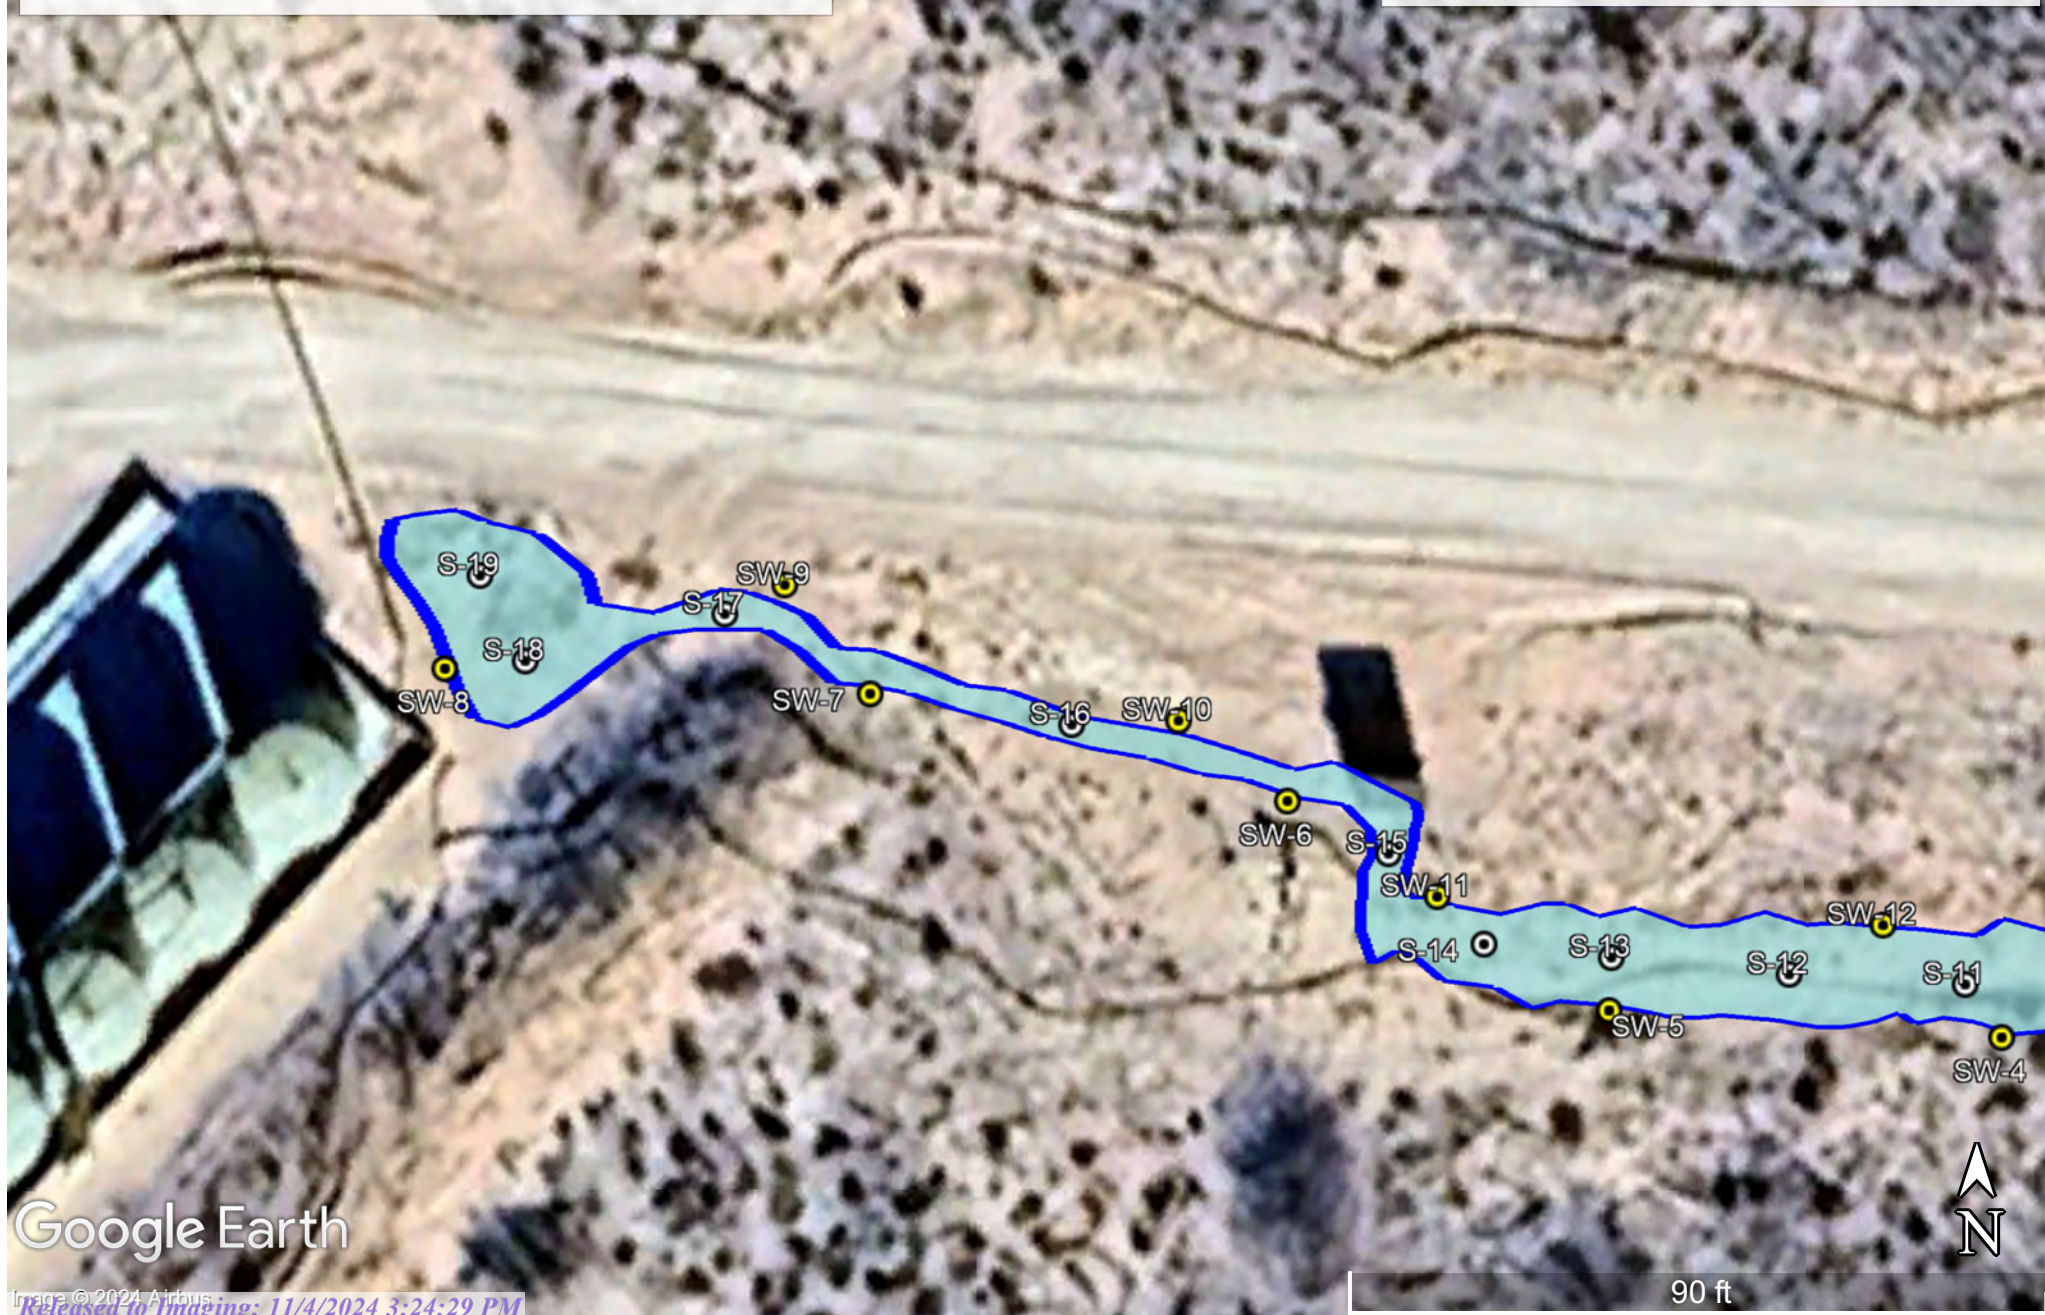
Sidewall Composite Confirmation Sample

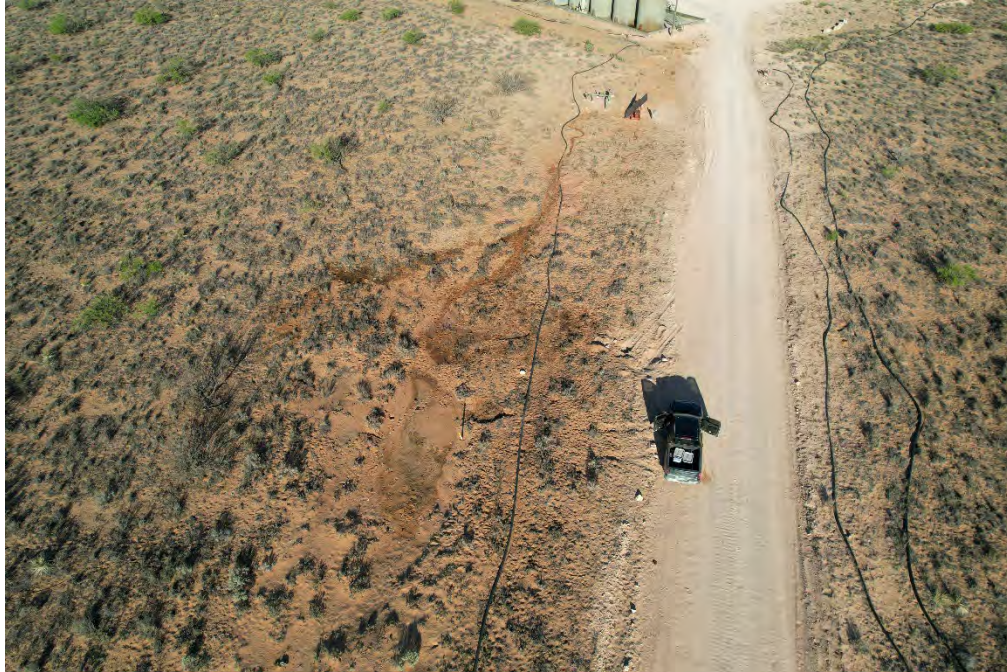
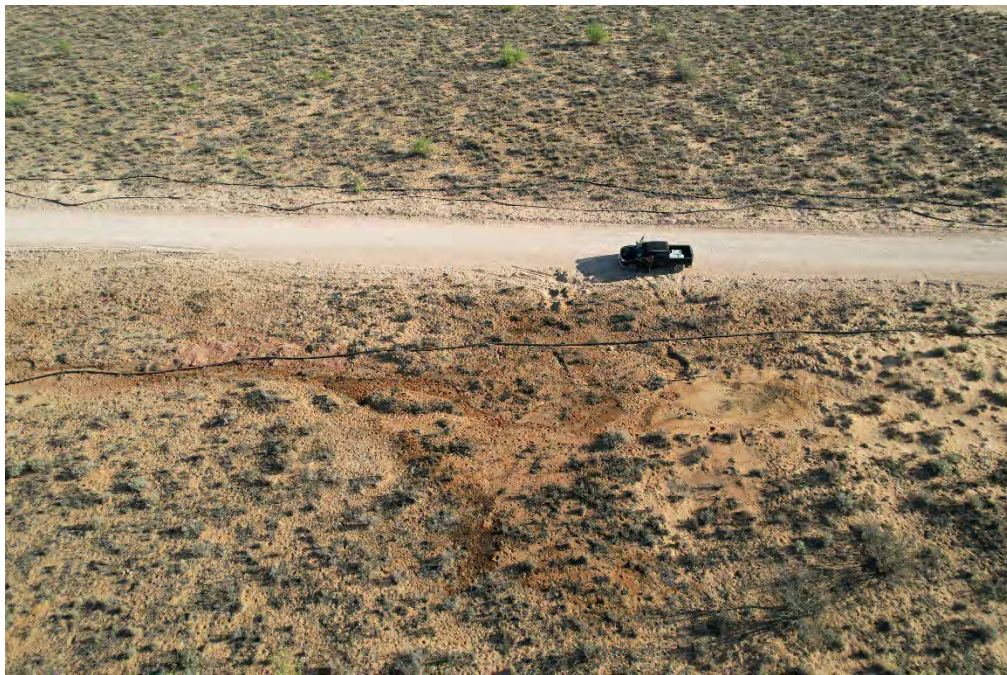
INITIAL RELEASE PHOTOGRAPHS

On May 04, 2024, it was discovered that a 4-inch poly line had failed causing the release of 28 barrels (bbls) of produced water onto the right-of-way where it was laying. A total of 0 bbls of fluid were recovered.

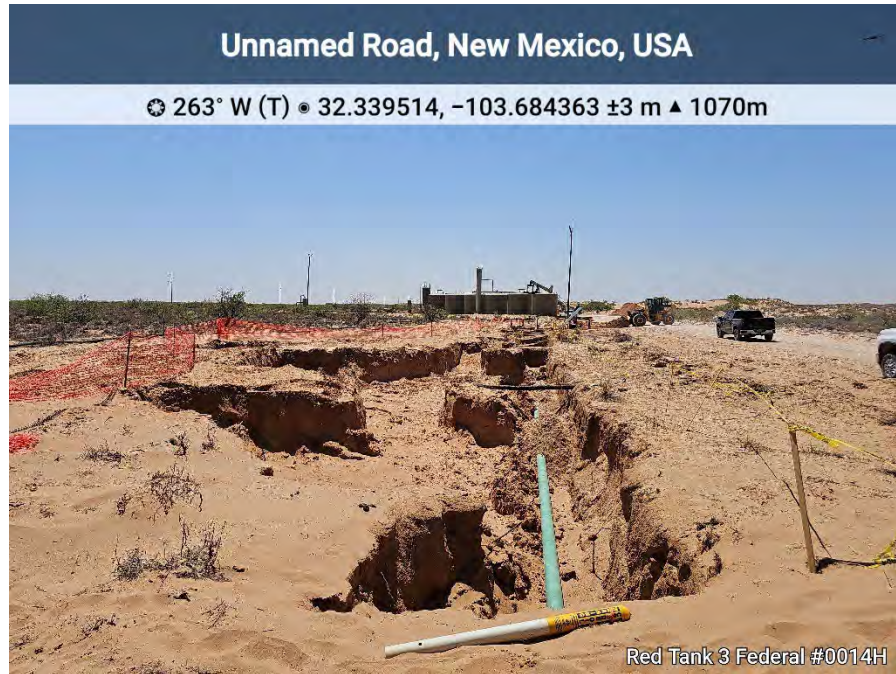
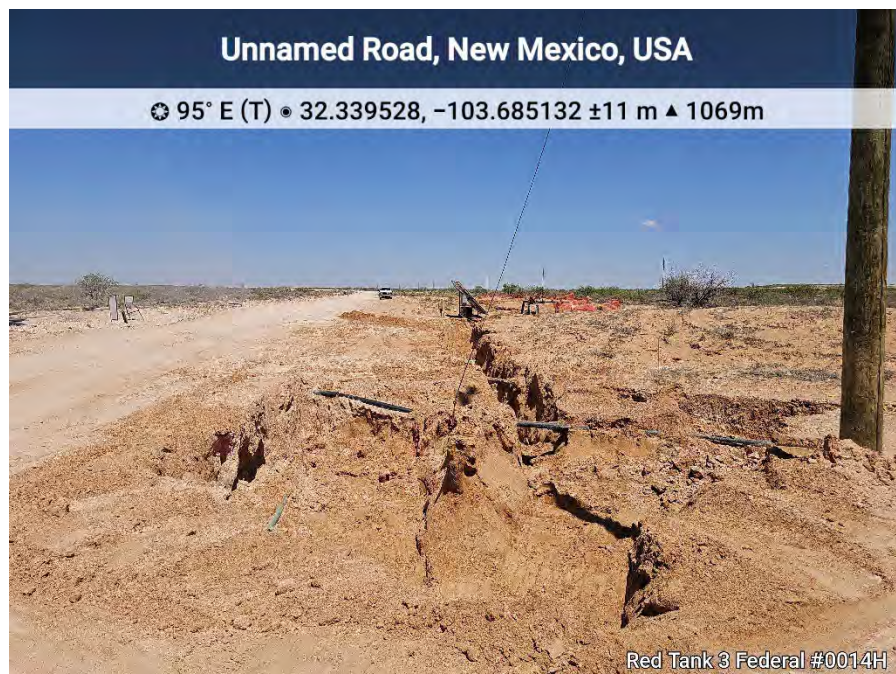
EXCAVATION PHOTOGRAPHS

H&R mobilized personnel to begin remediation and confirmation sampling activities of the impacted area. Composite confirmation samples were obtained from the bottom and sidewalls of the excavation and transported to Cardinal Laboratory for analysis. The results of that analysis are presented in the table below. Confirmation sampling locations and excavation dimensions are illustrated on Confirmation Sample Map, [Appendix I](#). Photographic documentation is attached in [Appendix IV](#). Complete laboratory reports can be found in [Appendix V](#).
