**Re: Closure Request
Muy Wayno Recycle Facility
Incident Number nAPP2409948527
Eddy County, New Mexico**

Ensolum, LLC (Ensolum), on behalf of XTO Energy, Inc. (XTO), has prepared this *Closure Request* to document assessment, excavation of impacted soil, and soil sampling activities at the Muy Wayno Recycle Facility (Site). The purpose of the remediation activities was to remove impacted soil following a release of crude oil at the Site. Based on remediation soil sample laboratory analytical results following removal of impacted soil, XTO is submitting this *Closure Request*, describing remediation activities that have occurred and requesting no further action for Incident Number nAPP2409948527.

XTO Energy, Inc
Closure Request
Muy Wayno Recycle Facility

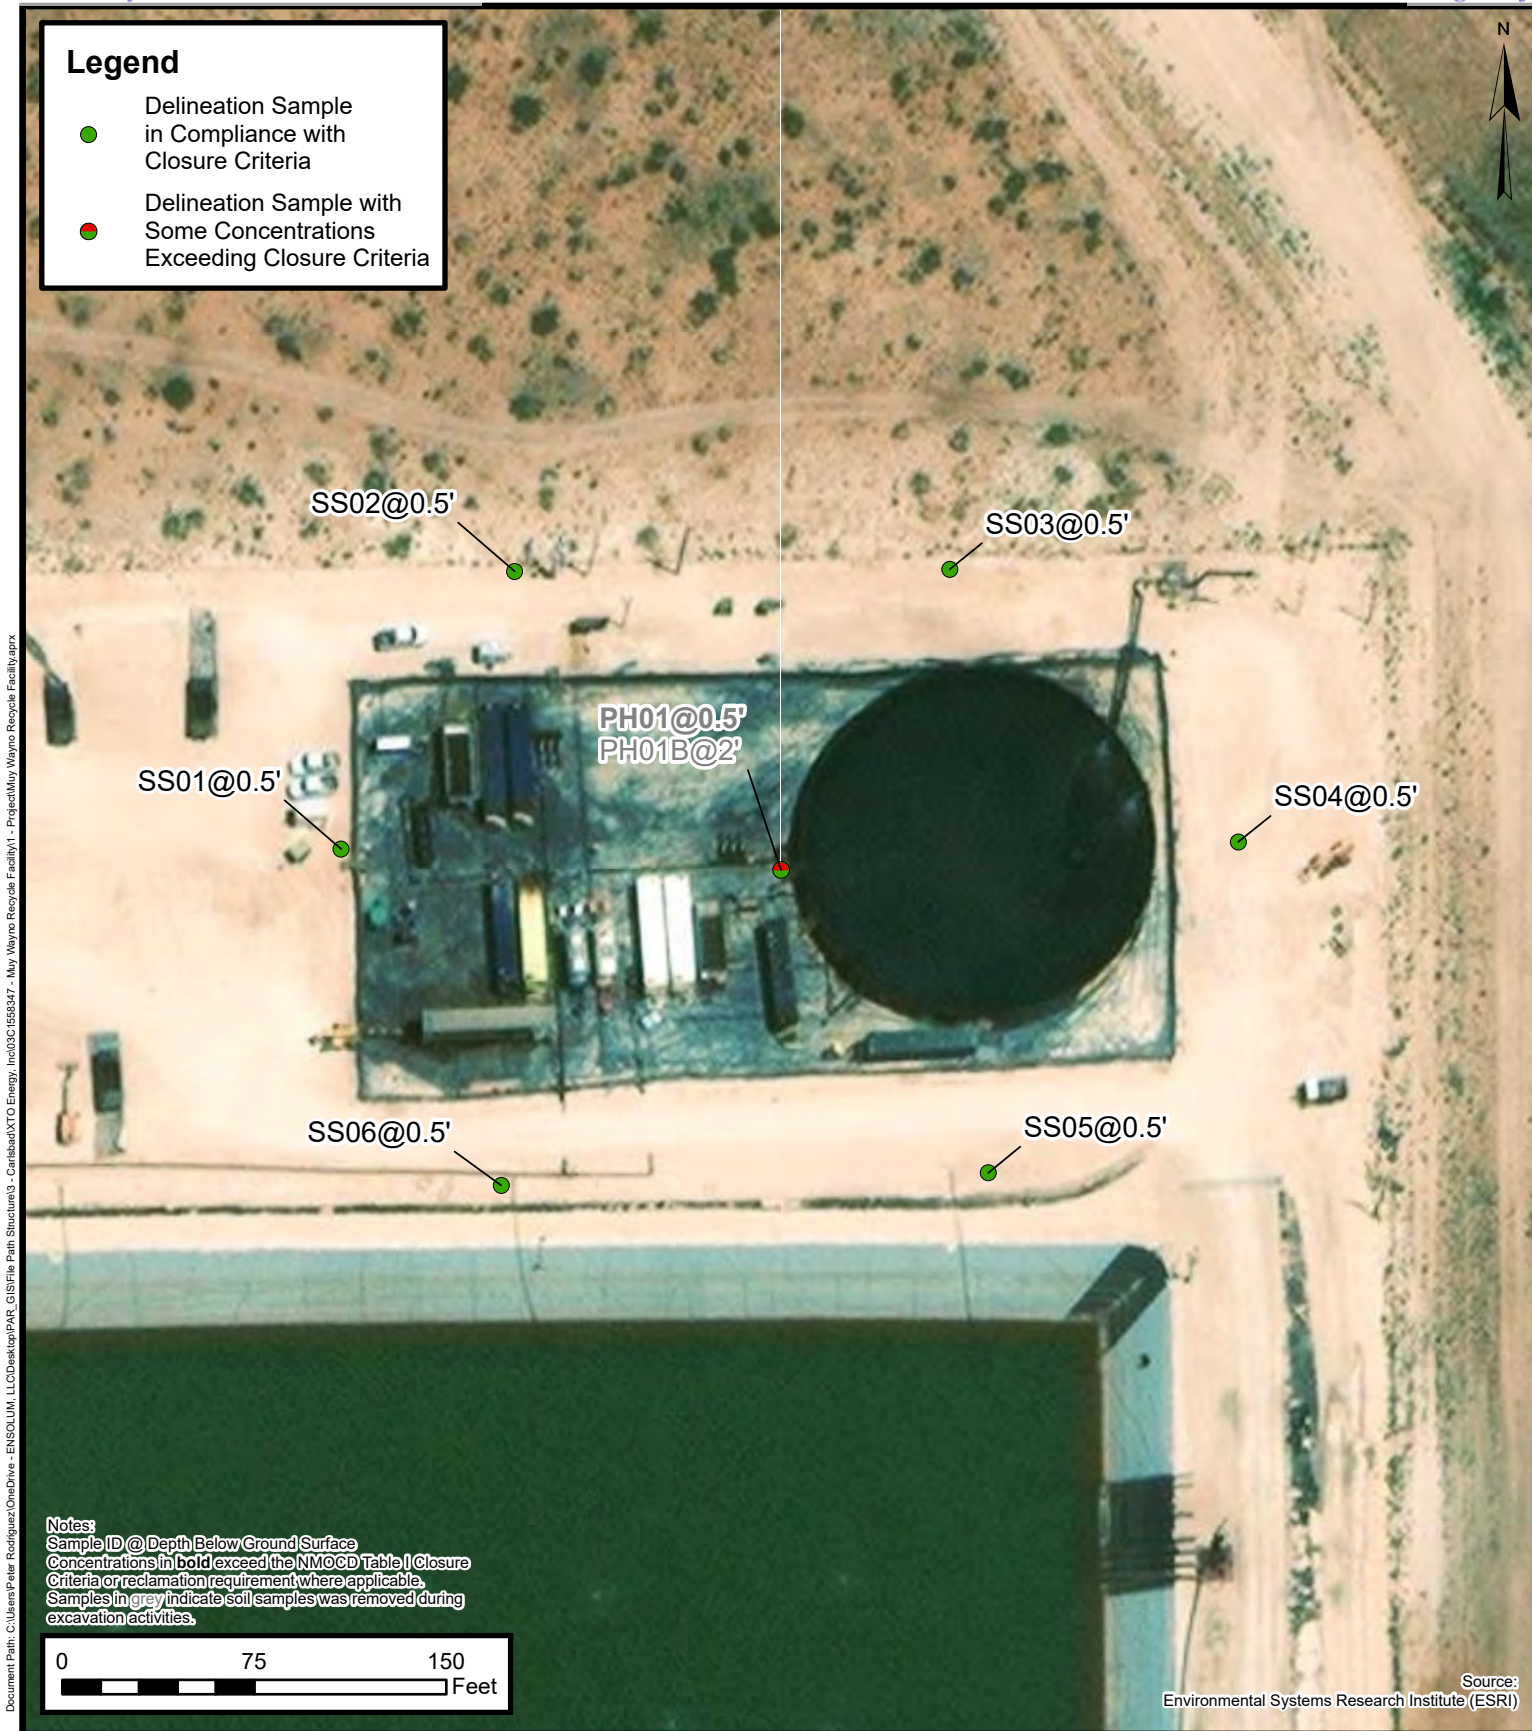
3

On April 26, 2024, Site assessment activities were conducted to evaluate the presence or absence of impacts to soil following the failed liner integrity inspection. Ensolum personnel advanced one pothole (PH01) via hand-auger at the location of the tear in the liner identified during the liner integrity inspection. Two discrete delineation soil samples were collected from the pothole at depths between 0.5 feet and 2 feet bgs. In addition, six delineation soil samples (SS01 through SS06) were collected around the lined secondary containment at a depth of 0.5 feet bgs in order to confirm the lateral definition of the release. The delineation soil samples were field screened for volatile organic compounds (VOCs) utilizing a calibrated photoionization detector (PID) and chloride utilizing Hach® chloride QuanTab® test strips. Field screening results and observations from the delineation pothole were documented on a lithologic/soil sampling log, which is included as Appendix B. The delineation soil sample locations were mapped utilizing a handheld Global Positioning System (GPS) unit and are depicted on Figure 3. Photo documentation was conducted during the Site visits and a photographic log is included in Appendix C.

Laboratory analytical results indicated COC concentrations for all lateral delineation soil samples were in compliance with the Closure Criteria, however, soil sample results from PH01, collected inside of the secondary containment, contained elevated chloride concentrations that exceeded the Closure Criteria. Laboratory analytical results from PH01B, collected at 2 feet bgs indicated all COC concentrations compliant with the Closure Criteria, confirming vertical delineation of the impacted soil. Laboratory analytical results are summarized in Table 1 and the complete laboratory analytical reports are included in Appendix D.

Delineation Soil Sample Locations

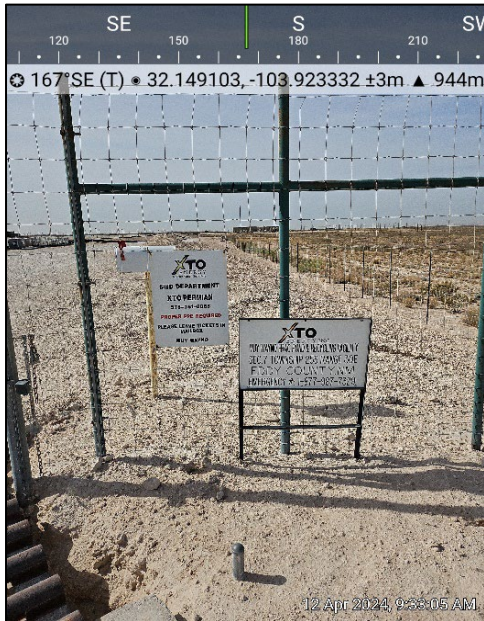
Photograph: 1 Date: 4/12/2024
Description: Well Sign
View: Southeast

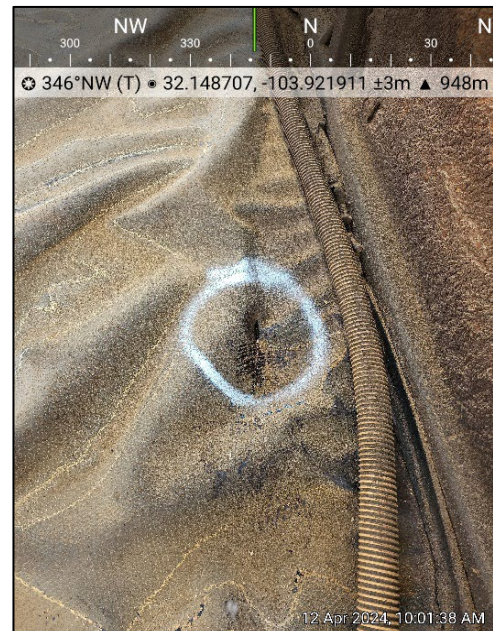
On March 26, 2024, human error resulted in the release of approximately 15 barrels (bbls) of crude oil into a lined secondary containment. XTO dispatched a hydrovacuum truck immediately and recovered all fluids. XTO submitted an Initial C-141 Application (C-141) on April 8, 2024. The release was assigned Incident Number nAPP2409948527. A liner integrity inspection was conducted by Ensolum personnel following a 48-hour notification. Ensolum personnel inspected the lined containment on April 12, 2024 and upon inspection, the liner was determined to be insufficient.

Photograph: 2 Date: 4/12/2024
Description: Site assessment, liner condition.
View: Northwest

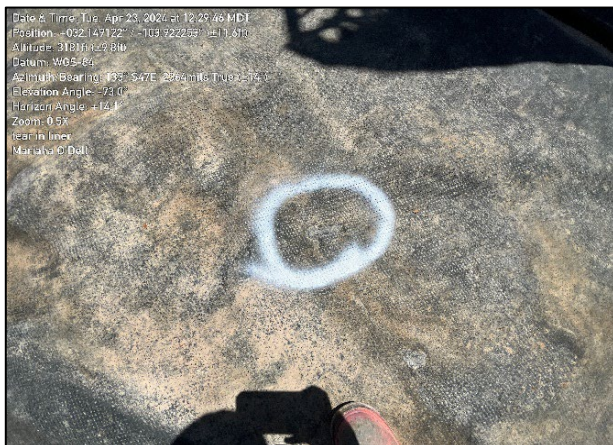
Photograph: 3 Date: 4/23/2024
Description: Site assessment, liner tear location.
View: Southeast

On August 19, 2024, the tanks were decommissioned and the secondary containment, including the liner, was removed from the Site. Following removal of the equipment, Ensolum personnel returned to the Site to oversee removal of the impacted soil identified at delineation soil sample PH01. Impacted soil was excavated as indicated by visible staining and laboratory analytical results for the delineation soil samples. Excavation activities were performed using track-mounted backhoe and transport vehicle. To direct excavation activities, soil was screened for VOCs and chloride. The excavation was completed to a depth of 3 feet bgs. Photographic documentation of the excavation activities is included in Appendix C.

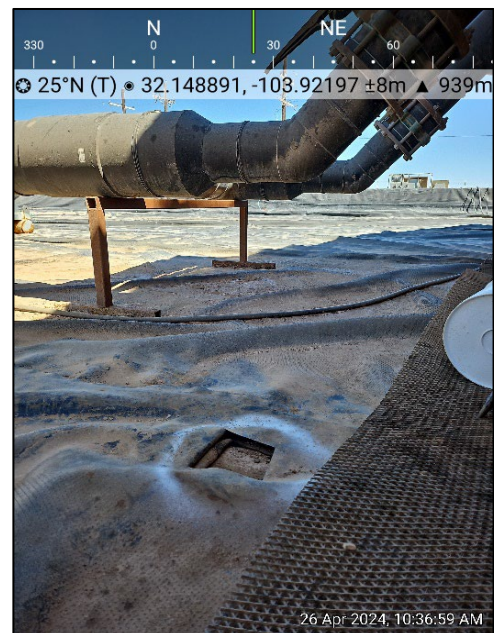
Photograph: 4 Date: 4/26/2024
Description: Delineation Activities
View: Northeast

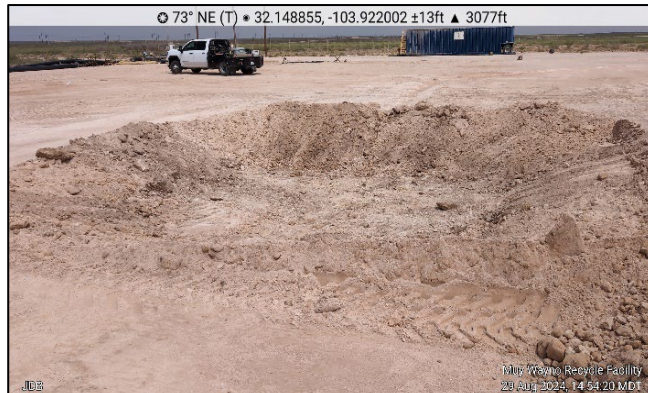
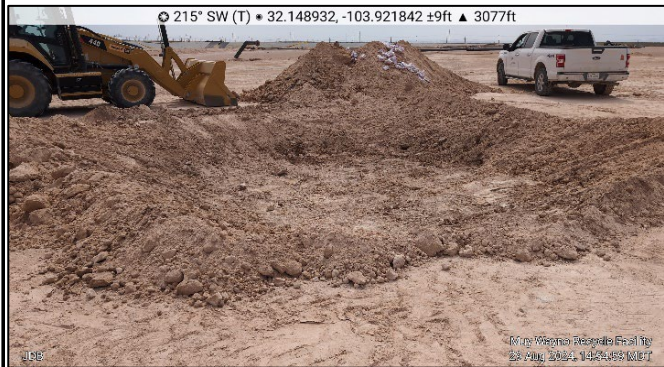
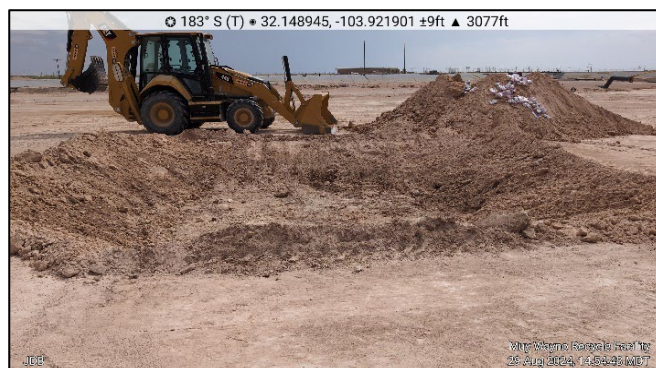
Photograph: 5 Date: 8/29/2024
Description: Excavation Activities
View: Northeast

Photograph: 6 Date: 8/29/2024
Description: Excavation Activities
View: Southwest

Photograph: 7 Date: 8/29/2024
Description: Excavation Activities
View: South

The excavation area measured approximately 250 square feet. A total of approximately 30 cubic yards of impacted soil were removed during the excavation activities. The impacted soil was transported and properly disposed of at the R360 Facility in Carlsbad, New Mexico.

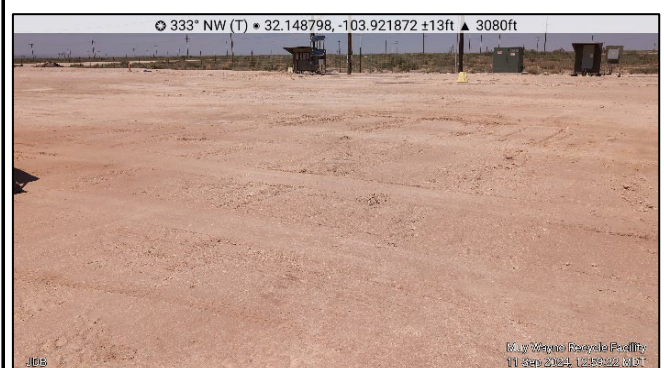
Photograph: 8 Date: 9/11/2024
Description: Backfill Activities
View: Northwest

Upon completion of excavation activities and receipt of final laboratory analytical results, the excavation was backfilled. One representative 5-point composite sample (BF01) was collected from the backfill material. The backfill soil sample was handled and analyzed following the same procedures as described above. Laboratory analytical results for the backfill soil sample confirmed compliance with the NMOCD requirement for the reclaimed area to contain non-waste containing, uncontaminated, earthen material with chloride concentrations less than 600 mg/kg and TPH concentrations less than 100 mg/kg. The laboratory analytical report is included in Appendix D.
