**Re: Closure Request
PLU 442-443 Battery
Incident Number nAPP2421837094
Eddy County, New Mexico**

Ensolum, LLC (Ensolum), on behalf of XTO Energy, Inc (XTO), has prepared this *Closure Request* to document the findings of a liner integrity inspection conducted at the PLU 442-443 Battery (Site) following the release of produced water and crude oil within a lined containment. Based on the liner integrity inspection activities, XTO is submitting this *Closure Request*, describing assessment activities that have occurred and requesting no further action and closure for Incident Number nAPP2421837094.

XTO Energy, Inc
Closure Request
PLU 442-443 Battery

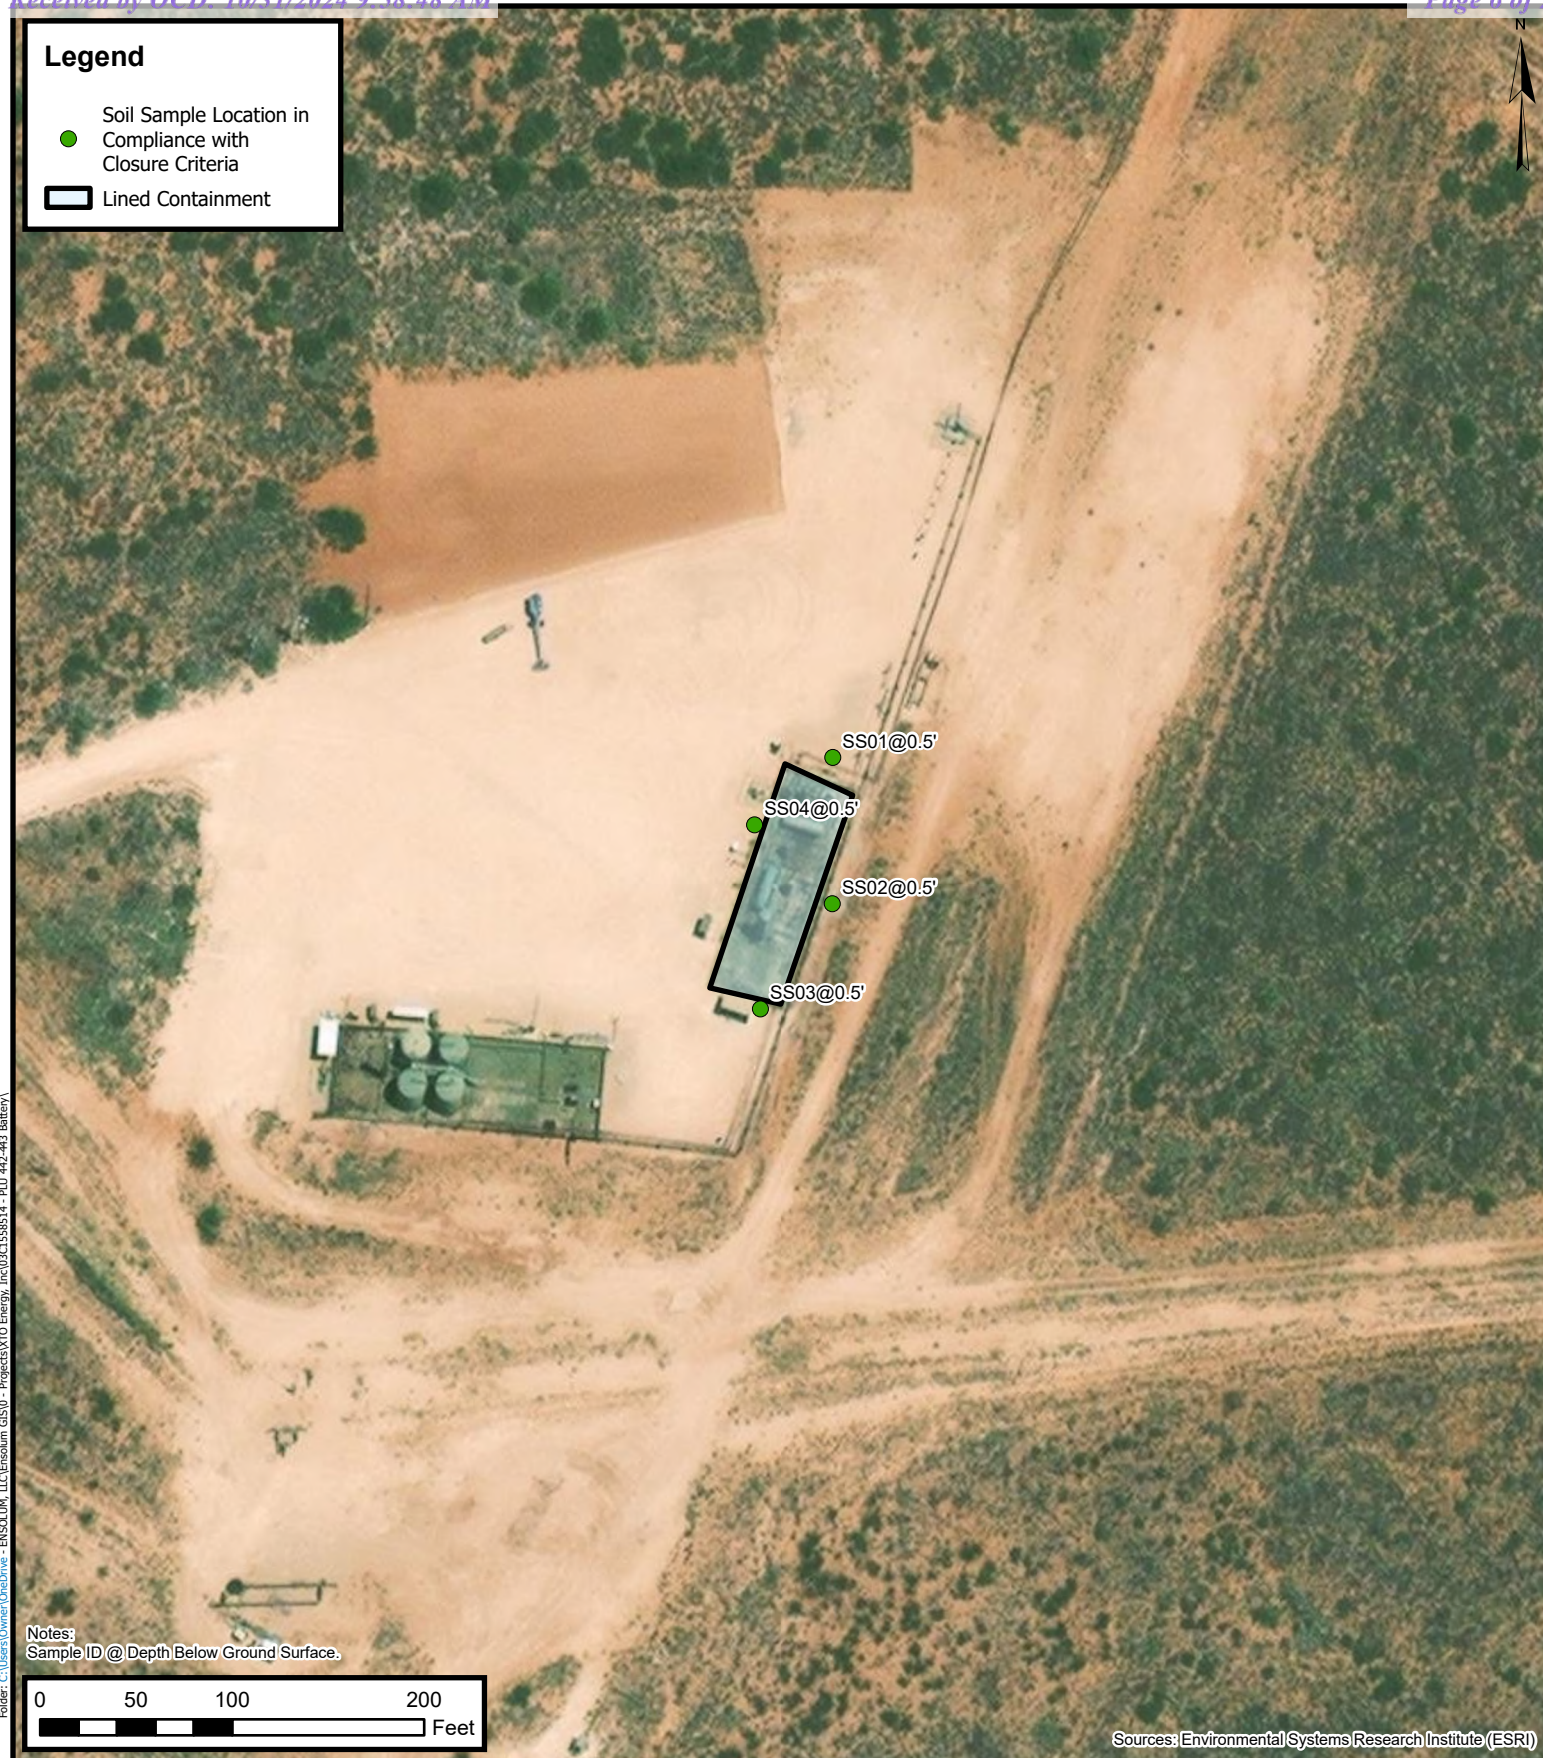
FIGURE
2

On August 20, 2024, Ensolum personnel conducted a Site visit to evaluate the release extent based on information provided on the C-141 and visual observations. Delineation soil samples, SS01 through SS04, were collected at a depth of 0.5 feet bgs surrounding the lined containment. The lined containment and delineation soil samples were mapped utilizing a handheld Global Positioning System (GPS) unit and are depicted in Figure 2. Photographic documentation was completed during the Site visit and a photographic log is included in Appendix B.

Laboratory analytical results for delineation soil samples SS01 through SS04 indicated all COCs were in compliance with the Closure Criteria and confirmed no fluids were released outside the containment. The laboratory analytical results are summarized in Table 1 and the complete laboratory analytical reports are included in Appendix C.

**Site Map**

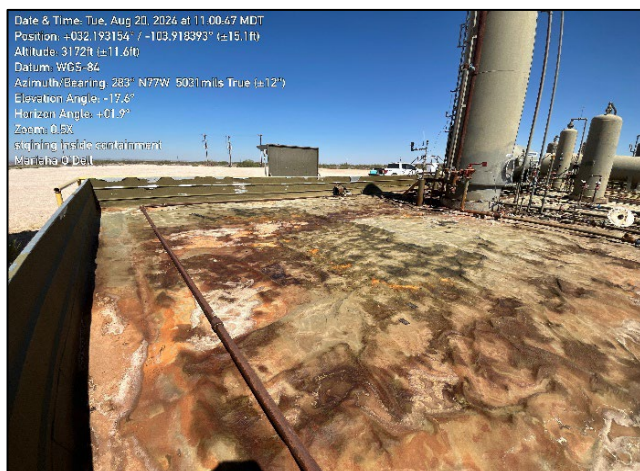
Photograph: 1 Date: 8/20/2024
Description: Initial Site visit activities
View: Northwest

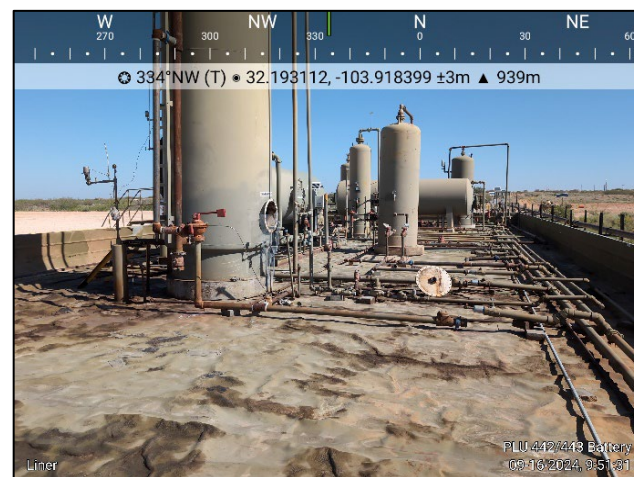
A 48-hour advance notice of the liner inspection was submitted to the NMOCD on September 10, 2024. The liner was cleared of all debris and fluids. A liner integrity inspection was conducted by Ensolum personnel on September 16, 2024. The lined containment was inspected and was determined to be operating as designed. Upon inspection, no rips, tears, holes, or damage was observed. The liner was determined to be sufficient, and all released fluids were recovered. Photographic documentation of the inspection is included in Appendix B.

Photograph: 4 Date: 9/16/2024
Description: Liner inspection
View: Northwest

Liner integrity inspection activities were completed following a release of produced water and crude oil within a lined containment at the Site. A liner integrity inspection was conducted by Ensolum personnel on September 16, 2024. Upon inspection, no rips, tears, holes, or damage was observed, and the liner was determined to be sufficient. The release was contained laterally by the lined containment, as confirmed by the delineation soil sample analytical results and the liner was performing as designed. Based on initial response efforts and the liner operating as designed, XTO respectfully requests closure for Incident Number nAPP2421837094.
