**Re: Closure Request Addendum
Corral Canyon Expansion Battery
Incident Number NAPP2322648859
Eddy County, New Mexico**

XTO Energy, Inc.
Closure Request Addendum
Corral Canyon Expansion Battery

XTO Energy, Inc
Corral Canyon Expansion Battery
Incident Number: nAPP2322648859
Unit P, Sec 5, T25S, R29E
Eddy County, New Mexico

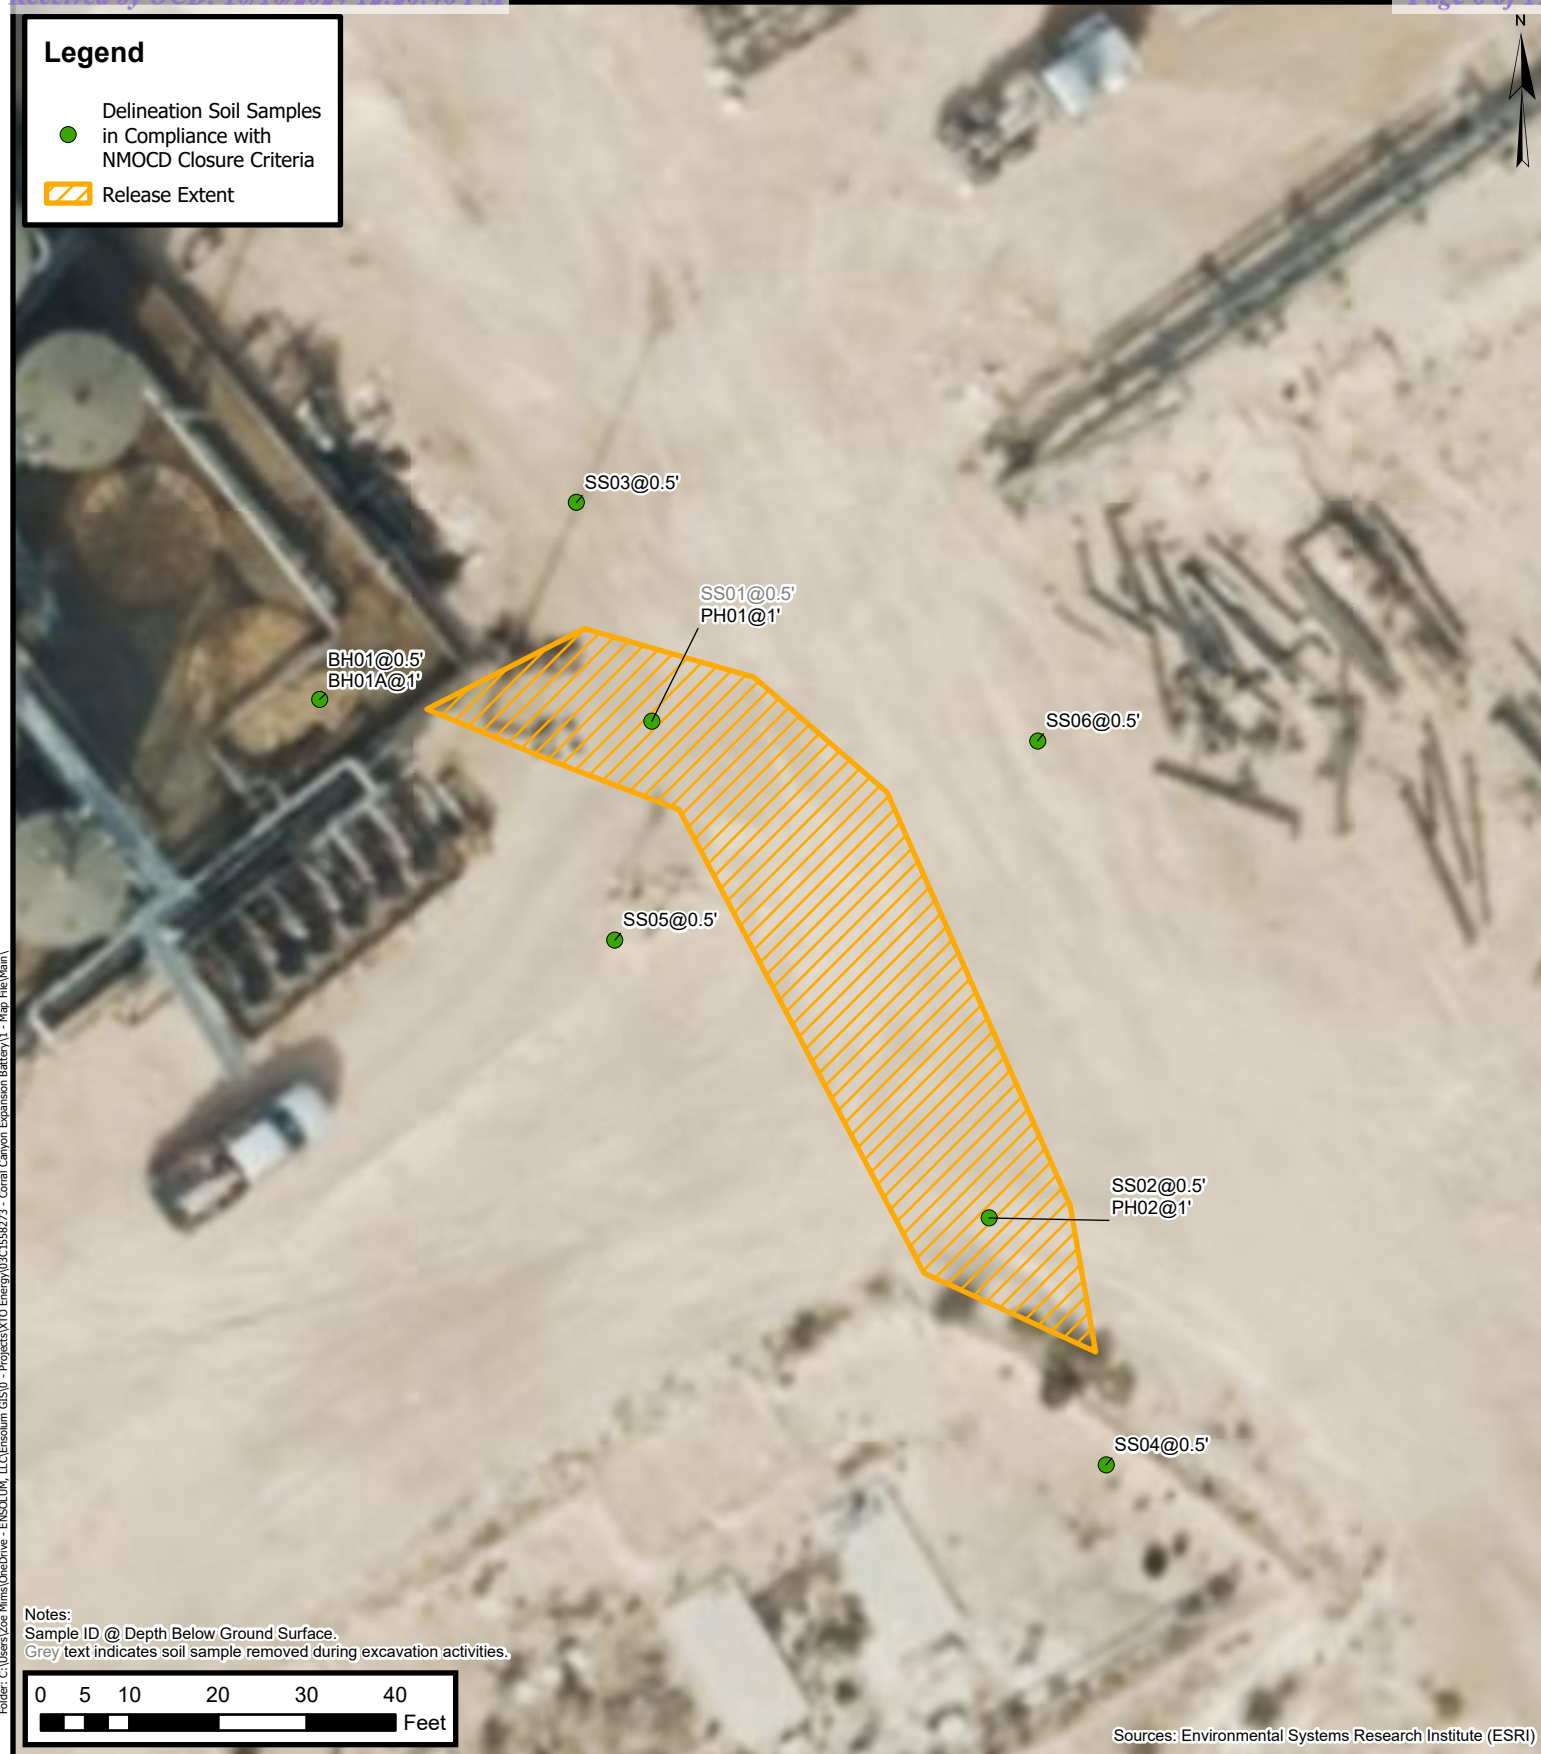
FIGURE
2

Delineation Soil Sample Locations

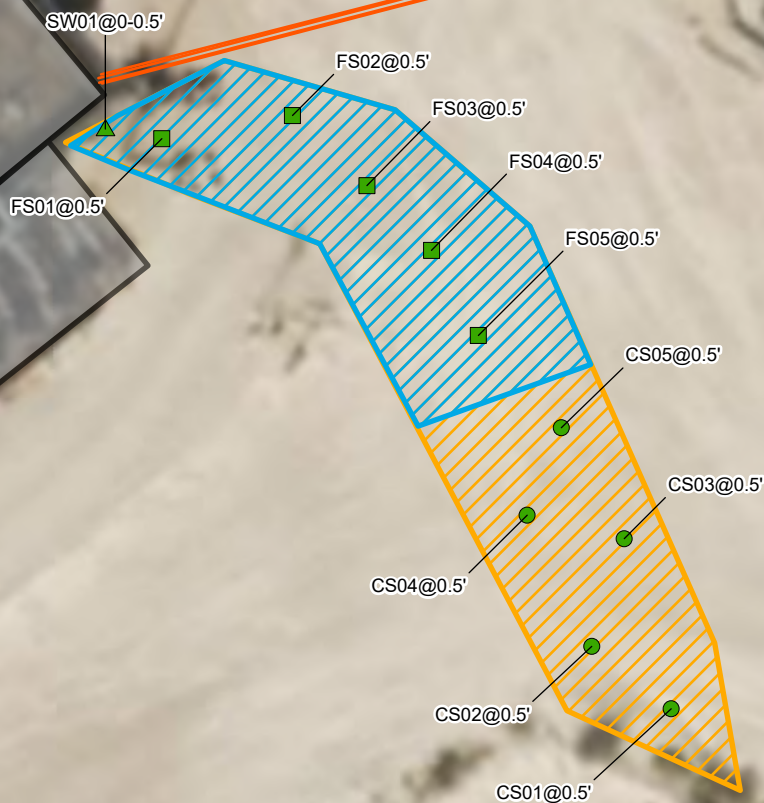
3

following EPA Method 8015M/D; and chloride following Standard Method SM4500. The excavation extent and confirmation soil sample locations are presented on Figure 2.

The excavation area measured approximately 972 square feet. The impacted soil was transported and properly disposed of at the R360 Disposal Facility in Hobbs, New Mexico. A total of 118 cubic yards of waste-containing soil were removed from the Site.

Confirmation Soil Sample Locations

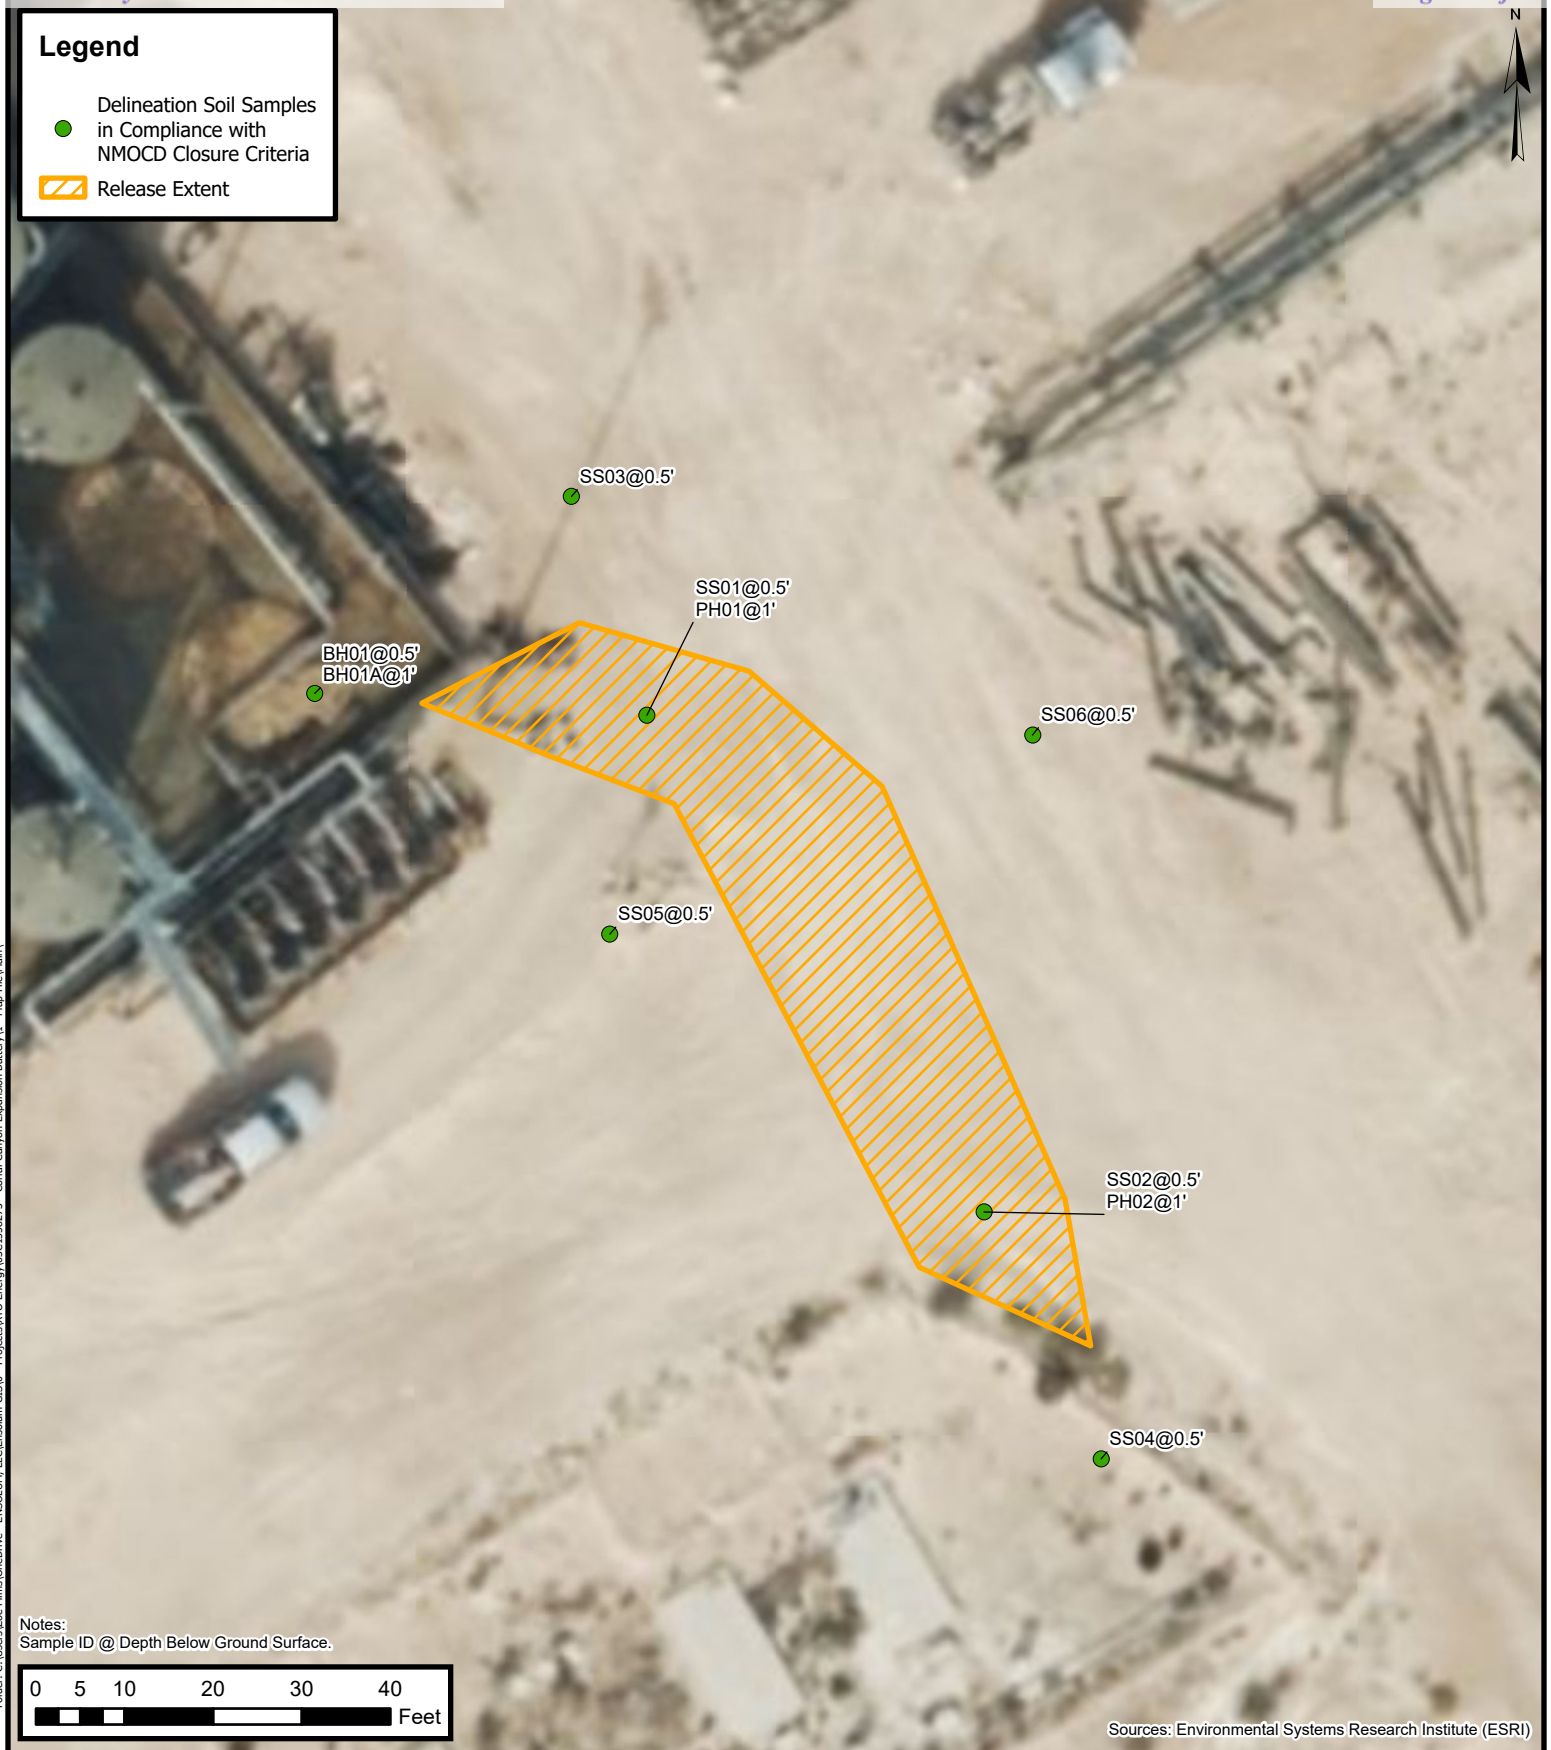
The borehole and potholes were backfilled with soil removed and an XTO contractor repaired the tear in the liner. The soil sample locations are depicted on Figure 2. Photographic documentation was conducted during delineation activities and a photographic log is included in Appendix B.

Delineation Soil Sample Locations

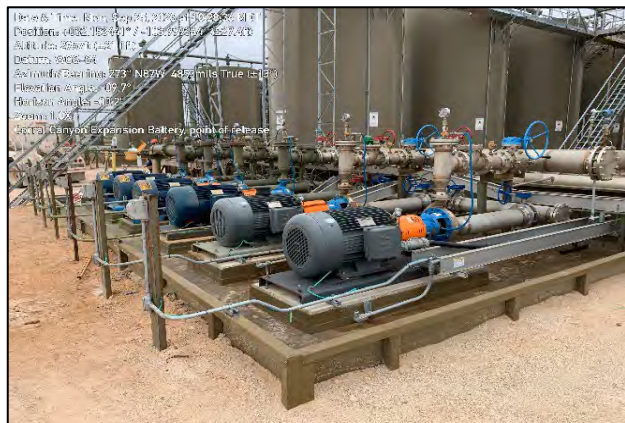
A 48-hour advance notice of liner inspection was provided via email to the NMOCD. On September 25, 2023, a liner integrity inspection was conducted by Ensolum personnel for both the pump containment and storage tank containment. Upon inspection, the pump containment liner had no tears or damage and was operating as designed. However, the tank battery containment was determined to be insufficient.

Photograph: 1 Date: 9/25/2023
 Description: Inspection of pump containment
 View: Northwest

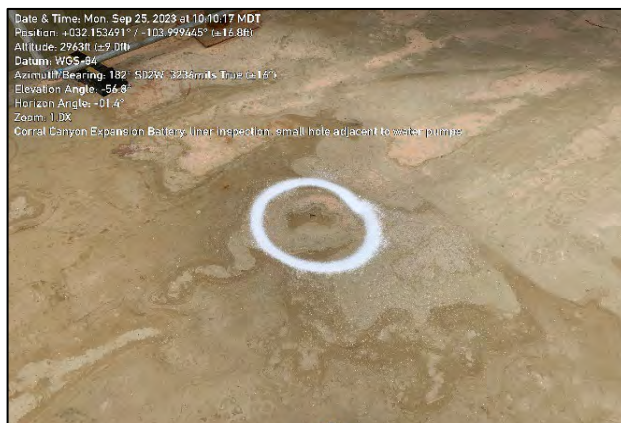
Photograph: 2 Date: 9/25/2023
 Description: Inspection of tank battery containment
 View: Southwest

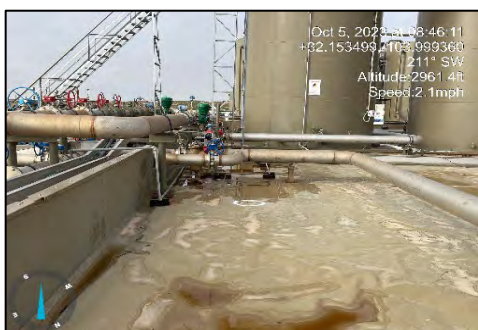
Photograph: 3 Date: 10/5/2023
 Description: Liner delineation activities
 View: Southwest

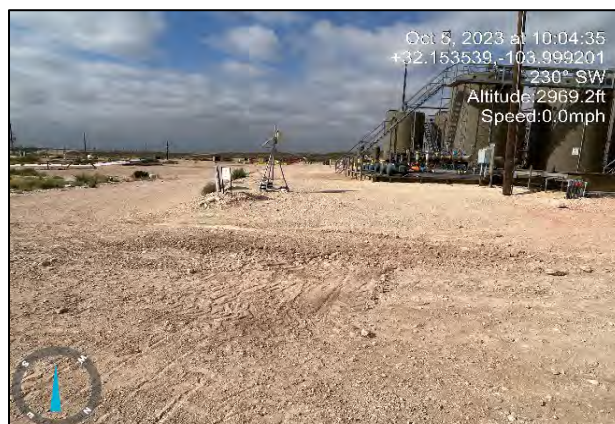
Photograph: 4 Date: 10/5/2023
 Description: Delineation activities
 View: Southwest

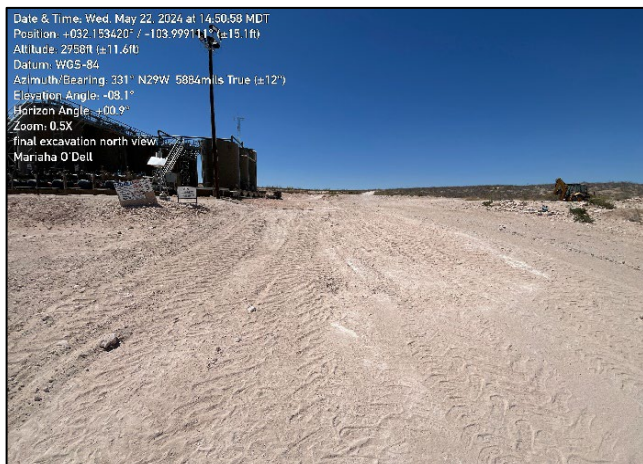
Photograph: 1 Date: 5/22/2024
Description: Final excavation extent.
View: North

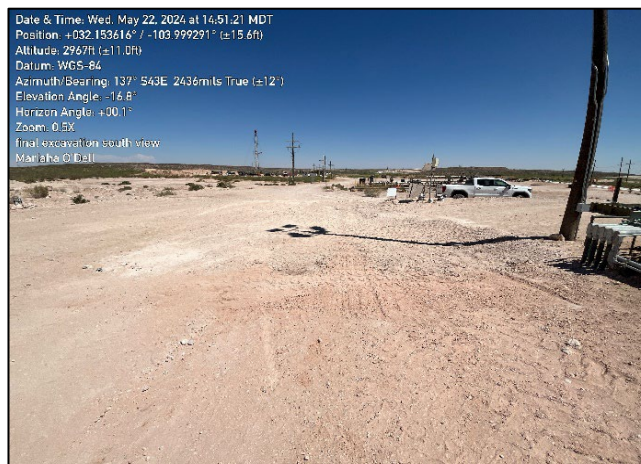
Photograph: 2 Date: 5/22/2024
Description: Final excavation extent.
View: South

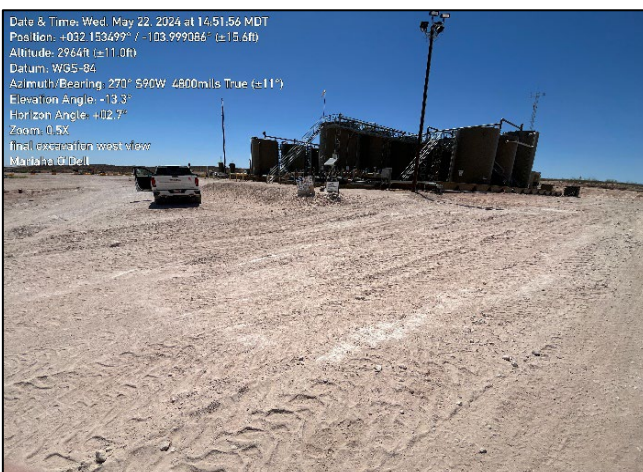
Photograph: 3 Date: 5/22/2024
Description: Final excavation extent.
View: West

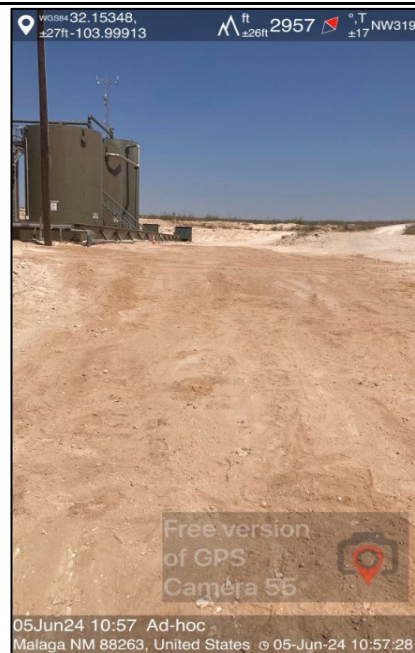
Photograph: 4 Date: 6/5/2024
Description: Excavation backfilled.
View: North
