**Re: Remediation Work Plan  
Perla Verde 31 State 001H  
Incident Number nAPP2412749555  
API 30-025-42063  
Lease Number L023780001  
Lea County, New Mexico**

XTO Energy, Inc.  
Remediation Work Plan  
Perla Verde 31 State 001H

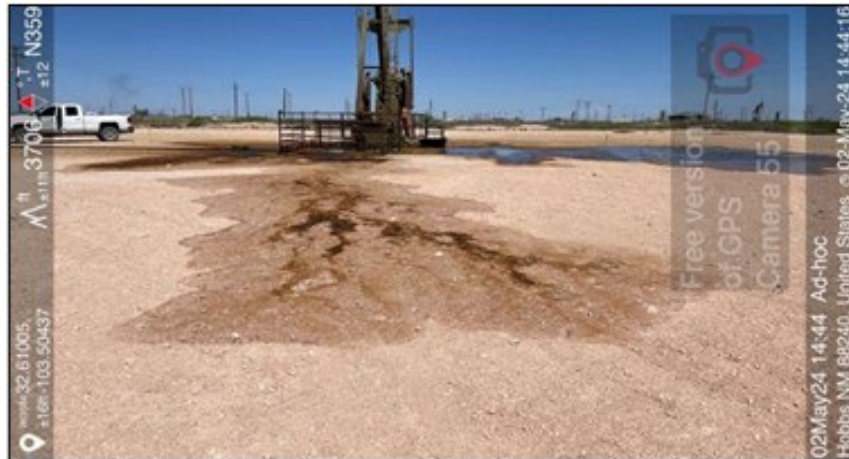
Photograph 1

Date: May 2, 2024

Description: View of release foot print facing east.

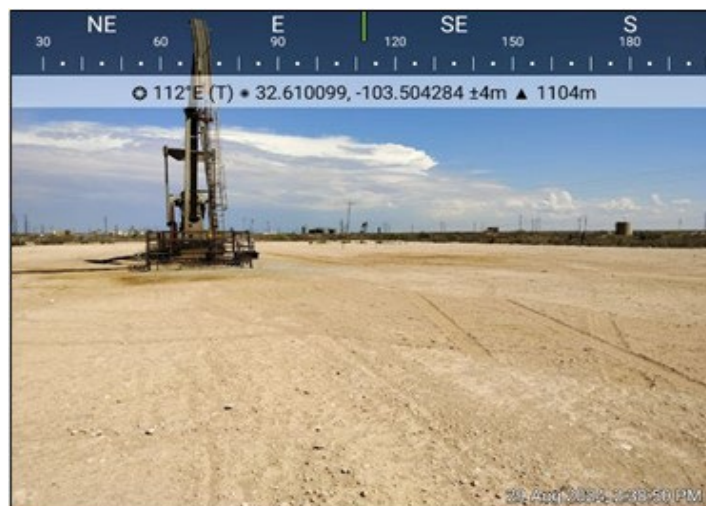
Photograph 2

Date: August 29, 2024

Description: View of release foot print facing east.

On August 29, 2024 Ensolum personnel conducted a Site visit to evaluate the release extent based on information provided on the C-141, internal reports, and visual observations. The release extent was mapped utilizing a handheld Global Positioning System (GPS) unit and is depicted on Figure 2. Photographic documentation was completed during the Site visits and a photographic log is included in Appendix B.
