**Re: Closure Request
PLU Phantom Banks 4-26-31 CTB
Incident Numbers nAPP2328641933 and nAPP2328646222
Eddy County, New Mexico**

XTO Energy, Inc
Closure Request
PLU Phantom Banks 4-26-31 CTB

**Photographic Log**

PLU Phantom Banks 4-26-31 CTB

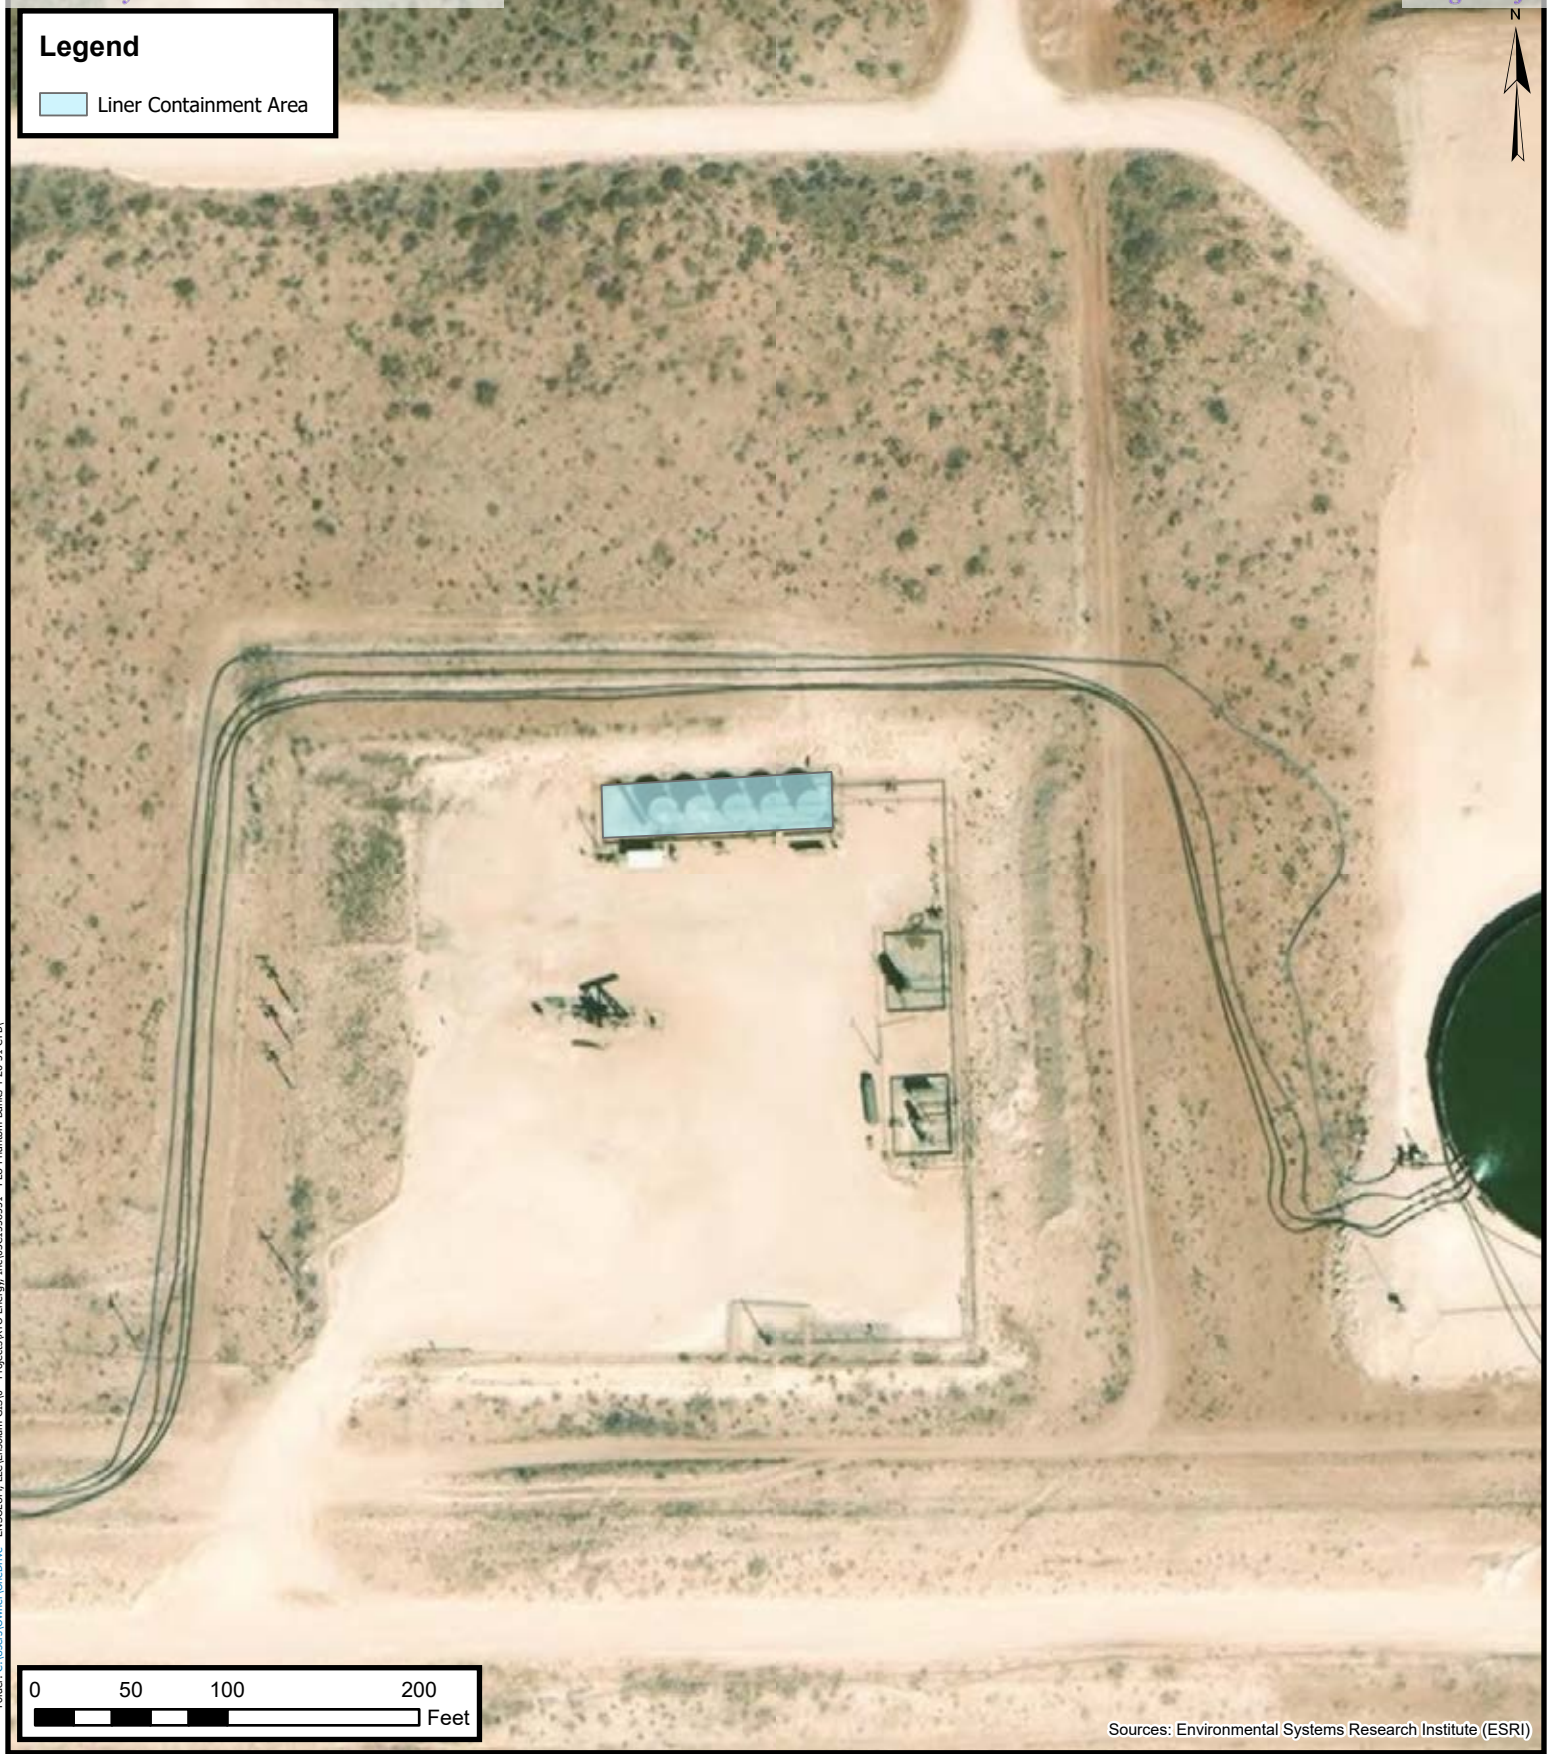
FIGURE
2

After a review of the C-141, internal documents, and initial release photographs, it was confirmed both releases occurred within the same lined containment. The lined containment was cleaned of all debris, power washed and a 48-hour advance notice of the liner inspection was submitted on September 19, 2024. On September 26, 2024, the lined containment was inspected by Ensolum personnel and was determined to be operating as designed. Upon inspection, no rips, tears, holes, or damage were observed. The liner was determined to be sufficient, and all released fluids had been previously recovered. A Site map of the liner is included in Figure 2. Photographic documentation of the inspection is included in Appendix B.

Site Map
XTO Energy, Inc.
PLU Phantom Banks 4-26-31 CTB
Incident Number: NAPP2328641933 and NAPP2328646222
N-04-26S-31E
Eddy County, New Mexico

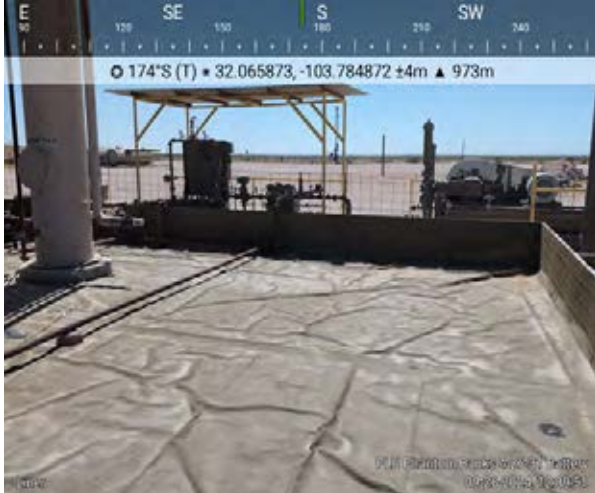
Photograph: 1 Date: 9/26/2024
Description: Liner Inspection Activities
View: South

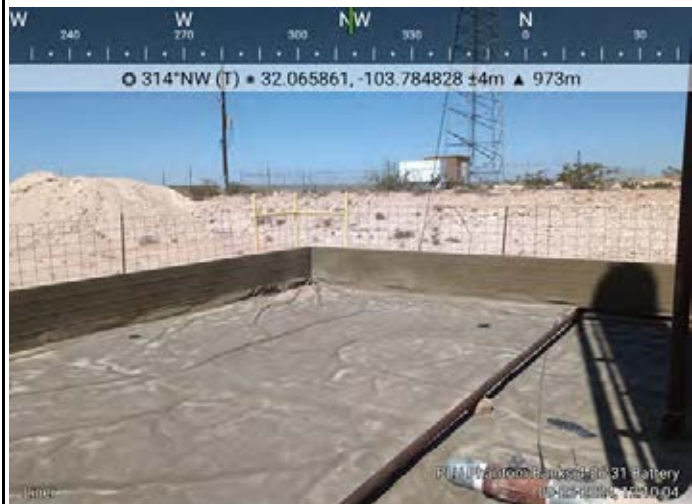
Photograph: 2 Date: 9/26/2024
Description: Liner Inspection Activities
View: Northwest

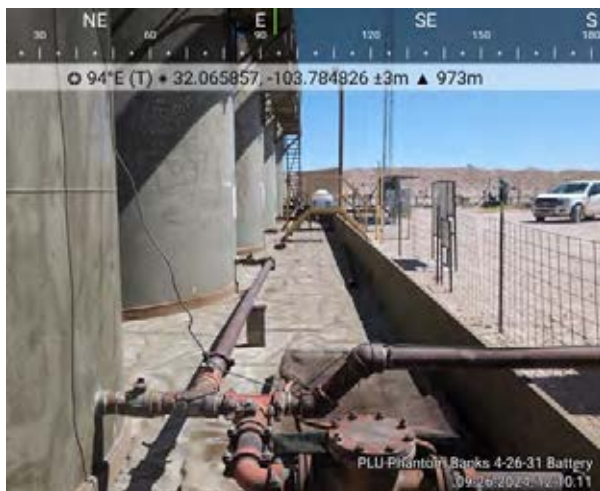
Photograph: 3 Date: 9/26/2024
Description: Liner Inspection Activities
View: East

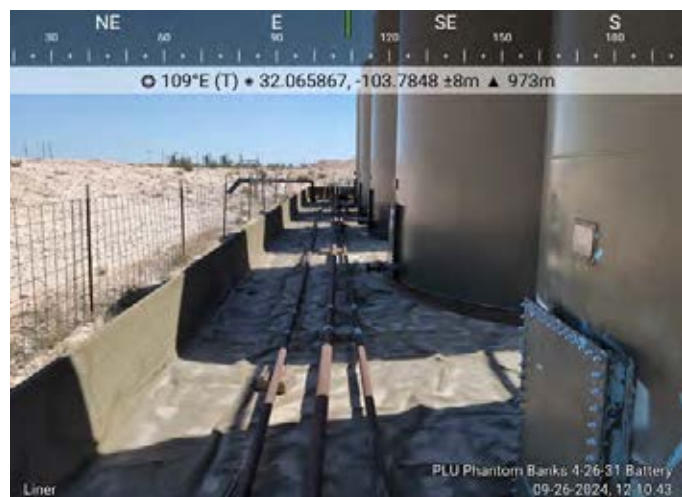
inspection, no rips, tears, holes, or damage were observed, and the liner was determined to be operating as designed. The releases were contained laterally by the lined containment walls. Based on initial response efforts and the liner operating as designed, XTO respectfully requests closure for Incident Numbers nAPP2328641933 and nAPP2328646222.

Photograph: 4 Date: 9/26/2024
Description: Liner Inspection Activities
View: East
