## ZZ-1 LINE LEAK

### Remediation Summary & Closure Report

NMOCD Incident No. nAPP2422124658  
UL "P", Sec. 11, T18S, R27E  
32.755311°, -104.241111°  
Eddy County, New Mexico

November 12, 2024

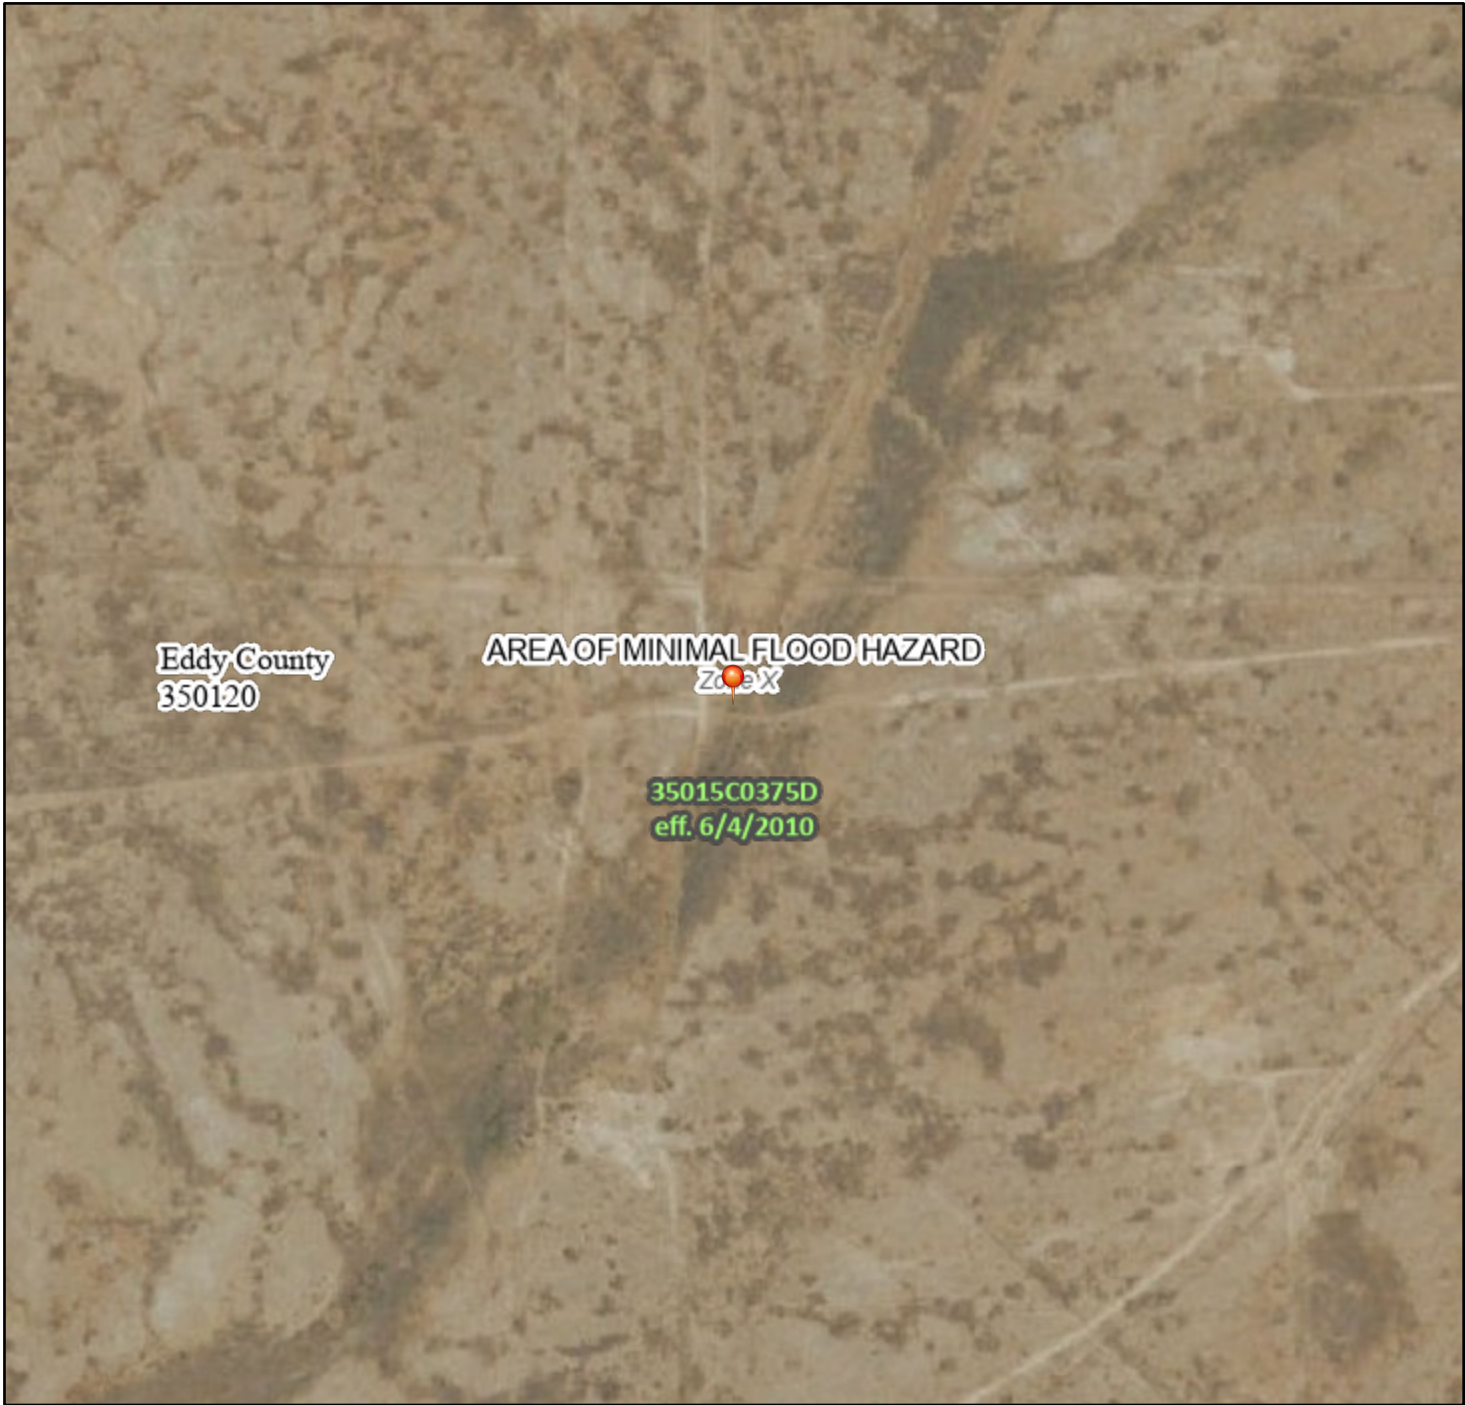
# National Flood Hazard Layer FIRMette

Review of flood map data published by the Federal Emergency Management Agency (FEMA) indicates the site is not located within a 100-year floodplain. A copy of the FEMA FIRMeMap can be found attached as Figure 4.
