Incident # **nAPP2406628203**

The Central Basin SWD #001 API# 30-045-34426 is in Unit N, Section 09, Township 28 North, Range 13 West, San Juan County, New Mexico.

RE: The cause of the release was determined that the motor failed was from the SWD and resulted in the release on pad. The estimated release volume was 6 BBLS and 6 BBLS were recovered via water truck. Volume lost was calculated using telemetry.

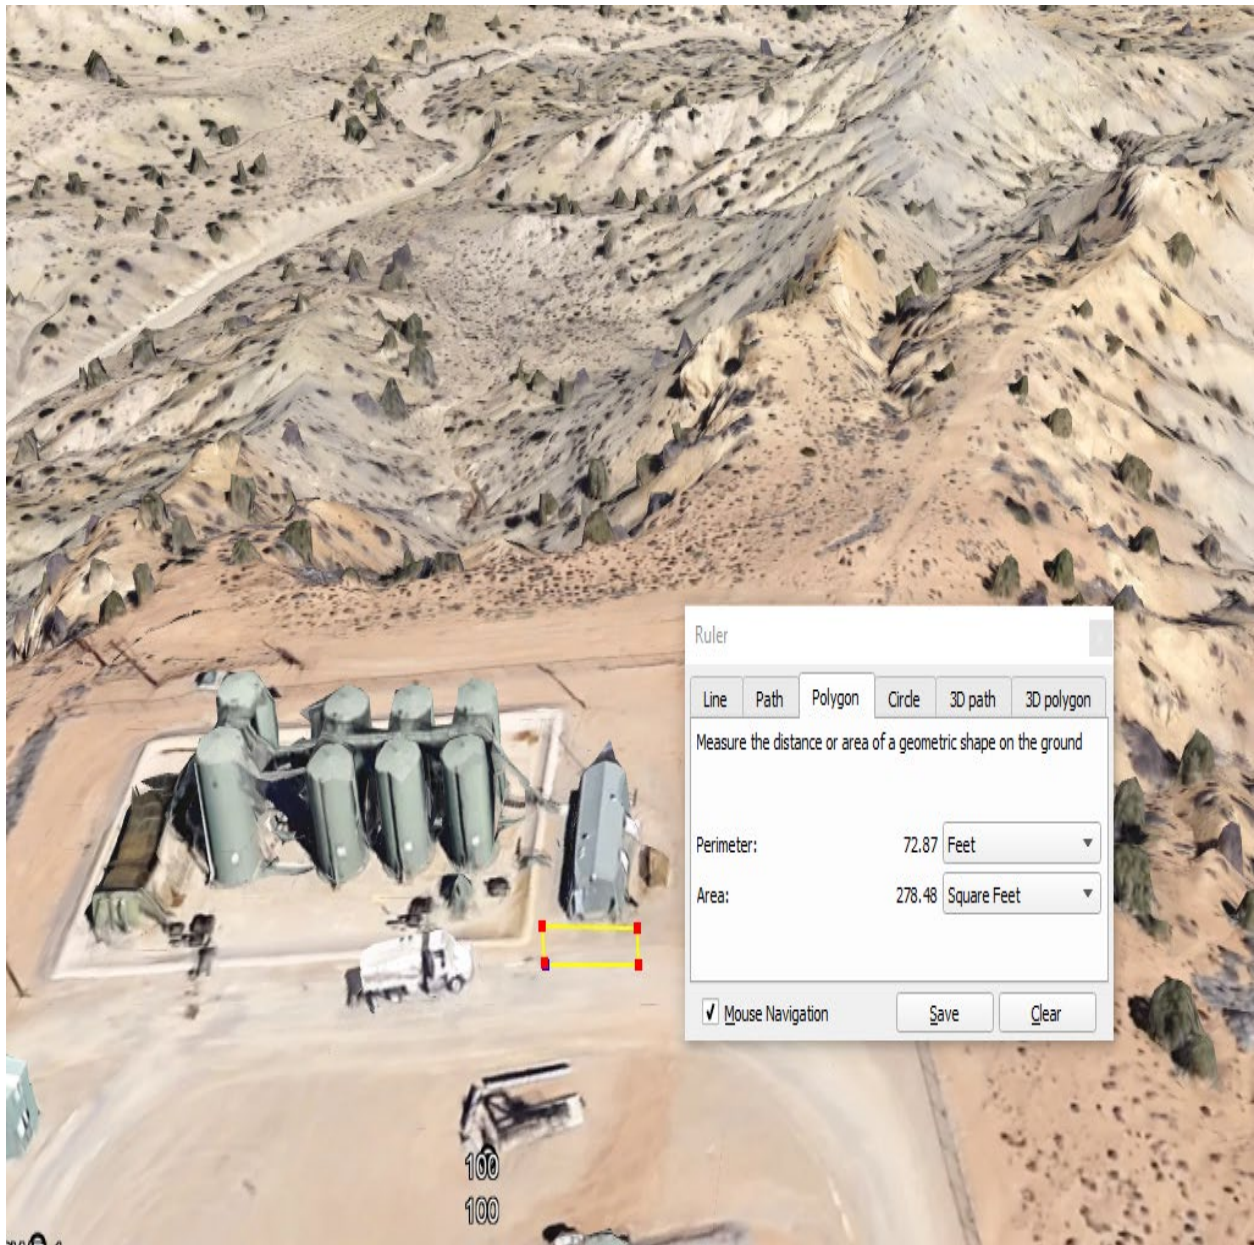
Release Area

On March 1, 2024, LOGOS CENTRAL BASIN SWD #001 SWD Motor at the pump house experienced a failure resulting in 6 barrels of produced water released on location, no fluids left the vicinity and water truck was able to recover 6 barrels of free liquid.

The release size was 13'x52x2''' equaling 556 sq ft in the release are. The release area was contained on pad. Due to the release area fluid being removed quickly LOGOS was able to skim the release area with a water truck. LOGOS complied with 19.15.29 when remediation occurs.

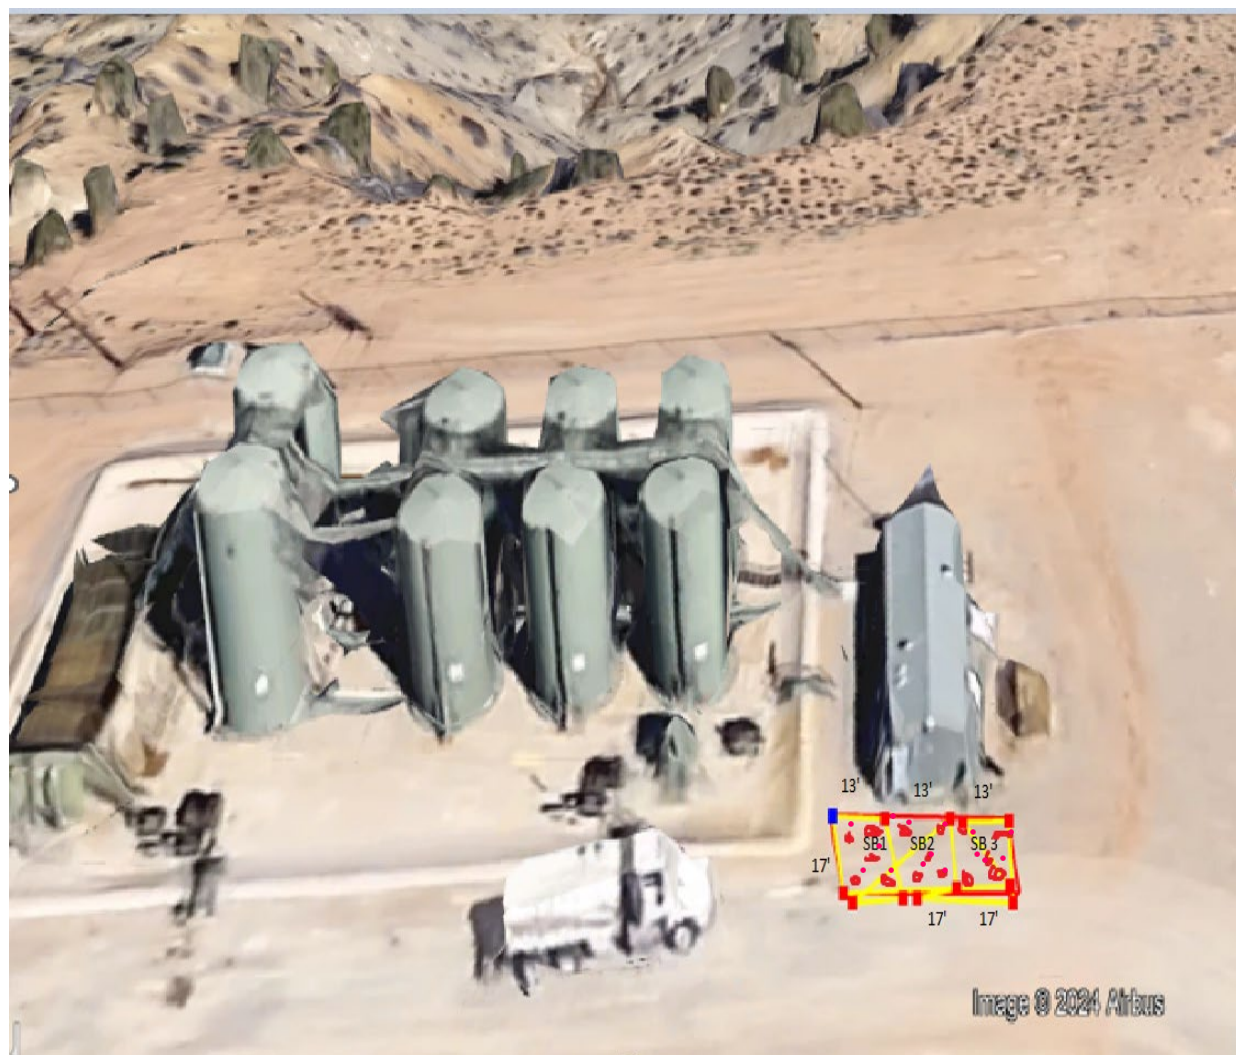
Sample Area

On May 31, 2024, LOGOS representatives performed sampling. A representative from the NMOCD nor the BLM were present at the confirmation sampling. 3 (5)- point confirmation samples were collected from the release area. The sampling area was 1,352 sq ft in size (3) 200 sq ft (5)- point confirmation samples were collected. No odor or staining was observed during the sampling event. The sample results were below regulatory standards in all constituents. Please refer to Table 1 for analytical results.

5 -point composite sample area of samples colled SB 1, SB 2 and SB 3

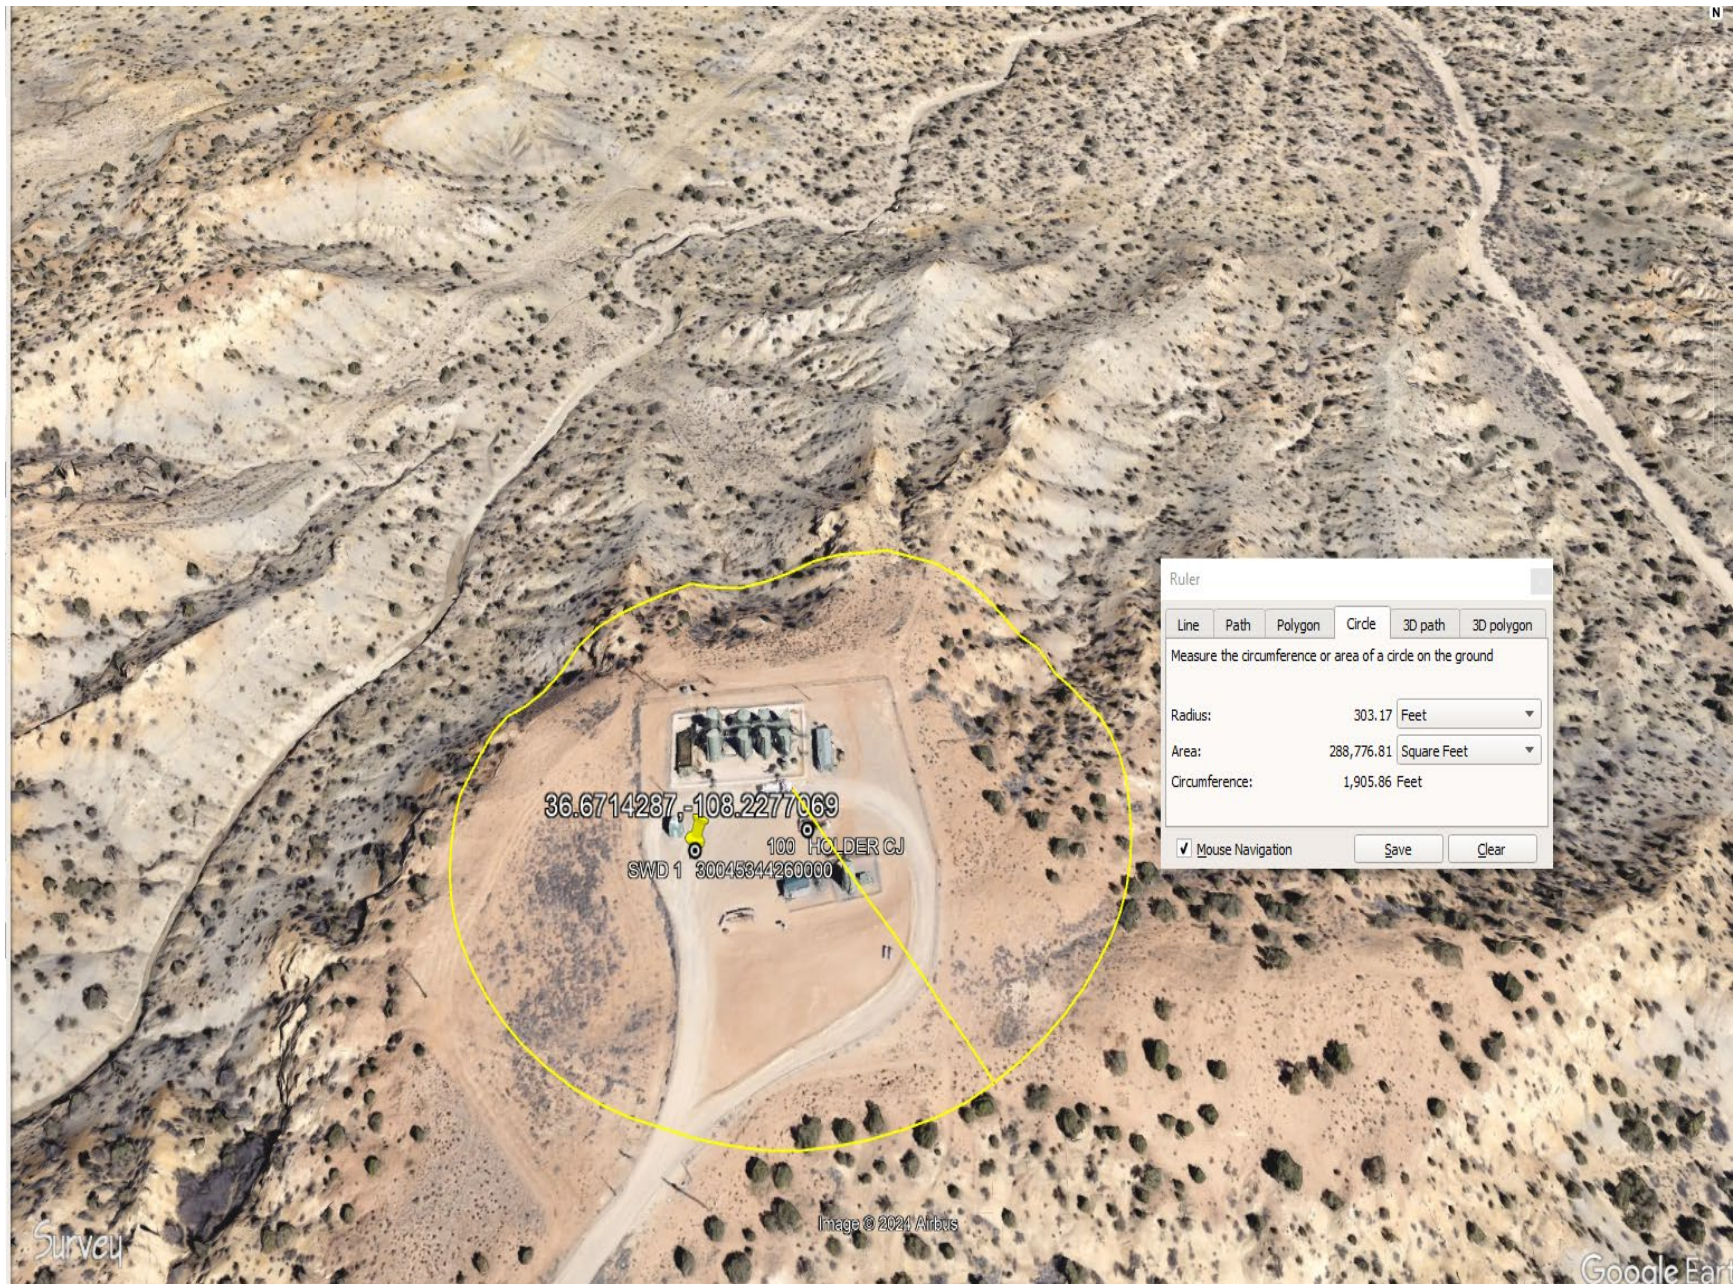
Central Basin SWD# 001 Sitting Criteria 300' Radius Map

The attached sitting criteria demonstrates that the area is not within a floodplain or wetlands nor over a karst and the depth to ground water is greater than 100' below ground surface.

Release of 6 BBLS was determined by soil type sandy loom and release area 13'x52x2"

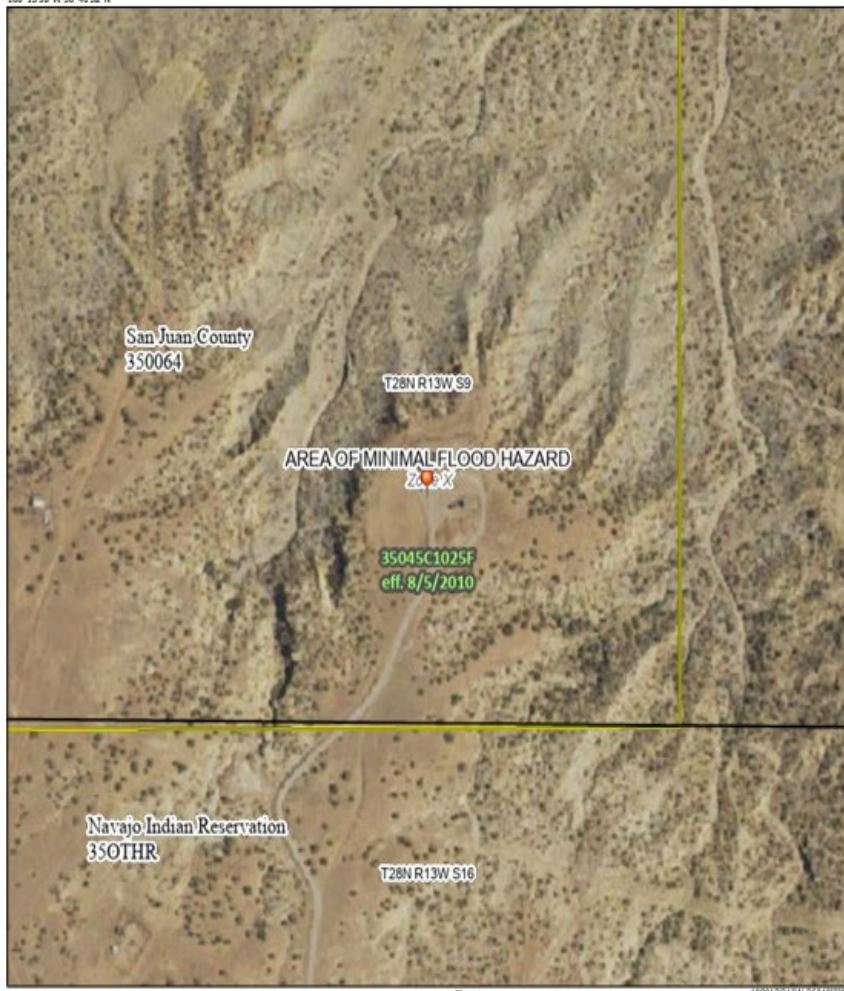
National Flood Hazard Layer FIRMette

The temporary pit for the Central Basin SWD #1 is located outside of all nearby flood boundaries.
