Closure Report
M-Suction to Lusk 6" S-09062024
Eddy County, New Mexico
Incident ID: nAPP2426029063
Unit M Sec 27 T18S R31E
32.712283°, -103.863468°

Natural Gas Release
Point of Release: Equipment Failure
Release Date: 09.06.2024
Volume Released: 5 barrels of Condensate
Volume Recovered: 0 barrels of Condensate

Re: Closure Report
M-Suction to Lusk 6"-S-09062024
Kinetik Midstream
Incident ID: nAPP2426029063
Site Location: Unit M, S27, T18S, R31E
(Lat 32.712283°, Long -103.863468°)
Eddy County, New Mexico

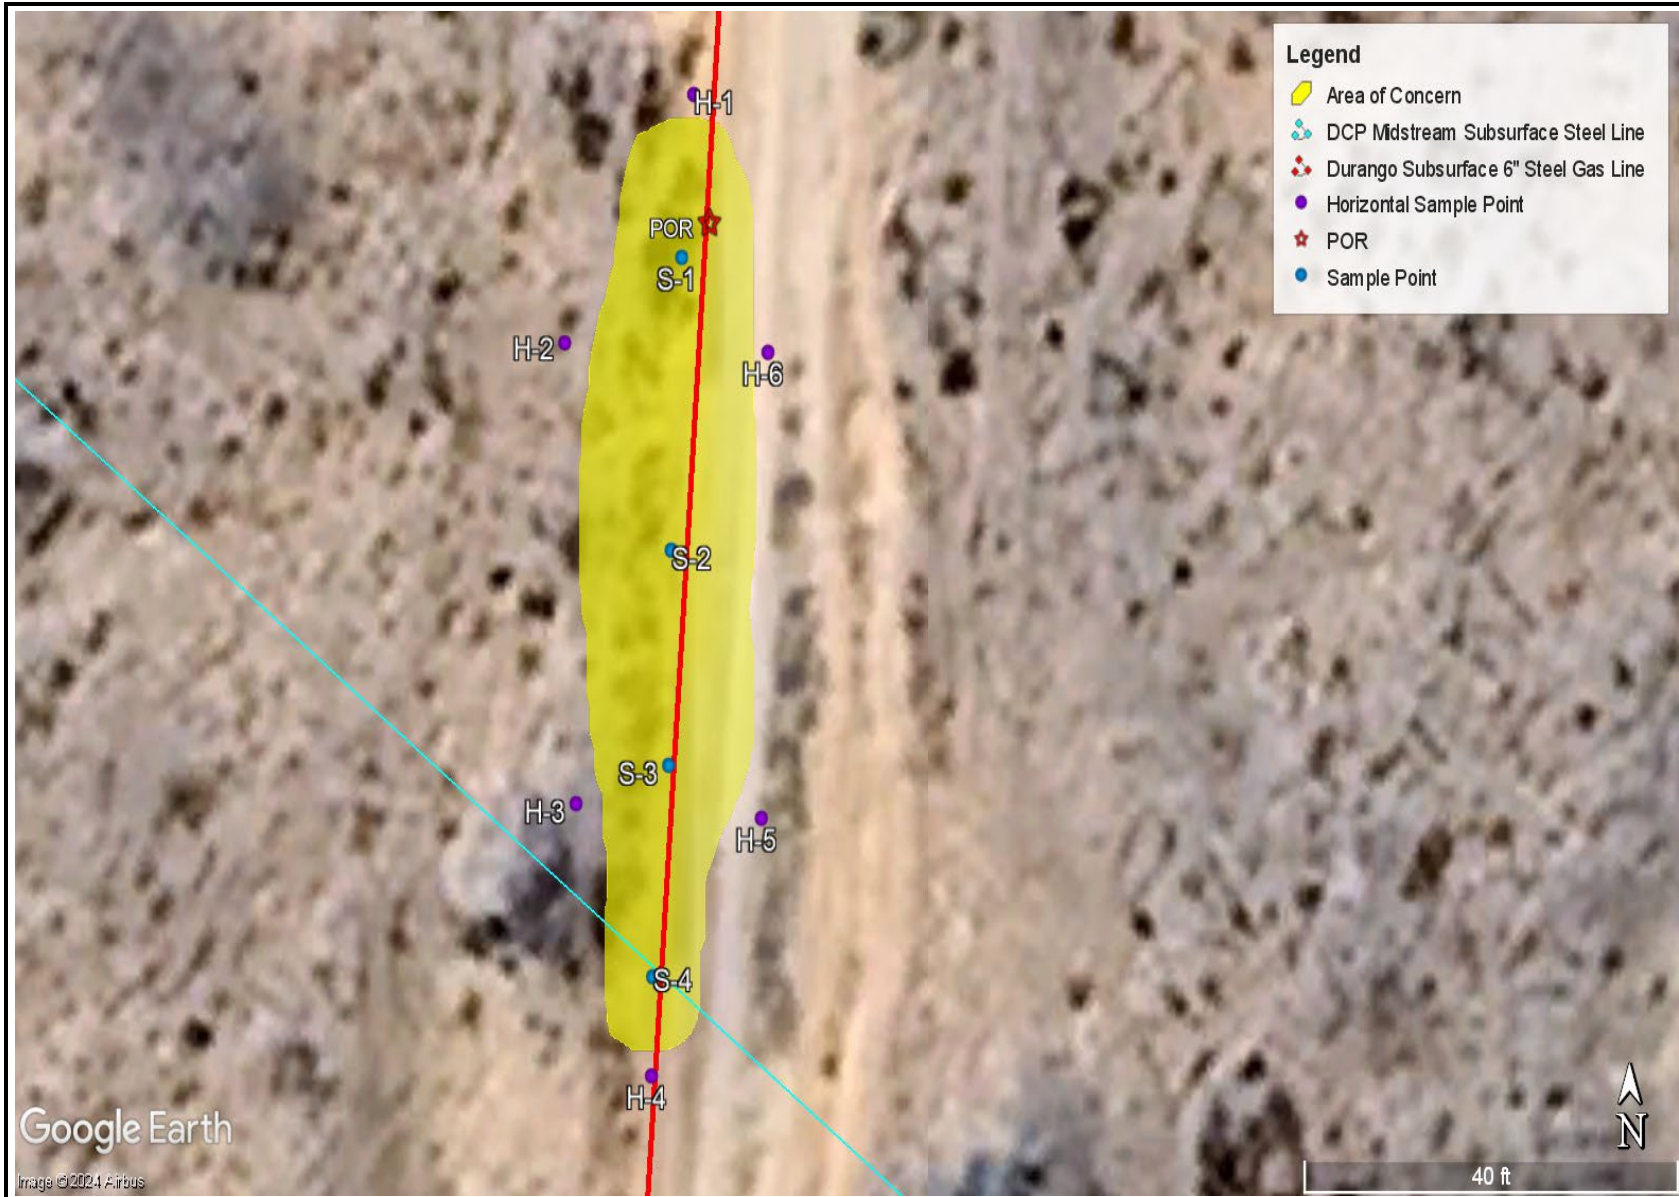
</p>	<p>FIGURE 3</p>
---	--	-----------------

Based on the Notice of Release obtained from the New Mexico Oil Conservation Division (NMOCD), the release was discovered due to equipment failure on a 6" steel gas line on September 06, 2024. It released approximately five (5) barrels of condensate, with zero (0) barrels recovered. The impacted area occurred on the R.O.W. See Figure 3. The Notice of Release form is attached in Appendix C.

<p>SAMPLE LOCATION MAP KINETIK MIDSTREAM M-SUCTION TO LUSK 6" S-09062024 EDDY COUNTY, NEW MEXICO 32.712283°, -103.863468°</p>	<p>CARMONA RESOURCES

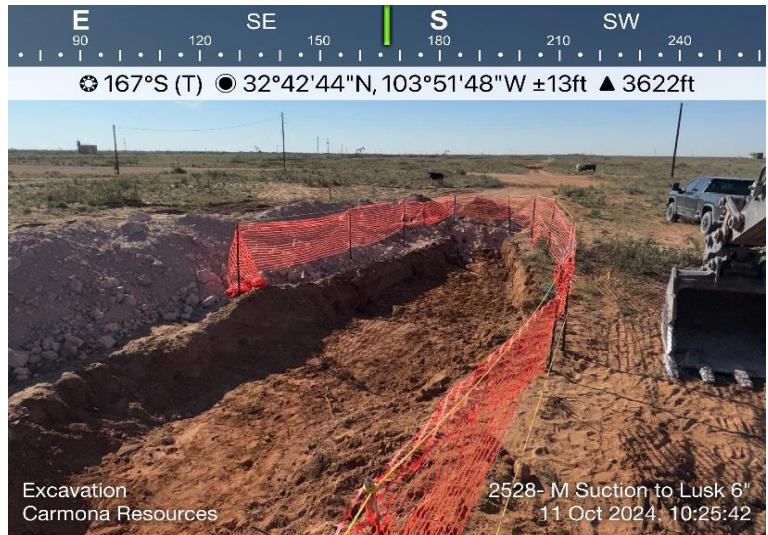
Description:
View South, area of Confirmation Samples (1-3).

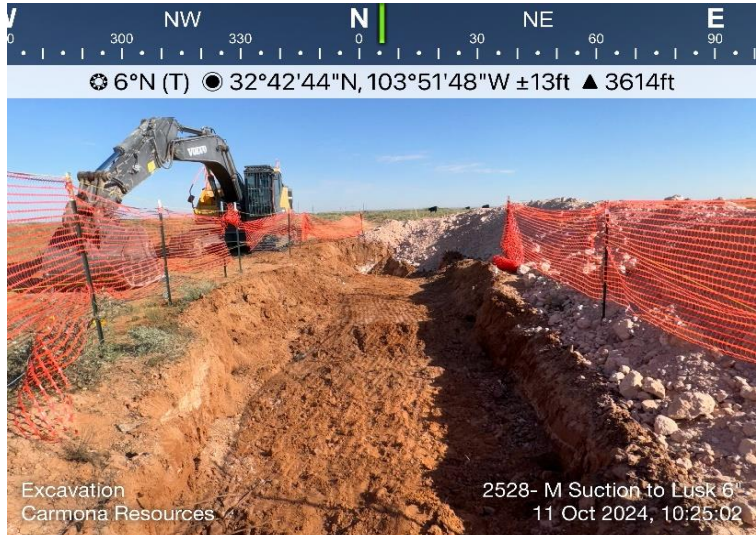
Photograph No. 2

Description:
View North, area of Confirmation Samples (4-6).

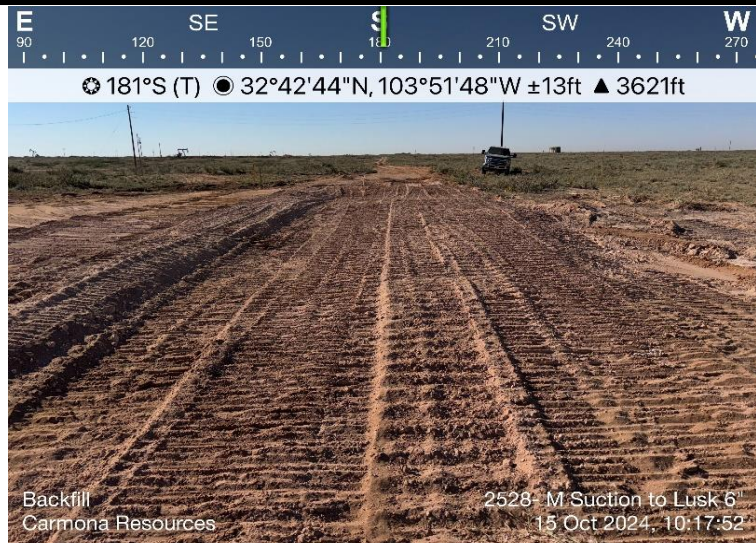
Photograph No. 3

Description:
View South, area of the backfilled excavation.
