CLOSURE REPORT

Florance #62F (05/29/24)
Unit Letter F, S20 T27N R8W
San Juan County, New Mexico

New Mexico EMNRD OCD Incident ID No. NAPP2415052060

August 27, 2024

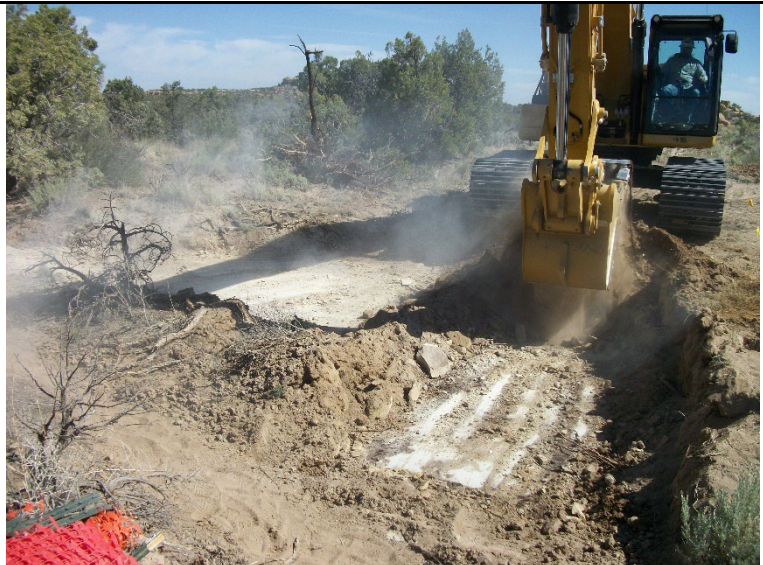
**Photograph 1**

Photograph Description: View of the in-process excavation activities.

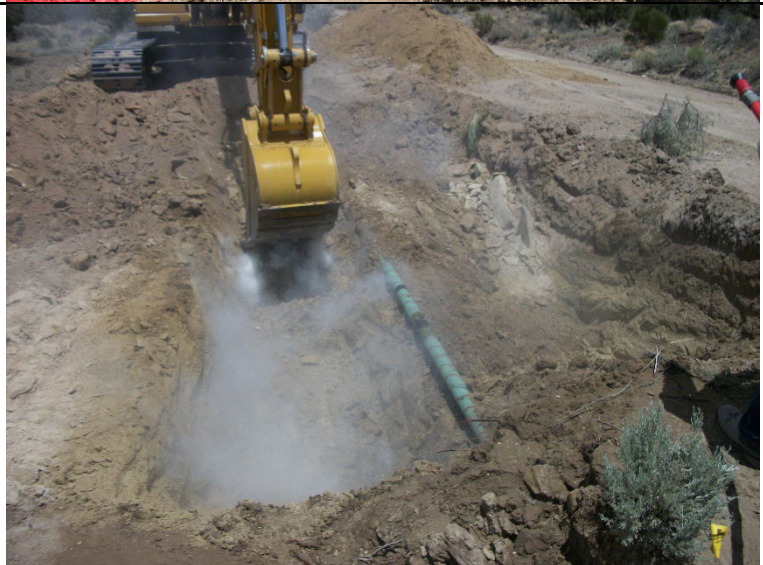
**Photograph 2**

Photograph Description: View of the in-process excavation activities.

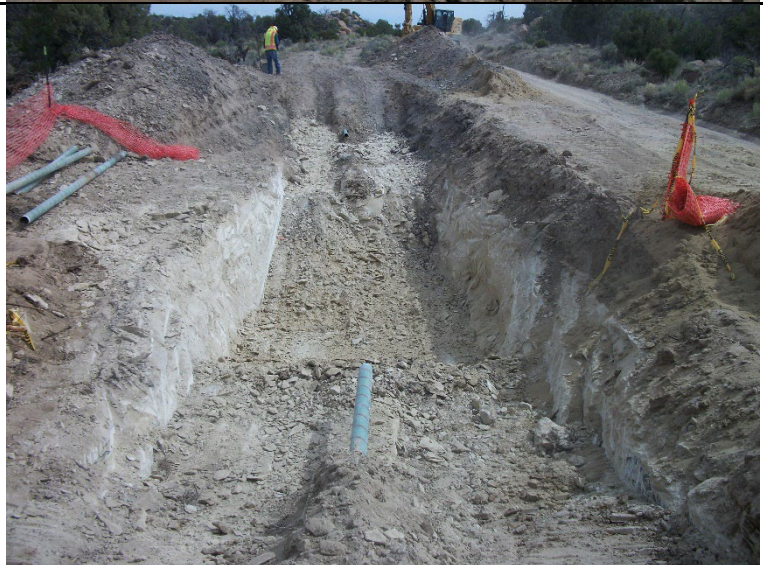
**Photograph 3**

The excavation measured approximately 18 feet long and 10 feet wide at the maximum extent. The maximum depth of the primary excavation measured approximately 8 feet bgs. The flow path excavation measured approximately 21 feet long and 9 feet wide at the maximum extents. The maximum depth of the flow path excavation measured approximately 0.5 feet bgs. The lithology encountered during the completion of remediation activities consisted primarily of silty sand and sandstone.

Photograph Description: View of final excavation.

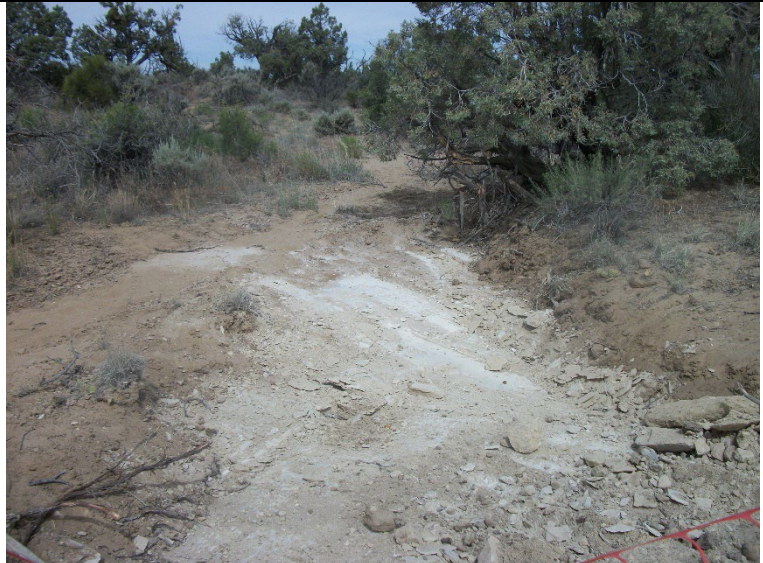
**Photograph 4**

Photograph Description: View of final flow path excavation.

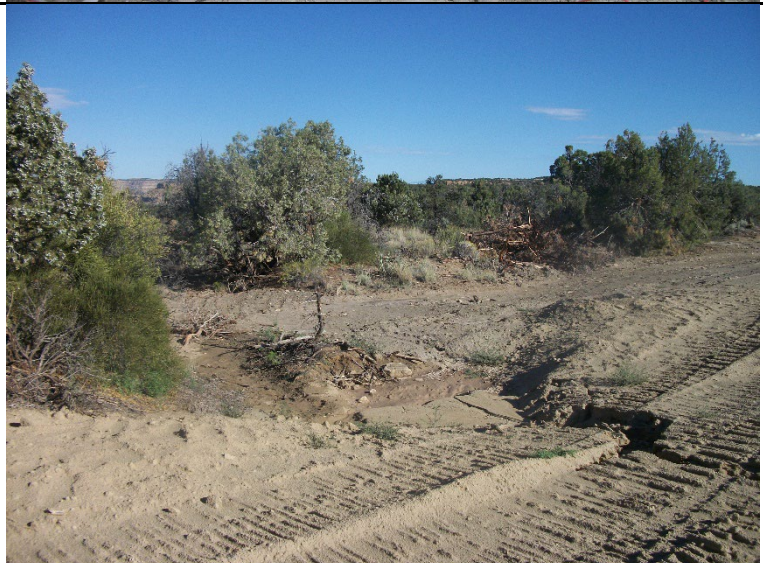
**Photograph 5**

Photograph Description: View of the site after initial restoration.

The excavation was backfilled with imported fill and then contoured to the surrounding grade. Once the Site is no longer being used for oil and gas production, final reclamation and revegetation will be addressed in accordance with 19.15.29.13 NMAC.

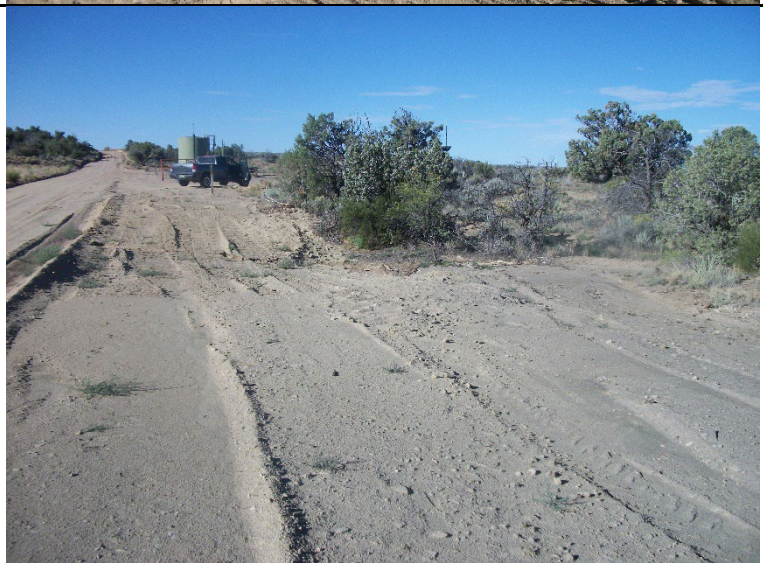
**Photograph 6**

Photograph Description: View of the site after initial restoration.
