Deferment Request

Re: State PA 7 Battery
Case nAPP242223824

On 7/31/2024 a release occurred due to a corrosion on an oil line from the treater releasing fluid inside a lined secondary containment. The release (GPS: 32.386556, -103.202833) is located south of Eunice, New Mexico in unit letter N section 18 township 22S range 37E. A groundwater survey was conducted utilizing NMOSE and USGS wells of record. The nearest wells of record suggest that the depth to groundwater beneath the release is 108 feet.

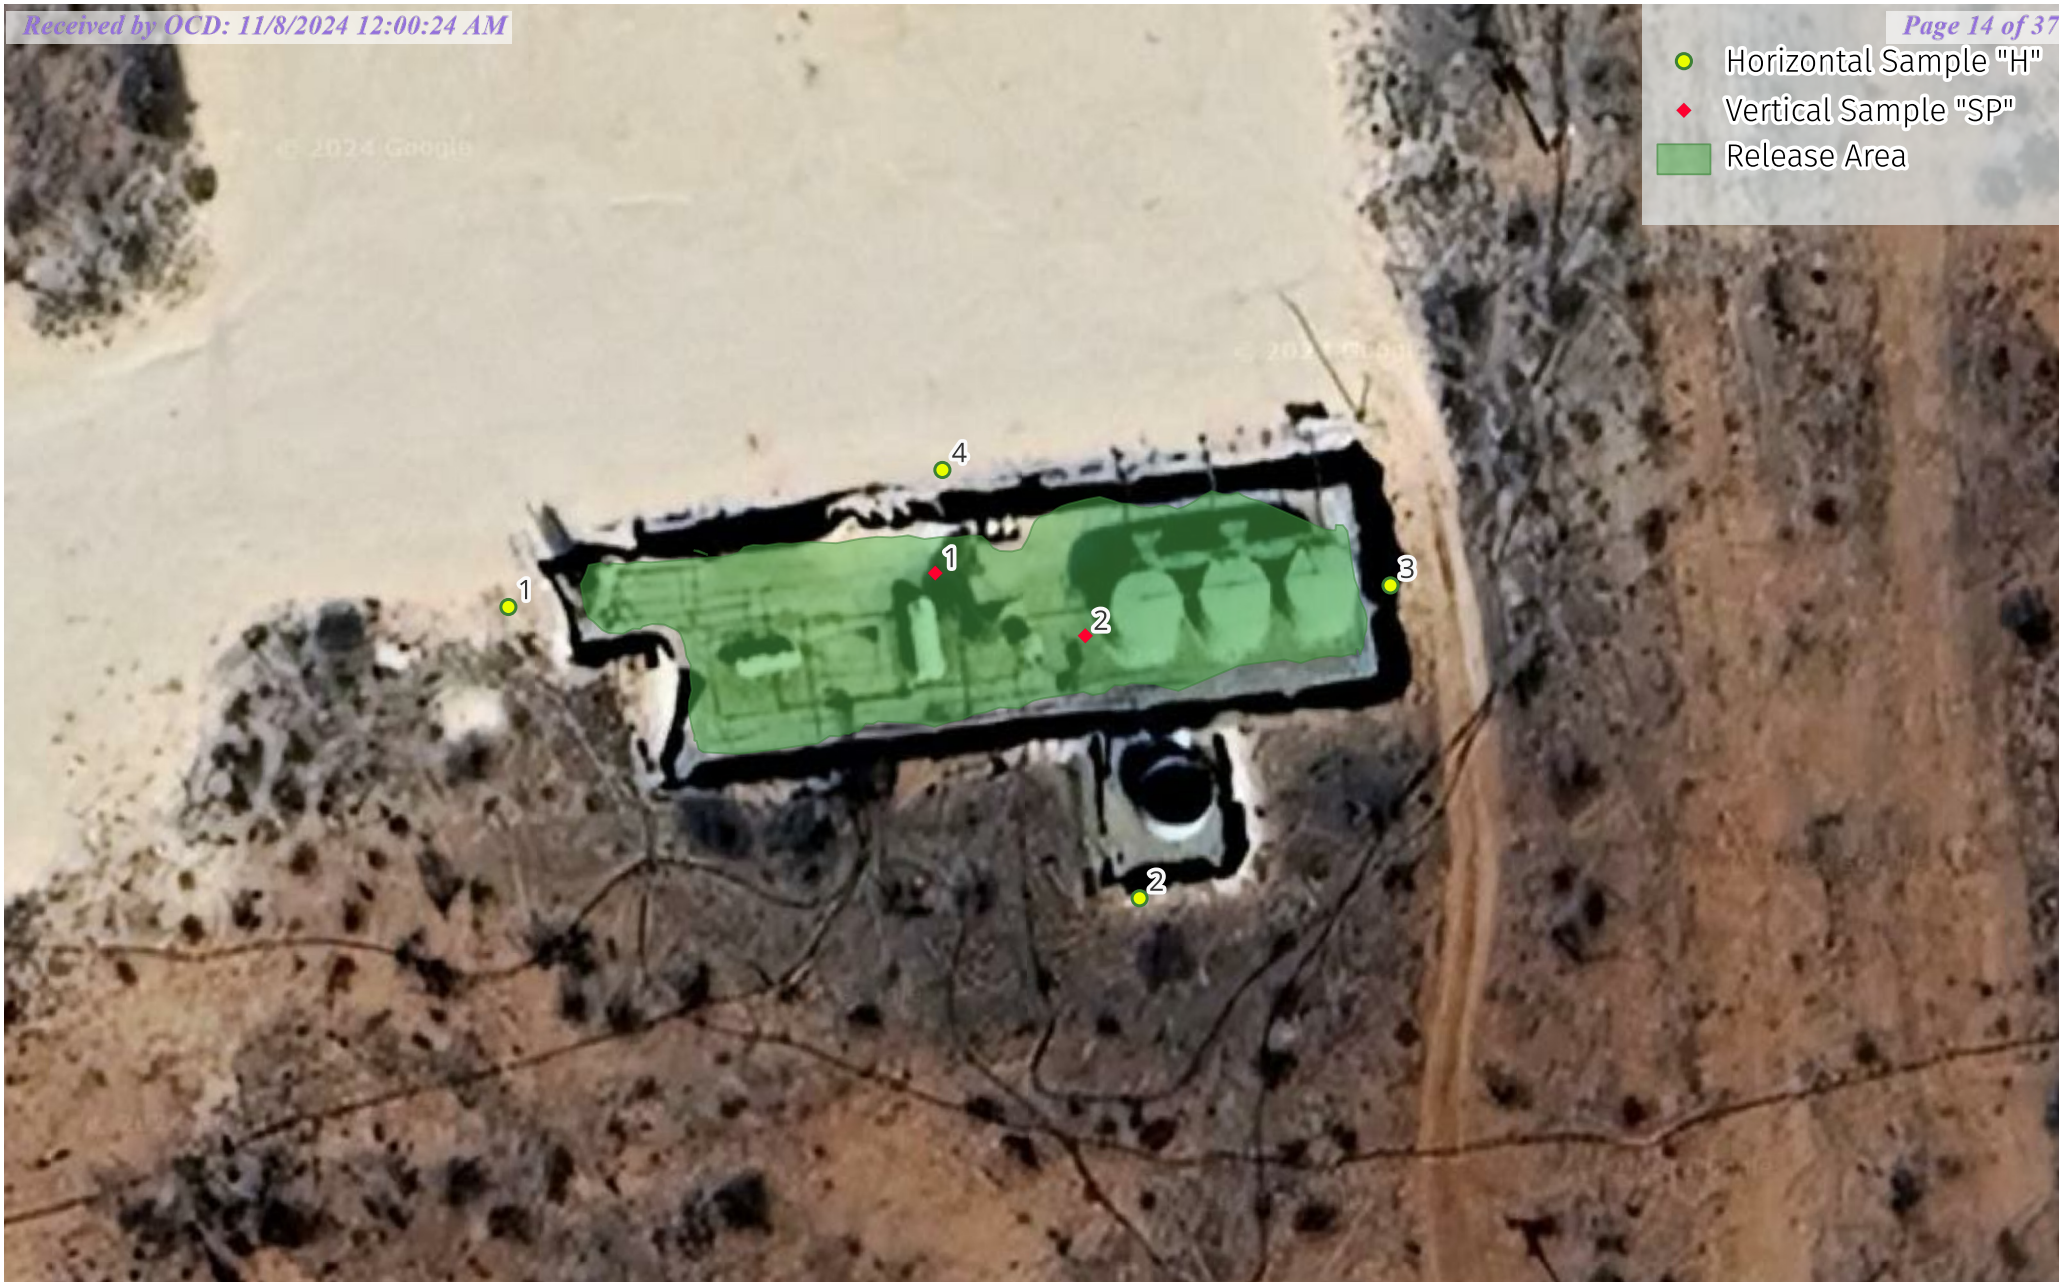
ST PA #7 CTB
Sample Map

Name ID	Latitude	Longitude	Date	
H1	32.3865460764148	-103.203181845816	2024-09-04T07:34:24.504	
H2	32.3863683651999	-103.202740307173	2024-09-04T07:35:29.040	
H3	32.3865533904204	-103.202561616661	2024-09-04T07:36:07.859	
H4	32.3866250868832	-103.202875753728	2024-09-04T07:33:30.785	
Name ID	Depth	Latitude	Longitude	Date
SP1	1'	32.3865636170956	-103.202881538011	2024-09-04T07:31:47.838
SP2	1'	32.3865252837622	-103.202776538011	2024-09-04T07:32:19.173
