**Re: Closure Request  
PLU Big Sinks 3 25 31 Battery  
Incident Numbers nAPP2425933523 & nAPP2432150756  
Eddy County, New Mexico**

Ensolum, LLC (Ensolum) on behalf of XTO Energy, Inc. (XTO), has prepared this *Closure Request* to document the findings of a liner integrity inspection conducted at the PLU Big Sinks 3 25 31 Battery (Site) following two releases of produced water within a lined containment. Based on the liner integrity inspection activities, XTO is submitting this *Closure Request*, describing assessment activities that have occurred and requesting no further action and closure for Incident Numbers nAPP2425933523 and nAPP2432150756.

XTO Energy, Inc.  
Closure Request  
PLU Big Sinks 3 25 31 Battery

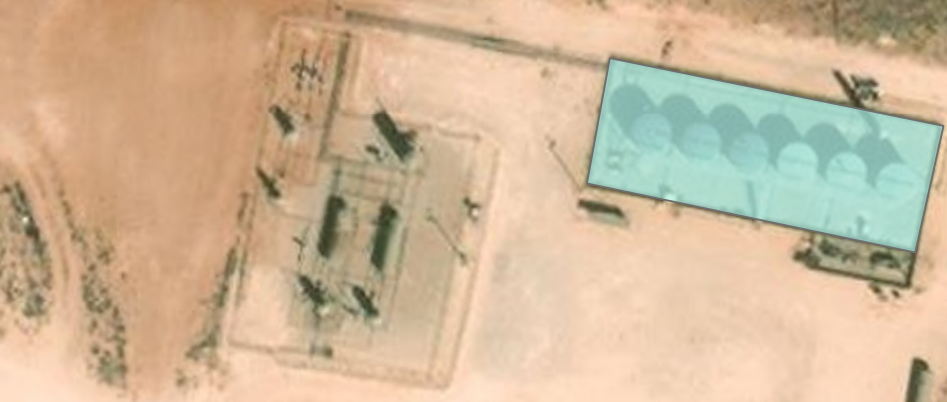
## Site Map

After a review of the C-141, internal documents, and initial release photographs, it was confirmed the two releases occurred within the lined containment. The lined containment was cleaned of all debris and power washed. A 48-hour advance notice of the liner inspection was submitted on December 4, 2024. On December 6, 2024, the lined containment was inspected by Ensolum personnel and was determined to be operating as designed. Upon inspection, no rips, tears, holes, or damage were observed. The liner was determined to be sufficient, and all released fluid had been recovered. A site map depicting the lined containment is included in Figure 2. Photographic documentation of the inspection is included in Appendix B.

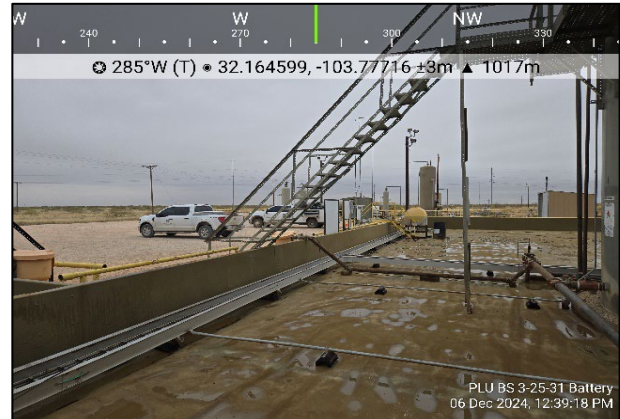
Photograph: 2 Date: 12/6/2024  
Description: Power washing crew on site  
View: West

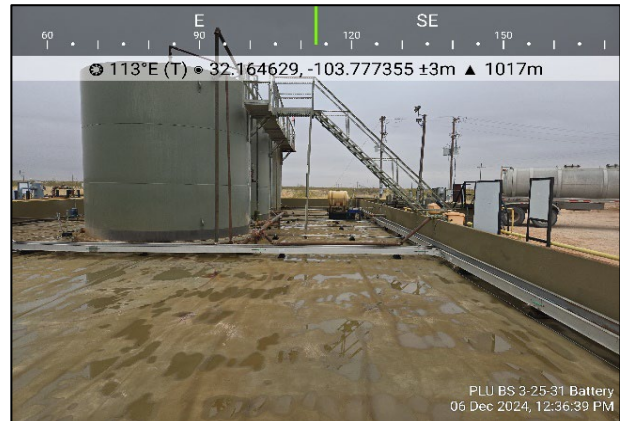
Liner integrity inspection activities were completed following a release of produced water within a lined containment at the Site. A liner integrity inspection was conducted by XTO personnel, and, upon inspection, no rips, tears, holes, or damage was observed, and the liner was determined to be sufficient. The releases were contained laterally by the lined containment and the liner was performing as designed. Based on initial response efforts and the liner operating as designed, XTO respectfully requests closure for Incident Numbers nAPP2425933523 and nAPP2432150756.

Photograph: 4 Date: 12/6/2024  
Description: Liner inspection activities  
View: East
