**Re: Closure Request  
Big Eddy Unit DI 29 Battery  
Incident Number nAPP2424738940  
Lea County, New Mexico**

Ensolum, LLC (Ensolum) on behalf of XTO Energy, Inc. (XTO), has prepared this *Closure Request* to document liner inspection, delineation, and soil sampling activities at the Big Eddy Unit DI 29 Battery (Site). The purpose of the liner inspection, delineation, and soil sampling activities was to assess for the presence or absence of impacts to soil following a release of crude oil. Based on field observations, field screening activities, and soil sample laboratory analytical results, XTO is submitting this *Closure Request*, describing remedial activities that have occurred and requesting no further action for Incident Number nAPP2424738940.

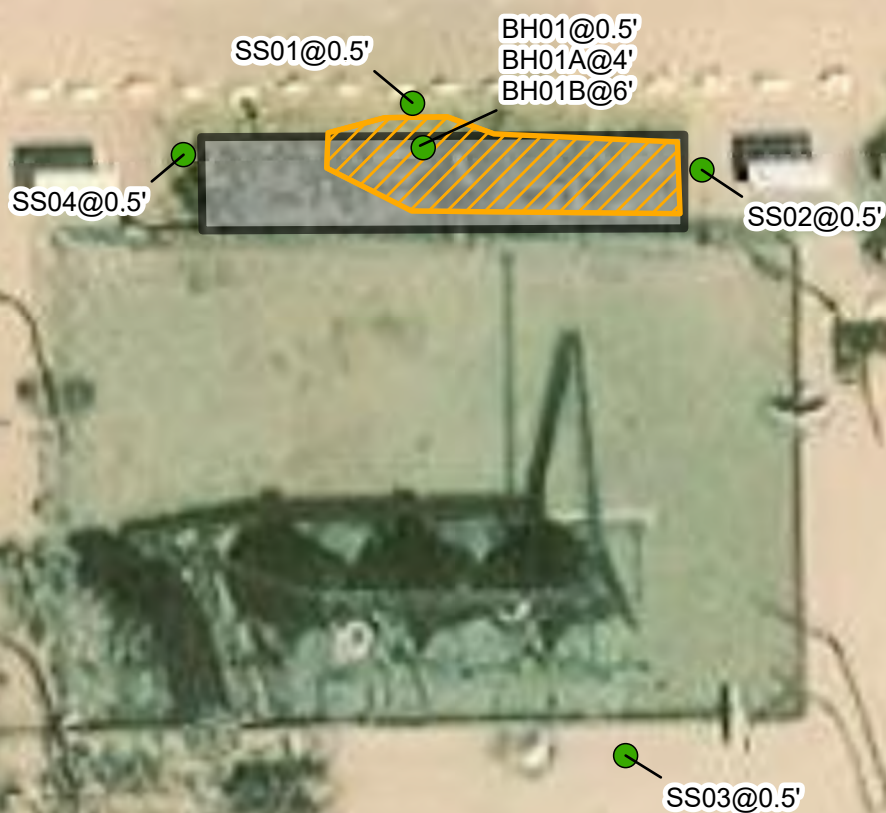
**FIGURE**  
**2**

On November 18, 2024, Ensolum personnel returned to the Site to conduct delineation activities. One borehole (BH01) was advanced at the location of the tear in the liner identified during the liner inspection. Due to competent bedrock underlying the lined containment at the Site, borehole BH01 was completed utilizing a core drill. Three discrete delineation soil samples were collected from the borehole at depths of 0.5 feet, 4 feet, and 6 feet bgs. Soil from the borehole was field screened for volatile organic compounds (VOCs) utilizing a calibrated photoionization detector (PID) and chloride using Hach® chloride QuanTab® test strips. Field screening results and observations from the borehole were documented on a lithologic/soil sampling log, which is included as Appendix C. The borehole was backfilled with soil removed and the liner was repaired. Four additional delineation soil samples (SS01 through SS04) were collected around the lined containment from a depth of 0.5 feet bgs to confirm the lateral extent of the release. Borehole BH01 and the delineation soil sample locations were mapped utilizing a handheld GPS unit and are depicted on Figure 2.

## Delineation Soil Sample Locations

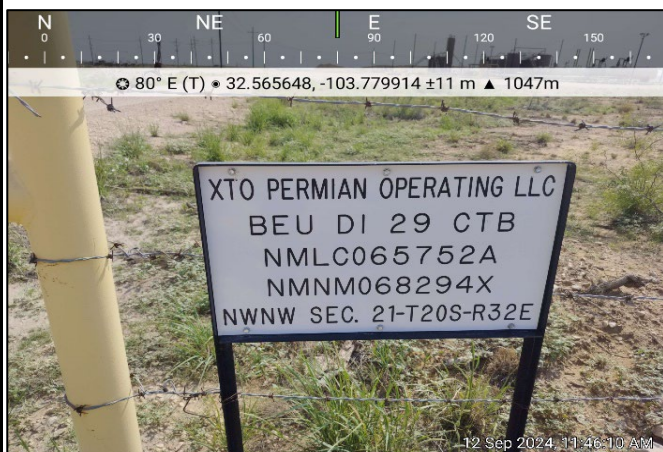
Photograph: 1 Date: 9/12/2024  
Description: Liner inspection activities, facility sign.  
View: East

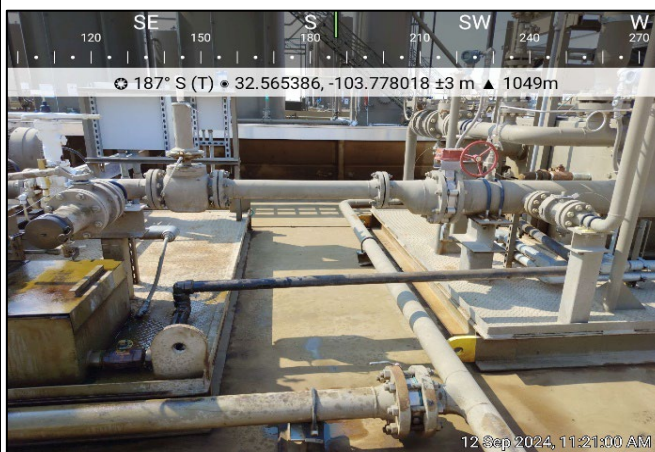
Photograph: 2 Date: 9/12/2024  
Description: Liner inspection activities.  
View: South

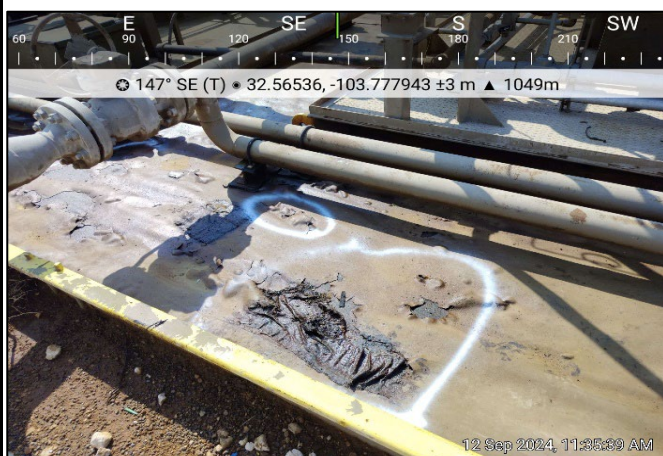
On September 10, 2024, a 48-hour advance notice of liner inspection was provided to the NMOCD and a liner integrity inspection was conducted by Ensolum on September 12, 2024. Liner inspection results indicated the liner was not operating as designed as a tear in the liner was observed. The location of the tear was mapped utilizing a handheld Global Positioning System (GPS) unit and is depicted on Figure 2. Photographic documentation was collected during the inspection and a photographic log is provided in Appendix B.

Photograph: 3 Date: 9/12/2024  
Description: Liner inspection activities, liner breach.  
View: Southeast

Based on initial response efforts, surface scraping activities, the liner repair following delineation activities, and all soil sample laboratory analytical results compliant with the Closure Criteria, XTO respectfully requests closure for Incident Number nAPP2424738940. XTO believes these remedial actions are protective of human health, the environment, and groundwater.

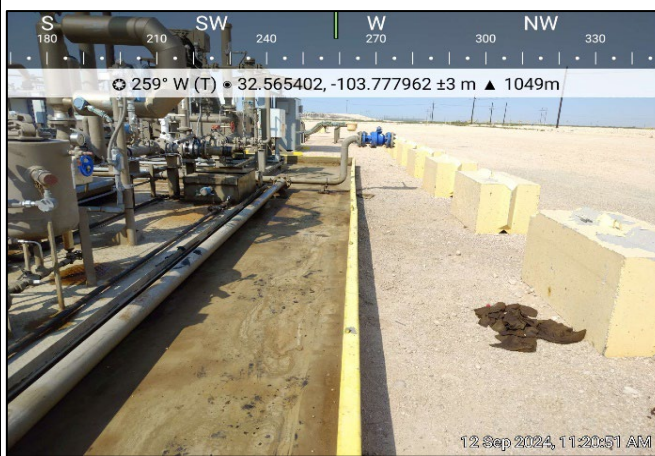
Photograph: 4 Date: 9/12/2024  
Description: Liner inspection activities.  
View: West

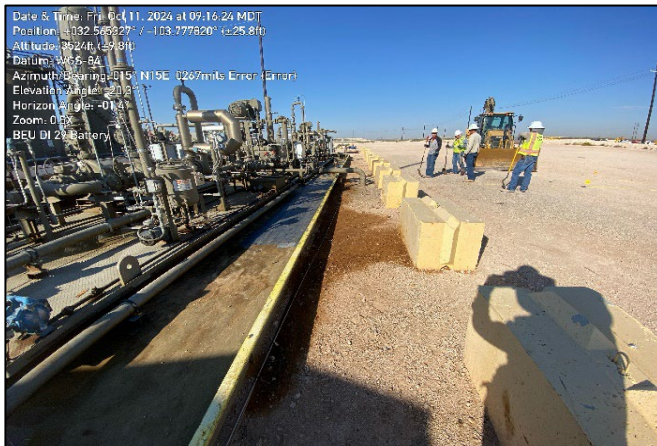
Photograph: 5 Date: 10/11/2024  
Description: Surface scraping activities.  
View: West

Between October 11 and November 22, 2024, surface scraping and soil sampling activities were conducted to address the small release area resulting from the release overflowing the containment. The soil was removed from the release area as indicated by visible staining. The surface scraping was conducted utilizing hand tools and a backhoe and occurred on the facility pad, immediately adjacent to the lined containment. Approximately 1 cubic yard of soil was removed in a 55 square foot area. Following the removal of the stained soil, Ensolum personnel collected a 5-point composite soil sample (CS01) representing the surface scraped area. The 5-point composite soil sample was collected by placing five equivalent aliquots of soil into a 1-gallon, resealable plastic bag and homogenizing the samples by thoroughly mixing. Confirmation soil sample CS01 was collected from surface scraped area at a depth of approximately 0.5 feet bgs. The surface scraped area and CS01 locations are presented on Figure 3.

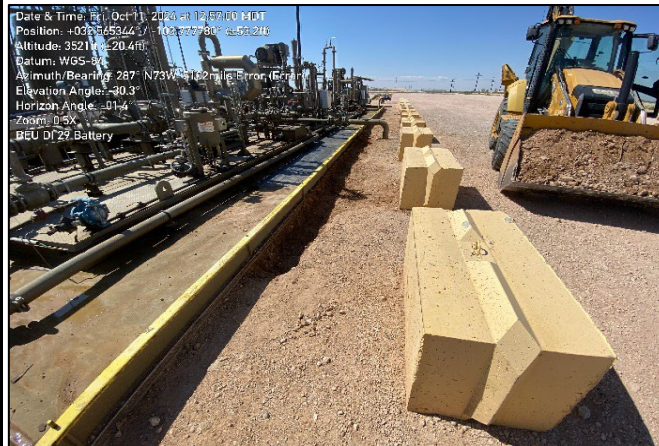
Photograph: 6 Date: 10/11/2024  
Description: Surface scraping activities.  
View: West

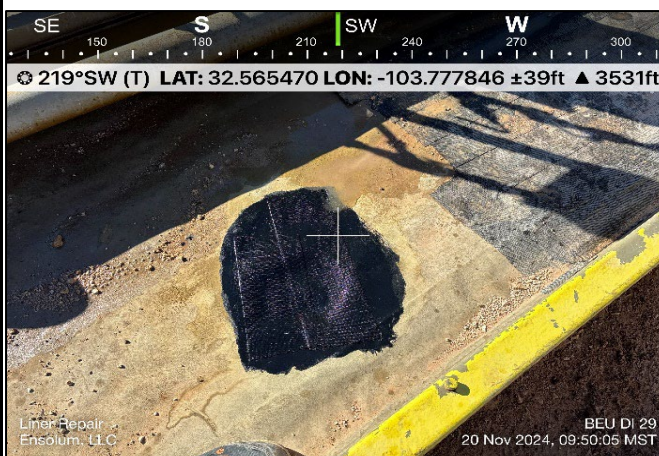
Photograph: 8 Date: 11/20/2024  
Description: Patching of BH01.  
View: Southwest
