CLOSURE REQUEST REPORT

Hayhurst NM Section 35 CTB
Eddy County, New Mexico
Incident Number nAPP2302742810

Prepared for:
Chevron USA, Inc.
6301 Deauville Blvd
Midland, TX, 79706

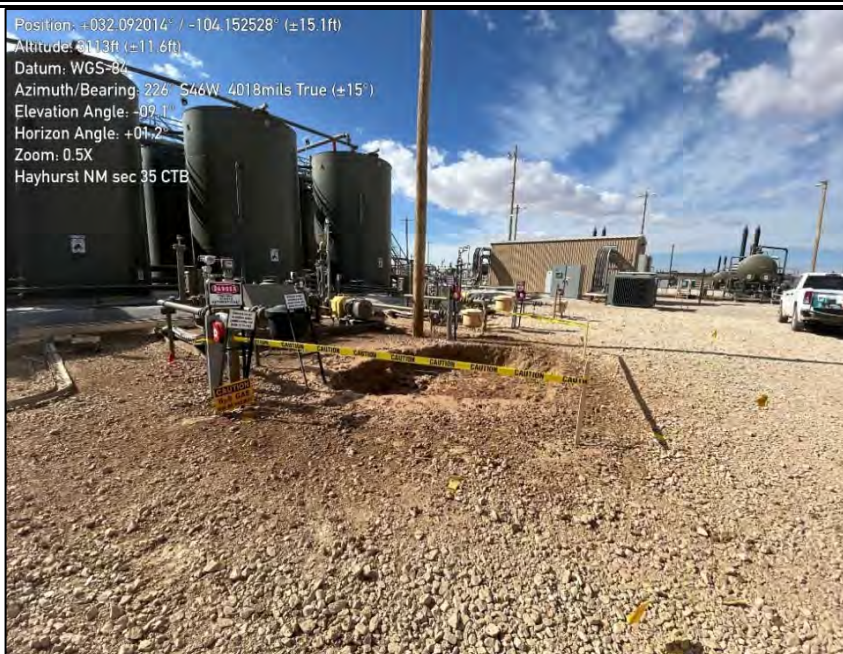
**Photograph 1****Date: 10/30/2024**

Description: Southwestern view of completed excavation extent.

On October 30, 2024, excavation activities were performed via hydrovac to remove residual impacts identified by COCs exceedances as summarized in the approved RWP. Excavation activities were driven by field screening soil samples for volatile organic compounds (VOCs) utilizing a calibrated photoionization detector (PID) and chloride using Hach® chloride QuanTab® test strips

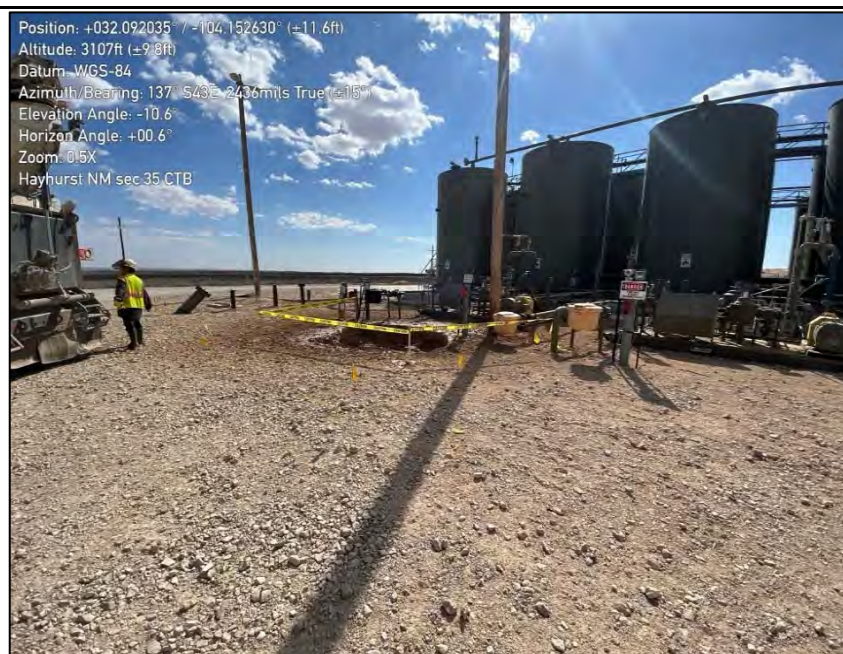
**Photograph 2****Date: 10/30/2024**

Description: Southeastern view of completed excavation extent.

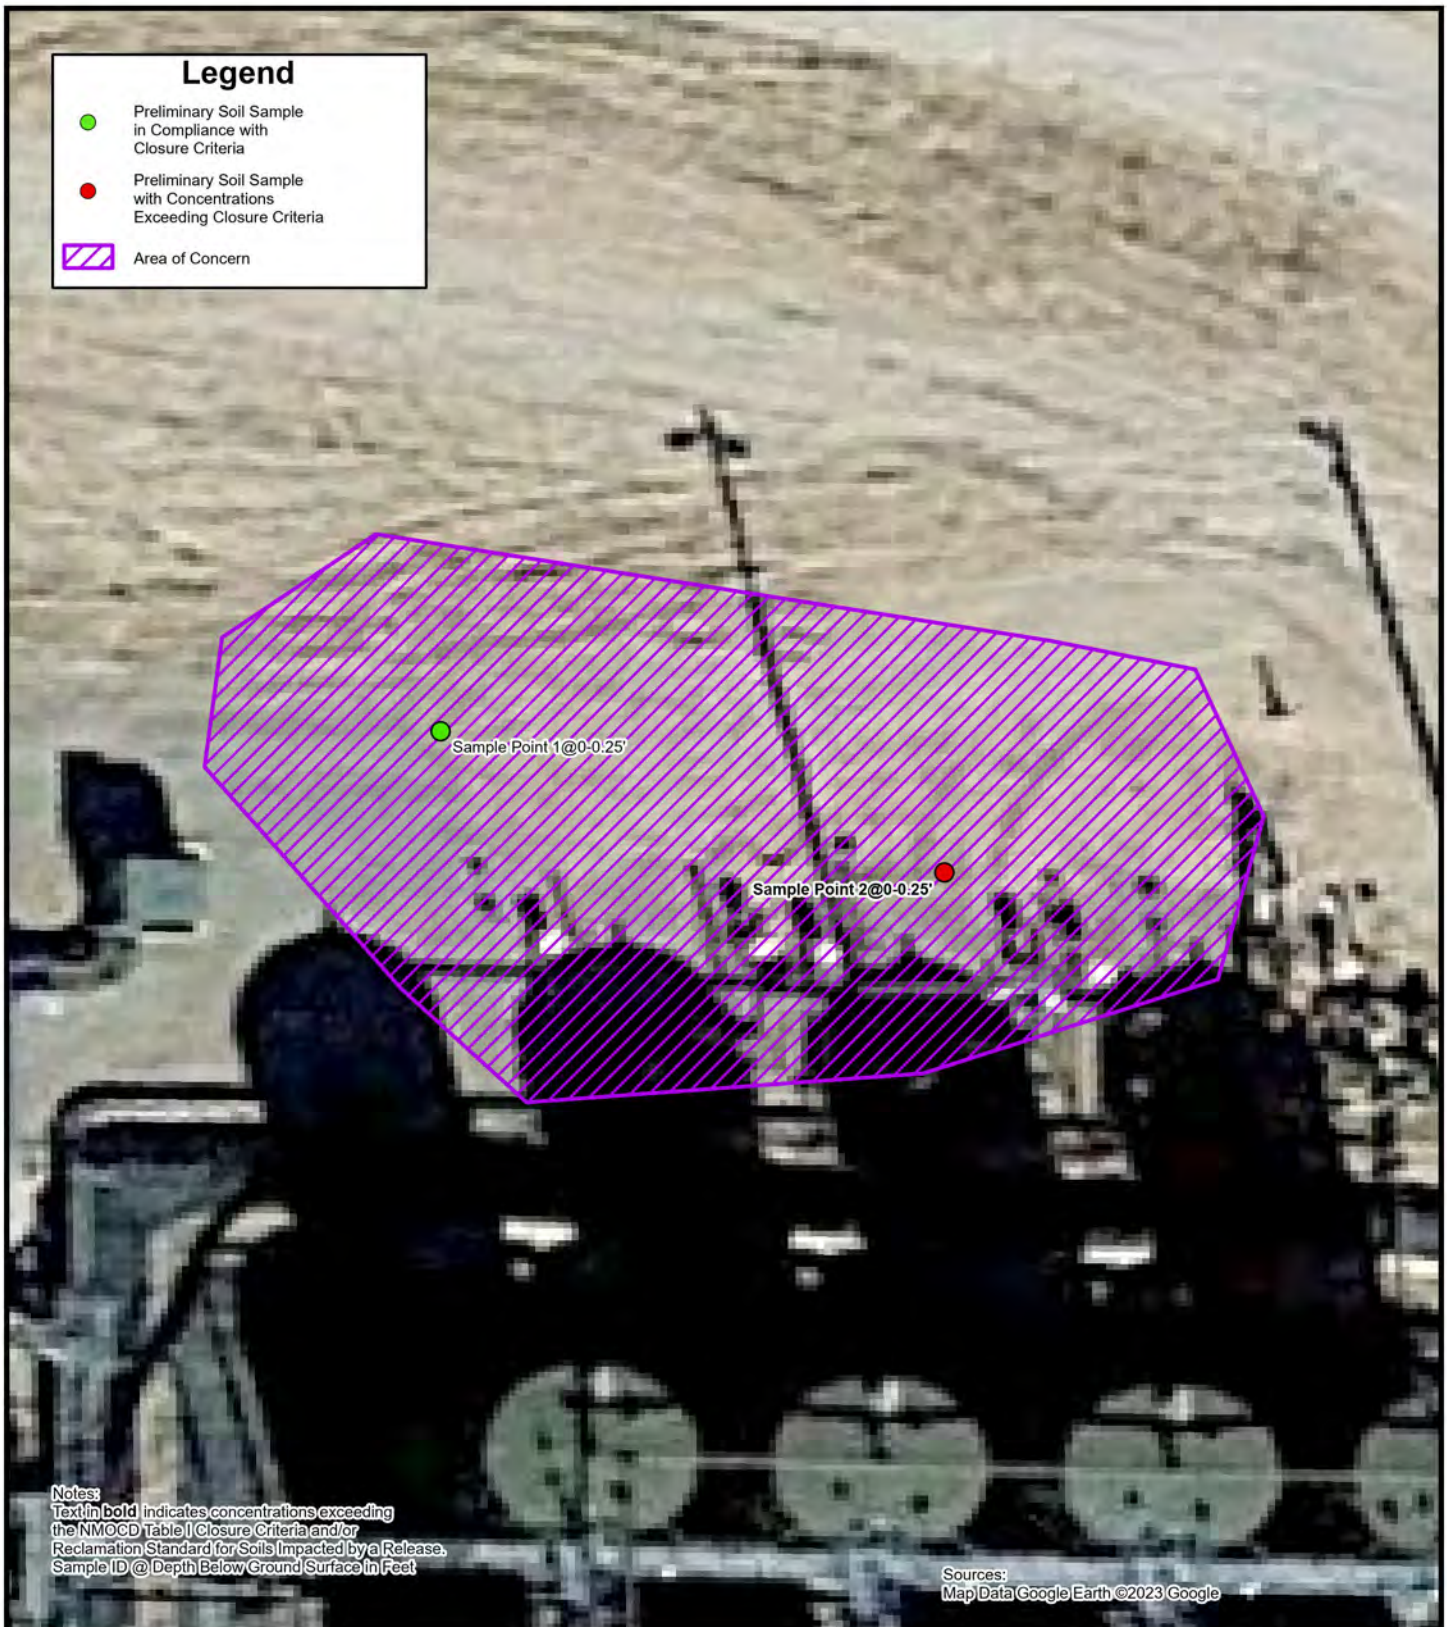
FIGURE 2

Preliminary Soil Sample Locations

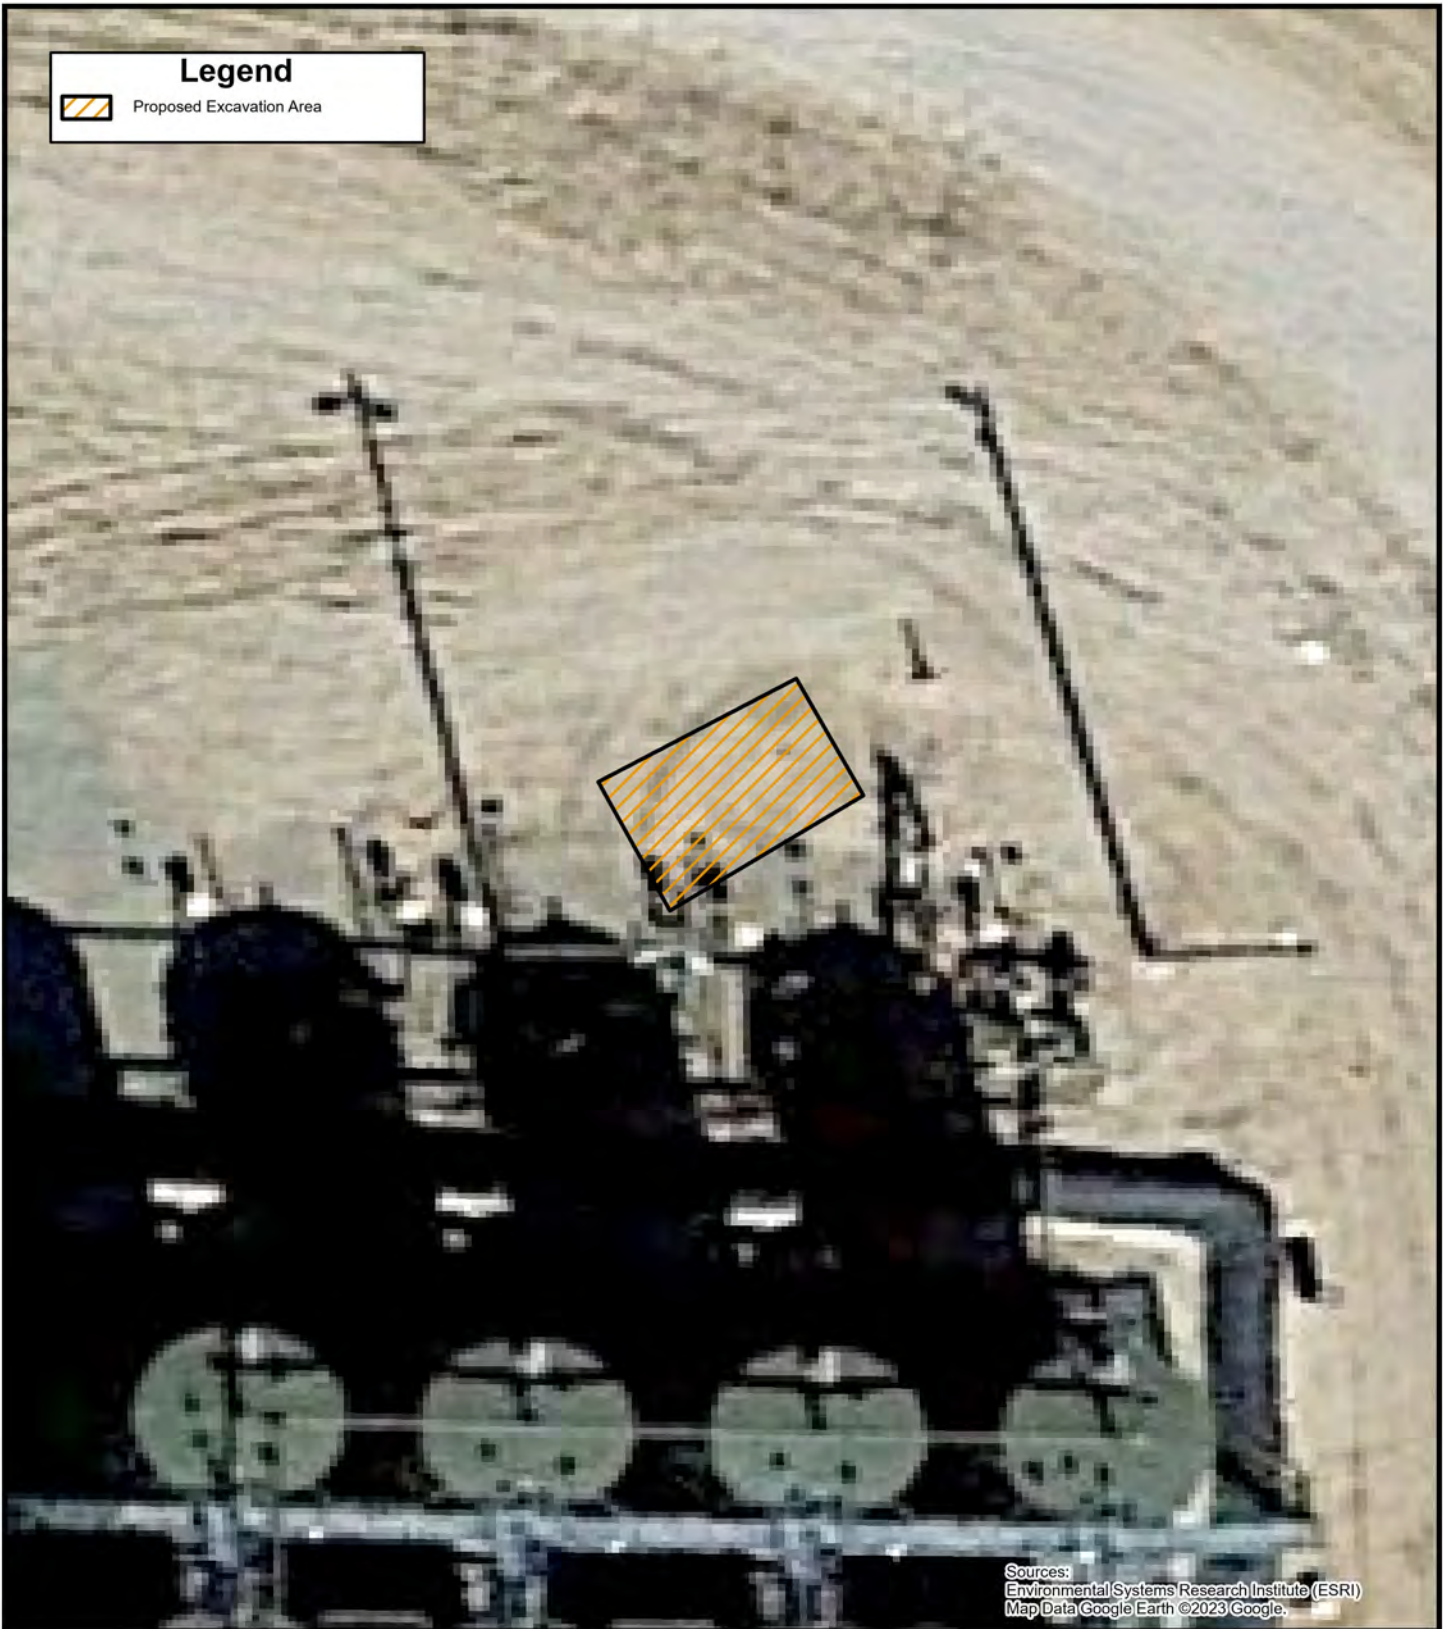
FIGURE 4

Proposed Excavation Area

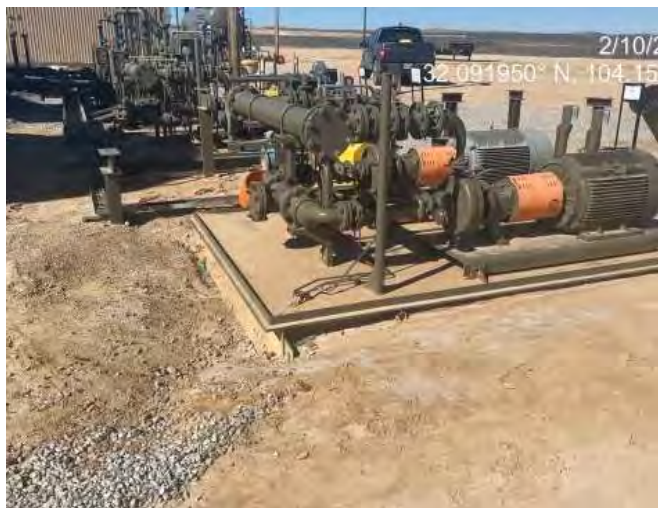
**Photograph 1****Date: 02/10/2023**

Description: Northwest view of site assessment.

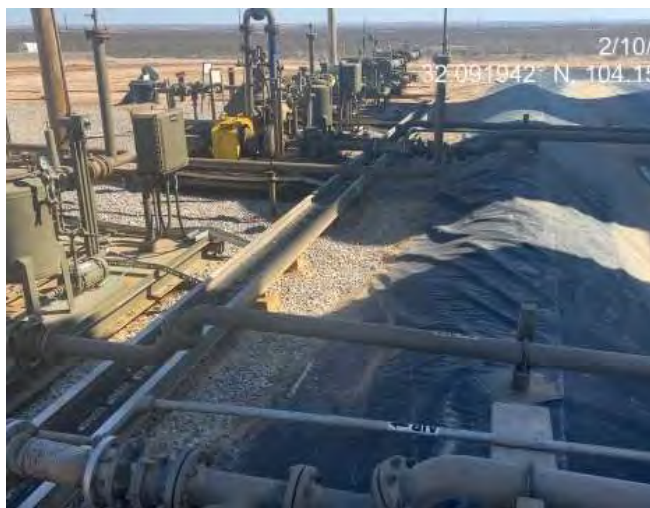
**Photograph 2****Date: 02/10/2022**

Description: Northeast view of site assessment.

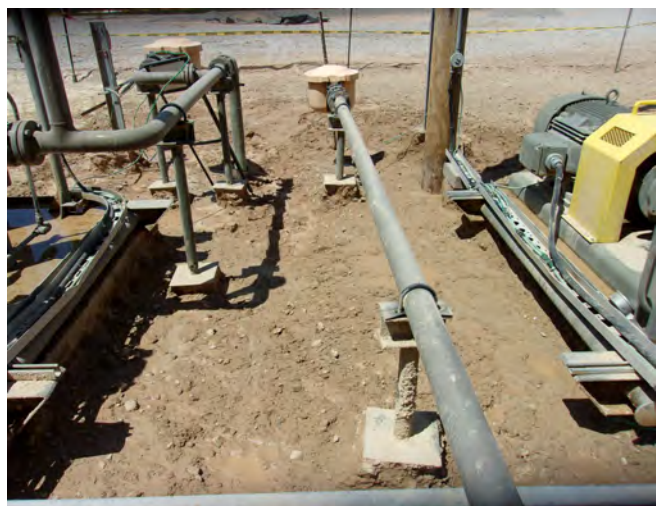
**Photograph 3****Date: 08/11/2023**

Description: Northern view of excavation activities.

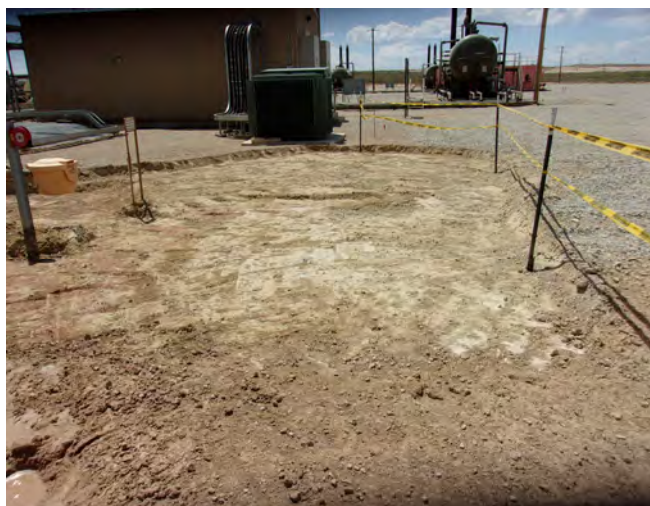
**Photograph 4****Date: 08/11/2023**

Description: Western view of excavation activities.

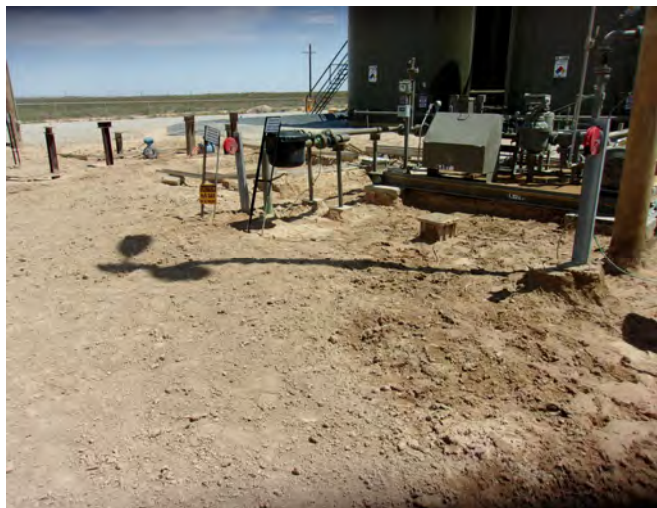
**Photograph 5****Date: 08/11/2023**

Description: Southeastern view of excavation activities.

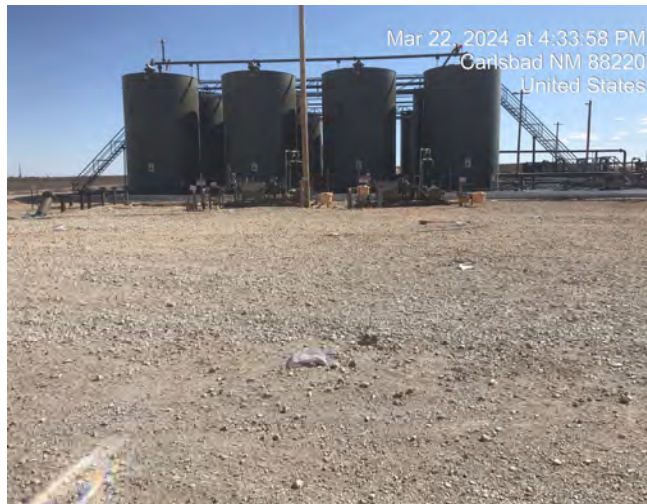
**Photograph 6****Date: 03/22/2024**

Description: Southeastern view of site restoration activities.

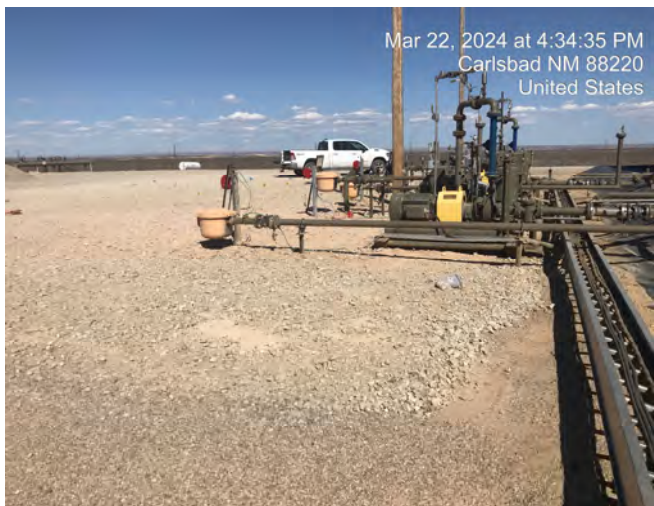
**Photograph 7****Date: 03/22/2024**

Description: Northeast view of site restoration activities.

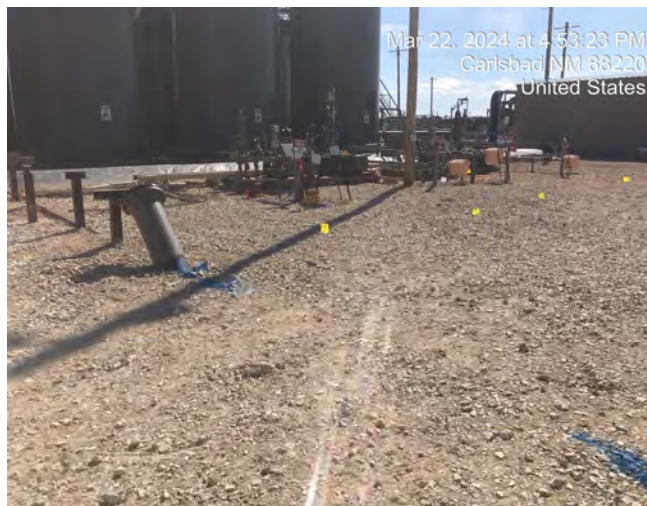
**Photograph 8****Date: 03/22/2024**

Description: Southwest view of site restoration activities.
