**Re: Closure Request  
PLU Big Sinks 3 25 31 Battery  
Incident Numbers nAPP2425933523 & nAPP2432150756  
Eddy County, New Mexico**

Ensolum, LLC (Ensolum) on behalf of XTO Energy, Inc. (XTO), has prepared this *Closure Request* to document the findings of a liner integrity inspection conducted at the PLU Big Sinks 3 25 31 Battery (Site) following two releases of produced water within a lined containment. Based on the liner integrity inspection activities, XTO is submitting this *Closure Request*, describing assessment activities that have occurred and requesting no further action and closure for Incident Numbers nAPP2425933523 and nAPP2432150756.

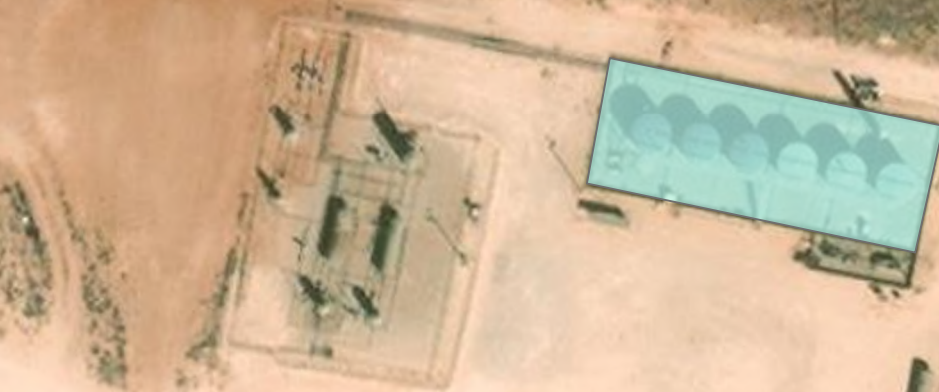
**2**

## Site Map

XTO Energy Inc.  
PLU Big Sinks 3 25 31 Battery  
Incident Numbers: nAPP2425933523 & nAPP2432150756  
Unit A, Sec 04, T25S, R31E  
Eddy County, New Mexico

After a review of the C-141, internal documents, and initial release photographs, it was confirmed the two releases occurred within the lined containment. The lined containment was cleaned of all debris and power washed. A 48-hour advance notice of the liner inspection was submitted on December 4, 2024. On December 6, 2024, the lined containment was inspected by Ensolum personnel and was determined to be operating as designed. Upon inspection, no rips, tears, holes, or damage were observed. The liner was determined to be sufficient, and all released fluid had been recovered. A site map depicting the lined containment is included in Figure 2. Photographic documentation of the inspection is included in Appendix B.
