# SITE CHARACTERIZATION AND REMEDIATION PLAN

**RDX 15 East Production Pad**

**Incident Number nAPP2423222600**

*Eddy County, New Mexico*

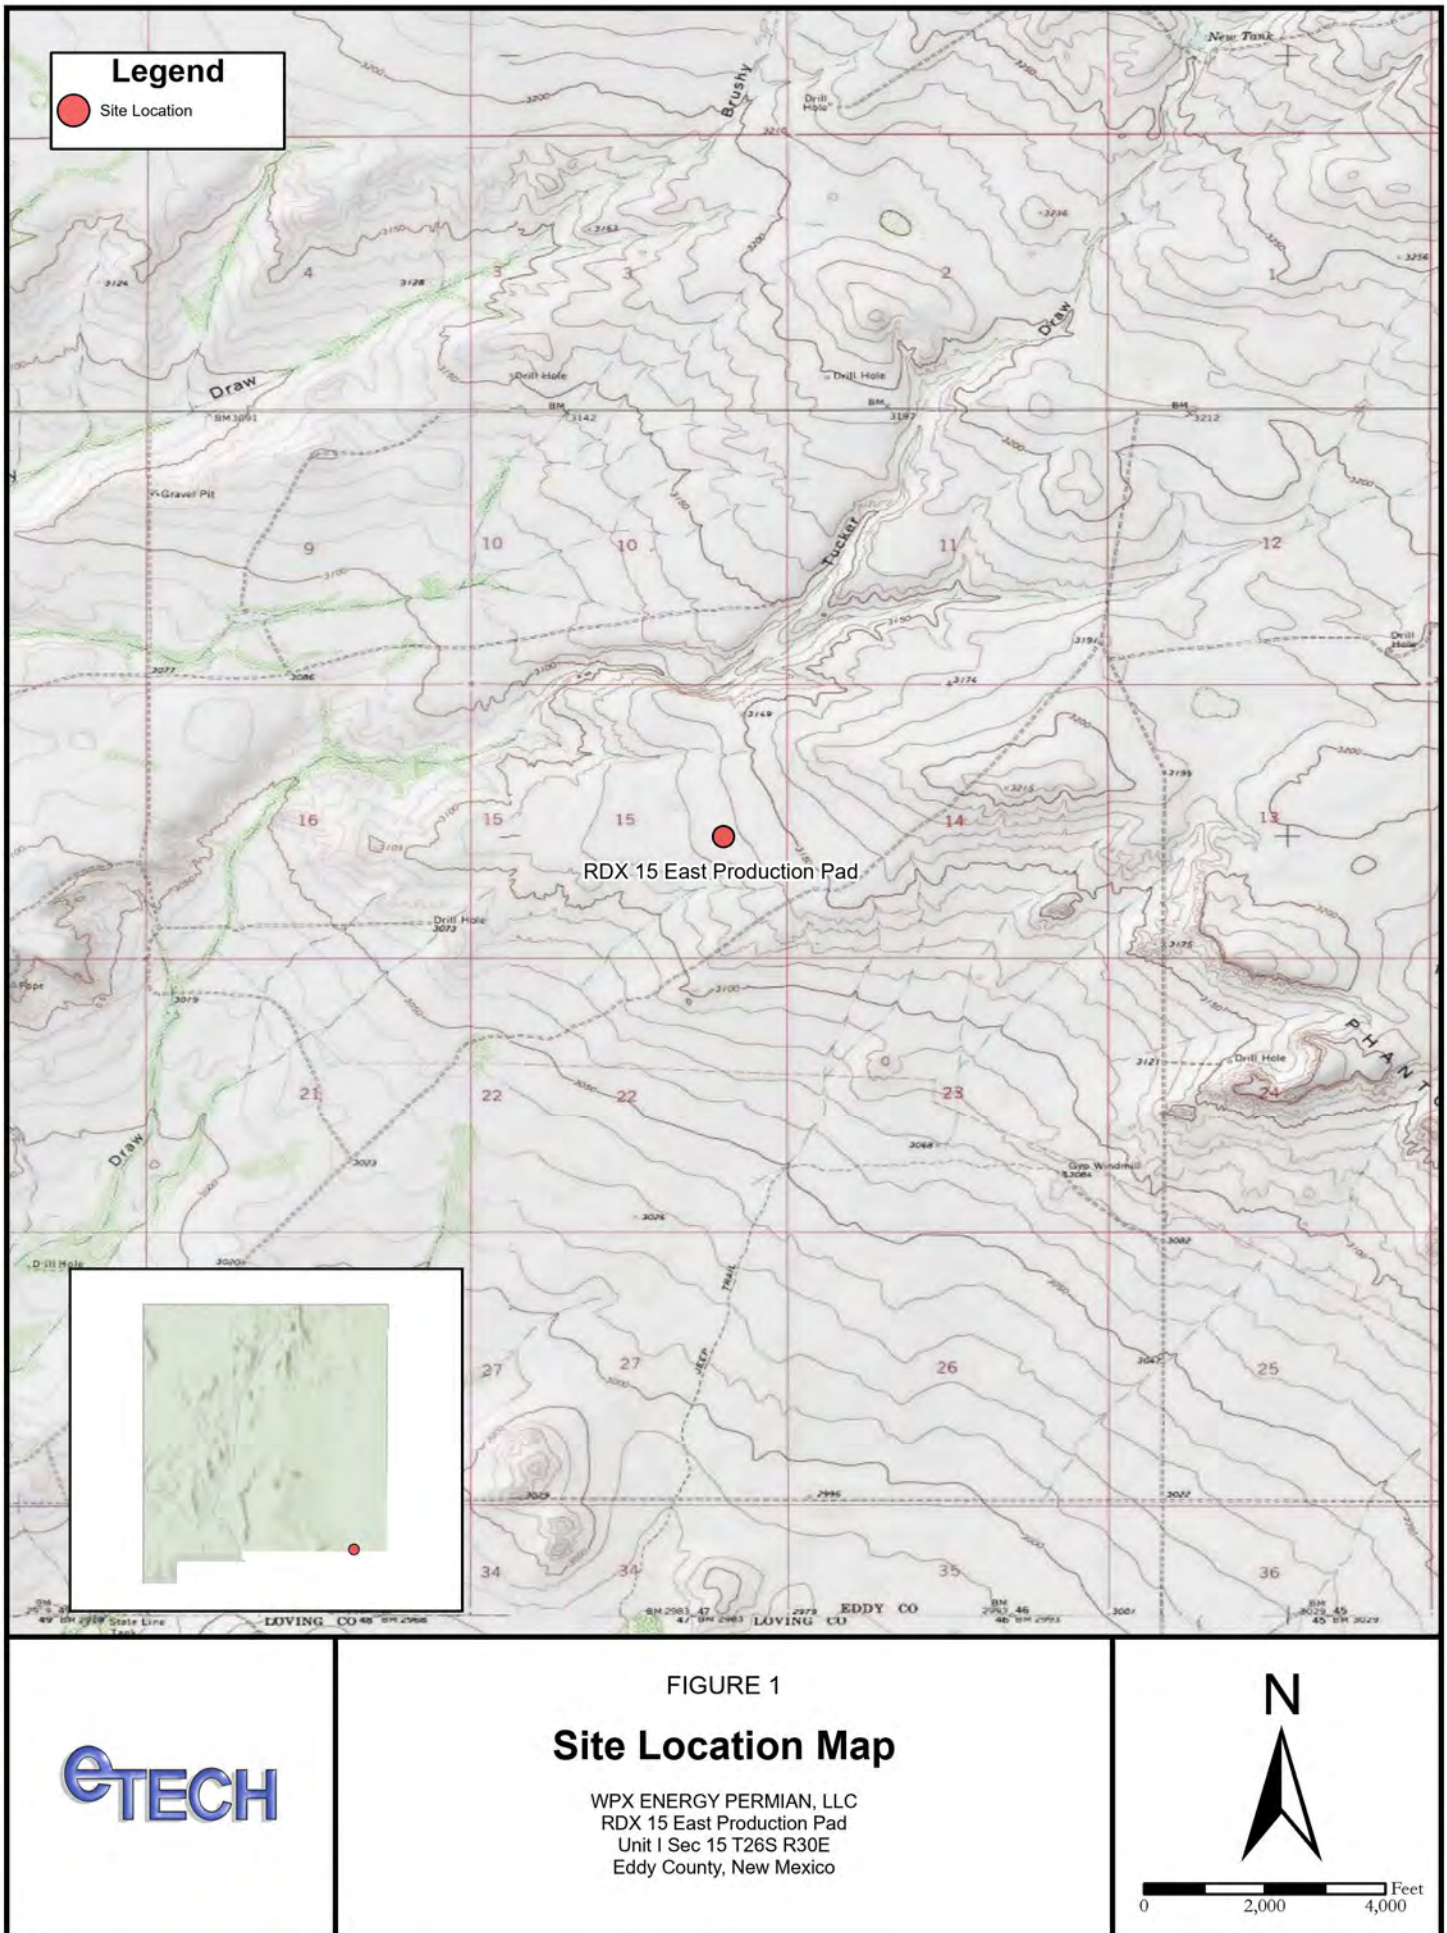
**Appendix A:** Figure 1: Site Map

The production well (API 30-015-39935) for this Site is associated with oil and gas exploration and production operations on Federal Land managed by the Bureau of Land Management (BLM). The subject release is located west of the production well at the tank battery containment, which is depicted on **Figure 1** in **Appendix A**.

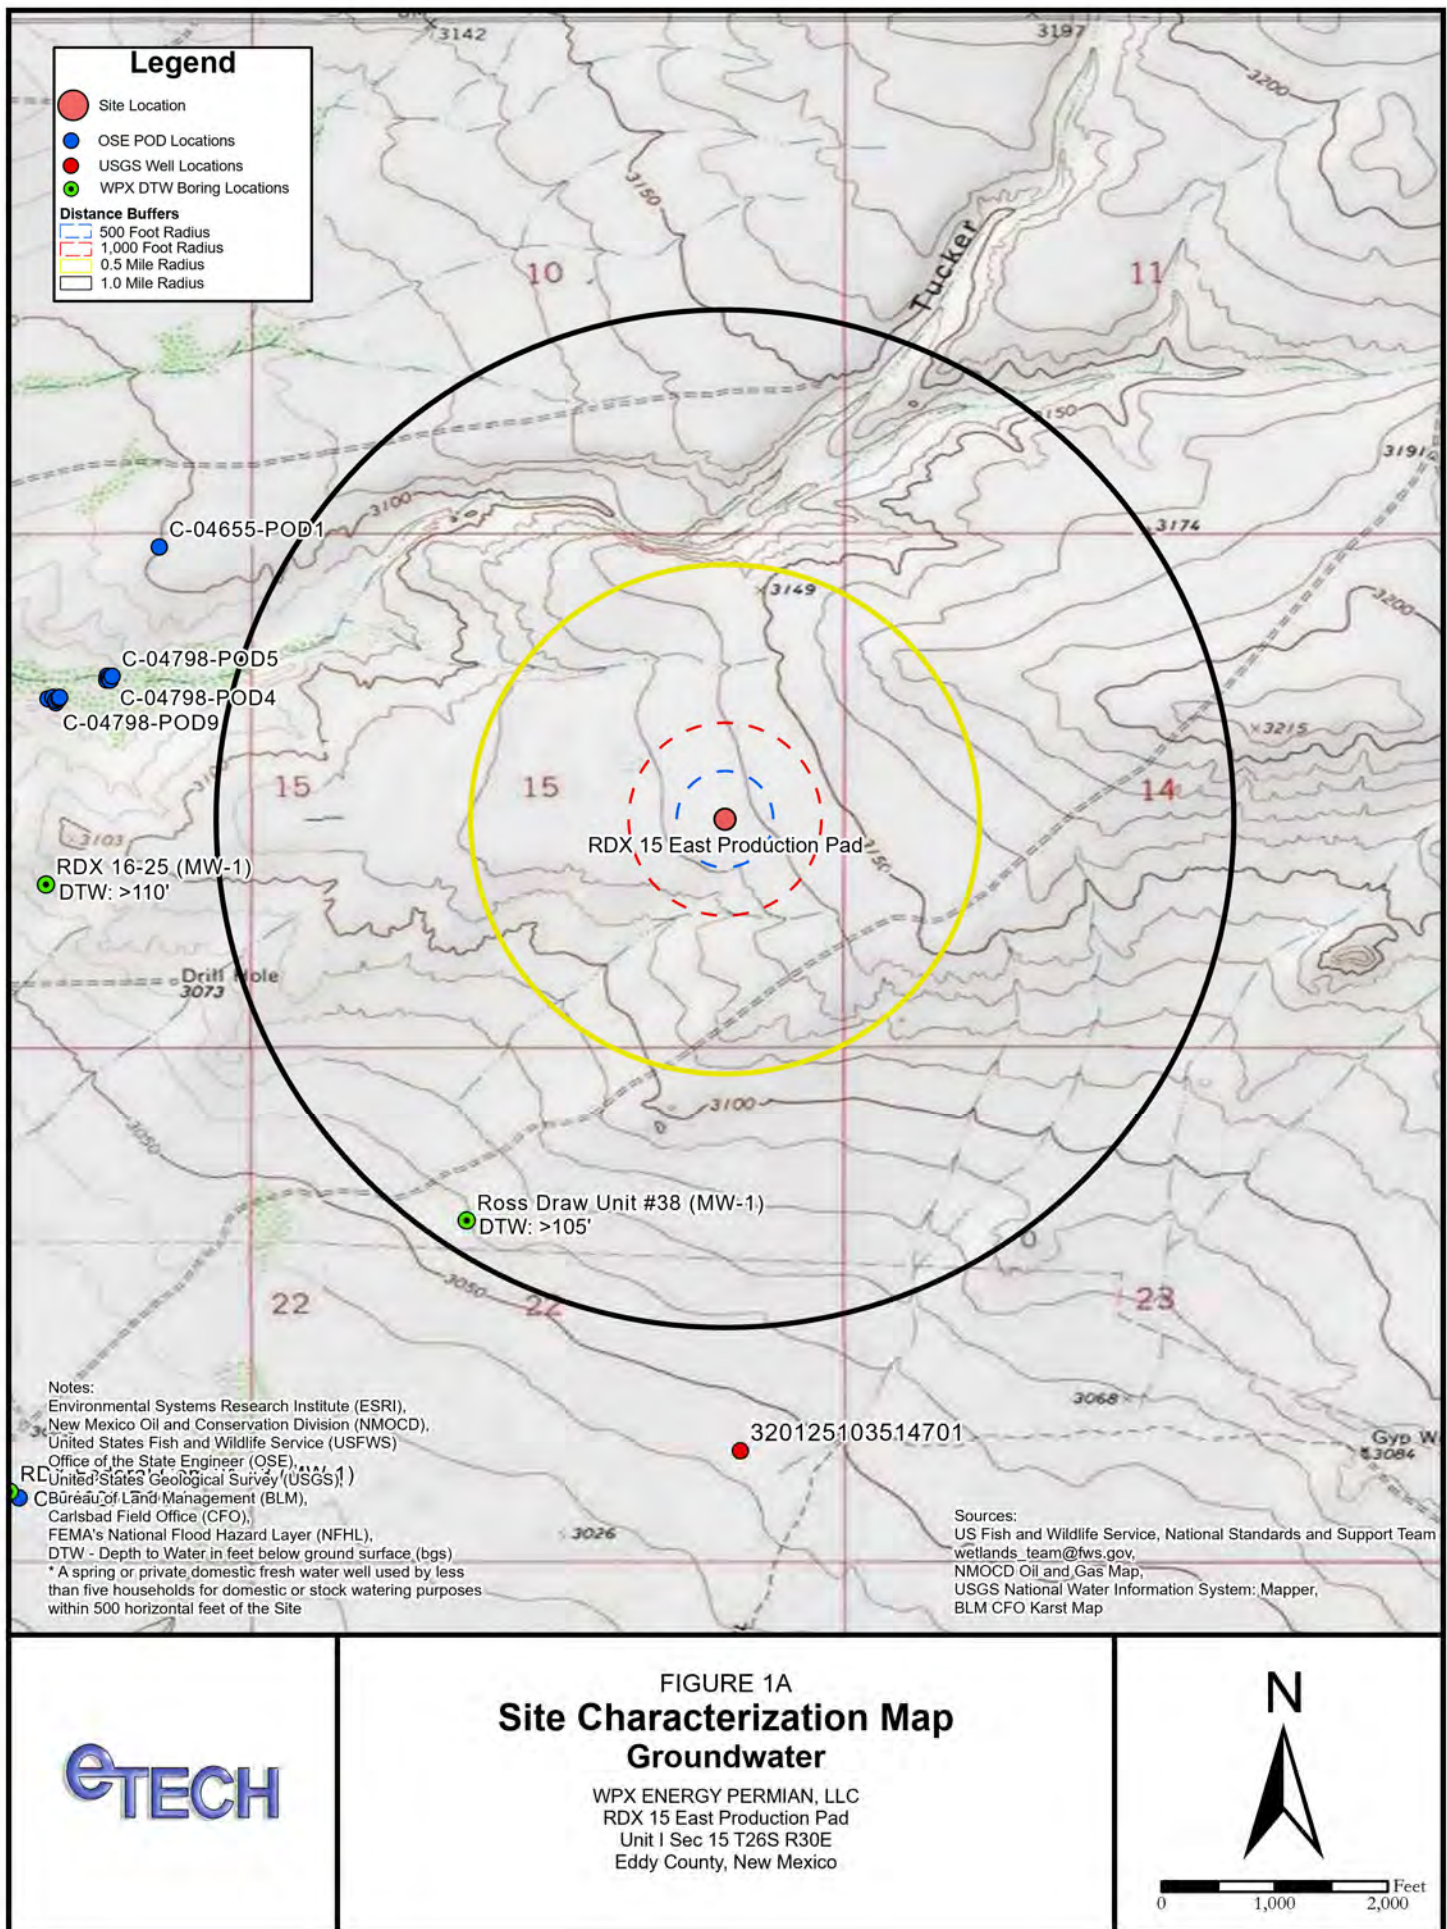
Figure 1A: Site Characterization Map – Groundwater

Regional depth to groundwater is estimated to be greater than 100 feet below ground surface (bgs) based on borings surrounding the Site with recent depth to groundwater data, defined by no greater than 25 years old. The most recently advanced soil boring (MW-1) was drilled by Talon LPE for WPX on December 8, 2020, located approximately 0.9 miles southwest of the Site on the Ross Draw Unit #38 well pad (**Figure 1A** in **Appendix A**). Using a truck mounted drill rig equipped with hollow stem auger, the soil boring was advanced to a total depth of 110 feet bgs. No fluids were observed throughout the drilling process nor after a 72-hour observation period. Following the observation period, the boring was plugged and abandoned according to the appropriate regulations. Regional soil borings and groundwater wells are shown on **Figure 1A** in **Appendix A**. The referenced boring log is provided as **Appendix B**.

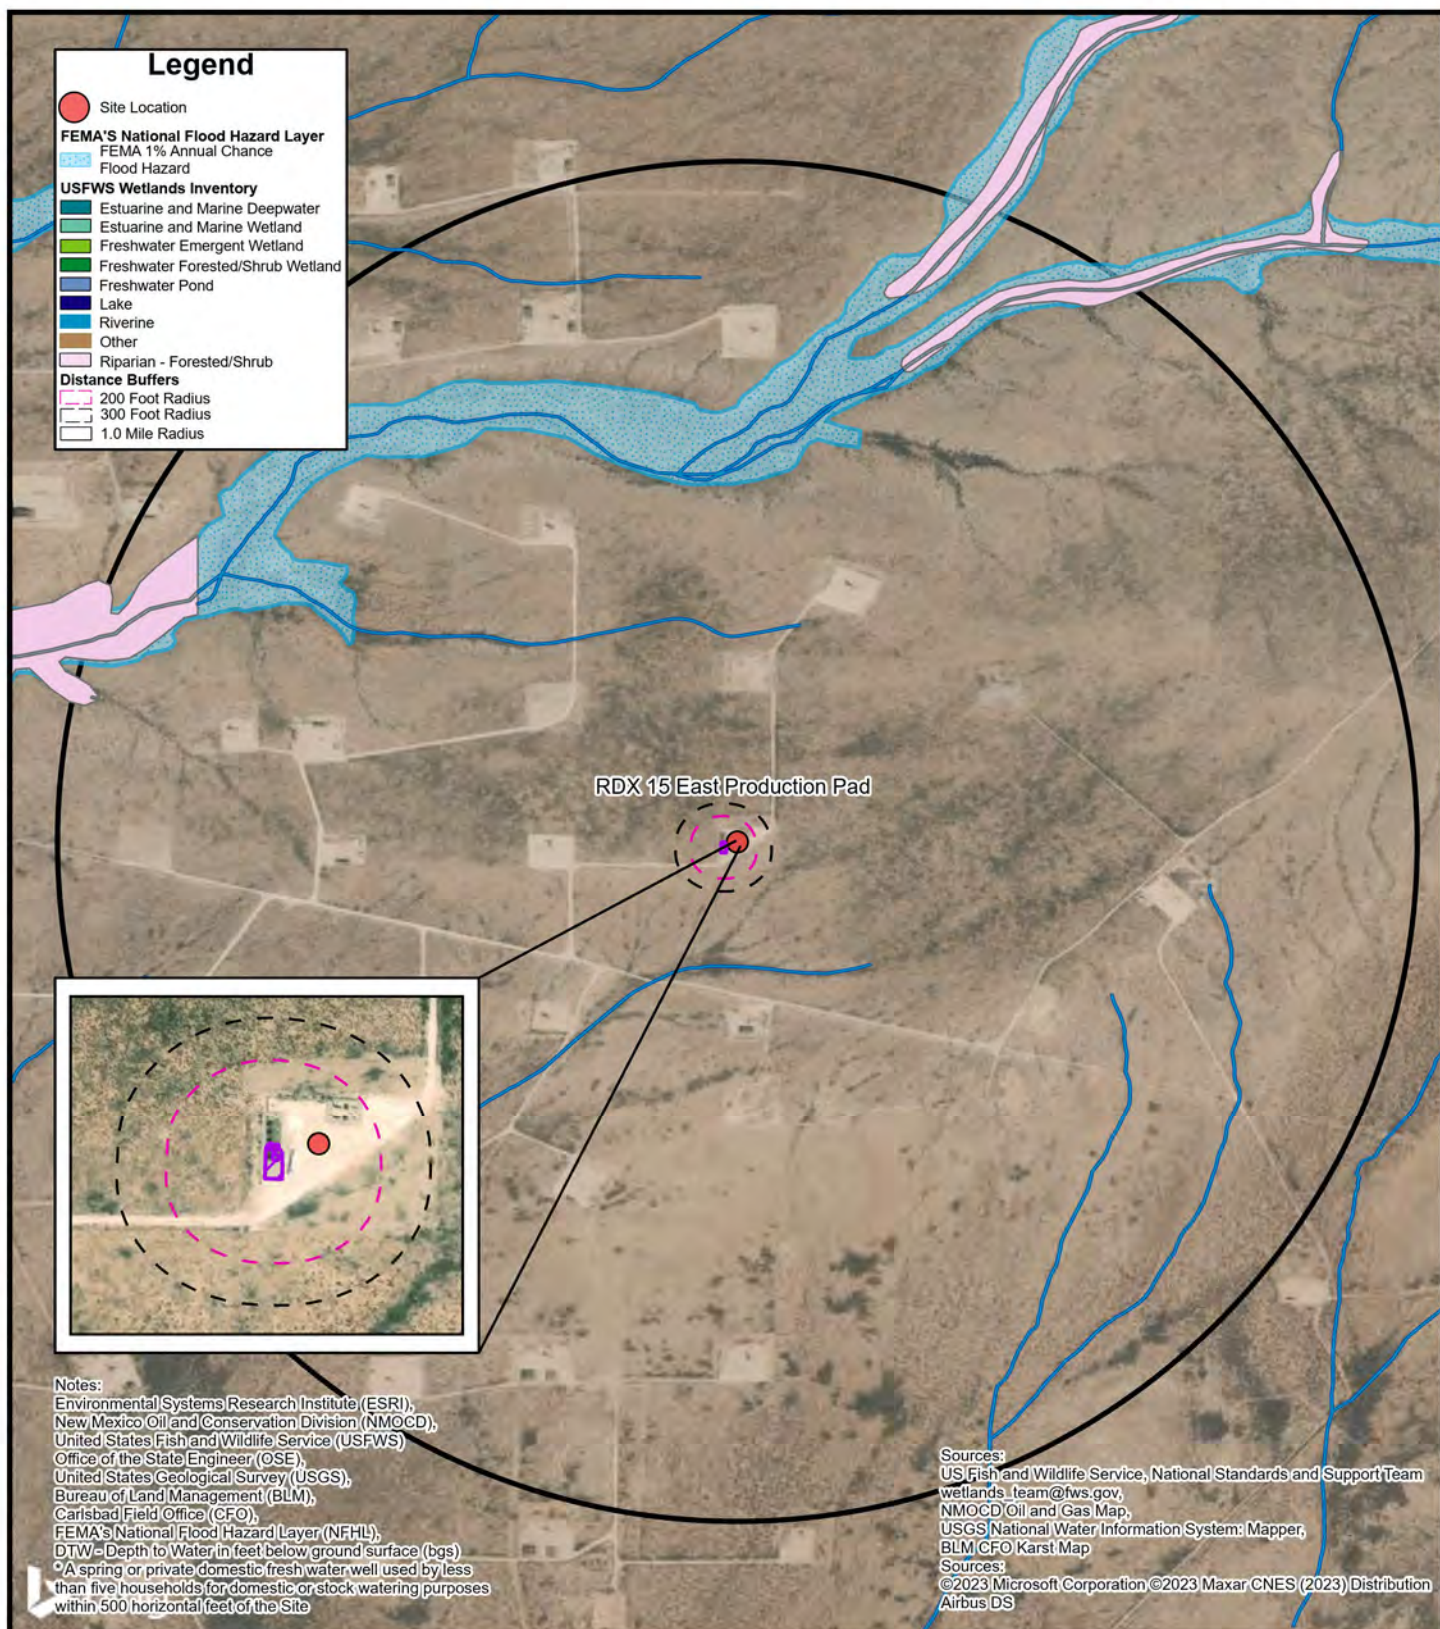
Figure 1B: Site Characterization Map – Surficial Receptors

All other potential receptors are not within the established buffers in NMAC 19.15.29.12. Receptor details from the site characterization are included in **Figure 1B** and **Figure 1C** in **Appendix A**.

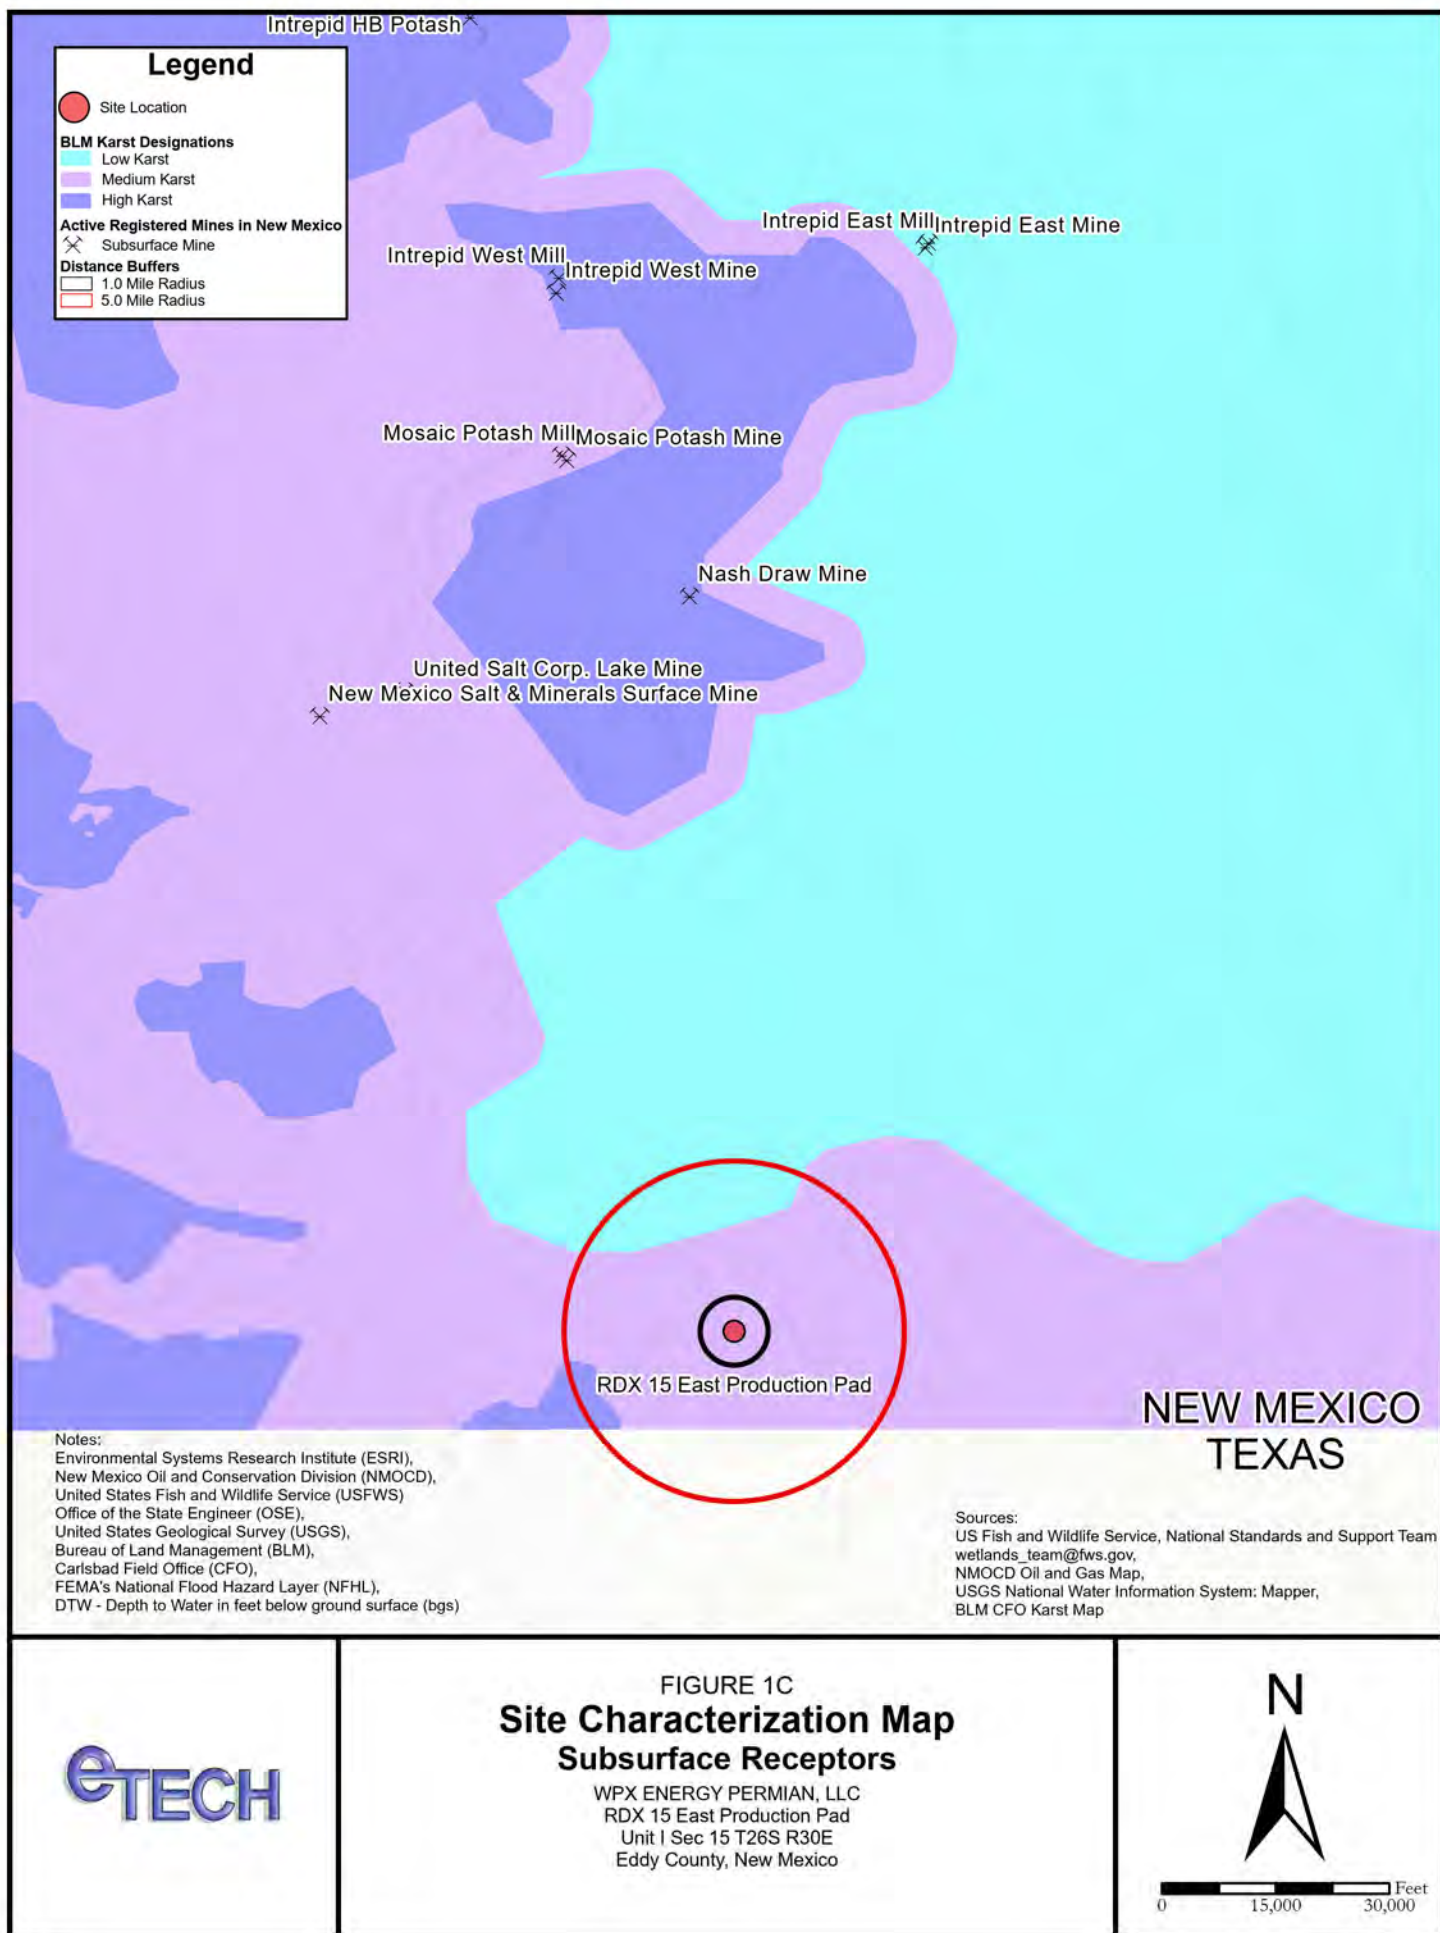
Figure 1C: Site Characterization Map – Subsurface Receptors

All potential receptors are not within the established buffers in NMAC 19.15.29.12. Receptor details and sources used to determine the site characterization are included in **Figure 1A**, **Figure 1B**, and **Figure 1C** in **Appendix A**.

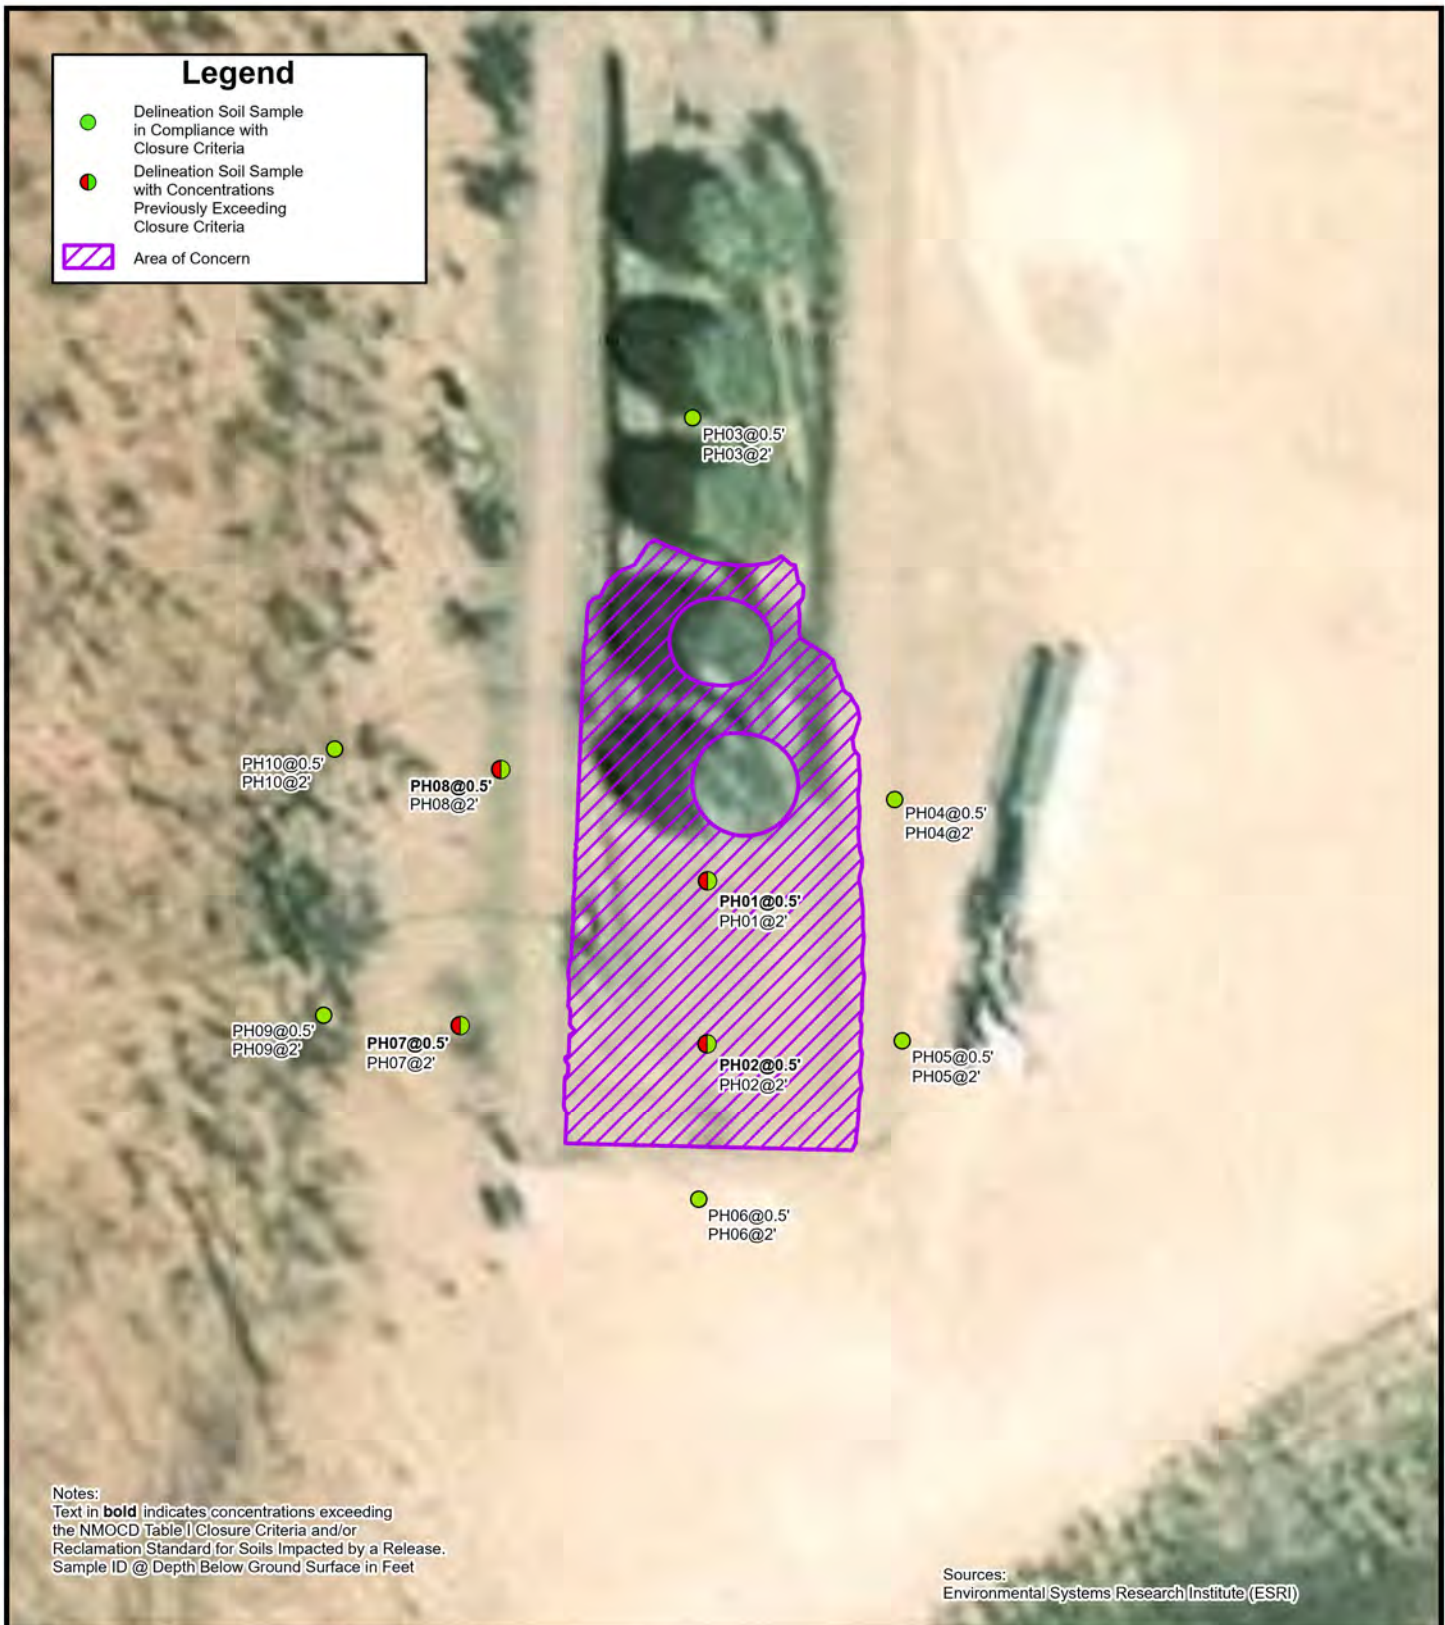
FIGURE 2

On August 15, 2024, a storage tank failure resulted in the release of approximately 20 barrels (bbls) of produced water within an earthen bermed tank battery containment. A vacuum truck was dispatched to the Site and recovered approximately 15 bbls of fluids. The incident was reported to the New Mexico Conservation Division (NMOCD) on a Release Notification and Corrective Action Form (Form C-141) on August 19, 2024, and was subsequently assigned Incident Number nAPP2423222600. The observed extent of the release was mapped with a handheld Global Positioning System (GPS) unit, hereafter referred to as the Area of Concern (AOC), which is depicted on **Figure 2** in **Appendix A**.

On September 12, 2024, Etech conducted delineation to assess the vertical and lateral extents of residual impacts associated with the AOC. Ten delineation potholes (PH01 through PH10) were advanced to 2 feet bgs within and surrounding the AOC. Delineation was driven by field screening soil for volatile organic compounds (VOCs) utilizing a calibrated photoionization detector (PID) and chloride using Hach® chloride QuanTab® test strips. Two soil samples were collected for laboratory analysis per delineation soil sampling location, representing the highest observed field screening concentration(s) and the terminus depth. Field screening results and soil descriptions are detailed on Soil Sampling Logs included in **Appendix C**. Photographic documentation of excavation activities is included in **Appendix D**.

The delineation soil samples were placed into lab provided pre-cleaned glass jars, packaged with minimal void space, labeled, and immediately placed on ice. The soil samples were transported under strict chain-of-custody procedures to Envirotech, Inc. in Farmington, New Mexico, for analysis of the COCs. The delineation soil sample locations are shown in **Figure 2** in **Appendix A**.

Laboratory analytical results for delineation soil samples collected within the AOC indicated chloride concentrations exceeded the Site Closure Criteria at 0.5-foot bgs. Laboratory analytical results for all delineation soil samples collected outside of the AOC indicated chloride concentrations were below the Site Closure Criteria, except PH07 and PH08 at 0.5-foot bgs.

Concentrations of residual chloride impacts may be characterized by concentrations ranging from 880 mg/kg to 16,800 mg/kg within the top 0.5-foot bgs. The terminus soil sample from each delineation soil sampling location yielded concentrations of COCs below the Site Closure Criteria.

## Delineation Soil Sample Locations

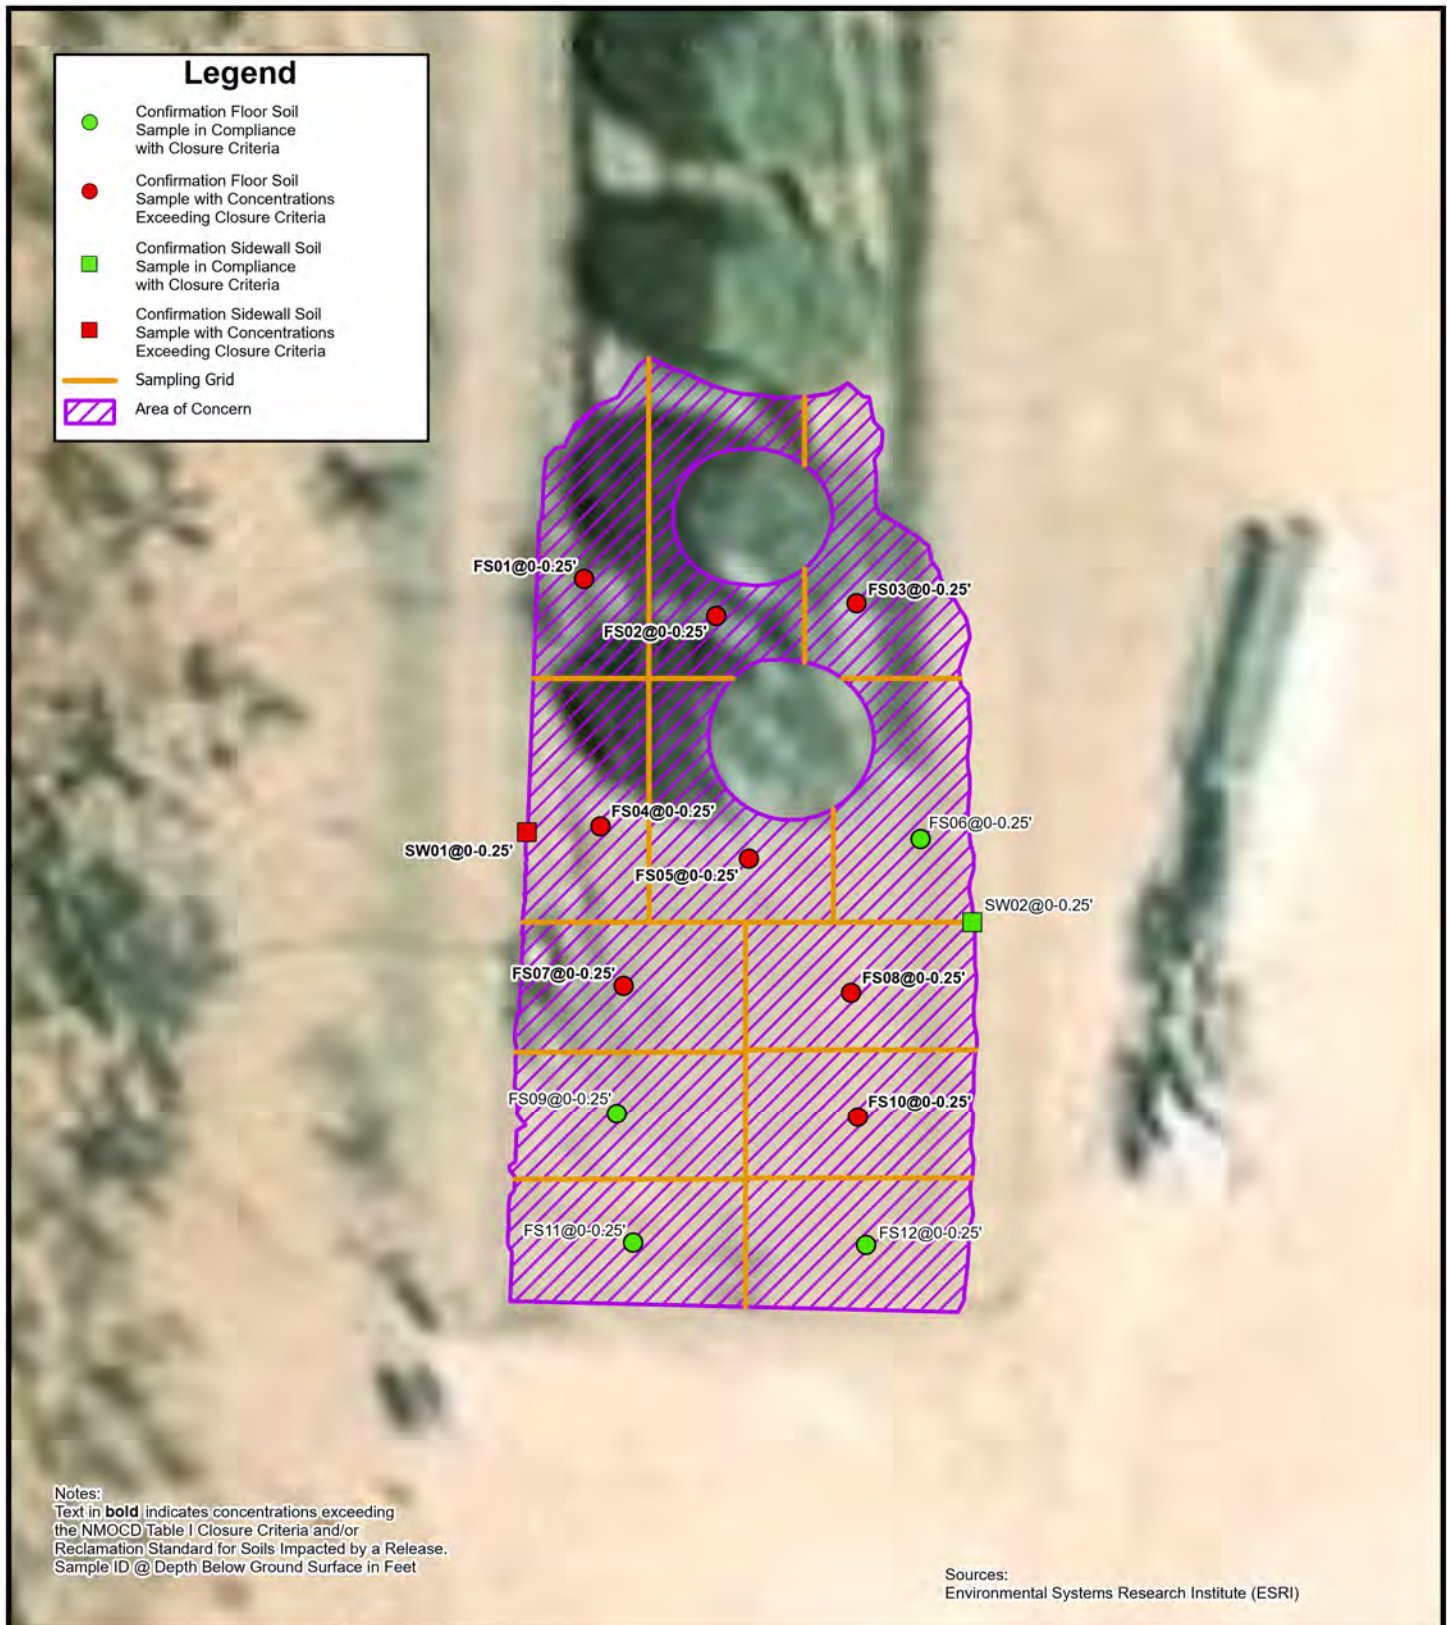
FIGURE 3

On November 7, 2024, Etech collected 5-point composite confirmation soil samples from the floors (FS01 through FS12) and sidewalls (SW01 and SW02) of the AOC, representing no more than 200 square feet per composite soil sample. Soil was field screening soil for VOCs and chloride as previously described. The 5-point composite soil samples were comprised of five equivalent aliquots homogenized in a 1-gallon, resealable plastic bag. The samples were then handled and analyzed as previously described. The confirmation soil sample locations are shown in **Figure 3** in **Appendix A**. Photographic documentation of confirmation soil sampling activities is included in **Appendix D**.

Laboratory analytical results for the final confirmation excavation soil samples indicated TPH and/or chloride concentrations exceeded the Site Closure Criteria for all confirmation soil samples, except FS06, FS09, FS11, FS12 and SW02.

## Excavation Soil Sample Locations

- As such, the Site will be remediated via dig and haul method according to the appropriate Site Closure Criteria, which is to be determined pending the results of the proposed soil boring.

- Any excavation(s) required for removal of identified impacts will be advanced laterally and vertically until confirmation soil sample results from the floor and sidewalls of the excavation meet the Site Closure Criteria, unless advancement is inhibited by existing, active infrastructure. In which case, WPX may implement encroachment requirements for the health and safety of on-site personnel and for the structural integrity of active infrastructure. Such restricts include but are not limited to leaving soil in place beneath and/or directly adjacent to said infrastructure within an area reasonably being used for production purposes.

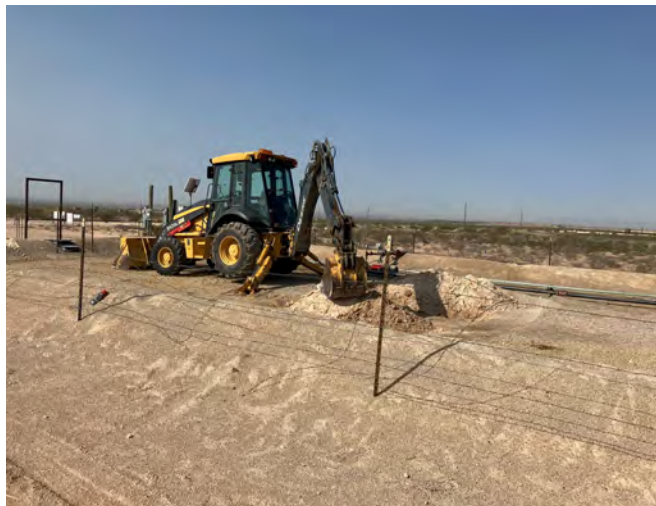
**Photograph 1****Date: 09/12/2024**

Description: Southwestern view of delineation activities.

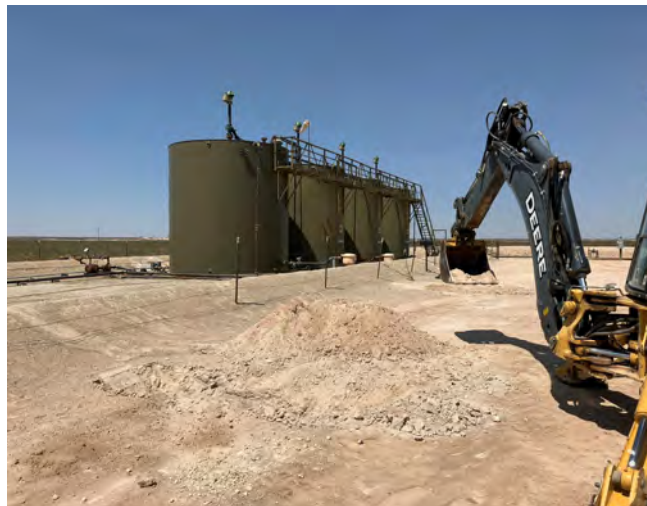
**Photograph 2****Date: 09/12/2024**

Description: Northwestern view of delineation activities.

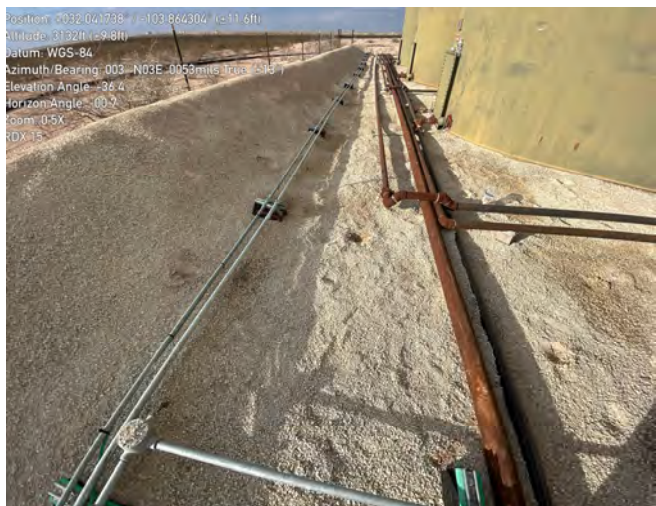
**Photograph 3****Date: 11/07/2024**

Description: Northern view of confirmation activities.

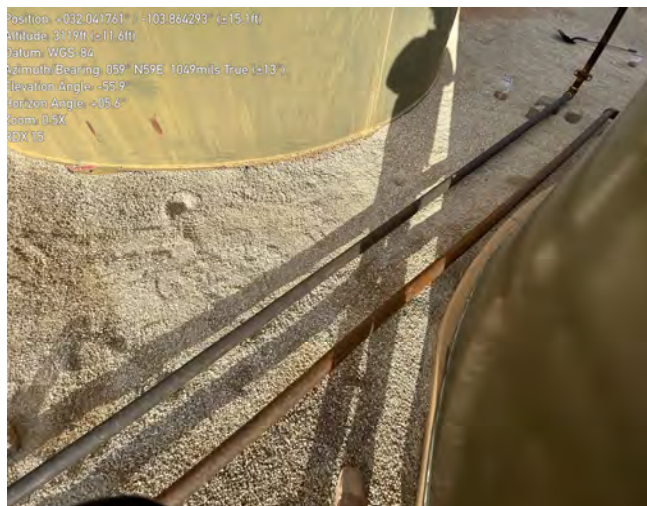
**Photograph 4****Date: 11/07/2024**

Description: Northeastern view of confirmation activities .
