PREPARED BY:  
PIMA ENVIRONMENTAL SERVICES, LLC

PREPARED FOR:  
DEVON ENERGY PRODUCTION CO, LP

LONE TREE DRAW 13 STATE COM #2H  
Incident ID nAB1909833450

## Remediation Closure Report

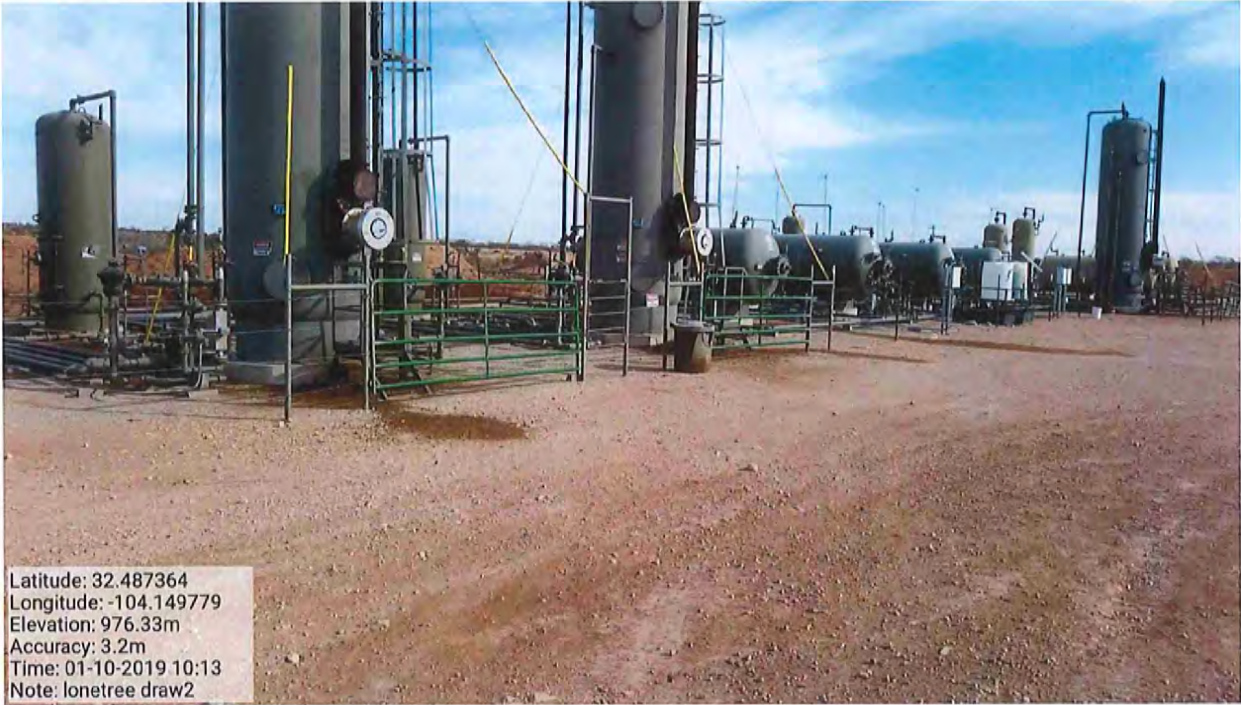
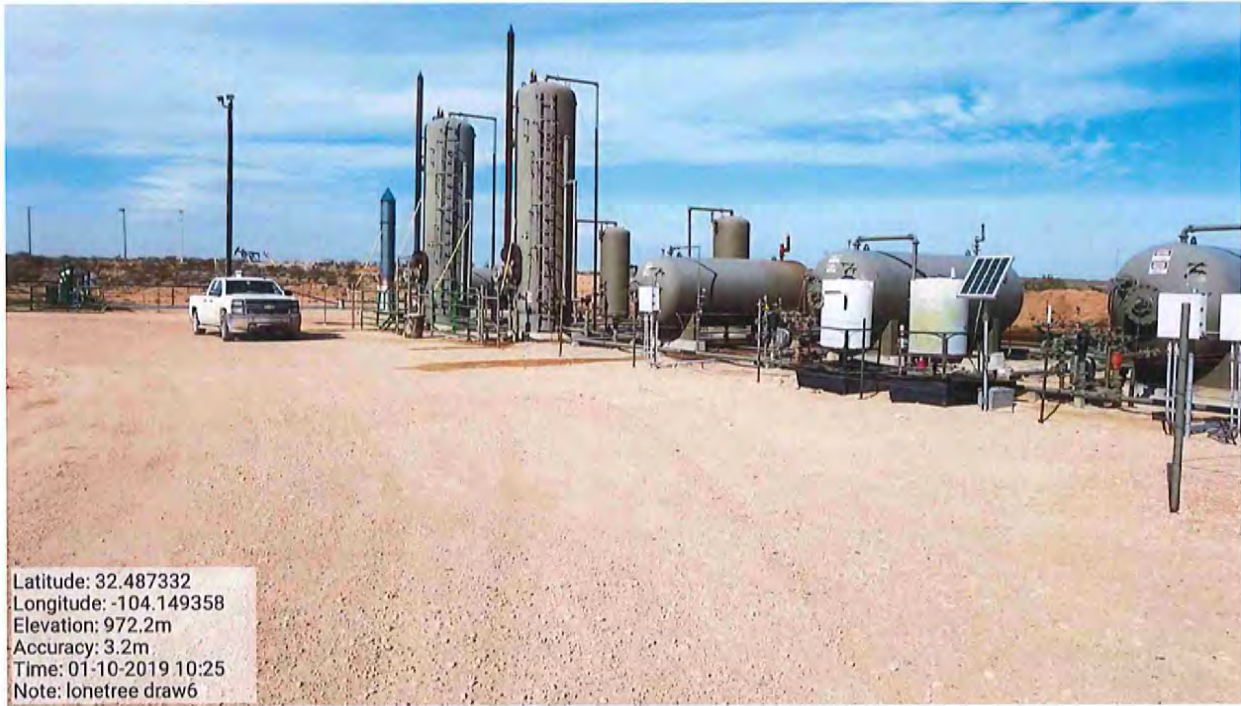
South side of separator battery/spill area

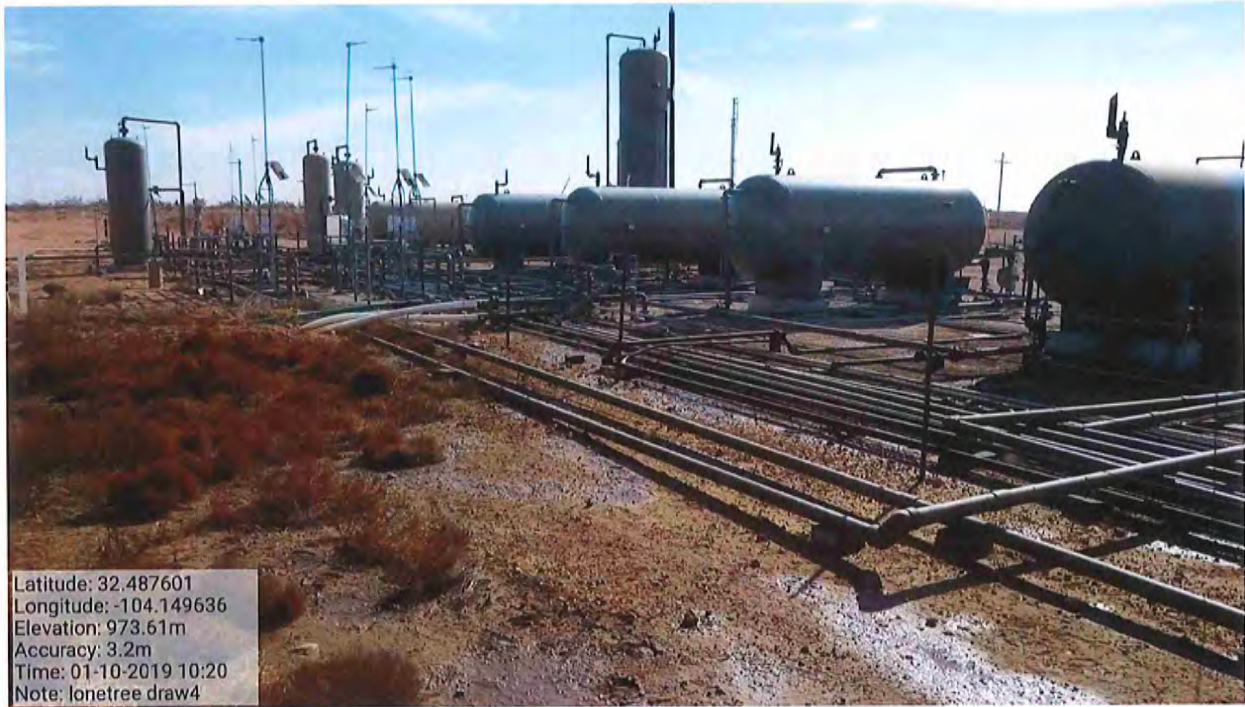
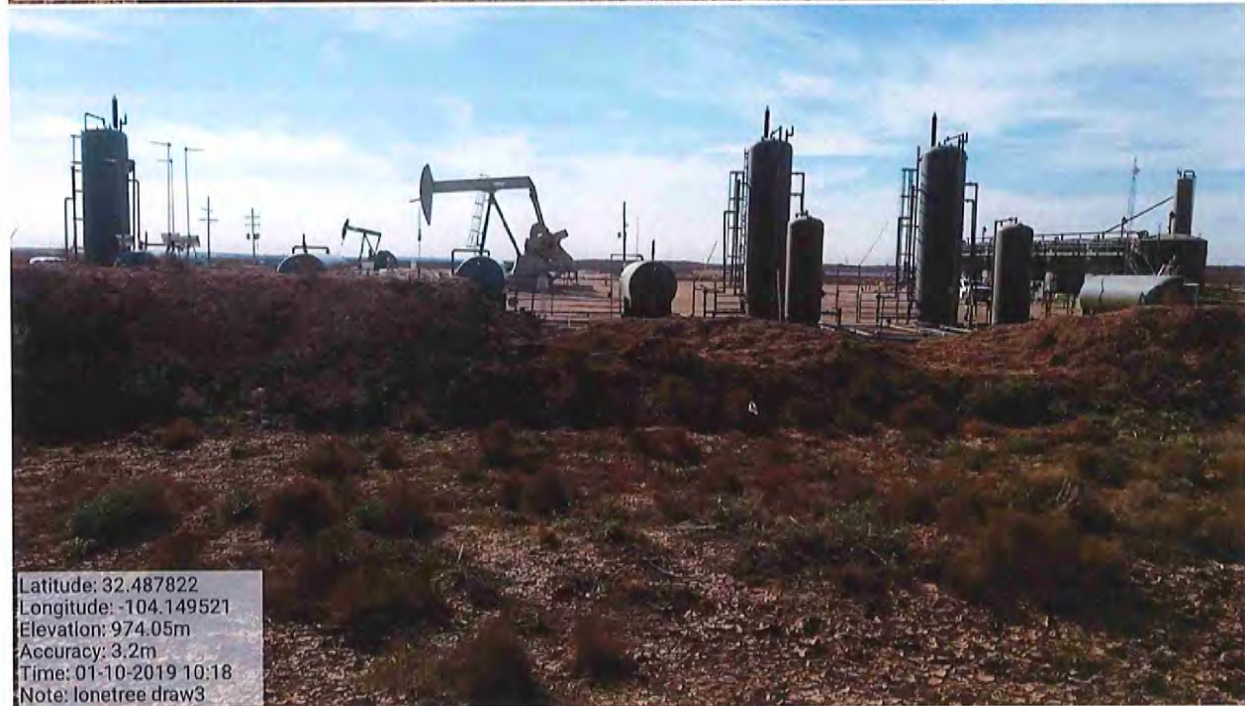
North side of spill area

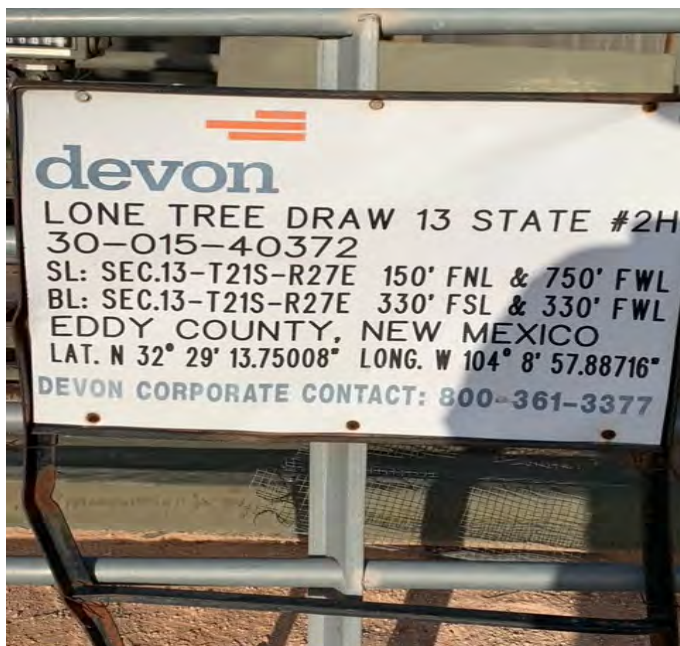
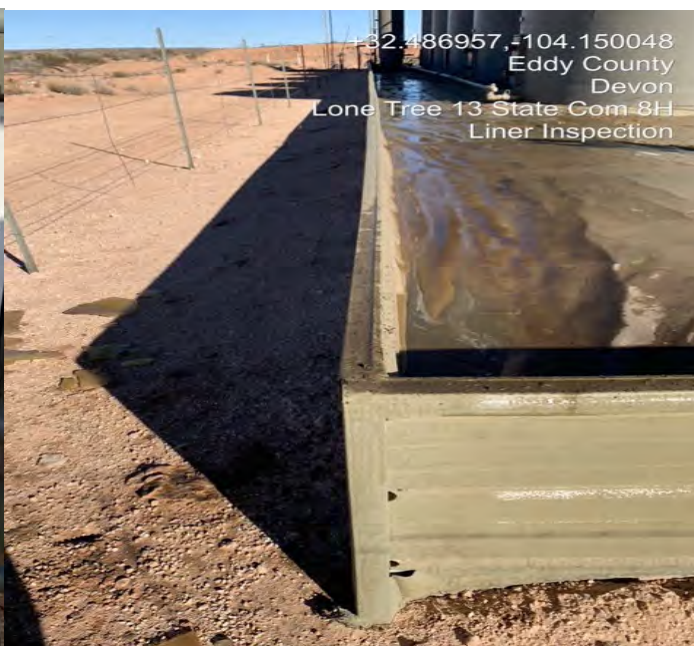
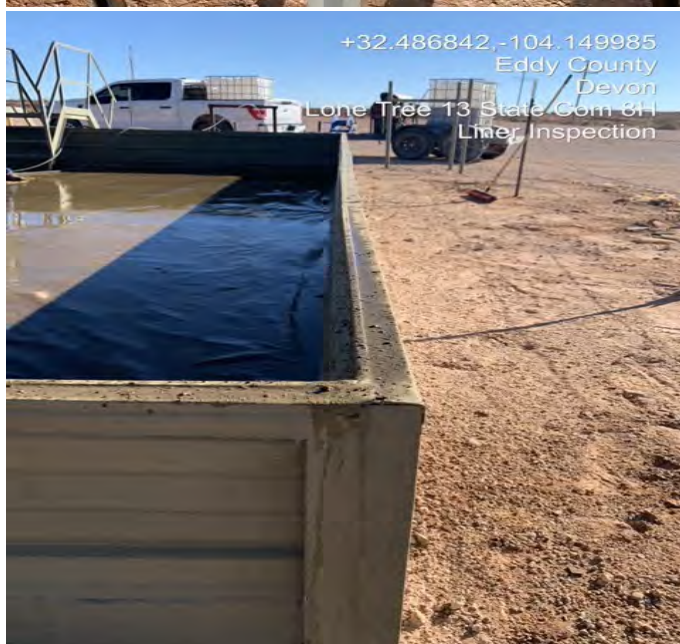
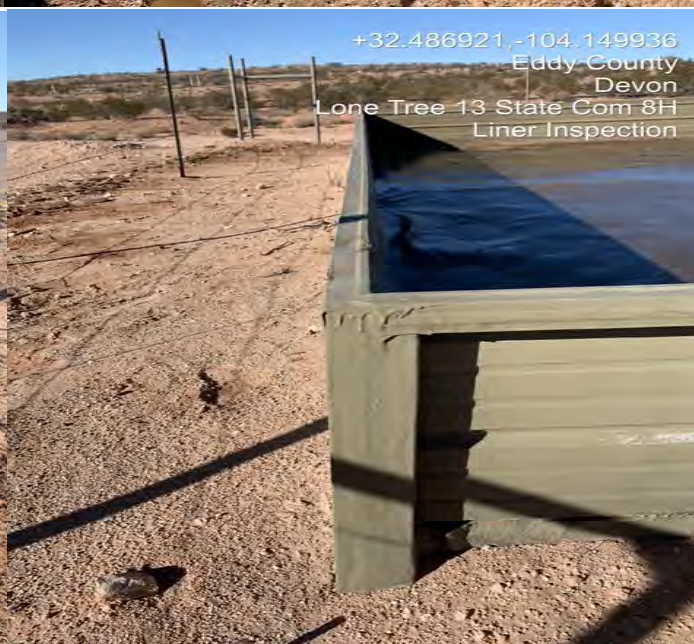
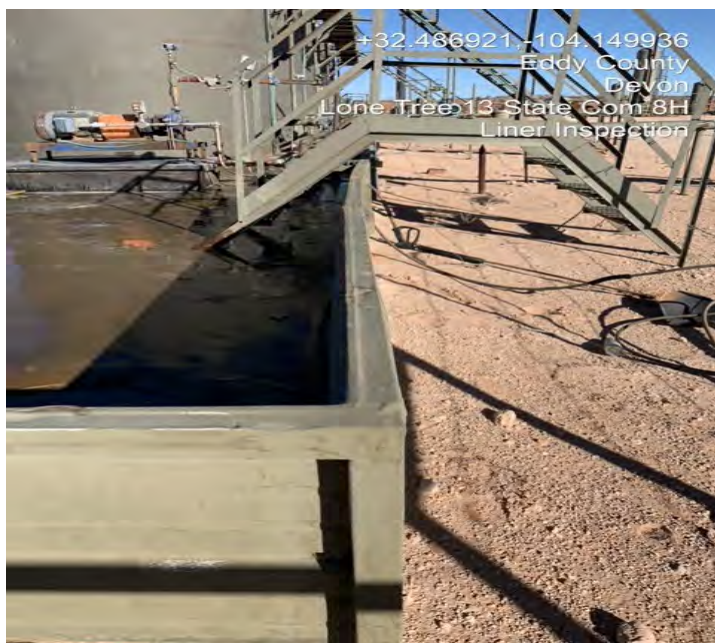
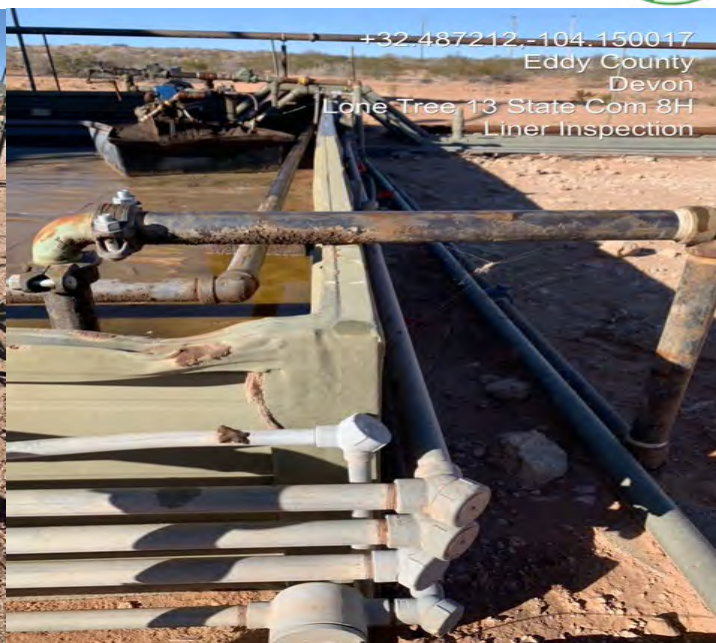
### Liner Inspection

Visualization	Yes	No	Comments
Is there a tear in the liner?		X	
Are there holes in the liner?		X	
Is the liner retaining any fluids?	X		Fluid from the power washing of the liner
Does the liner have integrity to contain a leak?	X

The LoneTree 13 State Com 2 H & 8H share the same facility, the images were labeled as Lone Tree 13 State Com 8H

containment maintained its integrity and was able to retain the fluids. The Liner Inspection Form and Photographic Documentation can be found in Appendix D.

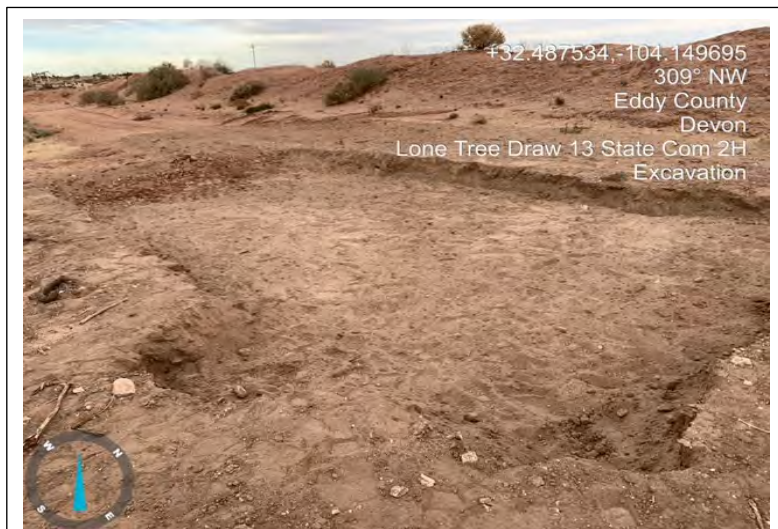
C15 Excavation 1

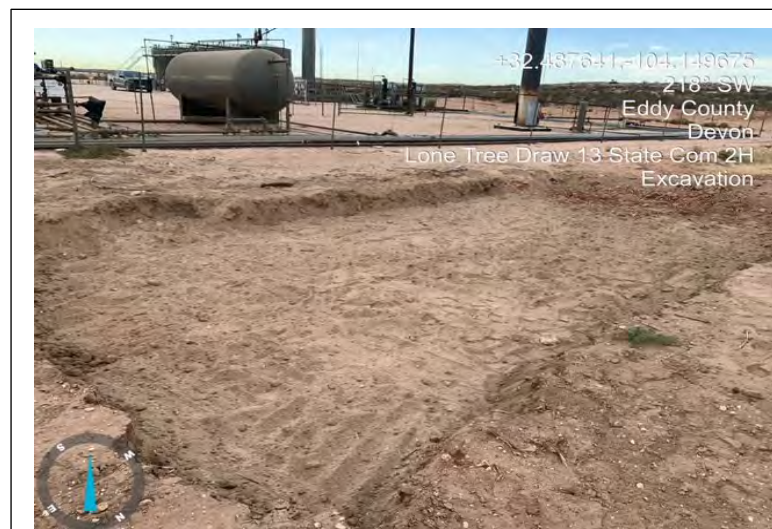
C15 Excavation 2

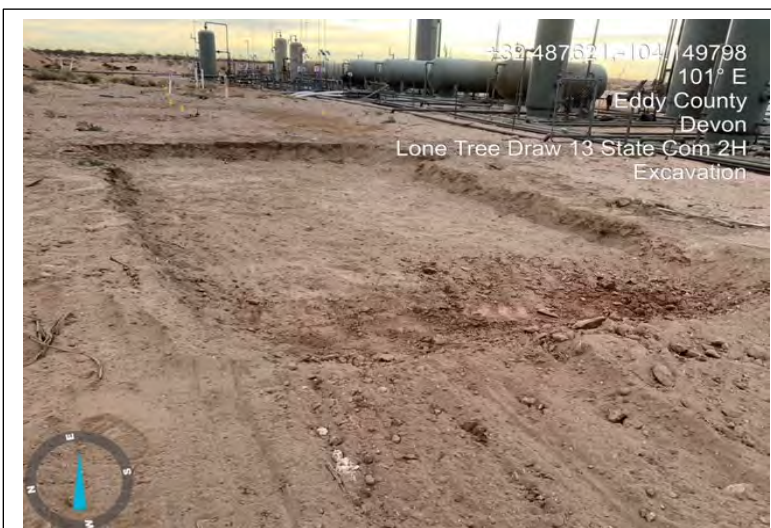
C15 Excavation 3

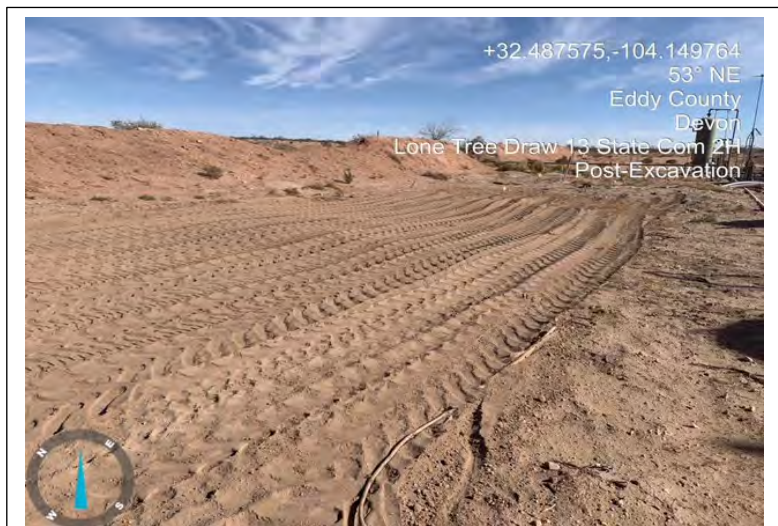
Backfill 1
