**Re: Closure Request
PLU 21 DTD CVB
Facility ID fAPP2402925499
Incident Number nAPP2428834682
Eddy County, New Mexico**

Ensolum, LLC (Ensolum) on behalf of XTO Energy, Inc. (XTO), has prepared this *Closure Request* to document assessment, excavation, and soil sampling activities at the PLU 21 DTD CVB (Site). The purpose of the assessment and soil sampling activities was to assess for the presence or absence of impacts to soil following a release of produced water into a temporary lined containment and onto the facility pad. Based on field observations, field screening activities, and soil sample laboratory analytical results, XTO is submitting this *Closure Request*, describing assessment, excavation, and delineation activities that have occurred and requesting no further action for Incident Number nAPP2428834682.

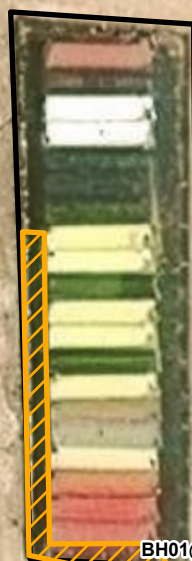
Delineation Soil Sample Locations

On November 25, 2024, Ensolum personnel visited the Site to evaluate the release extent based on information provided on the C-141, internal documents, and visual observations. No soil samples were collected during this visit. A preliminary inspection of the temporary lined containment indicated the liner appeared to be competent but was not clear of debris. Due to the absence of a liner inspection notification to the NMOCD, the liner was scheduled to be cleaned and re-inspected on December 6, 2024. The release extent was mapped utilizing a handheld Global Positioning System (GPS) unit and is depicted on Figure 2. Photographic documentation is included in Appendix B.

On December 5, 2024, and December 6, 2024, Ensolum personnel returned to the Site to complete the lined containment inspection, delineation, and excavation activities. Upon arrival to the Site, it was discovered the temporary lined containment was in the process of being removed and was unable to be properly inspected. Delineation borehole BH01 was advanced via hand auger to a maximum depth of 1-foot bgs within the release extent to assess the vertical extent of the release. Delineation soil samples were collected from the borehole at depths ranging from 0.5 feet to 1-foot bgs. Soil from the delineation borehole was field screened for volatile organic compounds (VOCs) utilizing a calibrated photoionization detector (PID) and chloride using Hach® chloride QuanTab® test strips. Field screening results and observations for the borehole were logged on a lithologic/soil sampling log, which is included in Appendix C. The delineation soil sample location is depicted on Figure 2. Photographic documentation is included in Appendix B.

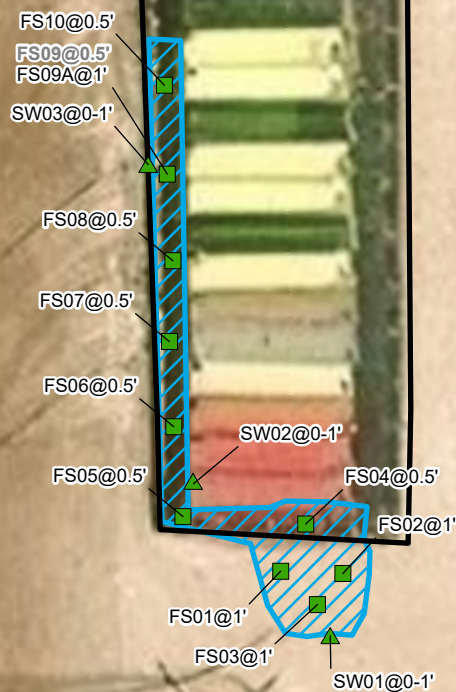
**Confirmation Soil Sample Locations**

Following the removal of the lined containment, composite confirmation soil samples were collected within the release extent to confirm the presence or absence of impacts beneath the liner. Composite confirmation soil samples FS05 through FS10 were collected from a depth of 0.5 feet bgs and represented no more than 200 square feet following surface scraping activities. The excavation extent and confirmation soil sample locations are presented on Figure 3. All confirmation soil samples were collected, handled, and analyzed by the same methods described above at Cardinal in Hobbs, New Mexico.

Laboratory analytical results for the confirmation floor soil samples FS01 through FS04, sidewall soil sample SW01, and confirmation soil samples FS05 through FS10, indicated that all COC concentrations were compliant with the Closure Criteria. Laboratory analytical results are summarized in Table 1 and the complete laboratory analytical reports are included as Appendix D.

On December 10, 2024, Ensolum personnel returned to the Site to oversee additional excavation activities. Based on laboratory analytical results, confirmation soil sample FS09 required excavation. The area represented by FS09 was excavated to a total depth of 1-foot bgs. Two 5-point composite samples, FS09A and SW03, were collected from the excavation. Soil sample FS09A was collected from a depth of 1-foot bgs and sidewall soil sample SW03 was collected from depths ranging from ground surface to 1-foot bgs. The soil samples were collected, handled, and analyzed by the same methods mentioned above.

The final excavation extent measured approximately 1,998 square feet. A total of approximately 55 cubic yards of impacted soil was removed during the excavation activities. The impacted soil was transported and properly disposed of at the R360 Disposal Facility in Hobbs, New Mexico. After completion of confirmation sampling, the excavation area was secured with fencing.

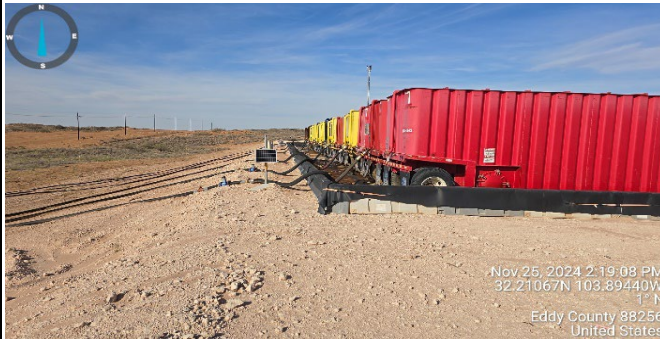
Photograph: 1 Date: 11/25/2024
 Description: Site Assessment activities
 View: North

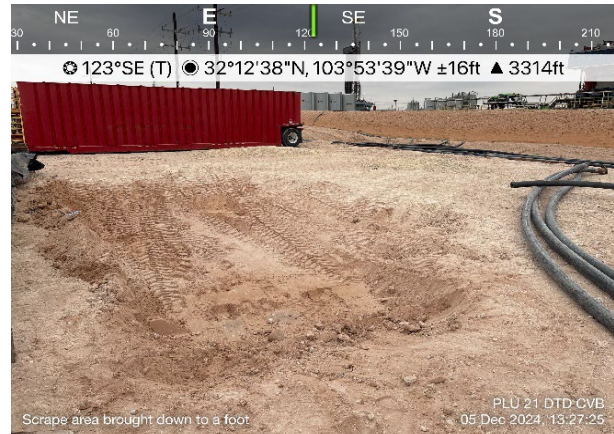
Photograph: 2 Date: 12/5/2024
 Description: Excavation activities
 View: Southeast

Based on delineation field screening results of the release extent, surface scraping and excavation activities were performed using a backhoe and transport vehicle. To direct excavation activities, Ensolum personnel field screened soil for VOCs and chloride. Following removal of impacted soil, Ensolum personnel collected 5-point composite soil samples representing no more than 200 square feet from the sidewalls and floor of the excavation. The 5-point composite soil samples were collected by placing five equivalent aliquots of soil into a 1-gallon, resealable plastic bag and homogenizing the samples by thoroughly mixing. Confirmation soil samples FS01 through FS04 were collected from the floor of the excavation at a depth of 1-foot bgs. Confirmation sidewall soil samples, SW01 and SW02, were collected from the sidewall of the excavation at depths ranging from ground surface to 1-foot bgs.

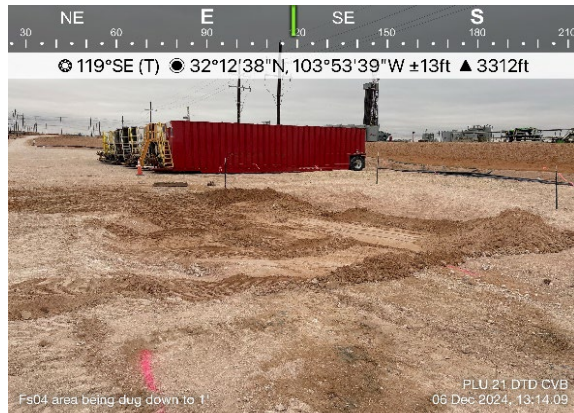
Photograph: 3 Date: 12/6/2024
 Description: Excavation activities
 View: Southeast

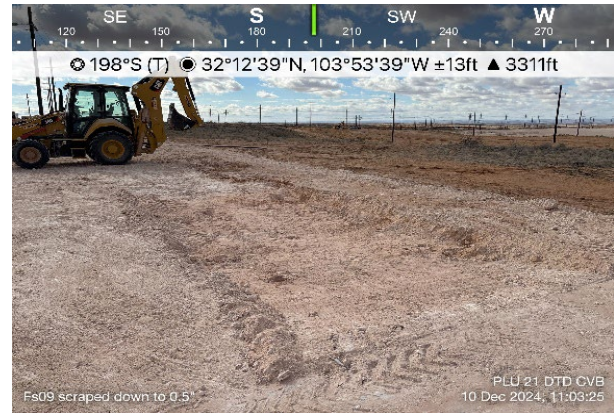
Photograph: 4 Date: 12/10/2024
 Description: Excavation activities
 View: South

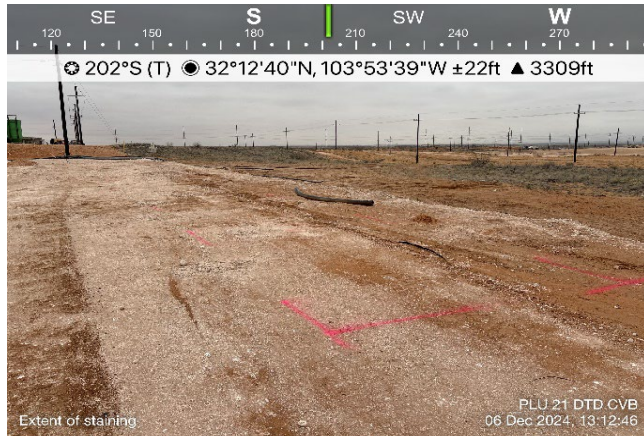
Photograph: 1 Date: 12/6/2024
 Description: Sampling activities of FS09
 View: Southwest

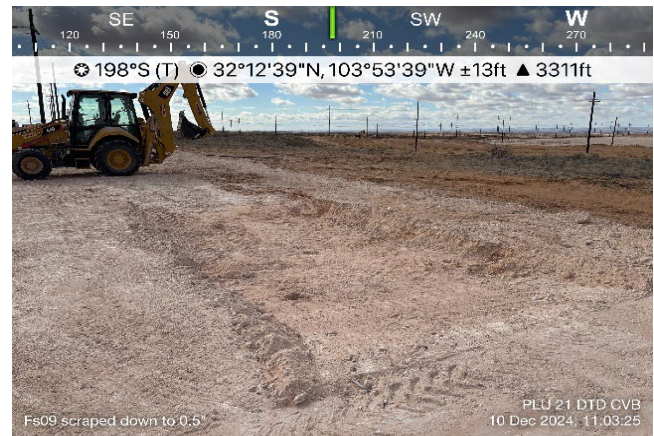
Photograph: 2 Date: 12/10/2024
 Description: Excavation activities of FS09A
 View: Southwest
