RE: Release Investigation and Remediation Closure Report  
PLU 210  
Unit I, Section 18, Township 24 South, Range 30 East  
32.2152420°, -103.9148870°  
Eddy County, New Mexico  
Terracon Project No. KH247048  
NMOCD Reference ID: nAPP2428245356

Closure Documentation  
PLU 210 | Eddy County, New Mexico  
January 5, 2025 | Terracon Project No. KH247048  
NMOCD Reference ID: nAPP2428245356

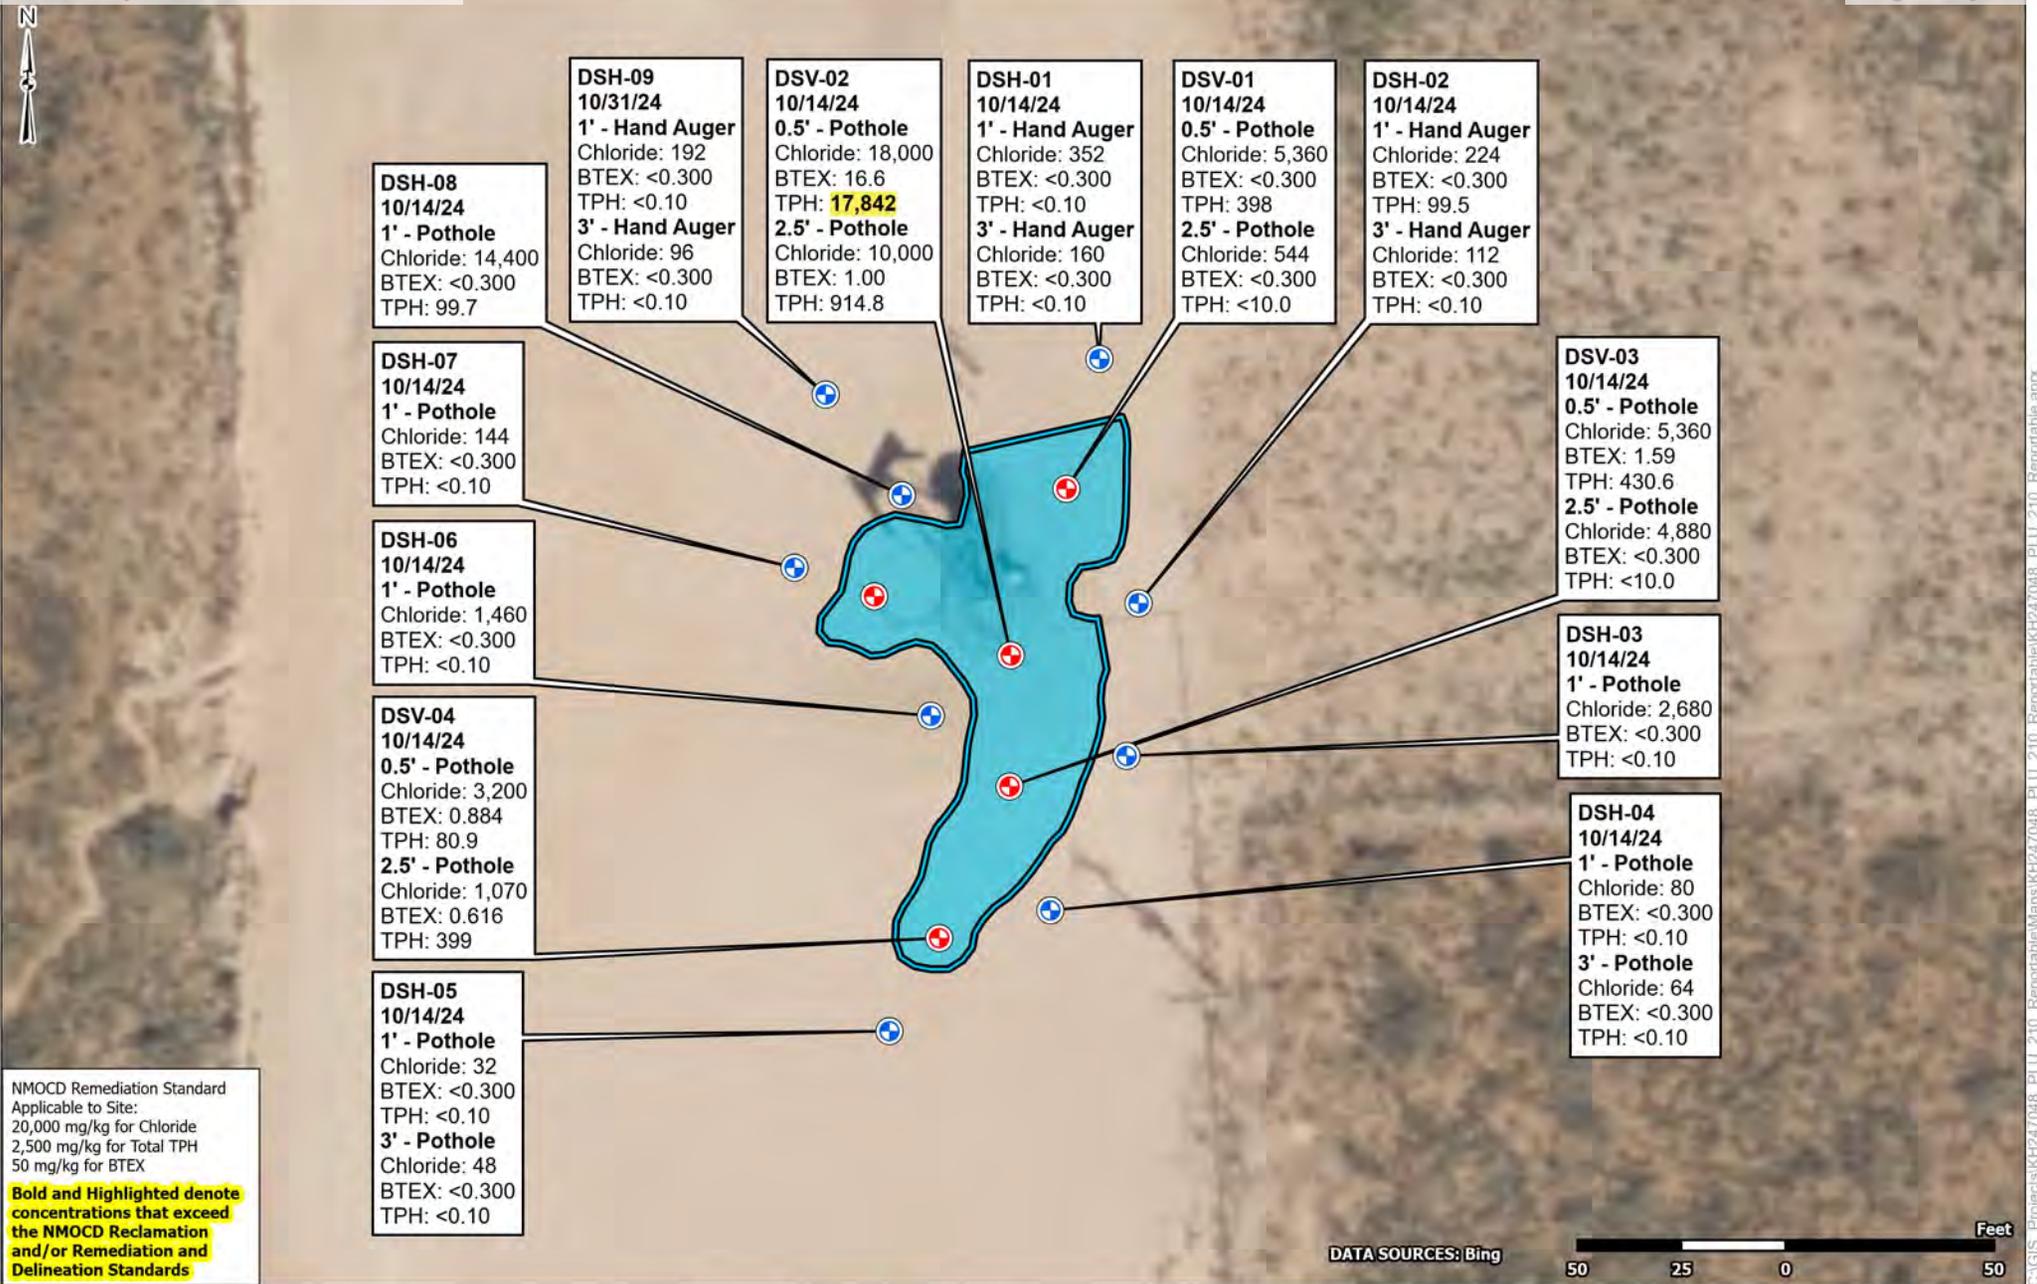
**3**

- Inferred Release (3,435 Sq. Ft.)
- Vertical Delineation Sample
- Horizontal Delineation Sample

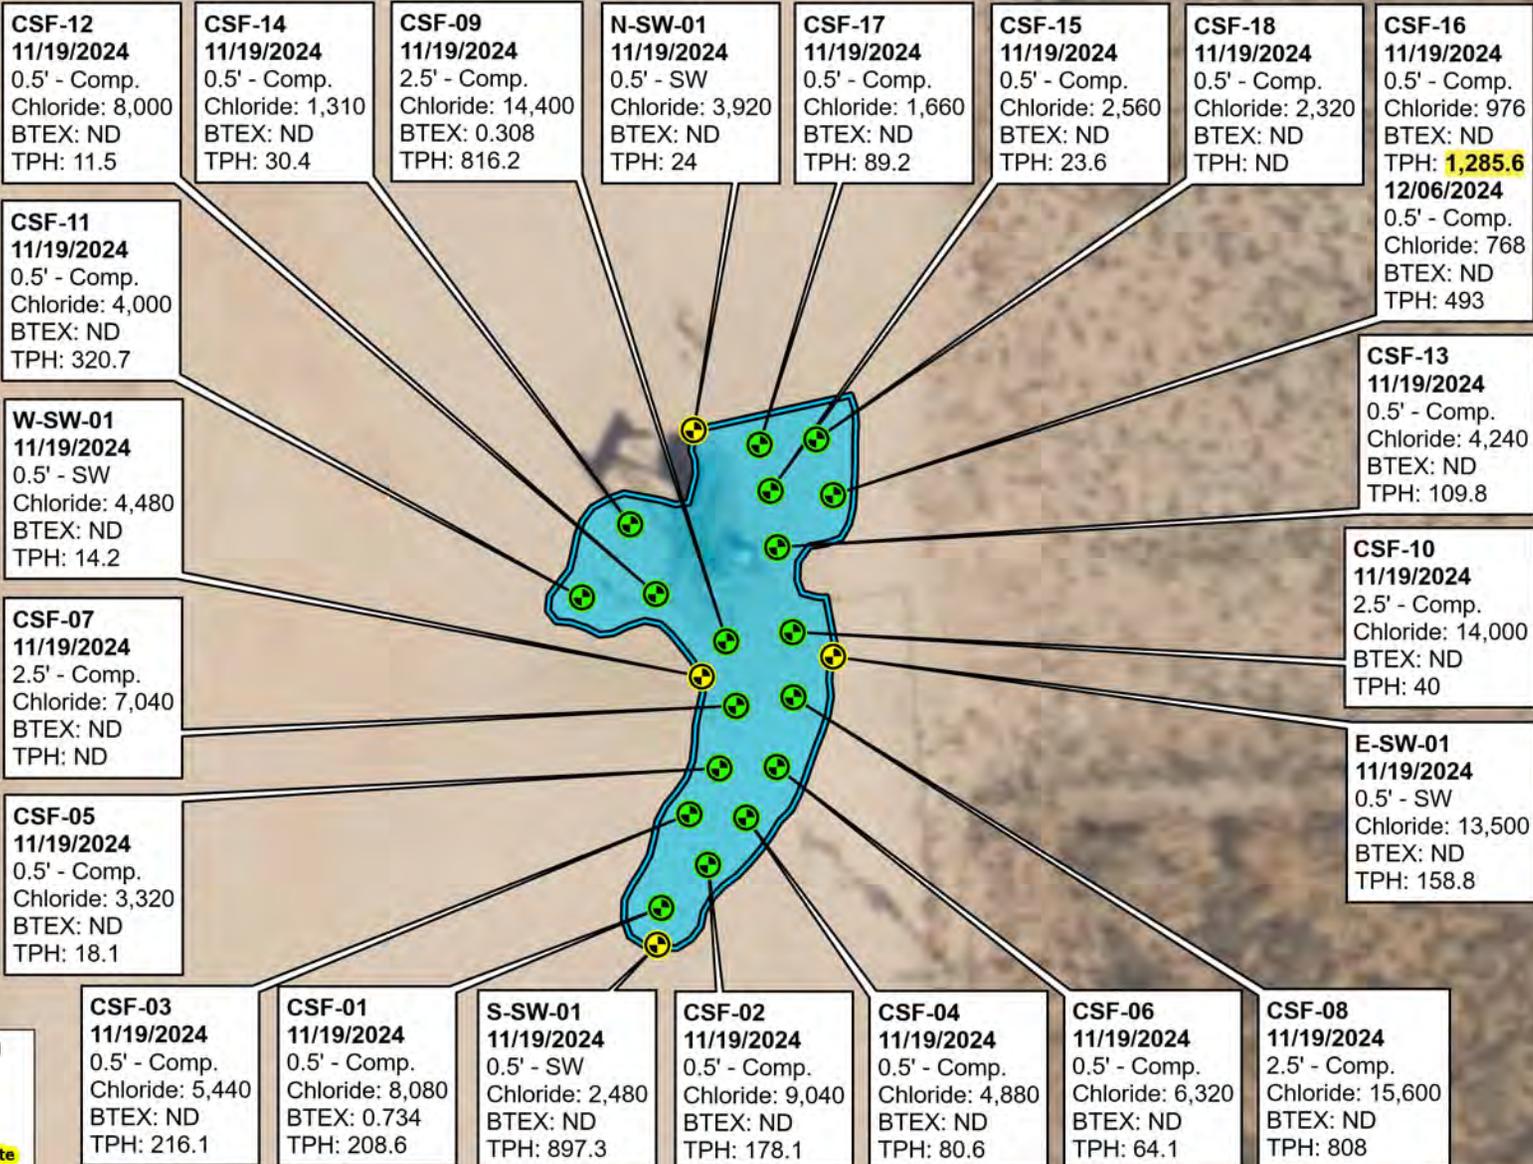
NMOCD Remediation Standard  
 Applicable to Site:  
 20,000 mg/kg for Chloride  
 2,500 mg/kg for Total TPH  
 50 mg/kg for BTEX

**Bold and Highlighted denote concentrations that exceed the NMOCD Reclamation and/or Remediation and Delineation Standards**

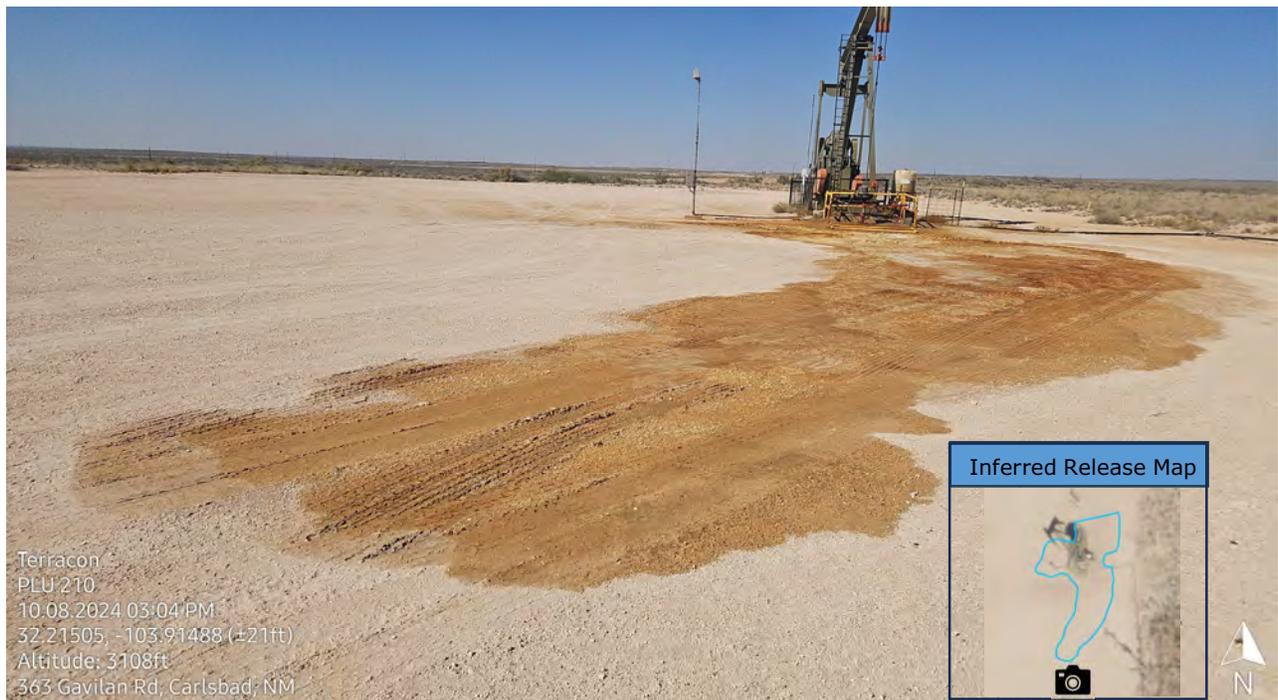
Photo 2

View of Release Facing North

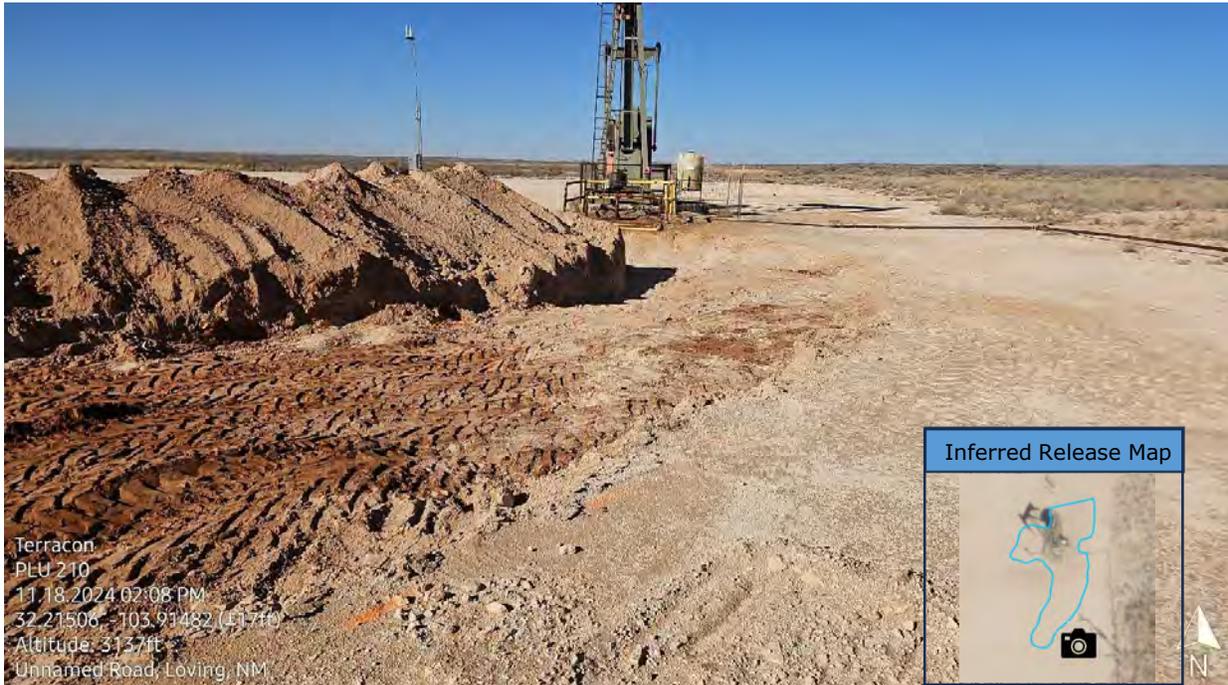
Photo 3

Excavation In Progress

A total of approximately 120 cubic yards (cu. yds.) of loose soil were excavated during remedial activities. Excavated material was stockpiled on-site atop a polyethylene liner pending disposal under an approved Form C-138. The excavated material was disposed of at Lea Land Facility. Soil disposal waste manifests are available upon request. A Confirmation Sample Map depicting the floor and wall sample locations and analytical results is included in Appendix A as Exhibit 8, respectively. Photographs of the project site are included in Appendix E. The analytical reports and Chain of Custody (COC) are included in Appendix F. Terracon's Standard of Care, Limitation, and Reliance is included in Appendix G.

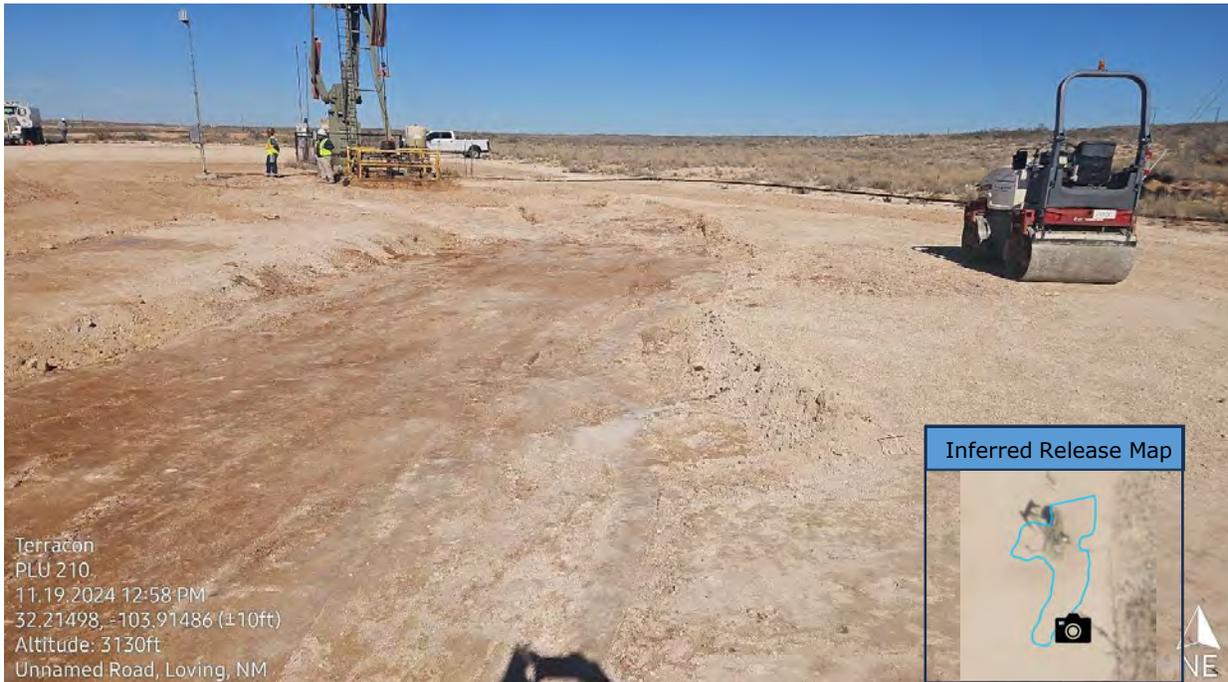
Photo 4

Excavation Complete

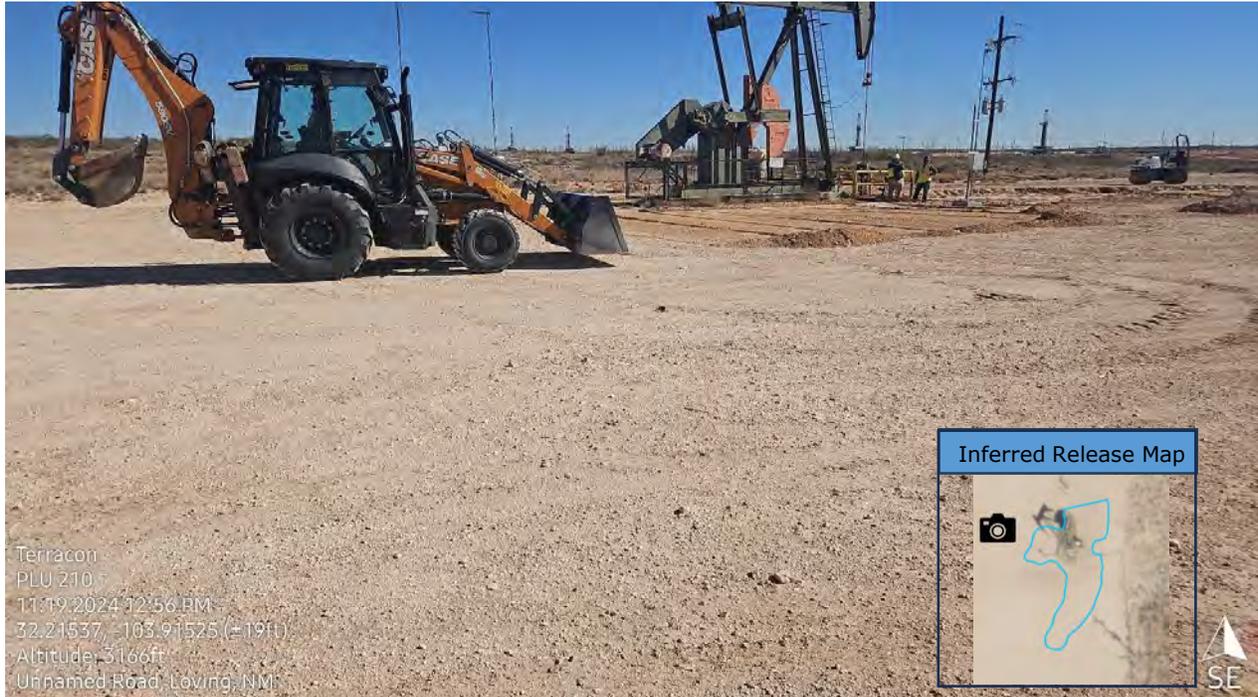
Photo 5

Western Scrape In Progress

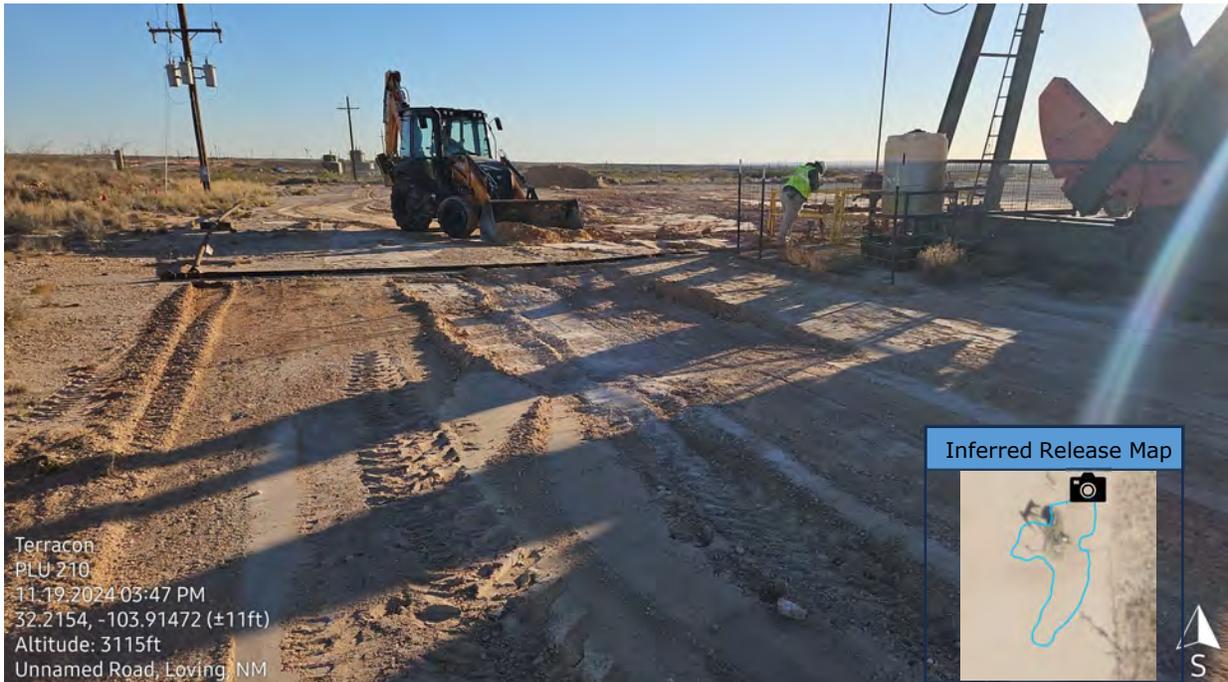
Photo 6

Eastern Scrape In Progress

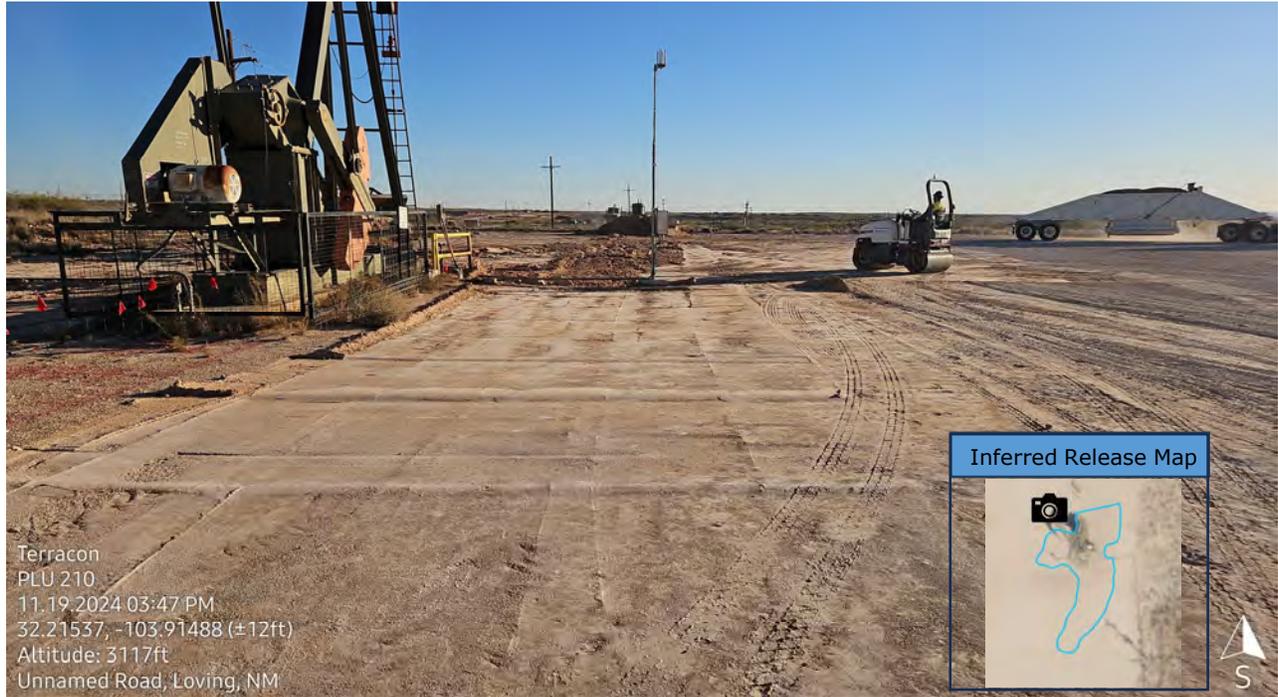
Photo 7

Western Area Being Compacted

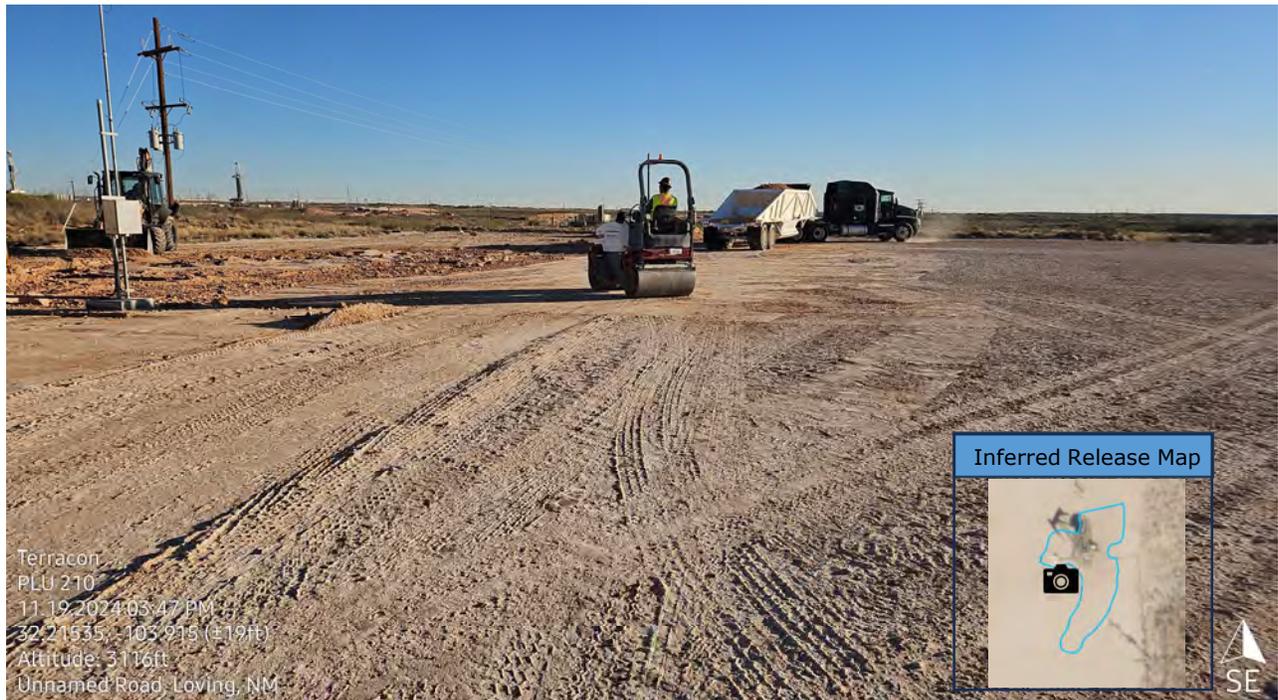
Photo 8

Excavation Area Being Backfilled and Compacted
