**Re: Closure Request Addendum  
Remuda 500 TB  
Incident Numbers NAPP2300441385, NAPP2300448092, and NAPP2300641362  
Eddy County, New Mexico**

XTO Energy, Inc  
Closure Request Addendum  
Remuda 500 TB

**Re: Closure Request  
Remuda 500 TB  
Incident Numbers NAPP2300441385, NAPP2300448092, and NAPP2300641362  
Eddy County, New Mexico**

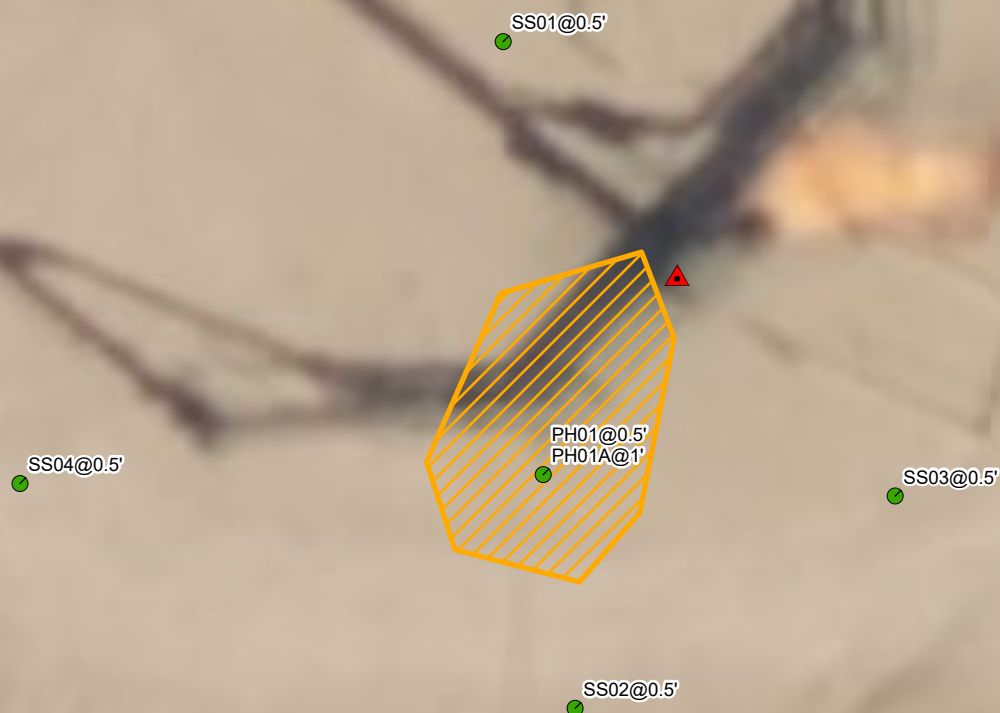
## FIGURE

## Site Receptor Map

- Delineation Soil Sample in Compliance with Closure Criteria
- ▲ Point of Release (POR)
- Release Extent

Notes:  
Sample ID @ Depth Below Ground Surface.

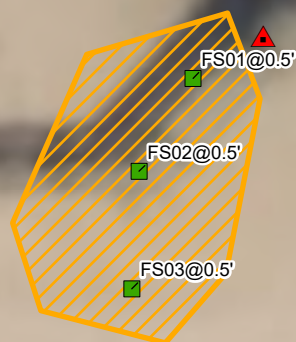
**FIGURE**  
**2**

## Delineation Soil Sample Locations

- Confirmation Soil Sample in Compliance with Closure Criteria
- ▲ Point of Release (POR)
- Surface Scrape Area

Notes:  
Sample ID @ Depth Below Ground Surface.

In response to NMOCD comments on the denied *Closure Request*, three 5-point composite confirmation soil samples (FS01 through FS03) were collected at least every 200 square feet from the surface-scraped, release extent on January 4, 2024. The 5-point composite samples were collected by placing five equivalent aliquots of soil into a 1-gallon, resealable plastic bag and homogenizing the samples by thoroughly mixing. The soil samples were field screened for volatile organic compounds (VOCs) utilizing a calibrated photoionization detector (PID) and chloride using Hach® chloride QuanTab® test strips. The composite soil samples were collected on the pad surface and encompassed the entirety of the release extent. While the NMOCD denial response indicates the collection of sidewall samples, no sidewall soil samples could be collected since excavation was not completed and thus, no sidewall had existed. The release extent/surface scrape area and confirmation soil sample locations were mapped utilizing a handheld Global Positioning System (GPS) unit and are depicted on Figure 3. Photographic documentation was completed during the soil sampling activities and a Photographic Log is included in Appendix B.

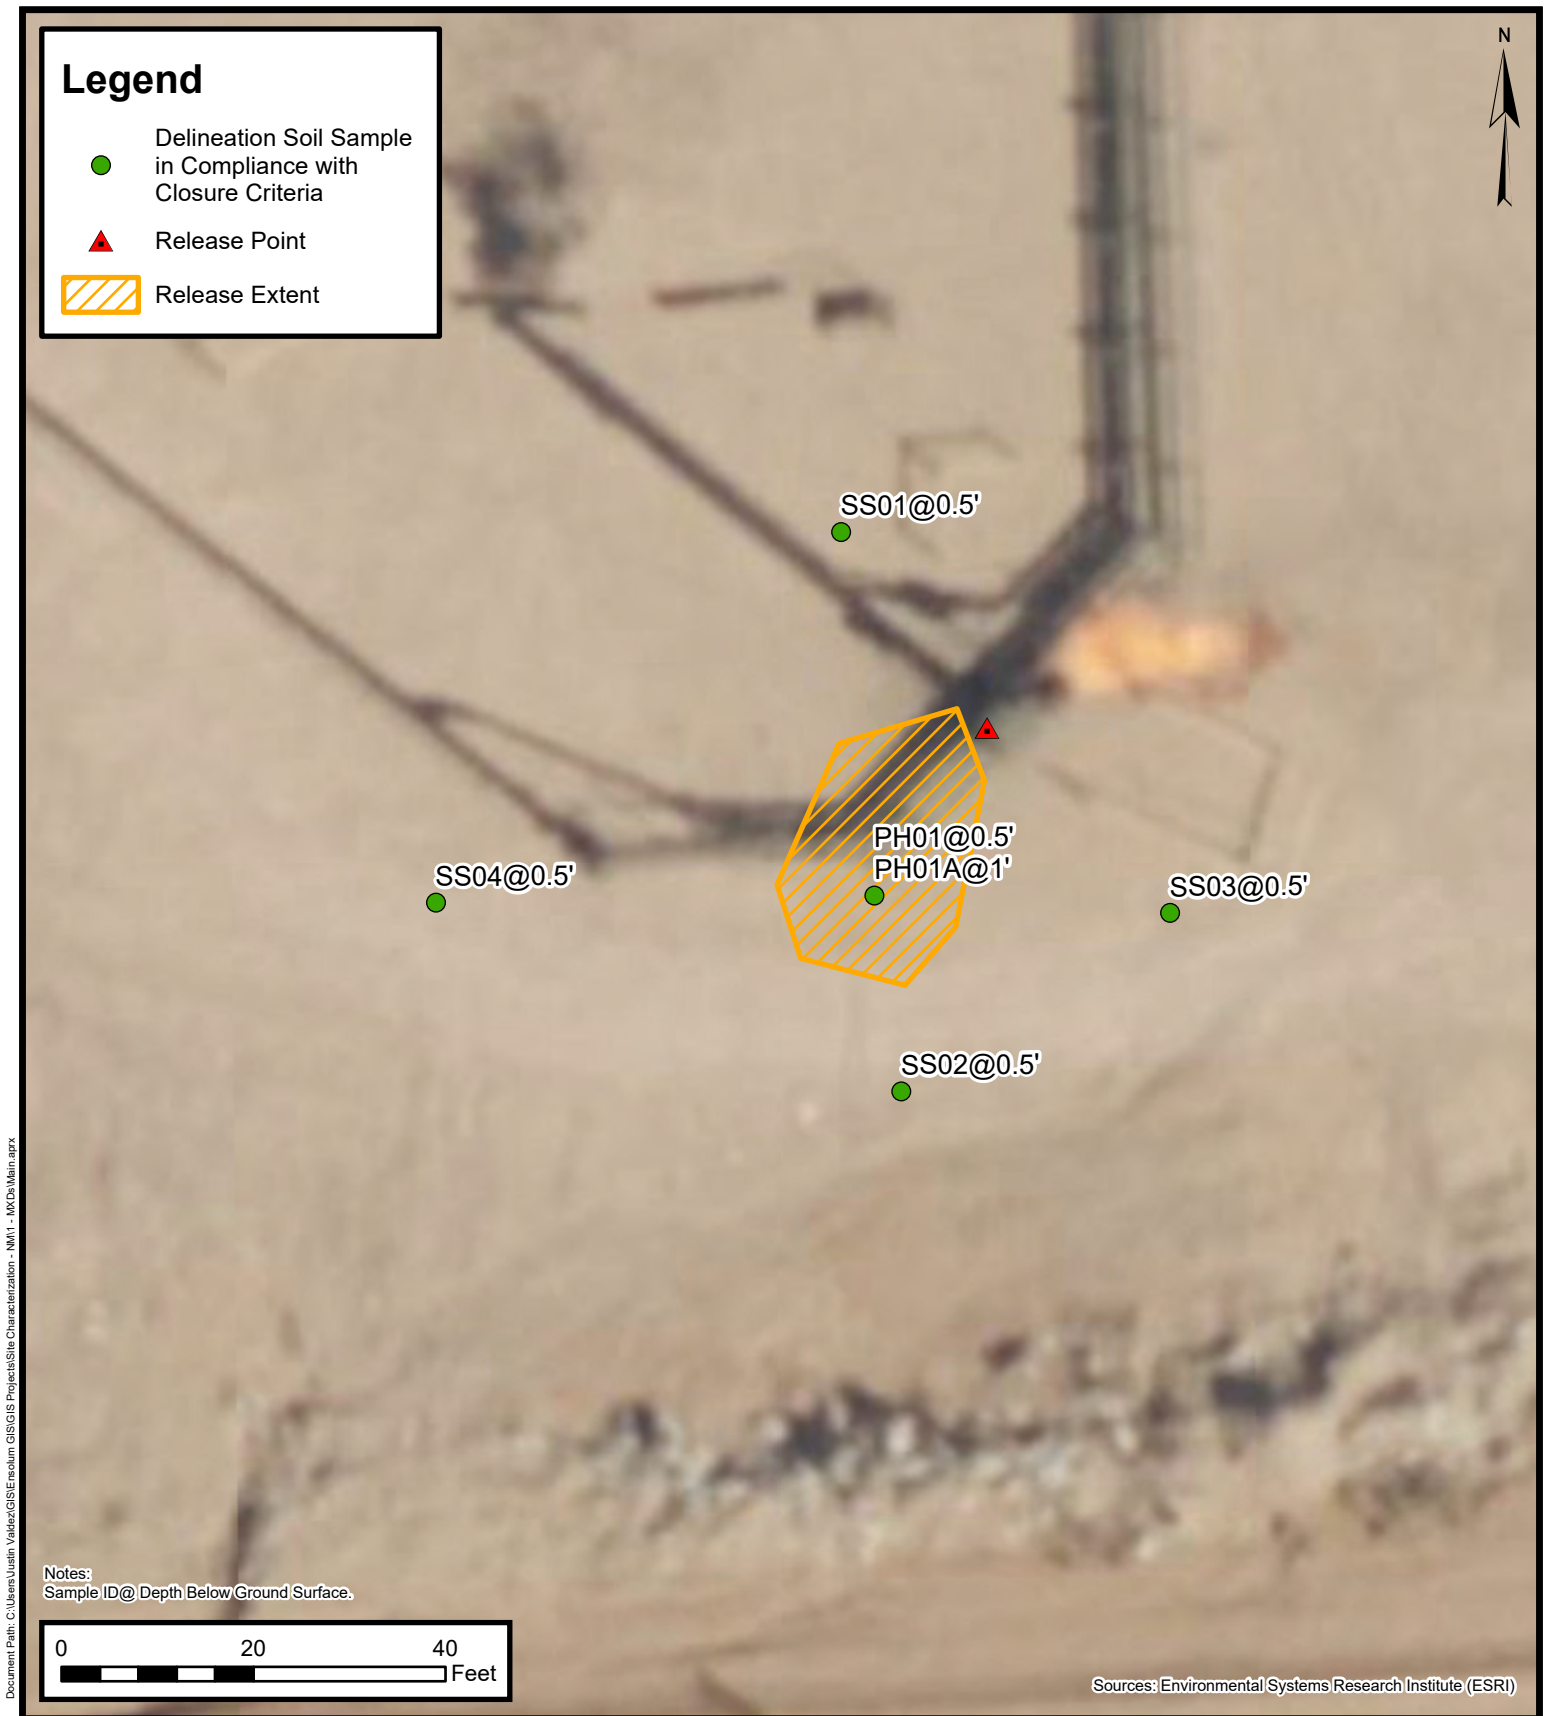
## Delineation Soil Sample Locations Map

Remuda 500 TB  
XTO ENERGY, INC  
Incident Numbers: NAPP2300441385, NAPP2300448092, NAPP2300641362  
Unit O, Sec 25, T23S, R29E  
Eddy County, New Mexico

On February 10, 2023, Site assessment and delineation activities were conducted by Ensolum to evaluate the release extent based on information provided on the Form C-141 and visual observations. One pothole (PH01) was advanced by use of heavy equipment within the release extent to assess the vertical extent of the release. Two discrete delineation soil samples were collected from the pothole at depths of 0.5 feet bgs and 1-foot bgs. Four discrete delineation soil samples (SS01 through SS04) were collected from a depth of 0.5 feet bgs to assess the lateral extent of the release. The delineation soil samples were field screened for volatile organic compounds (VOCs) utilizing a calibrated photoionization detector (PID) and chloride using Hach® chloride QuanTab® test strips. The release extent and delineation soil sample locations were mapped utilizing a handheld Global Positioning System (GPS) unit and are depicted on Figure 2. Field screening results on all delineation soil samples collected indicated no impacts to soil; however, surficial staining from the fire was scraped and removed from the Site by use of heavy equipment and hand tools. Field screening results and observations for the pothole

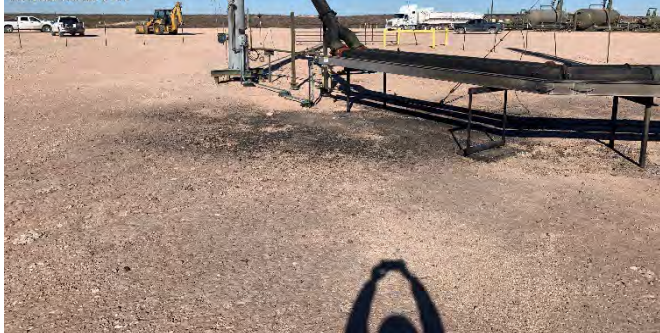
Photograph 1

Date & Time: Fri, Feb 10, 2023 at 09:14:11 MST  
 Position: 032.269720°N / 103.936930°W (±15.9ft)  
 Altitude: 3057ft (±10.5ft)  
 Datum: WGS-84  
 Azimuth/Bearing: 305° N55W 5422mils True (±15°)  
 Elevation Angle: +05.0°  
 Horizon Angle: +00.1°  
 Zoom: 1.0X  
 Remuda 500 flare line

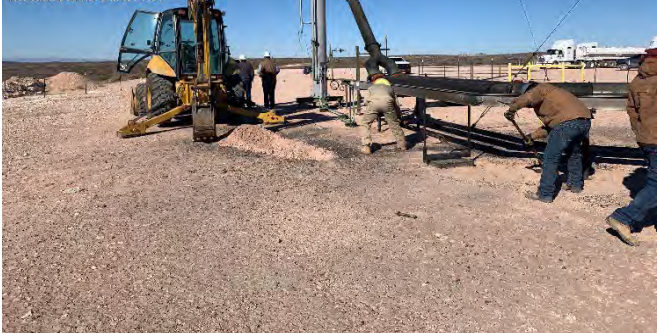
Photograph 2

Date & Time: Fri, Feb 10, 2023 at 09:37:56 MST  
 Position: 032.269752°N / 103.936923°W (±19.9ft)  
 Altitude: 3054ft (±19.9ft)  
 Datum: WGS-84  
 Azimuth/Bearing: 291° N69W 5173mils True (±15°)  
 Elevation Angle: +04.6°  
 Horizon Angle: +01.1°  
 Zoom: 1.0X  
 Remuda 500 flare line, PH01

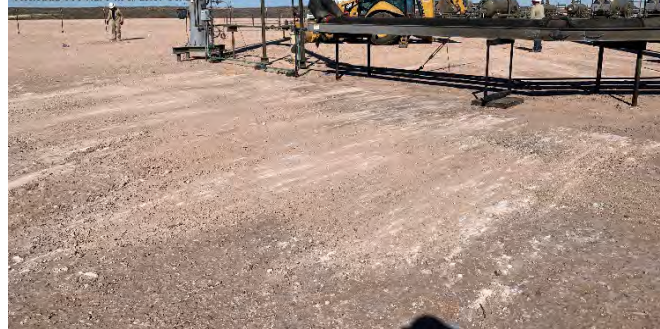
Photograph 3

Date & Time: Fri, Feb 10, 2023 at 10:10:31 MST  
 Position: 032.269759°N / 103.936990°W (±12.3ft)  
 Altitude: 3052ft (±19.5ft)  
 Datum: WGS-84  
 Azimuth/Bearing: 317° N43W 5336mils True (±12°)  
 Elevation Angle: +10.1°  
 Horizon Angle: +00.6°  
 Zoom: 1.0X  
 Remuda 500 flare line, after scrape

Site assessment and delineation activities were conducted at the Site to assess for the presence or absence of impacted soil resulting from a release of condensate that occurred on December 23, 2022, and two releases of crude oil occurring on December 26, 2022 and December 27, 2022, all of which resulted in a flare fire. Laboratory analytical results for all delineation soil samples indicated COC concentrations were compliant with the Site Closure Criteria and the most stringent Table I Closure Criteria. Following delineation activities, surface scraping was completed to remove surficial staining caused by the fires.

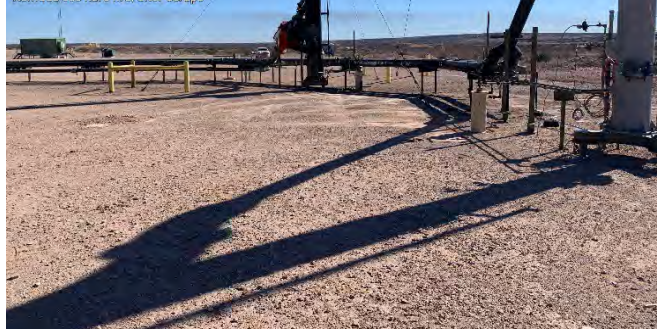
Photograph 4

Date & Time: Fri, Feb 10, 2023 at 10:12:35 MST  
 Position: 032.269863°N / 103.937182°W (±419.8ft)  
 Altitude: 3083ft (±454.8ft)  
 Datum: WGS-84  
 Azimuth/Bearing: 080° N80E 1422mils True (±12°)  
 Elevation Angle: +45.8°  
 Horizon Angle: +01.2°  
 Zoom: 1.0X  
 Remuda 500 flare line, after scrape

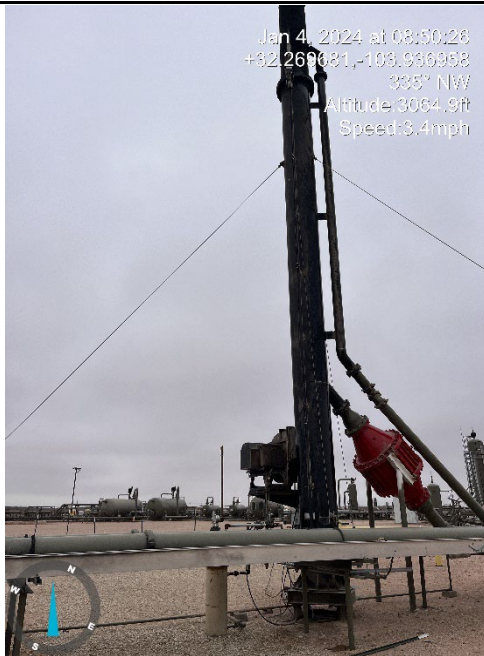
Photograph 1

Description: Soil sampling area

View: North-northwest

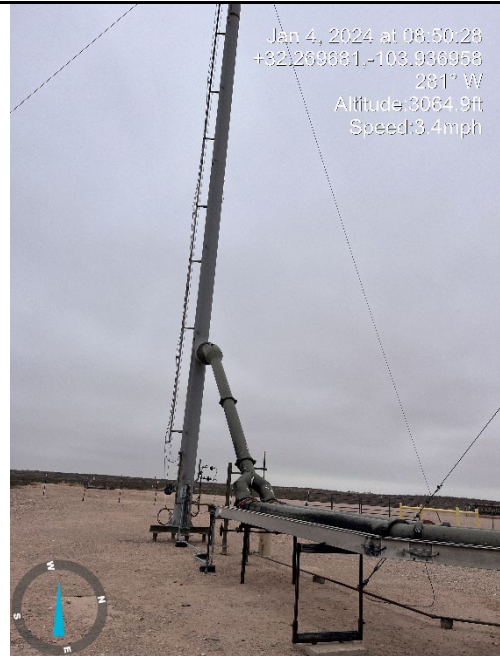
Photograph 2

Description: Soil sampling area

View: West

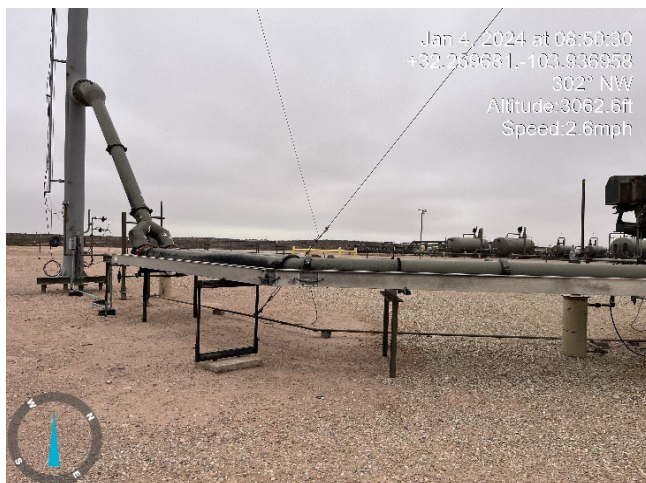
Photograph 3

Description: Soil sampling area

View: West-northwest
