# SITE ASSESSMENT AND REMEDIATION WORK PLAN

### Mean Green 23 CTB 2

Incident ID: NAPP2417834917

Prepared By: Pima Environmental Services, LLC

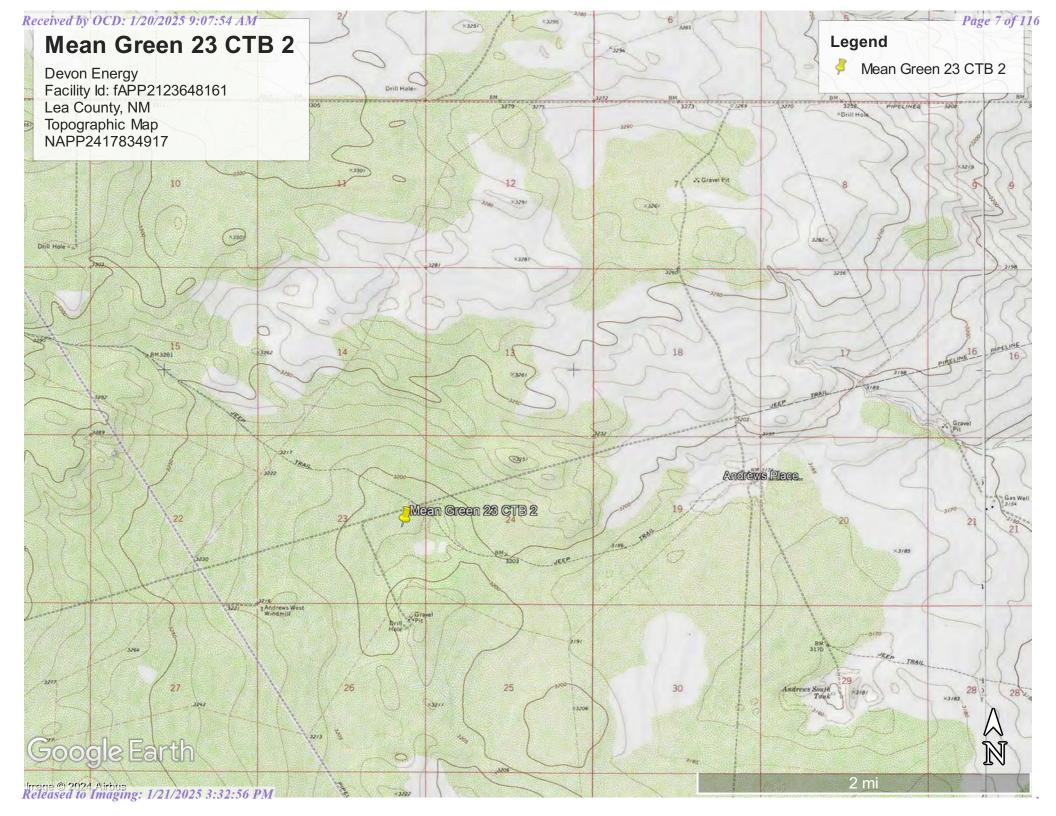
Figure 2- Topographic Map

Per the New Mexico Bureau of Geology and Mineral Resources, the geology is made up of Interlayered eolian sands and piedmont-slope deposits along the eastern flank of the Pecos River valley, primarily between Roswell and Carlsbad. Typically capped by thin eolian deposits. The soil in this area is made up of Pyote and Maljamar fine sands, according to the United States Department of Agriculture Natural Resources Conservation Service soil survey (Appendix B). The drainage class in this area is well drained. There is a low potential for karst geology to be present around the Mean Green (Figure 3). Reference Figure 2 for a Topographic Map.

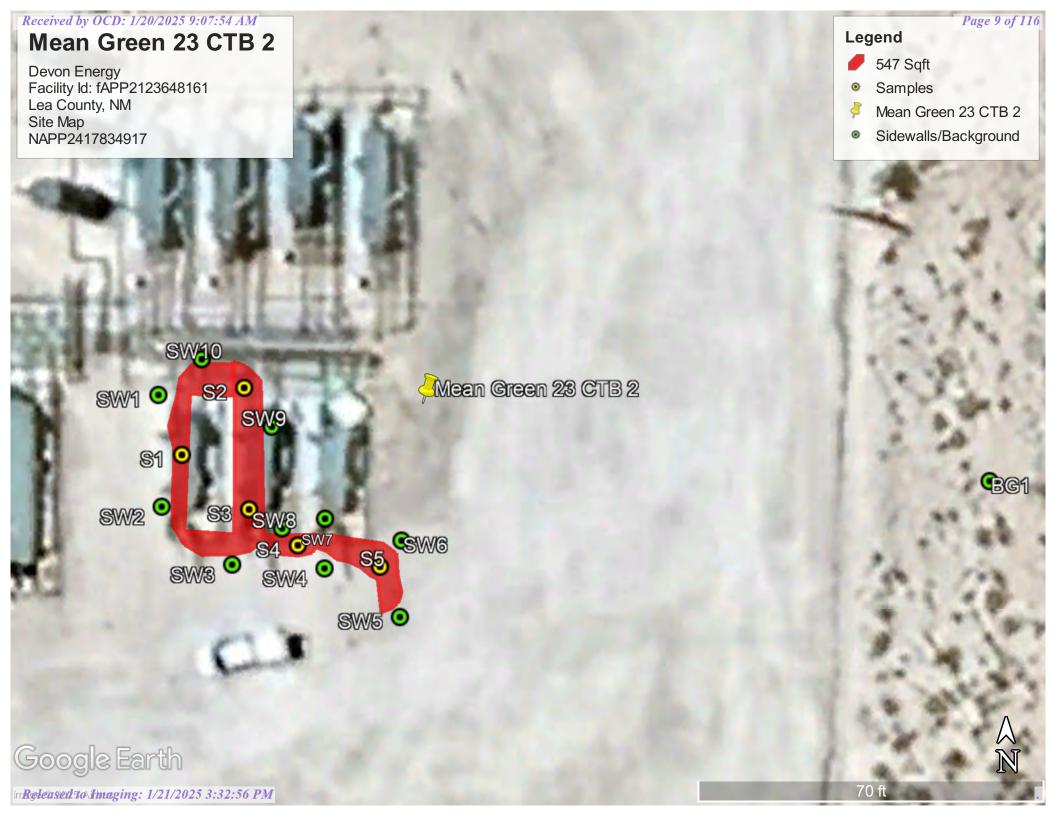
Figure 4- Site Map

On June 28, 2024, Pima mobilized personnel to the site to collect soil samples from the spill area. A hand auger was used to collect the samples from the affected area. The laboratory results of these sampling events are provided in the following data table. A Site Map is available in Figure 4.

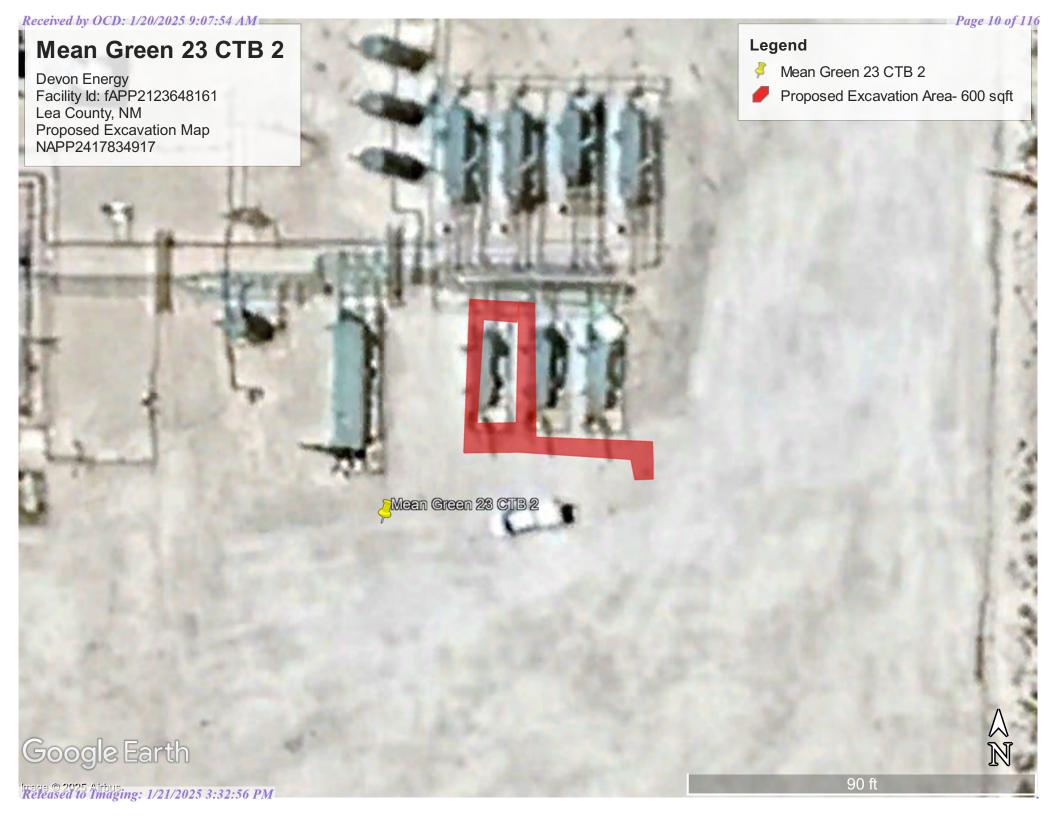
Figure 5-Proposed Excavation Map

Based on the sample results and available groundwater information, remediation of the impacted areas is not required beyond addressing surface staining. However, areas S1 through S5 will need to be excavated to a depth of six inches (6") below ground surface to remediate surface contamination.

- 1. Submit a one-call through the NM811 system.
- 2. The estimated volume of soil to be remediated from the above-mentioned sample points is totaling 600 square feet at an average depth of 6 inches below ground surface and approximately 11 cubic yards.

- 3. We propose to excavate the affected areas using mechanical and hand equipment and dispose of the contaminated soil at an NMOCD-approved facility. A Proposed Excavation Map can be found in Figure 5.

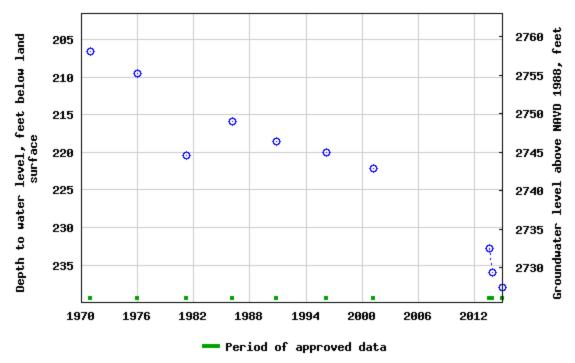
#### USGS 320108103191301 26S.35E.24.342444

Breaks in the plot represent a gap of at least one year between field measurements. <u>Download a presentation-quality graph</u>

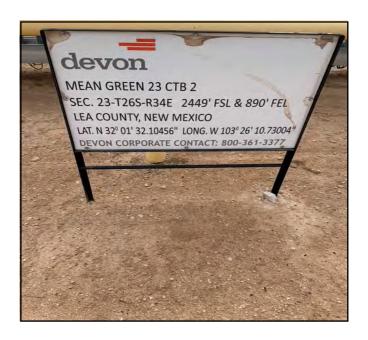
+32.026214,-103.435223
75° E
Devon
Mean Green 23 CTB 2
Assessment

Site Information Sign.

Photograph taken during assessment, facing East.

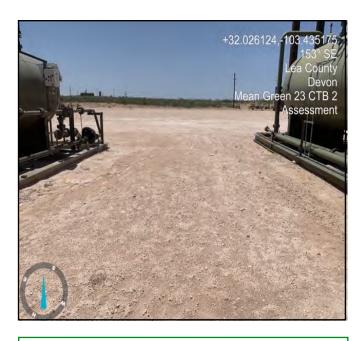
Photograph taken during assessment, facing Southeast.

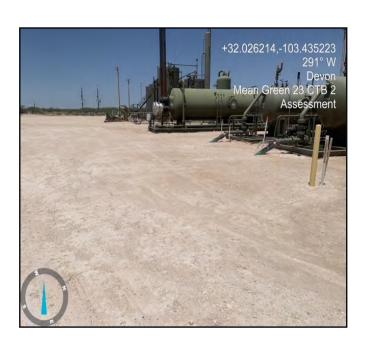
Photograph taken during assessment, facing West.

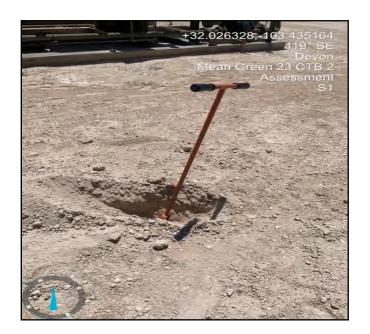
Photograph taken during assessment, facing Southeast.

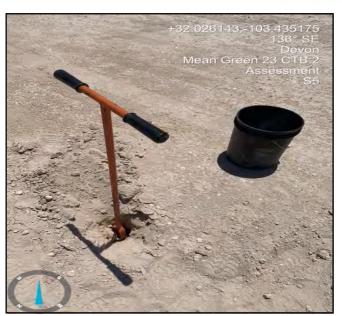
Photograph taken during assessment, facing Southeast.
