Re: Incident Closure Report

Caza Operating, LLC

Comanche 25-36 Fed State Com 1H-4H Production Facility

Incident ID: nAPP2500337377

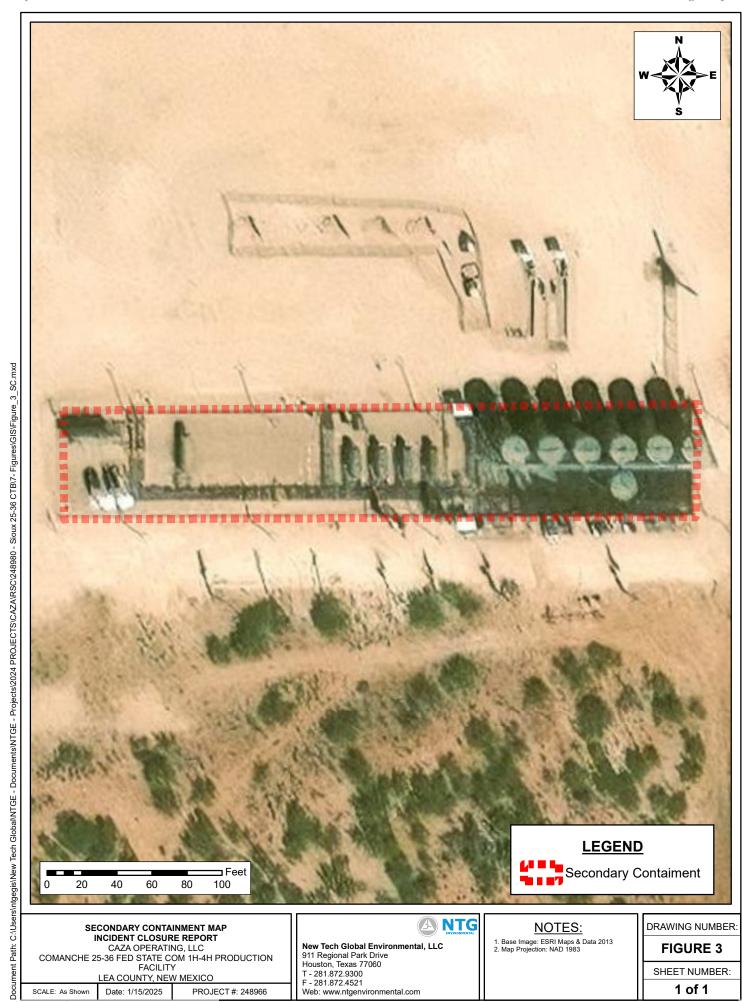
FIGURE 3 SHEET NUMBER:

Based on the initial C-141 submitted by Caza and obtained by the New Mexico Oil Conservation District (NMOCD), the release was discovered on January 03, 2025. The release was the result of an equipment failure (dump line), resulting in the release of twenty-five (25) barrels (bbls) of produced water, of which none were recovered for a net loss of twenty-five (25) bbls of produced water. Upon discovery the well was shut-in, and the area was secure. The liner area is shown on Figure 3.
