SITE ASSESSMENT AND REMEDIATION WORK PLAN

Continental Com Fed #001 Battery

Incident ID: NDHR1913635865

Re: Site Assessment, and Remediation Work Plan
Continental Com Fed #001 Battery
API No. 30-025-20912
GPS: Latitude 32.68409 Longitude -103.80346
UL -- O, Section 06, T19S, R32E
Lea County, NM
NMOCD Ref. No. NDHR1913635865

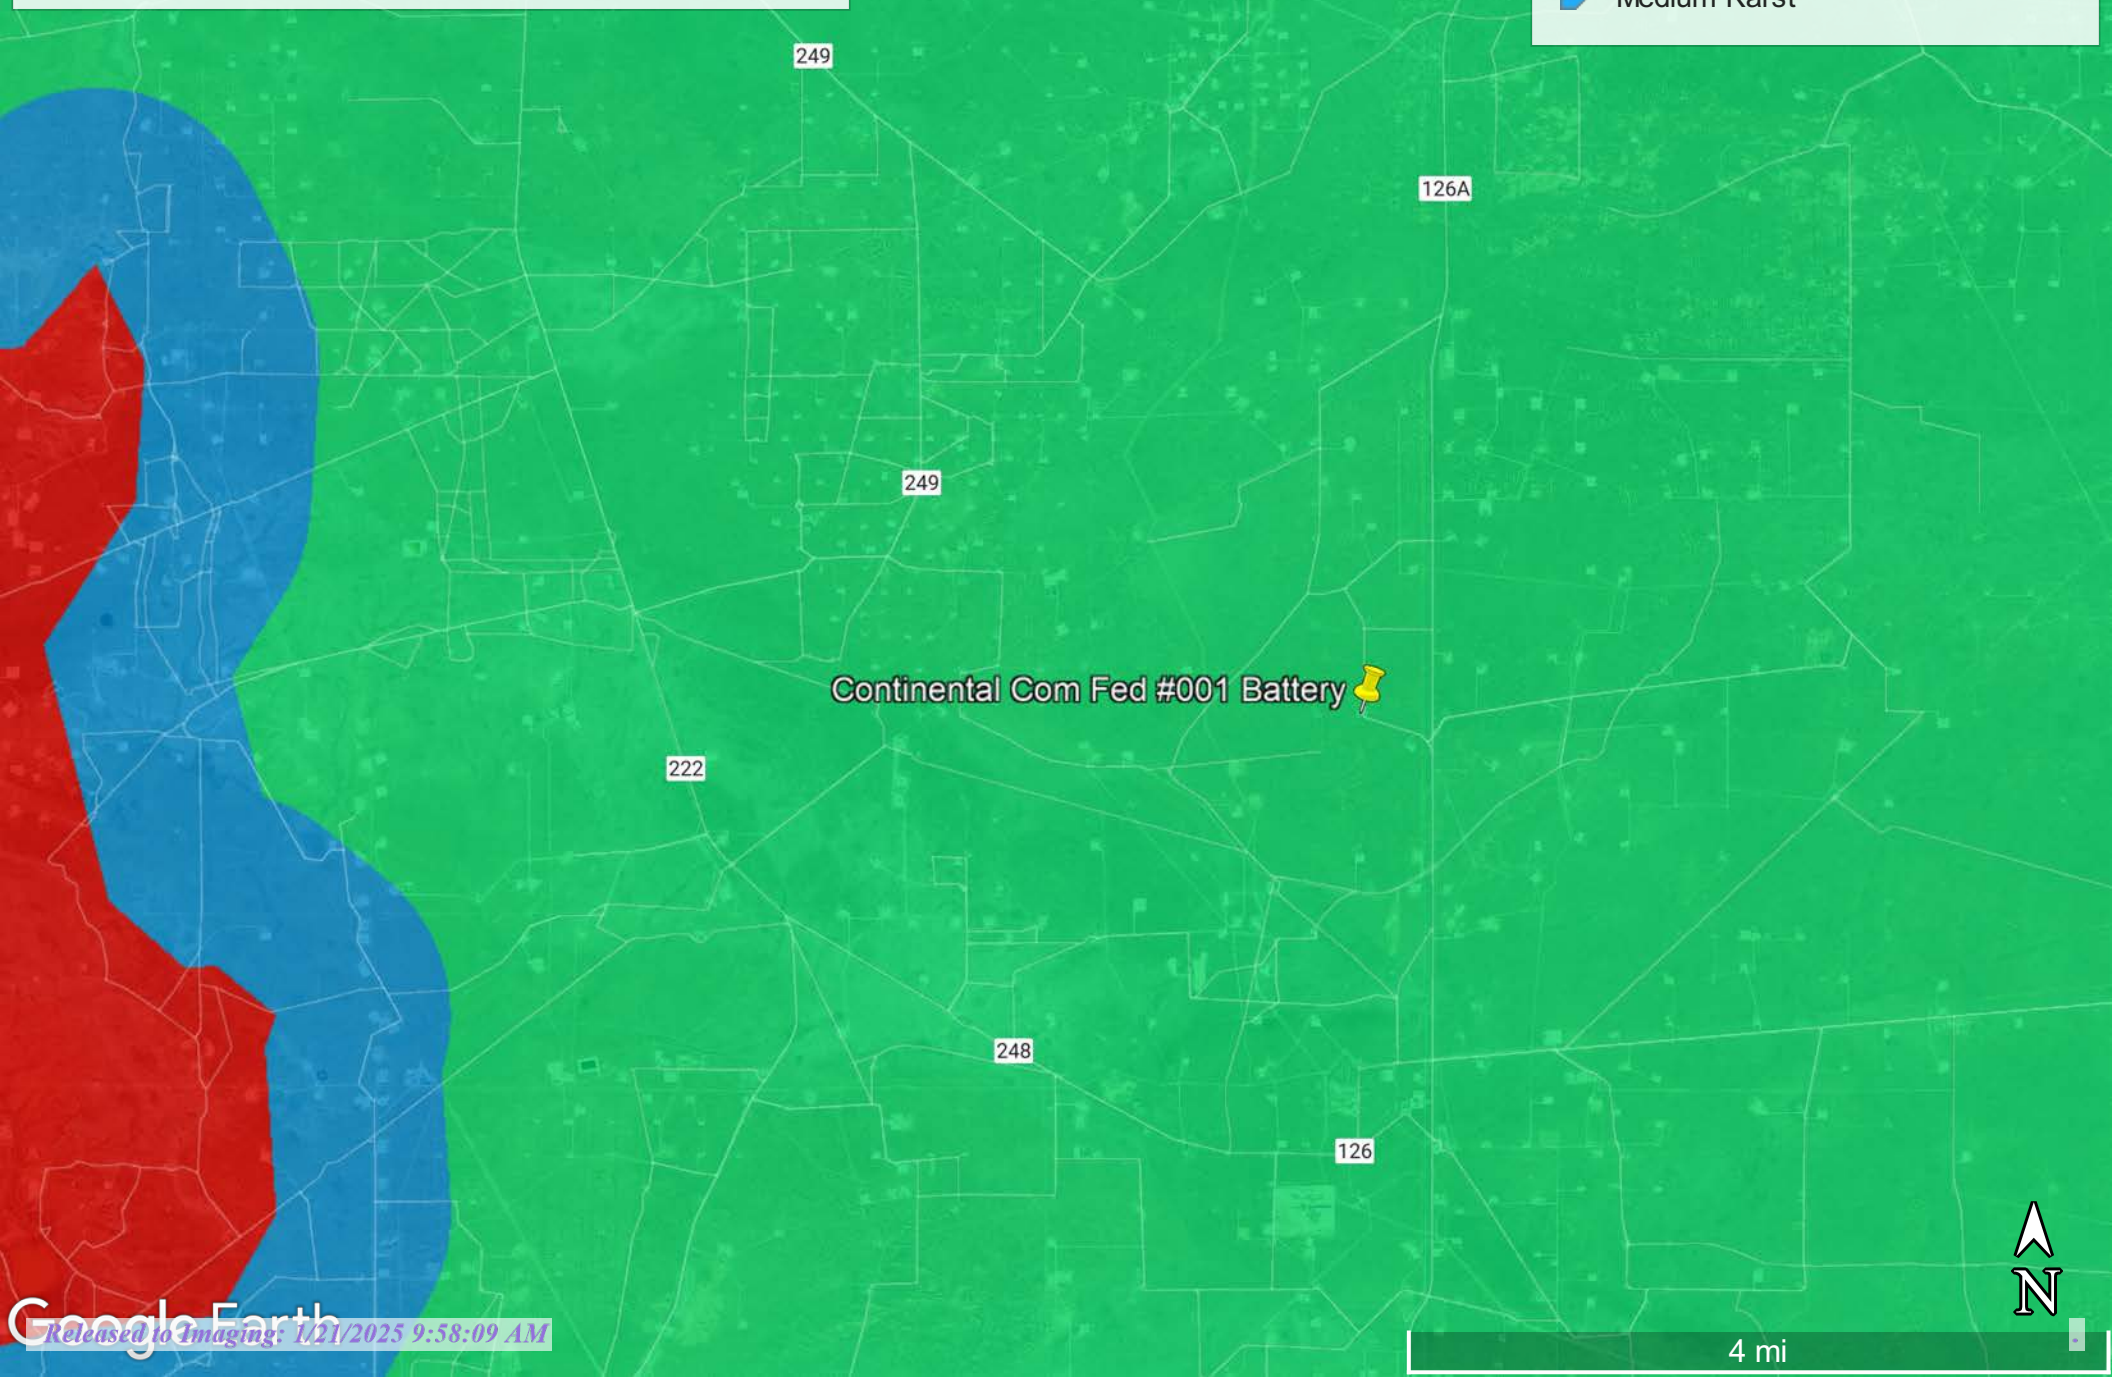
3-Karst Map

Per the New Mexico Bureau of Geology and Mineral Resources, the geology is made up of Eolian and piedmont deposits Interlayered eolian sands and piedmont-slope deposits along the eastern flank of the Pecos River valley, primarily between Roswell and Carlsbad. Typically capped by thin eolian deposits. The soil in this area is made up of Pyote and Maljamar fine sands, 0 to 3 percent slopes according to the United States Department of Agriculture Natural Resources Conservation Service soil survey (Appendix B). The drainage class in this area is well drained. There is a low potential for karst geology to be present around the Continental (Figure 3).

Devon Energy
API: 30-025-20912
Lea County, NM
Karst Map

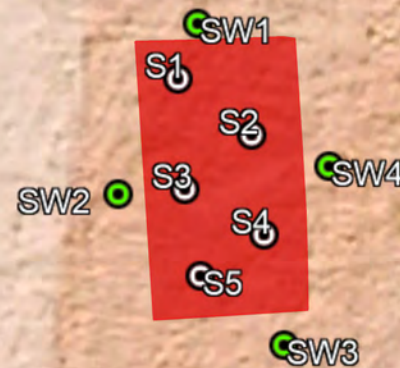
4-Site Map

On February 21, 2023, Pima mobilized personnel to the site to begin collecting soil samples from spill area. The laboratory results of this sampling event can be found in the following data table. A Site Map can be found in Figure 4.

- Composite Samples
- Composite Sidewalls
- Continental Com Fed #001 Battery
- Spill Area 11/2/2018

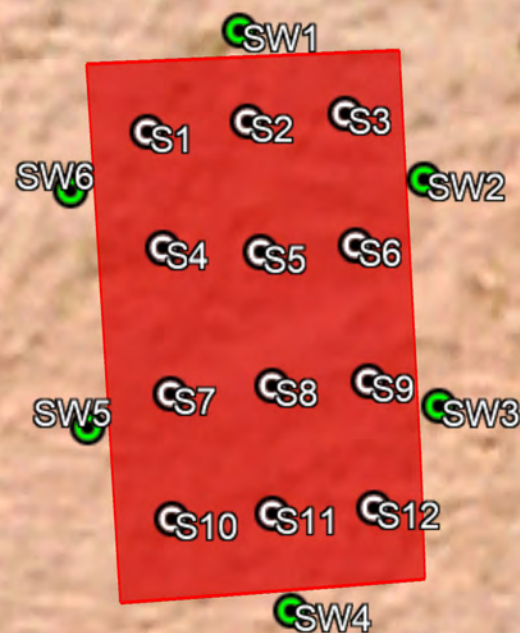
5-Proposed Sampling Map

1. Included in this remediation work plan is a Proposed Sampling Map (Figure 5) showing twelve (12) vertical samples and six (6) horizontal samples to be collected as delineation/exploration samples. These samples will represent a surface area of no more than 200 ft² and will be collected from surface, 1', 2', 3', and 4' bgs.
2. In the event that impact is encountered and samples come back over the regulatory limits, Devon Energy proposes to dig and haul contaminated soil to remediate/reclaim the site.
3. If the samples come back under the regulatory limits, Devon Energy is requesting a variance to use delineation samples as closure confirmation samples.

- Bottom Soil Samples
- Release Area 2,300 sq ft
- Sidewall Soil Samples

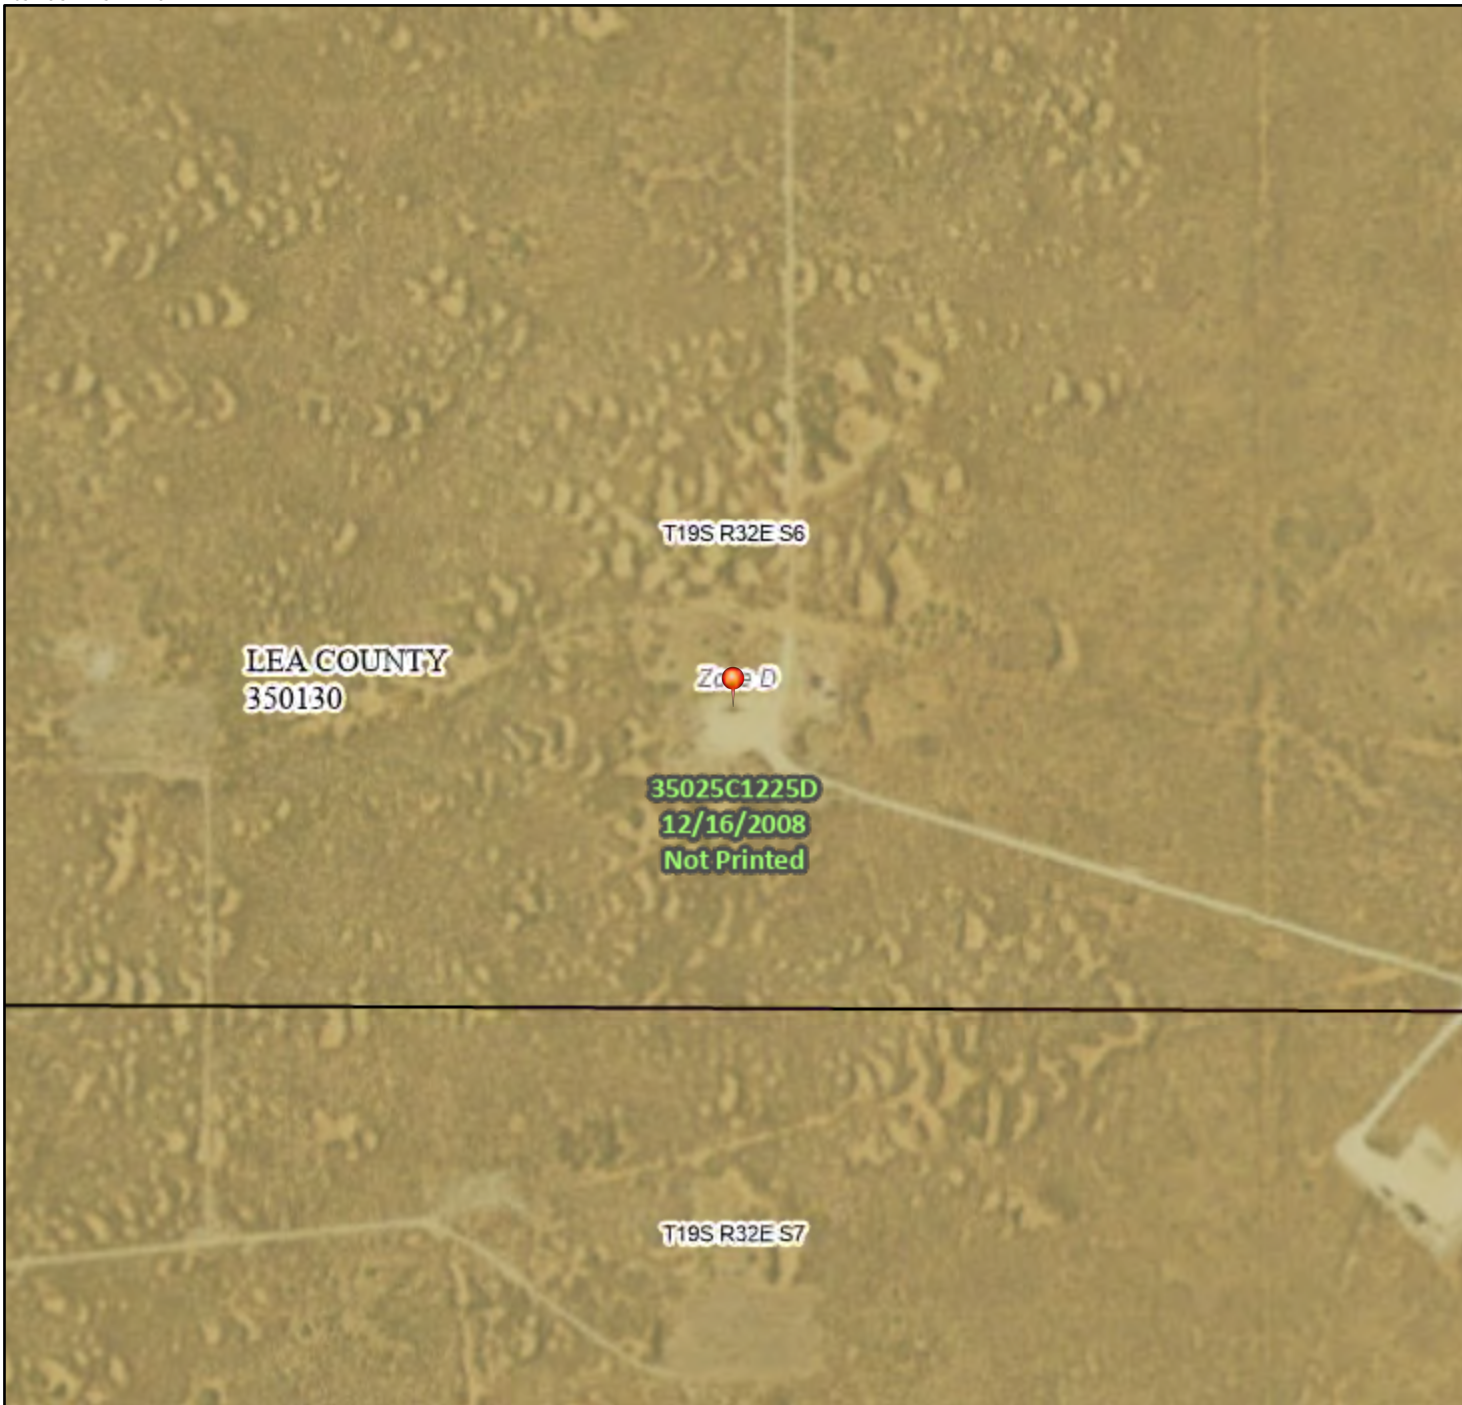
National Flood Hazard Layer FIRMMette

The flood hazard information is derived directly from the authoritative NFHL web services provided by FEMA. This map was exported on 2/12/2023 at 9:39 AM and does not reflect changes or amendments subsequent to this date and time. The NFHL and effective information may change or become superseded by new data over time.

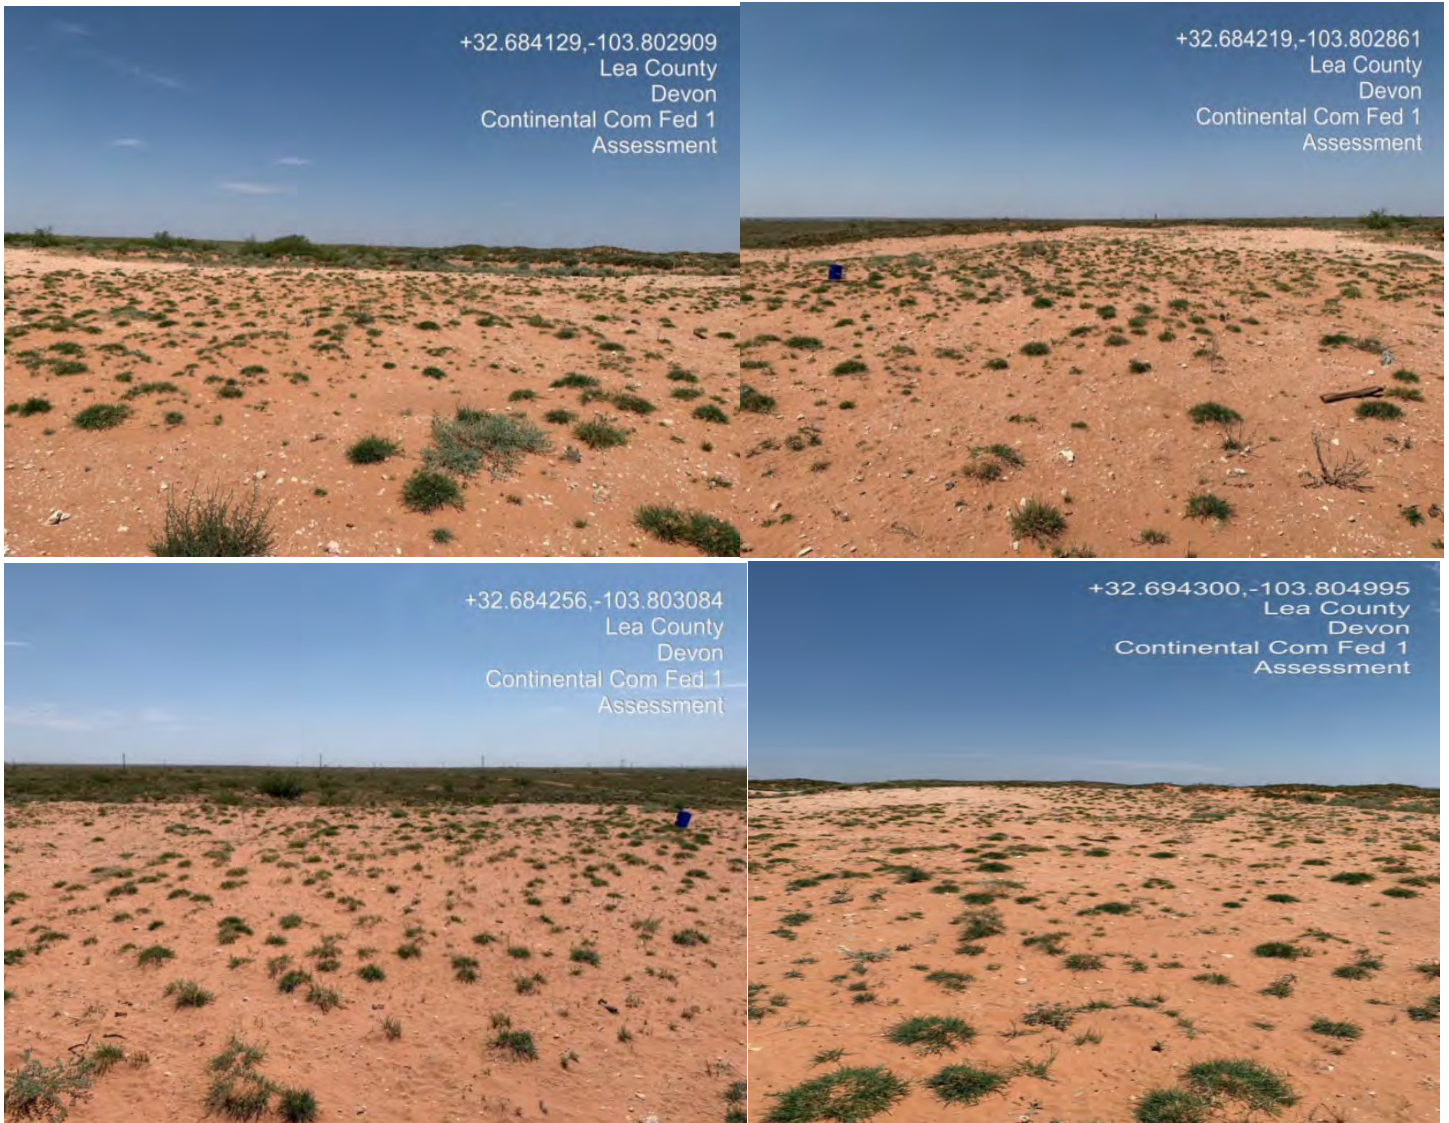
Site Assessment
