**Re: Enterprise Field Services, LLC - Limited Site Investigation  
2C-29 Pipeline Release  
Section 19, Township 25 North, Range 4 West  
Jicarilla Apache Nation, Rio Arriba County, New Mexico**

LIMITED SITE INVESTIGATION

2C-29 Pipeline Release  
Section 19, T25N, R4W  
Jicarilla Apache Nation, Rio Arriba County, New Mexico

September 14, 2011  
SWG Project No. 0411012

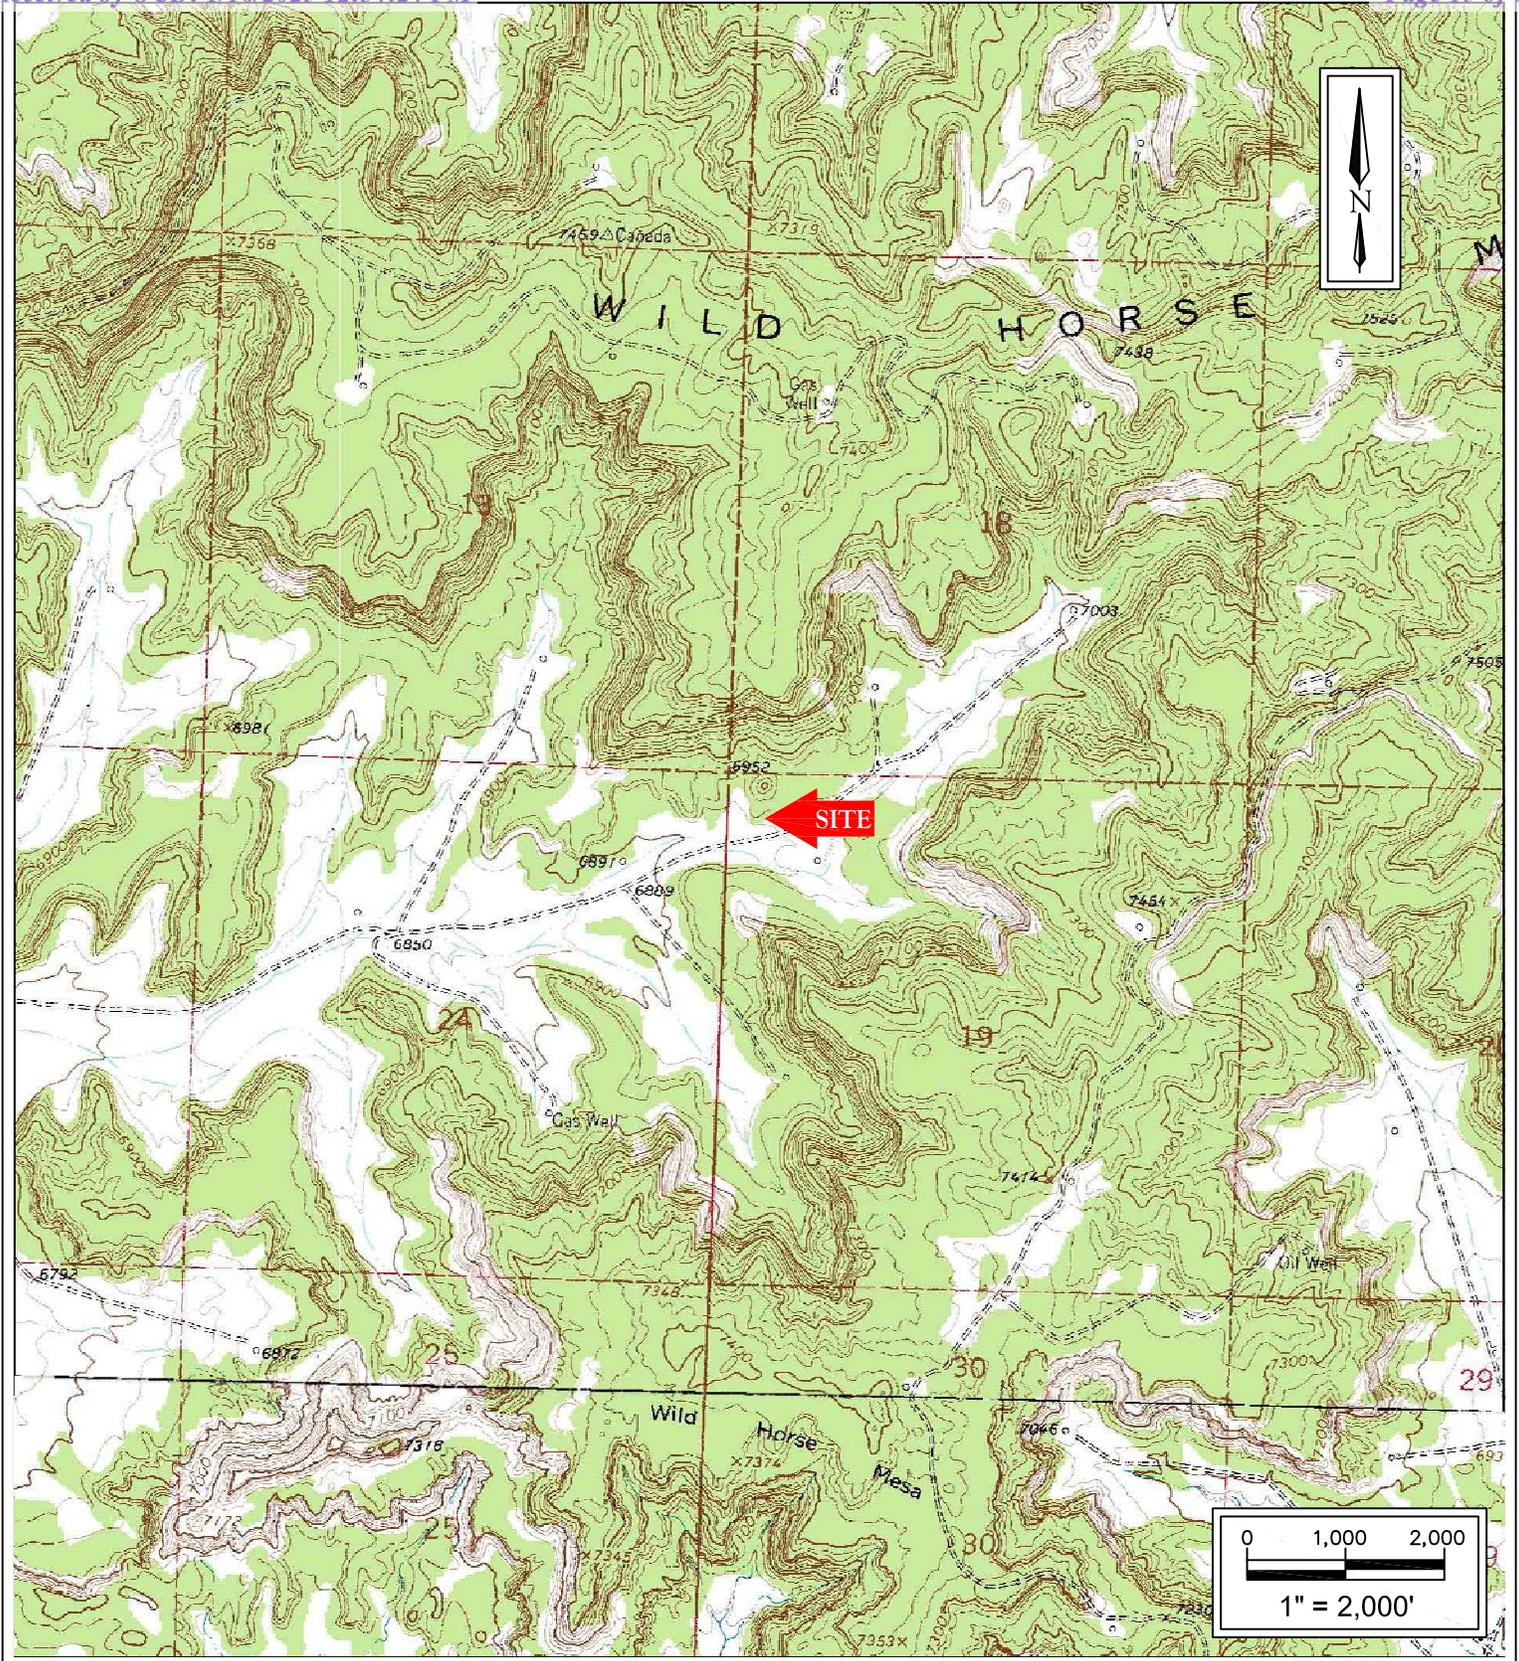
FIGURE 1  
 TOPOGRAPHIC MAP  
 LAPIS POINT & OTERO STORE,  
 NM QUADRANGLES  
 1963

A topographic map is included as Figure 1, a 2005 aerial photograph of the Site vicinity is included as Figure 2, and a site plan is included as Figure 3 of Appendix A.

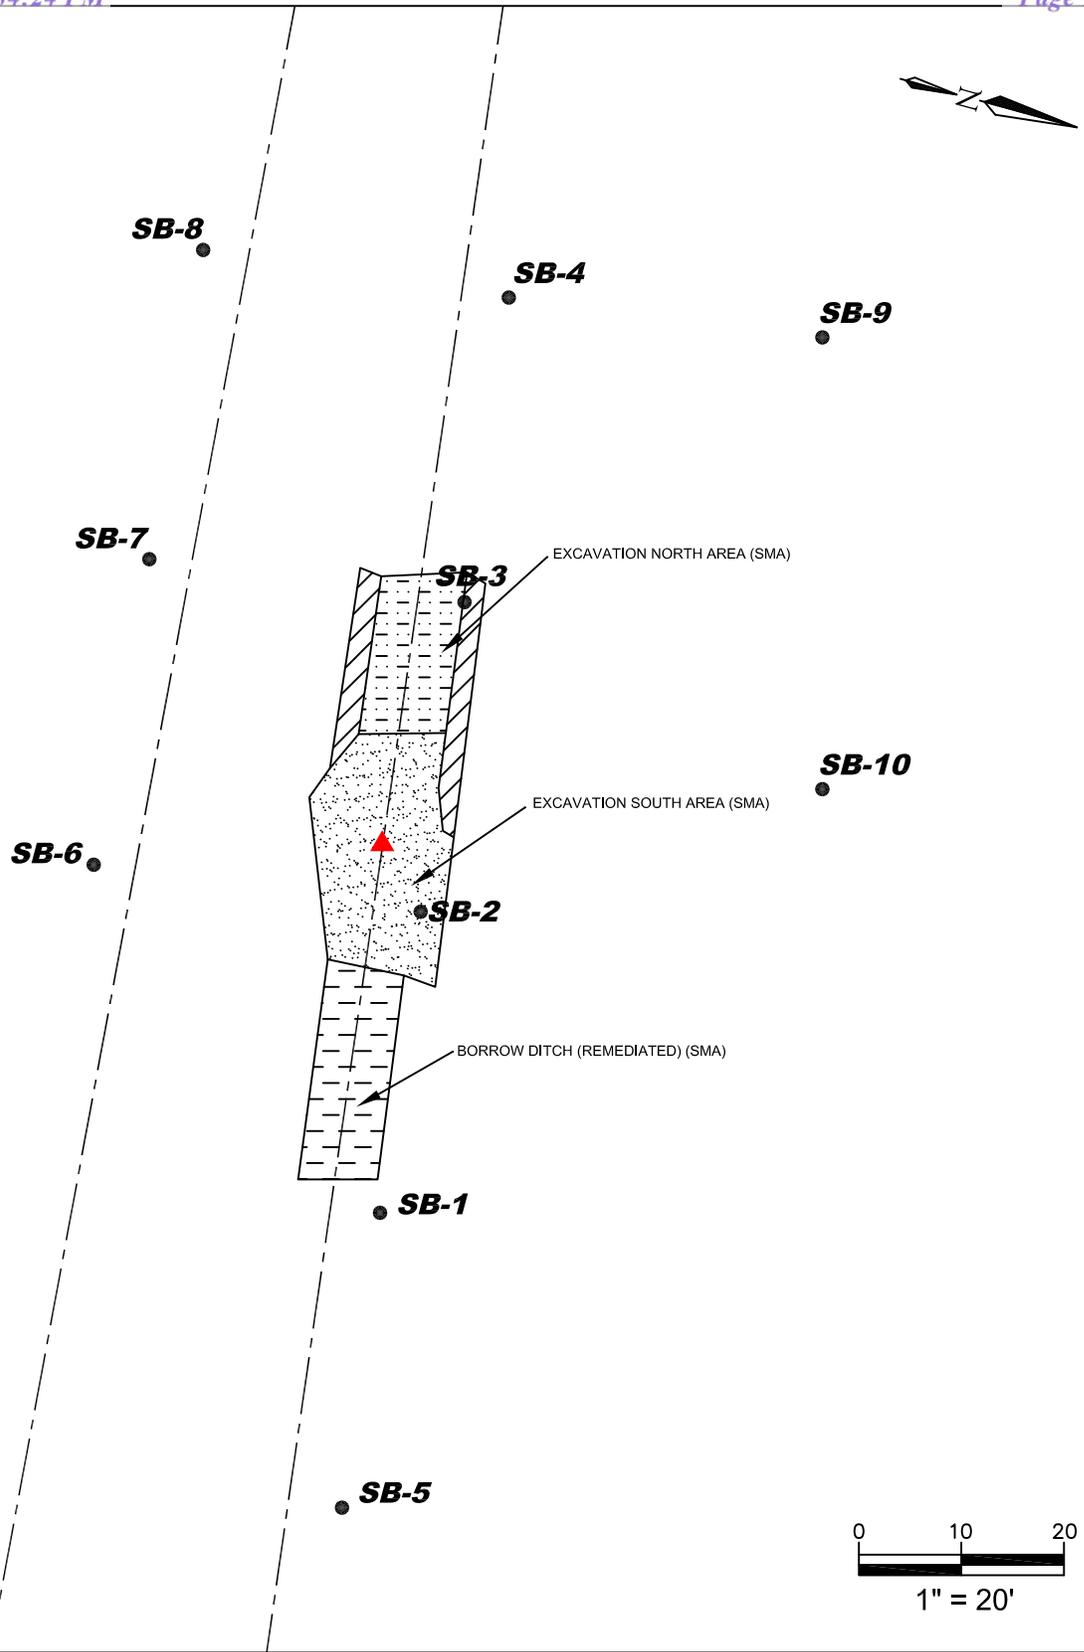
SWG's field investigation activities were conducted on July 25<sup>th</sup> and 26<sup>th</sup>, 2011 by Mr. Kyle Summers, a SWG environmental professional. As part of the approved scope of work, ten (10) soil borings were advanced in the vicinity of the former pipeline release. Each soil boring was advanced utilizing a direct push Geoprobe<sup>®</sup> drilling rig. Soil borings SB-1, SB-5, and SB-10 were advanced topographically upgradient of the former excavation; Soil borings SB-2 and SB-3 appear to have penetrated the northern edge of the former excavation; Soil borings SB-4, SB-6, SB-7, and SB-8 were advanced topographically downgradient of the former excavation; Soil boring SB-9 was advanced topographically cross-gradient of the former excavation.

Figure 3 is a site plan that depicts the approximate location of the soil borings in relation to pertinent land features (Appendix A).

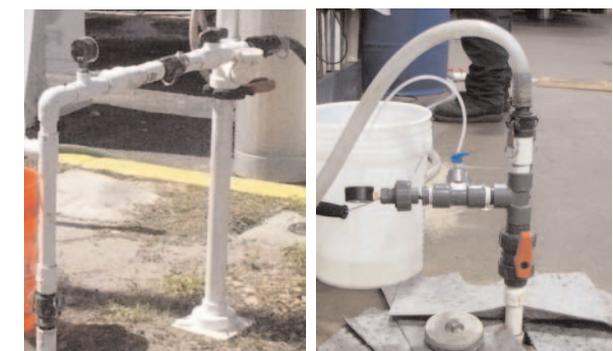
Typical well head assemblies for delivery of VeruSOLVE-HP™

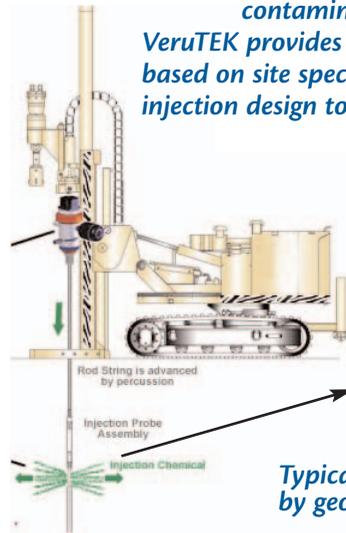
Typical In-Situ application by geoprobe

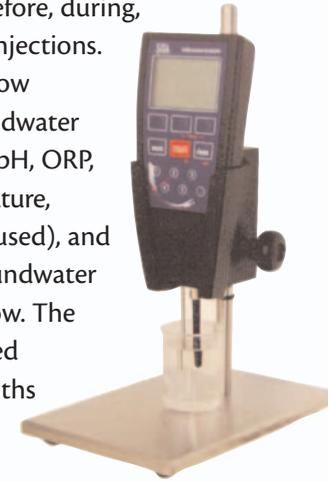
Monitoring is conducted before, during, and after VeruSOLVE-HP™ injections. Using laboratory and low flow sampling equipment, groundwater quality parameters such as pH, ORP, conductivity, head, temperature, persulfate concentration (if used), and IFT are measured from groundwater and the injection system flow. The monitoring is also conducted periodically for several months following injections.

Typical Monitoring Equipment IFT Meter
