REMEDIATION CLOSURE REPORT

Incident ID NAPP2212926148

Fighting Okra 18 CTB 4

5614 N Lovington Hwy
Hobbs, NM 88240
575-964-7740NMOCD District 1
1625 N. French Drive
Hobbs, NM 88240Bureau of Land Management
620 E Green St.
Carlsbad, NM 88220**Re: Site Assessment, Remediation, and Closure Report**
Fighting Okra 18 CTB 4
Facility ID: fAPP2123136022
GPS: Latitude 32.0424622 Longitude -103.5095972
UL - D, Section 18, T26S, R34E
Lea County, NM
NMOCD Ref. No. NAPP2212926148

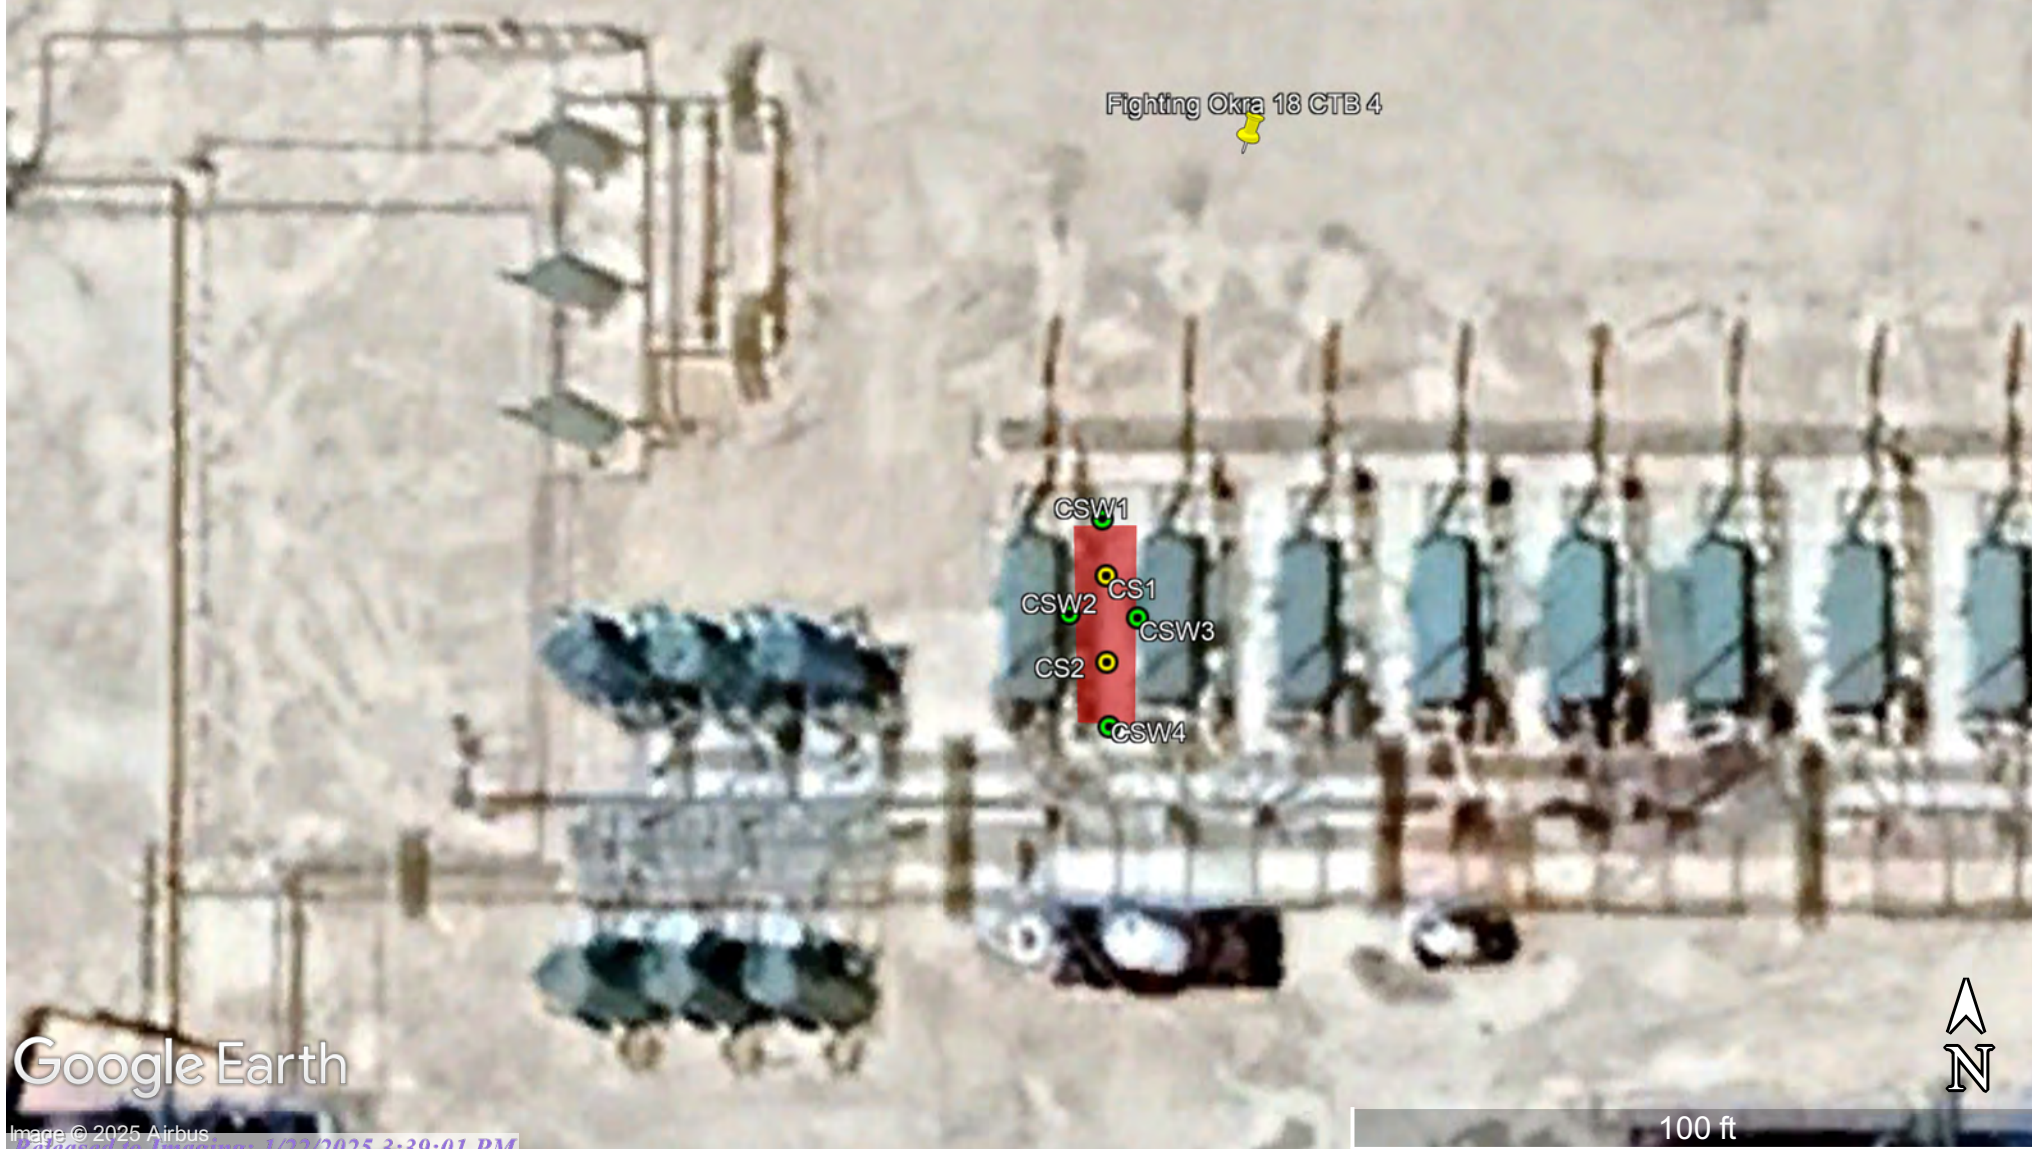
Figure 5- Confirmation Sample Map

On January 8th, 2025, after sending a 48-hour notification (application ID: 417410, Appendix C), Pima returned to the site to collect confirmation samples from the designated assessment area, including perimeter samples. The composite samples were collected from the surface down to a depth of 4 feet using a hand auger. The results of this sampling event are summarized in the table below, and the Confirmation Sample Map is included in Figure 5.

Based on the sample results, the bottoms and sidewalls were below NMOCD Closure Criteria 19.15.29 NMAC.

- Confirmation Samples
- Fighting Okra 18 CTB 4
- Release Area- 249 Sqft
- Confirmation Sidewall Samples

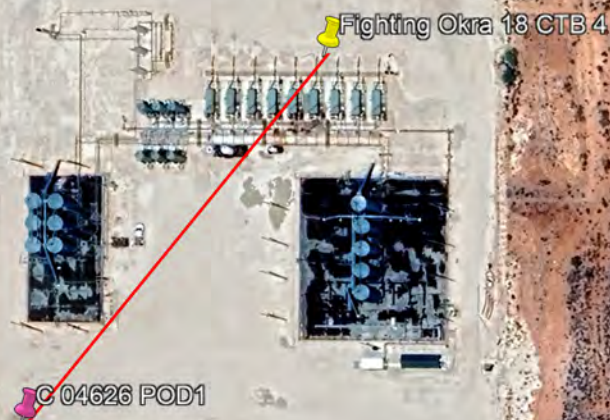
Devon Energy
Facility Id: fAPP2123136022
Lea County, NM
OSE Pod Map
NAPP2212926148

Based on the well water data from the New Mexico Office of the State Engineer water well (C-04626-POD1), the depth to the nearest groundwater in this vicinity measures 55 feet below grade surface (BGS), positioned 0.09 of a mile away from the Fighting Okra. Drilled on June 9, 2022. Conversely, as per the United States Geological Survey well water data (USGS320245103335901 26S.33E.10.334343), the nearest groundwater depth in this region is recorded at 124 feet BGS, situated approximately 3.35 of a mile away from the Fighting Okra, with the last gauge conducted in 2000 (Appendix A).

- 0.09 Miles
- C 04626 POD1
- Fighting Okra 18 CTB 4

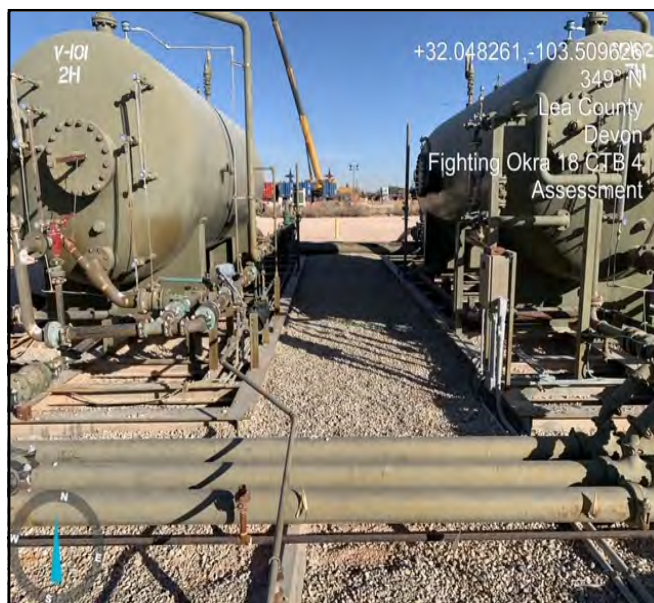
Photograph taken during assessment facing North.

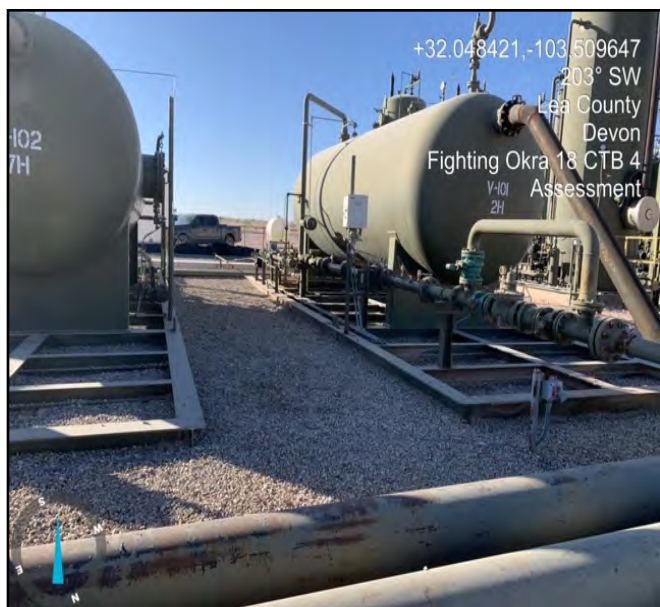
Photograph taken during assessment facing Southwest.

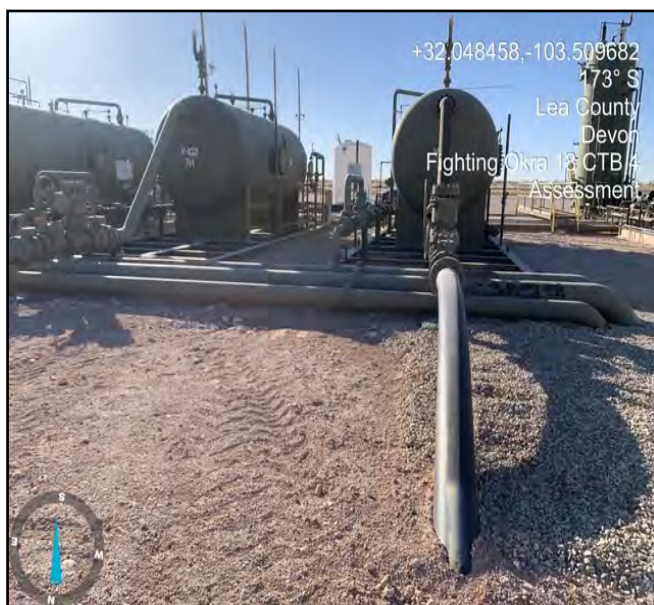
Photograph taken during assessment facing South.

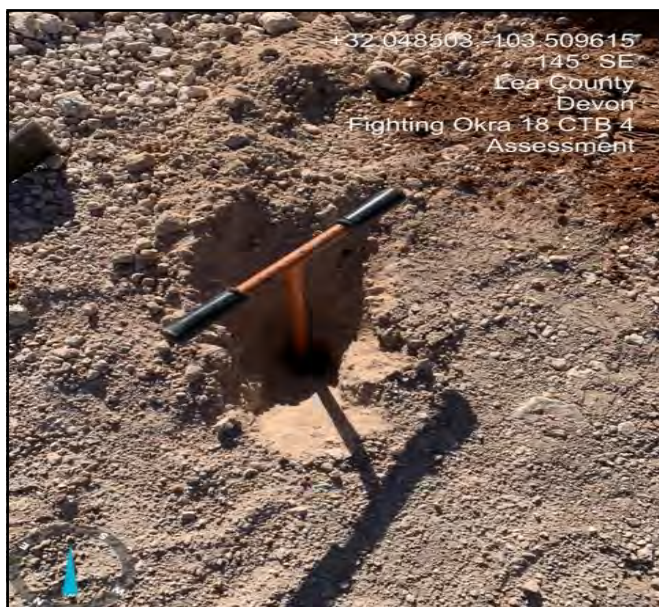
Photograph taken during assessment facing Southeast.

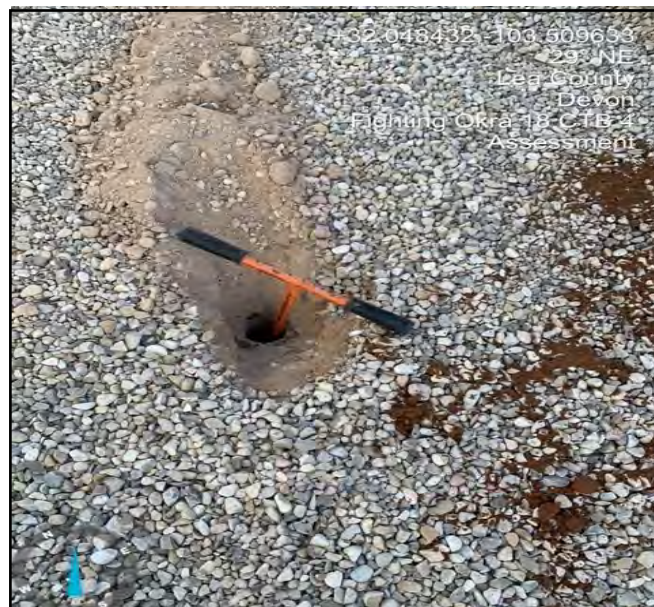
Photograph taken during assessment facing Northeast.

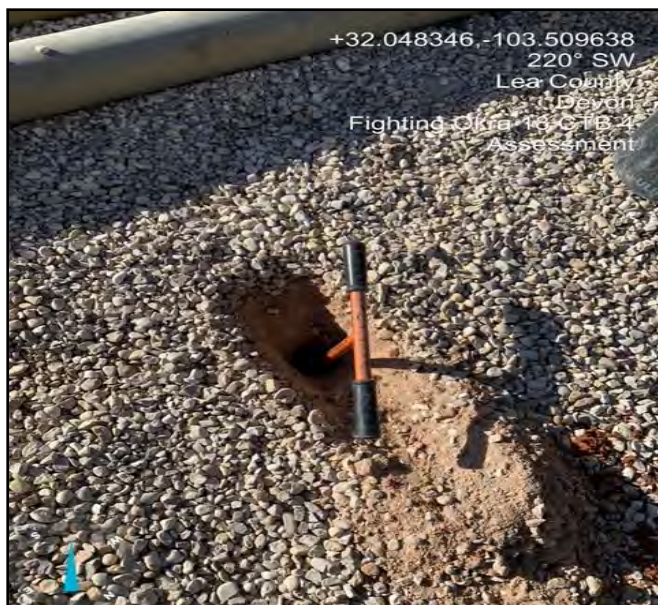
Photograph taken during assessment facing Southwest.
