Closure Report
Abe Unit #002
Incident ID: NAPP2427521789
Unit H Sec 29 T21S R33E
32.4525604°, -103.5881958°
Lea County, New Mexico

Produced Water Release

Re: Closure Report Abe Unit #002

4.0 Liner Inspection Activities

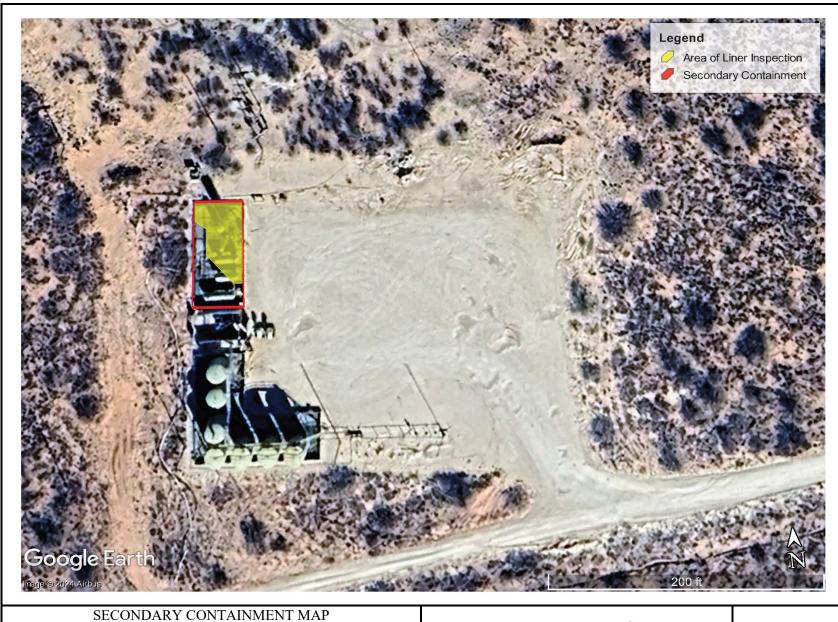
FIGURE 3

Based on the Notice of Release obtained from the New Mexico Oil Conservation Division (NMOCD), the incident was discovered on September 25, 2024, due to a sight glass failure on the water side of the separator inside the secondary containment. The incident released approximately nine-point-two-eight (9.28) barrels of produced water, with nine-point-two-eight (9.28) barrels of produced water recovered. All fluids were contained within the lined facility. See Figure 3. The Notice of Release form is attached in Appendix B.

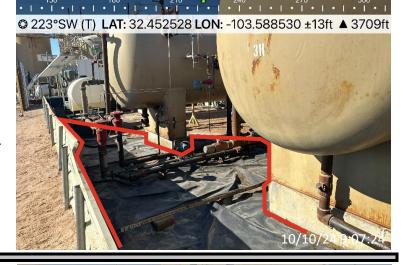
Photograph No. 2

View Southwest of the intact liner after the pea gravel has been removed. Red outline is the area of the liner inspection.

Before performing the liner inspection, a crew was onsite to remove all the impacted pea gravel so the liner would be free of any freestanding fluids. Once the plastic liner was thoroughly cleaned, the NMOCD division was notified via web portal on October 2, 2024, per Subsection D of 19.15.29.12 NMAC. On October 10, 2024, Carmona Resources, LLC conducted liner inspection activities to assess the liner's integrity within the facility and determined the liner was intact with no integrity issues. Refer to the Photolog in Appendix A.

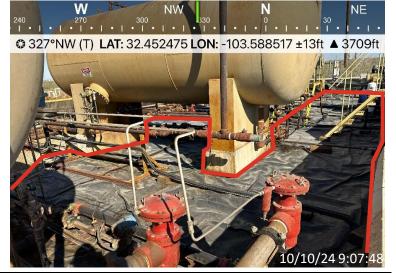
Photograph No. 3

View Northwest of the intact liner after the pea gravel has been removed. Red outline is the area of the liner inspection.

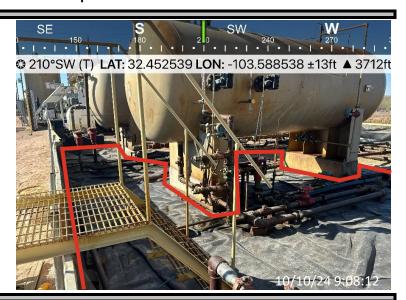
Photograph No. 4

View Southwest of the intact liner after the pea gravel has been removed. Red outline is the area of the liner inspection.

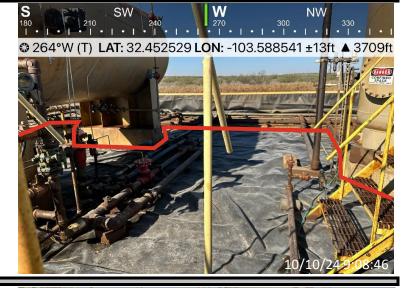
Photograph No. 5

View West of the intact liner after the pea gravel has been removed. Red outline is the area of the liner inspection.

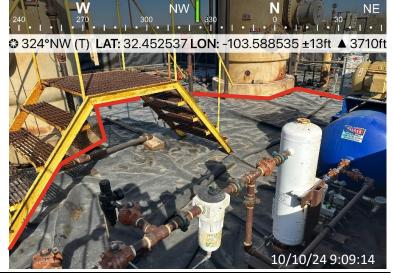
Photograph No. 6

View Northwest of the intact liner after the pea gravel has been removed. Red outline is the area of the liner inspection.

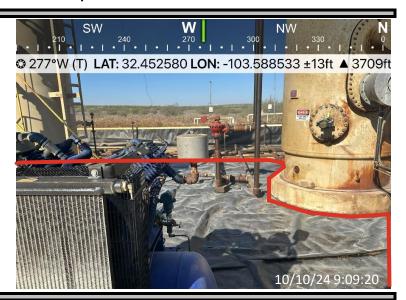
Photograph No. 7

View West of the intact liner after the pea gravel has been removed. Red outline is the area of the liner inspection.

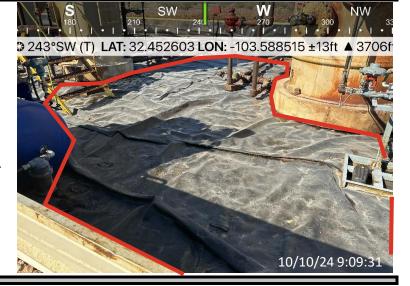
Photograph No. 8

View Southwest of the intact liner after the pea gravel has been removed. Red outline is the area of the liner inspection.

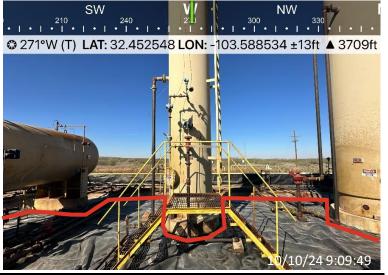
Photograph No. 9

View West of the intact liner after the pea gravel has been removed. Red outline is the area of the liner inspection.

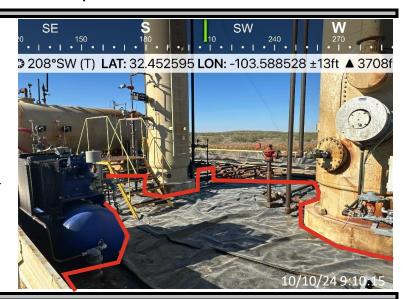
Photograph No. 10

View Southwest of the intact liner after the pea gravel has been removed. Red outline is the area of the liner inspection.

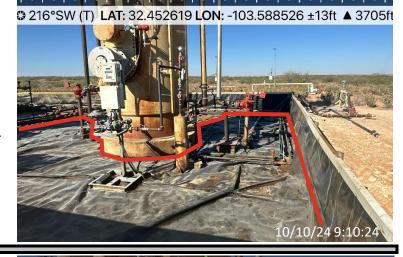
Photograph No. 11

View Southwest of the intact liner after the pea gravel has been removed. Red outline is the area of the liner inspection.

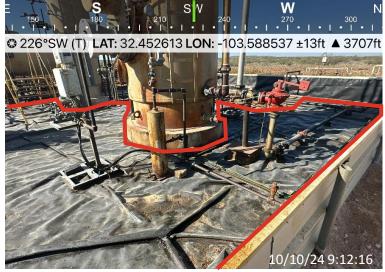
Photograph No. 12

View Southwest of the intact liner after the pea gravel has been removed. Red outline is the area of the liner inspection.

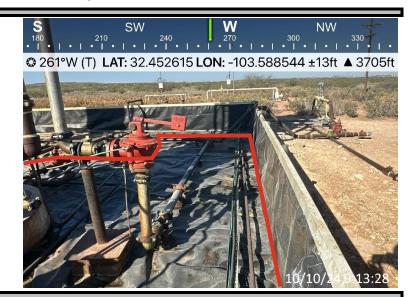
Photograph No. 13

View West of the intact liner after the pea gravel has been removed. Red outline is the area of the liner inspection.

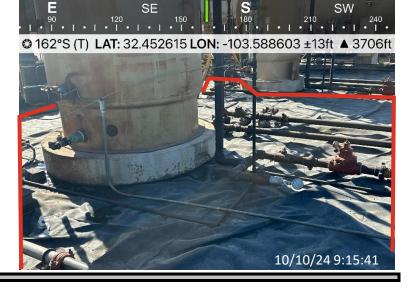
Photograph No. 14

View South of the intact liner after the pea gravel has been removed. Red outline is the area of the liner inspection.
