**Re: Closure Request  
PLU 20 BD West Battery  
Incident Number NAPP2429845171  
Eddy County, New Mexico**

XTO Energy, Inc  
Closure Request  
PLU 20 BD West Battery

**Photographic Log**  
 XTO Energy, Inc.  
 PLU 20 BD West Battery  
 nAPP2429845171

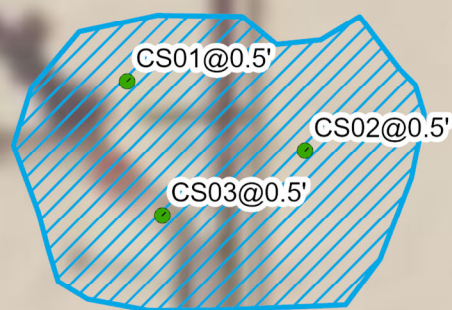
FIGURE  
2

## Confirmation Soil Sample Location

XTO Energy, Inc.  
PLU 20 BD West Battery  
Incident Number: nAPP2429845171  
Unit L, Sec 20, T 25S, R 30E  
Eddy County, New Mexico

On November 12, 2024, Ensolum personnel visited the Site to assess for the presence or absence of impacts to soil based on information provided on the C-141, internal reports, and visual observations. Composite sampling of the ground surface within the scorched area was performed. Three composite confirmation soil samples (CS01 through CS03) were collected at 0.5 feet bgs to assess for the presence or absence of impacted soil. The 5-point composite samples were collected by placing five equivalent aliquots of soil into a 1-gallon, resealable plastic bag and homogenizing the sample by thoroughly mixing. The confirmation soil samples were field screened for volatile organic compounds (VOCs) utilizing a calibrated photoionization detector (PID) and chloride utilizing Hach® chloride QuanTab® test strips. The location of the scorched soil, resulting from the fire, and the confirmation soil samples were mapped utilizing a handheld Global Positioning System (GPS) unit and are depicted on Figure 2. Photographic documentation was completed during the Site visit and a photographic log is included in Appendix B. The scorched soil was removed with hand shovels.

Laboratory analytical results for confirmation soil samples CS01 through CS03 indicated that all COC concentrations were compliant with the Site Closure Criteria. Laboratory analytical results are summarized in Table 1 and the complete laboratory analytical reports are included in Appendix C.

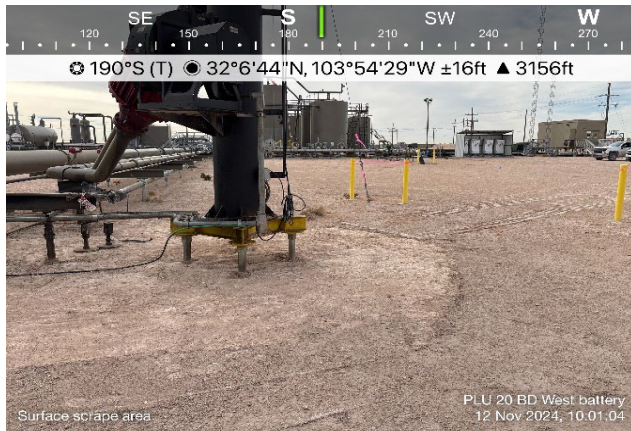
Photograph: 1 Date: 11/12/2024  
 Description: Surface scrape activities  
 View: South

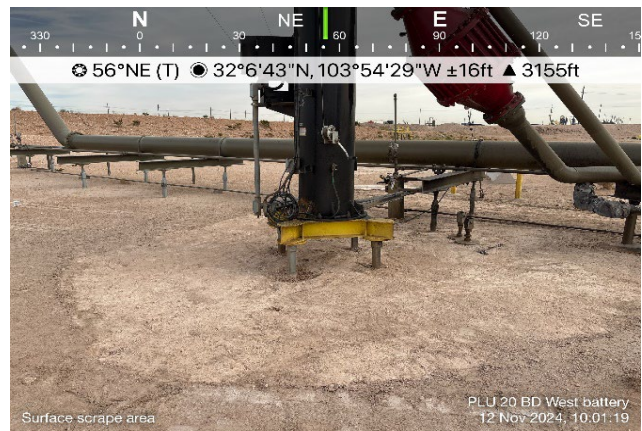
Photograph: 2 Date: 11/12/2024  
 Description: Surface scrape activities  
 View: Northeast

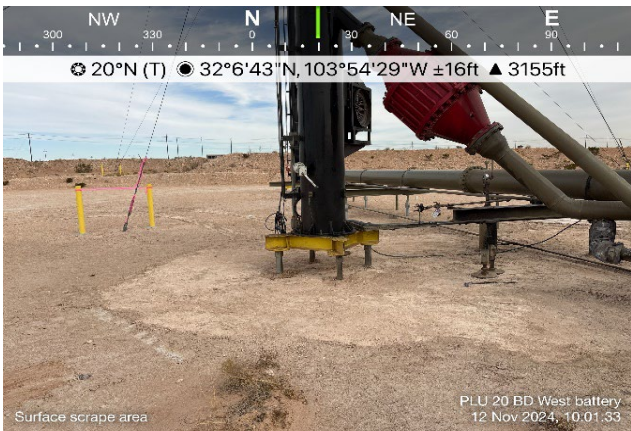
Photograph: 3 Date: 11/12/2024  
 Description: Surface scrape activities  
 View: North

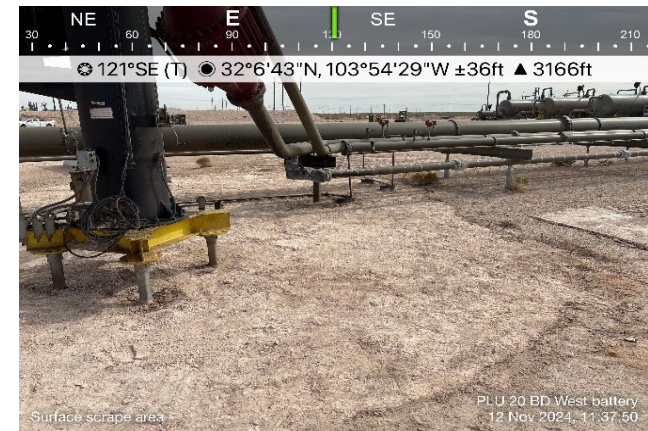
Photograph: 4 Date: 11/12/2024  
 Description: Surface scrape activities  
 View: Southeast
