Environmental Site Remediation Work Plan

NMOCD District:	District 2	Incident ID:	nAPP2500254282
Landowner:	Federal	Facility:	fAPP2207332396
Client:	XTO Energy, Inc.	Site Location:	Brushy Draw 30-31 Federal Battery
Date:	January XX, 2025	Project #:	25E-00017
Client Contact:	Colton Brown	Phone #:	575.988.7329
Vertex PM:	Chad Hensley	Phone #:	575.200.6167

ATTACHMENT 1

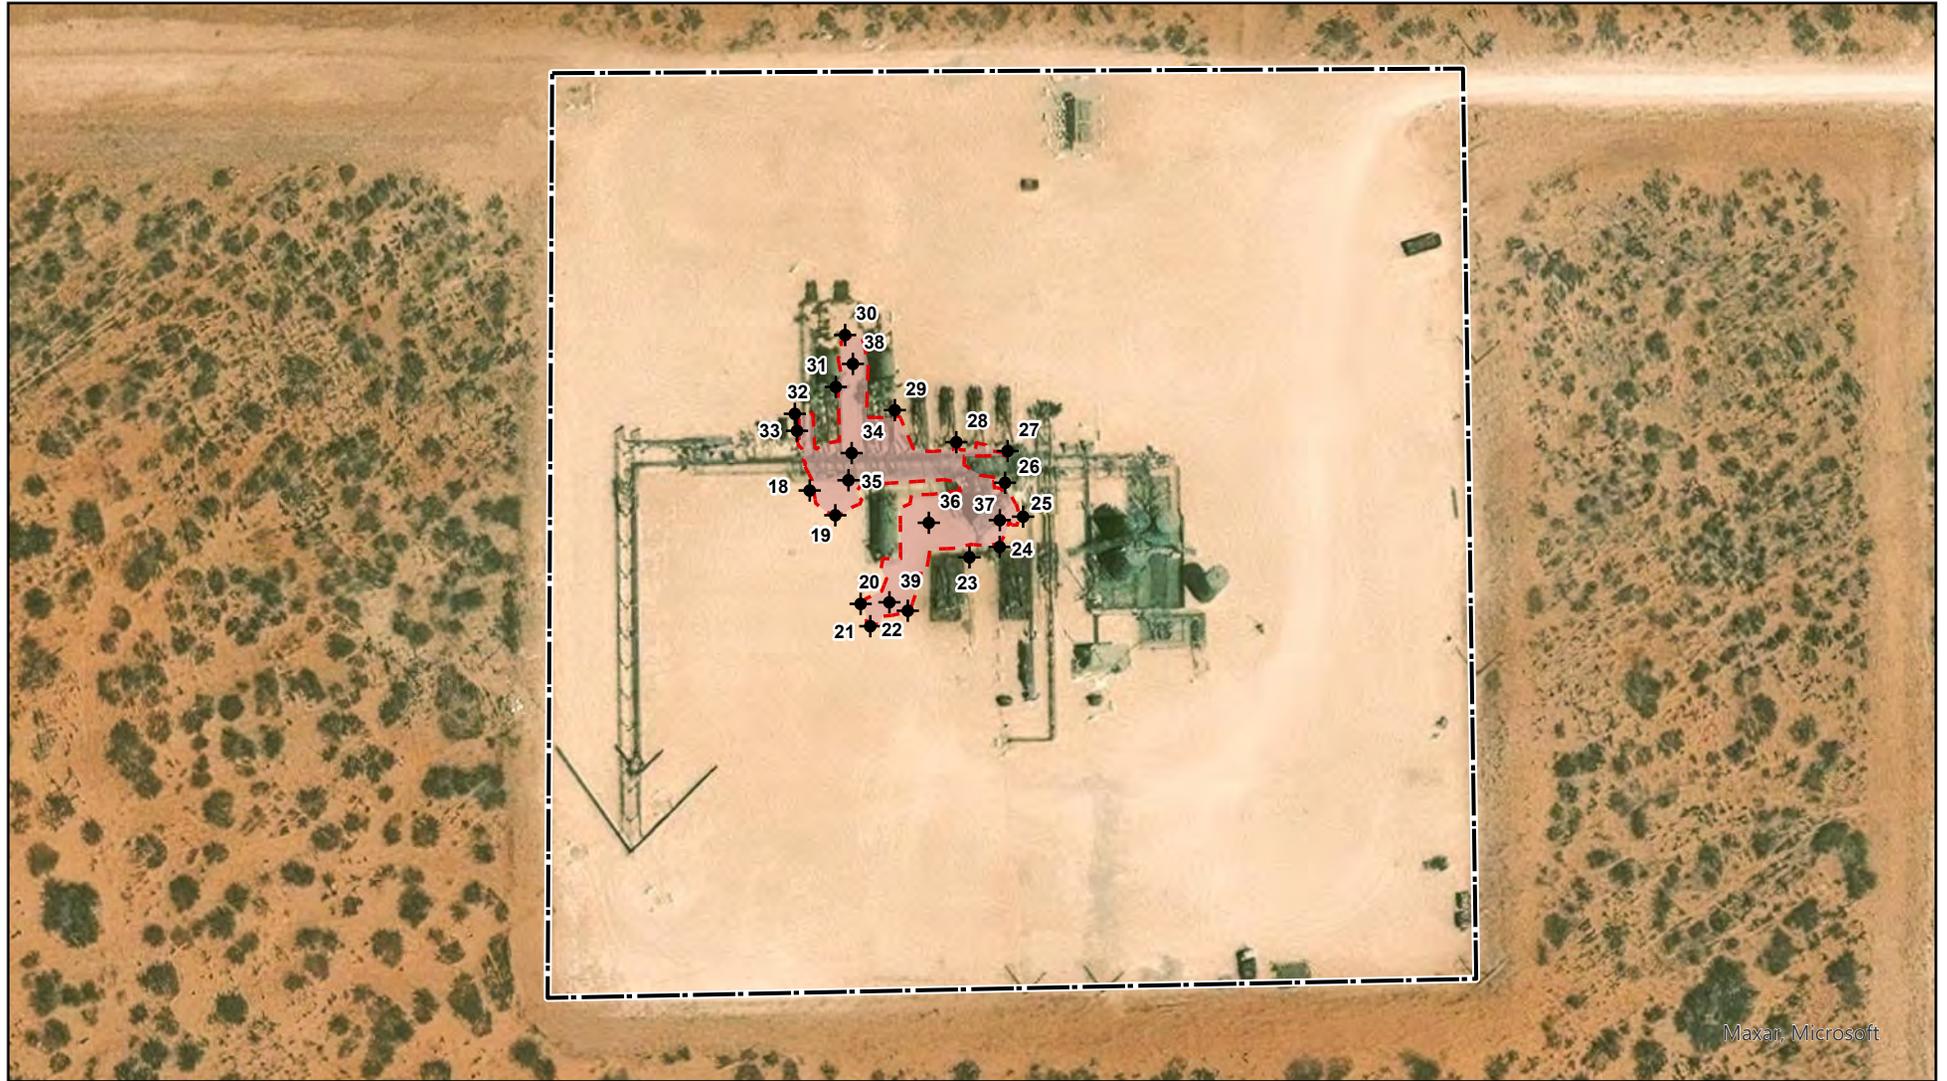
◆ Borehole (Prefixed by "BH25-")
 [Red dashed line] Release Area (~8,971 sq.ft. | 865 ft.)
 [Black dashed line] Approximate Lease Boundary

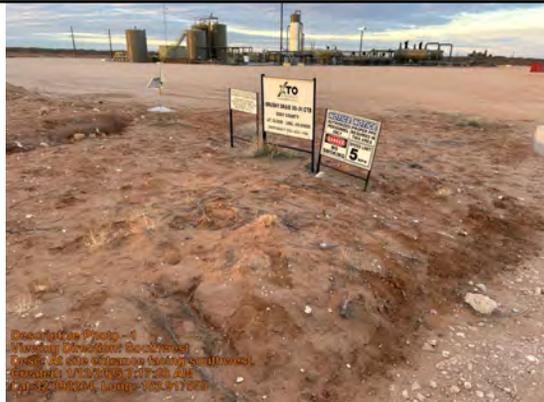
Viewing Direction: Southwest

At site entrance facing southwest.

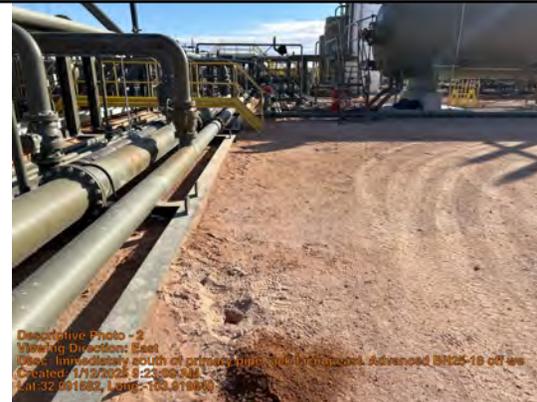
Viewing Direction: East

Immediately south of primary pipe rack facing east. Advanced BH25-18 off west edge of visible release area.

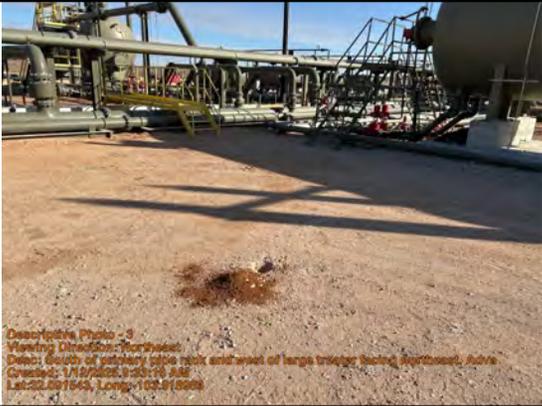
Descriptive Photo - 3
Viewing Direction: Northeast
Desc: South of primary pipe rack and west of large treater facing northeast. Advce
Created: 1/12/2025 9:53:10 AM
Lat:32.091843, Long: -103.918998

South of primary pipe rack and west of large treater facing northeast. Advanced BH25-19 off edge of visible release area.

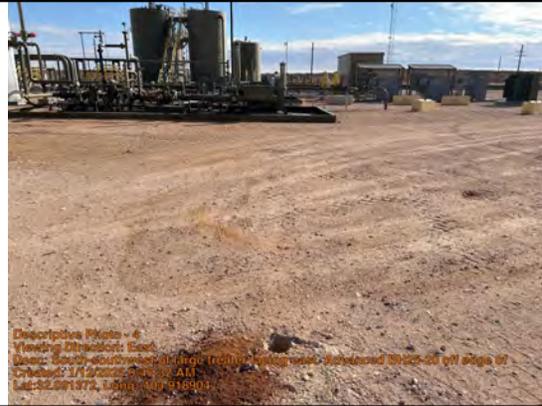
Descriptive Photo - 4
Viewing Direction: East
Desc: South-southwest of large treater facing east. Advanced BH25-20 off edge of
Created: 1/12/2025 9:53:10 AM
Lat:32.091872, Long: -103.918998

South-southwest of large treater facing east. Advanced BH25-20 off edge of visible release area.

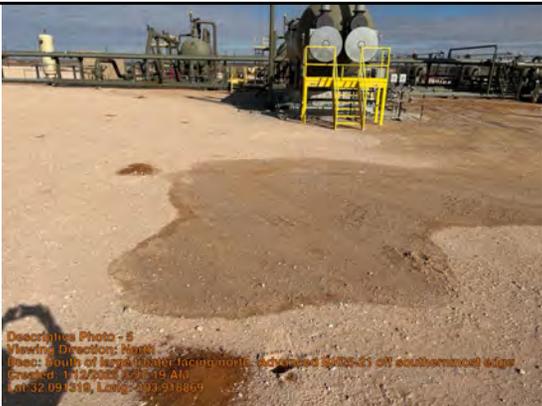
Descriptive Photo - 5
Viewing Direction: North
Desc: South of large treater facing north. Advanced BH25-21 off southernmost edge
Created: 1/12/2025 10:07:35 AM
Lat:32.091316, Long: -103.918669

South of large treater facing north. Advanced BH25-21 off southernmost edge of visible release area.

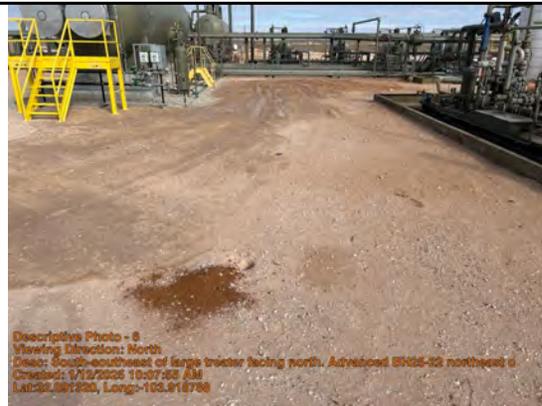
Descriptive Photo - 6
Viewing Direction: North
Desc: South-southeast of large treater facing north. Advanced BH25-22 northeast of
Created: 1/12/2025 10:07:35 AM
Lat:32.091220, Long: -103.918758

South-southeast of large treater facing north. Advanced BH25-22 northeast of BH25-21 off edge of visible release area.

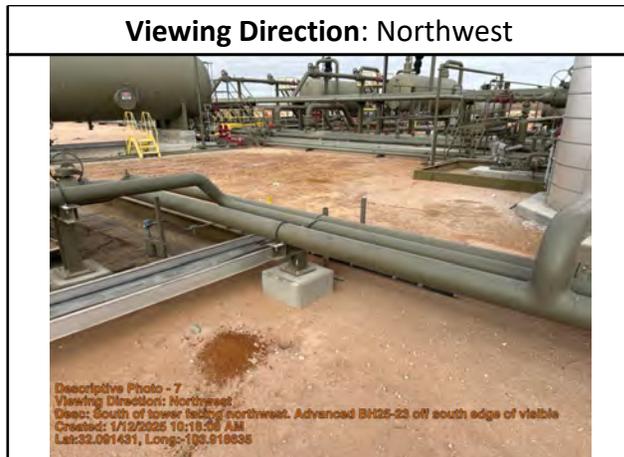
South of tower facing northwest. Advanced BH25-23 off south edge of visible release area.

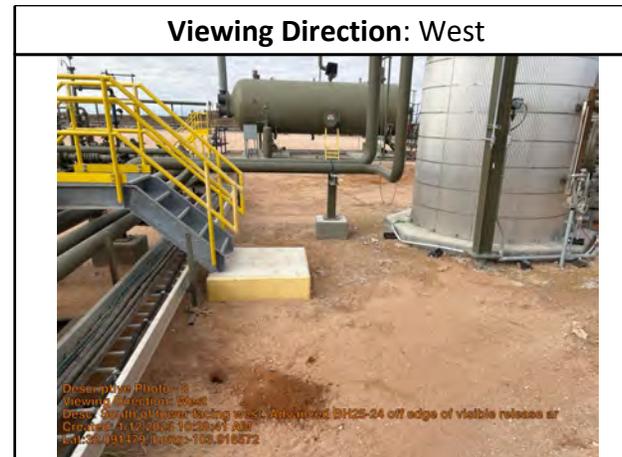
Southeast of tower facing west. Advanced BH25-24 off edge of visible release area.

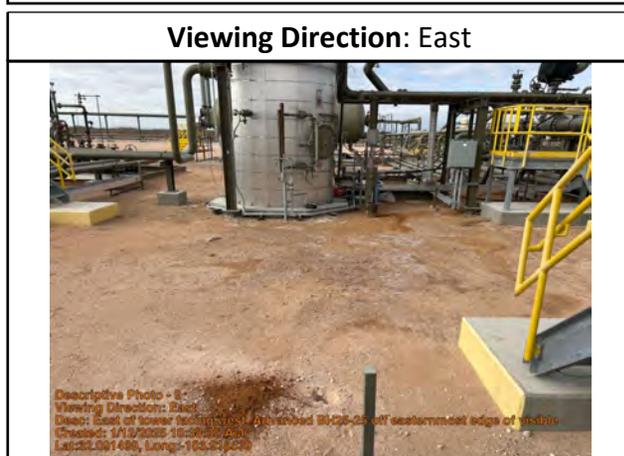
East of tower facing west. Advanced BH25-25 off easternmost edge of visible release area.

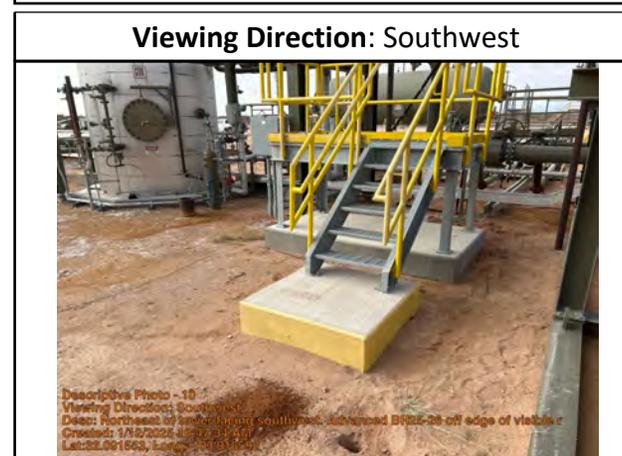
Immediately south of primary pipe rack, northeast of tower facing southwest. Advanced BH25-26 off edge of visible release area.

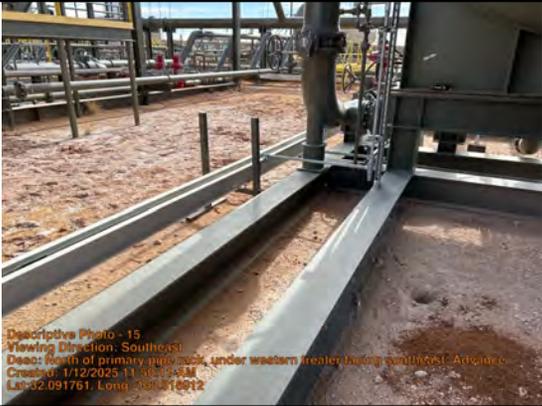
Descriptive Photo - 15
Viewing Direction: Southeast
Desc: North of primary pipe rack, under western treater facing southeast. Advanced BH25-31 off edge of visible release area.
Created: 1/12/2025 11:50:13 AM
Lat:32.091761, Long:-103.016012

North of primary pipe rack, under western treater facing southeast. Advanced BH25-31 off edge of visible release area.

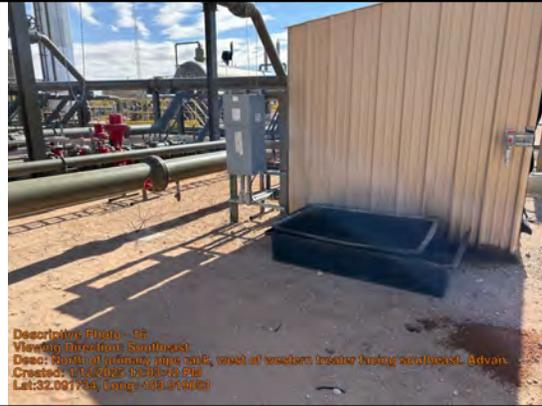
Descriptive Photo - 16
Viewing Direction: Southeast
Desc: North of primary pipe rack, west of western treater facing southeast. Advanced BH25-32 off west edge of visible release area.
Created: 1/12/2025 12:00:00 PM
Lat:32.091764, Long:-103.016005

North of primary pipe rack, west of western treater facing southeast. Advanced BH25-32 off west edge of visible release area.

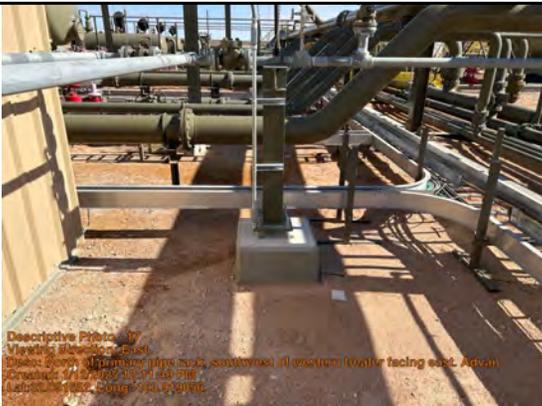
Descriptive Photo - 17
Viewing Direction: East
Desc: North of primary pipe rack, southwest of western treater facing east. Advanced BH25-33 off west edge of visible release area.
Created: 1/12/2025 12:14:40 PM
Lat:32.091882, Long:-103.016004

North of primary pipe rack, southwest of western treater facing east. Advanced BH25-33 off west edge of visible release area.

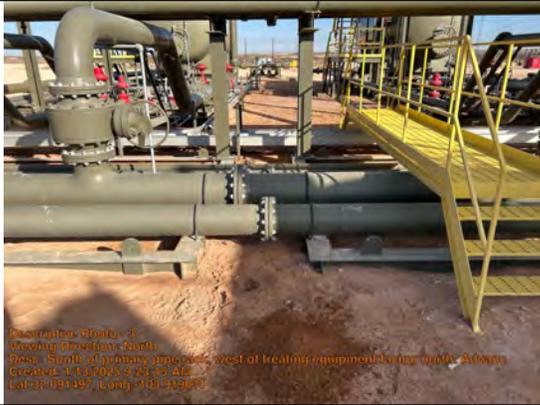
Descriptive Photo - 5
Viewing Direction: North
Desc: South of primary pipe rack, west of treating equipment facing north. Advanced BH25-35 immediately south of primary pipe rack.
Created: 1/13/2025 9:23:13 AM
Lat:31.091497, Long:-103.015559

South of primary pipe rack, west of treating equipment facing north. Advanced BH25-35 immediately south of primary pipe rack.

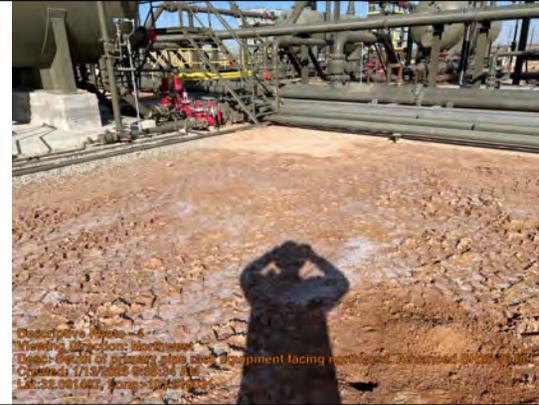
Descriptive Photo - 4
Viewing Direction: Northwest
Desc: South of primary pipe rack facing northwest. Advanced BH25-36 between treating equipment and tower.
Created: 1/13/2025 9:28:34 AM
Lat:31.091497, Long:-103.015559

South of primary pipe rack facing northwest. Advanced BH25-36 between treating equipment and tower.

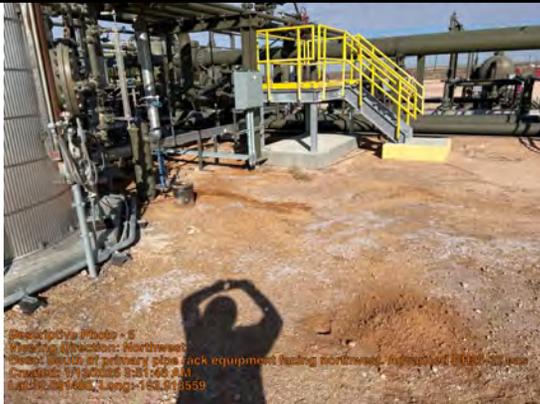
Descriptive Photo - 5
Viewing Direction: Northwest
Desc: South of primary pipe rack equipment facing southwest. Advanced BH25-37 east of tower.
Created: 1/13/2025 9:31:46 AM
Lat:31.091496, Long:-103.015559

South of primary pipe rack facing northwest. Advanced BH25-37 east of tower.

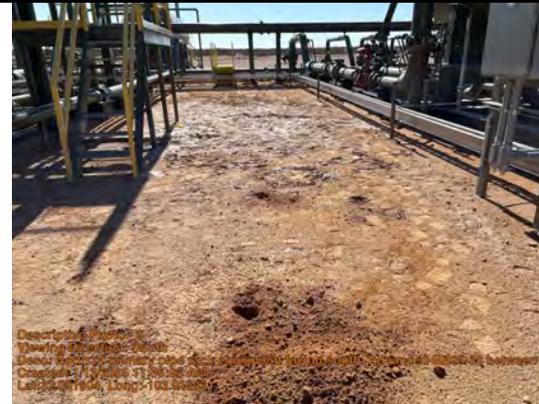
Descriptive Photo - 5
Viewing Direction: South
Desc: North of primary pipe rack facing south. Advanced BH25-38 between treating equipment.
Created: 1/13/2025 9:33:06 AM
Lat:31.091496, Long:-103.015559

North of primary pipe rack facing south. Advanced BH25-38 between treating equipment.

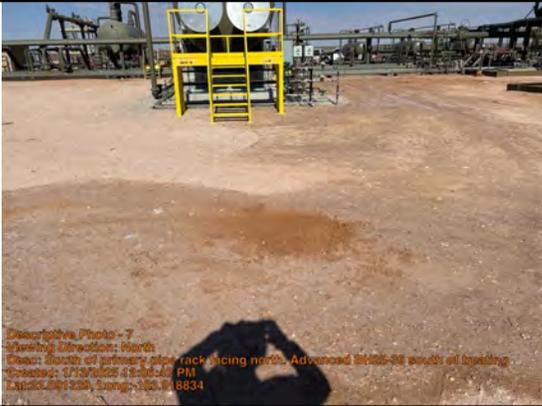
Descriptive Photo - 7
Viewing Direction: North
Elev: South of primary pipe rack facing north. Advanced BH25-39 south of treating equipment.
Created: 1/13/2025 4:26:50 PM
Lat: 29.1326, Long: -103.318834

South of primary pipe rack facing north.
Advanced BH25-39 south of treating equipment.

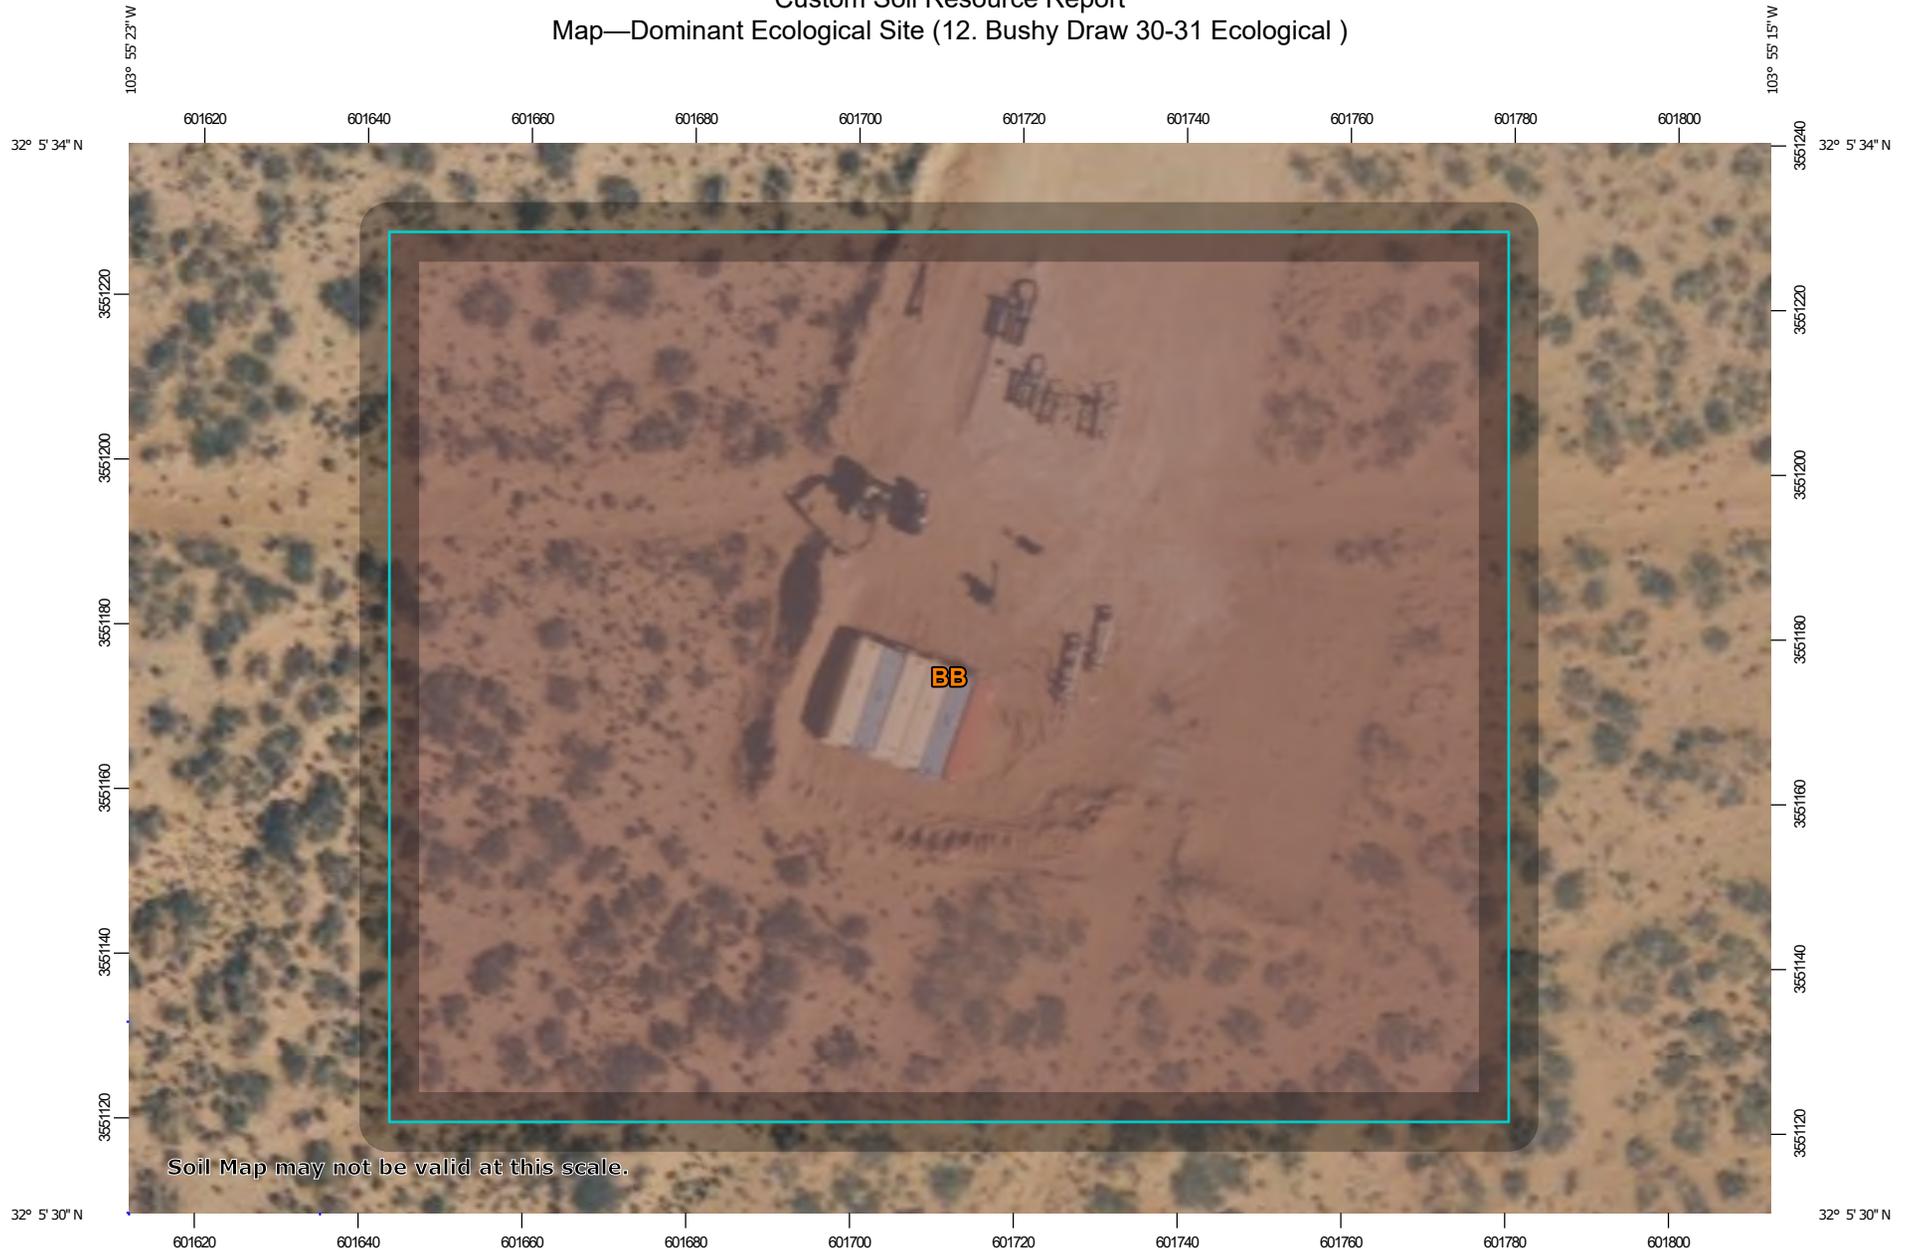
Custom Soil Resource Report Map—Dominant Ecological Site (12. Bushy Draw 30-31 Ecological)

The map identifies the dominant ecological site for each map unit, aggregated by dominant condition. Other ecological sites may occur within each map unit. Each map unit typically consists of one or more components (soils and/or miscellaneous areas). Each soil component is associated with an ecological site. Miscellaneous areas, such as rock outcrop, sand dunes, and badlands, have little or no soil material and support little or no vegetation and therefore are not linked to an ecological site. The table below the map lists all of the ecological sites for each map unit component in your area of interest.
