Re: Site Characterization and Remediation Closure Request  
Devon Energy Production Company  
Blondie 15 CTB 3  
Unit G, Section 15, Township 26S, Range 34E  
Site Coordinates: 32.0461321, -103.4549273  
Lea County, New Mexico  
Incident ID: nAPP2415023984

On behalf of Devon Energy Production Company (Devon), New Tech Global Environmental, LLC (NTGE) has prepared this Site Characterization and Remediation Closure Request for submittal to the New Mexico Oil Conservation Division (NMCOD) District 2 Office in Artesia, New Mexico to document site assessment, remedial action activities, and sample analysis results for release number: nAPP2415023984 – Blondie 15 CTB 3 (Site). The Site is in Unit Letter G, Section 26, of Township 15 South and Range 34 East in Lea County, New Mexico. The GPS coordinates for the release site are 32.0461321° N latitude and 103.4549273° W longitude. The site location with respect to the nearest town is shown on Figure 1 and the topography of the area is shown on Figure 2.

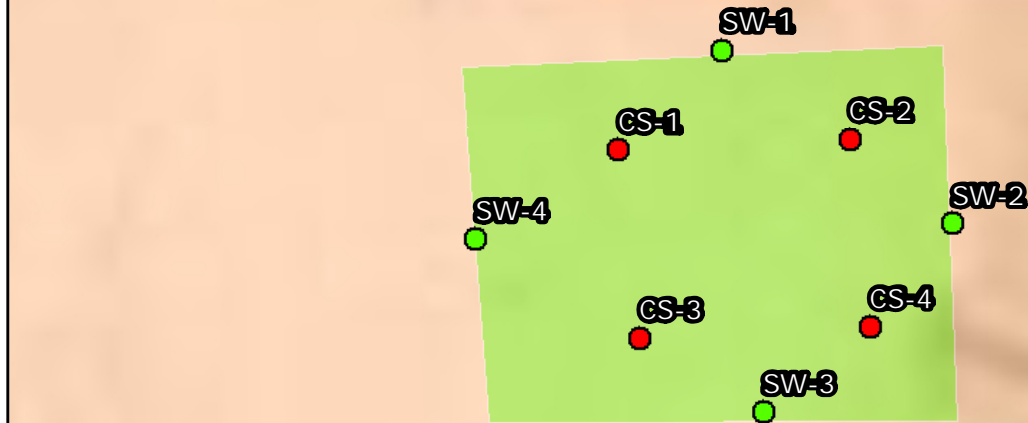
- Base Confirmation Sample Point
- Sidewall Confirmation Sample Point
- 1ft Excavation

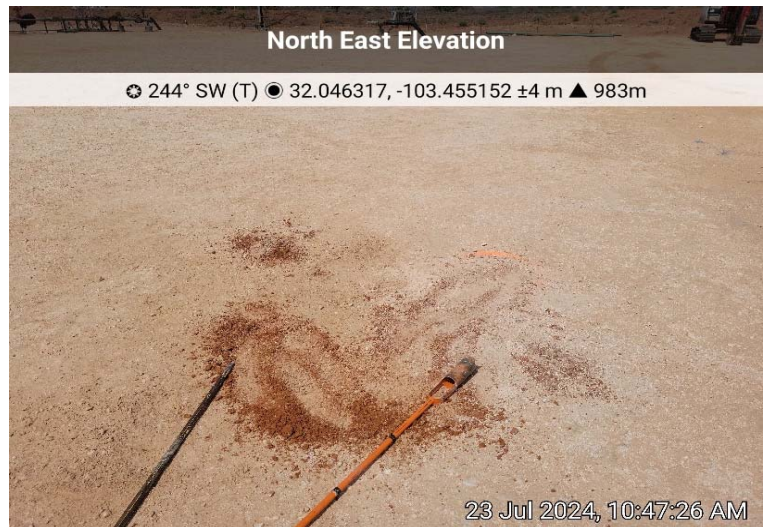
**Description:**  
Area of Concern

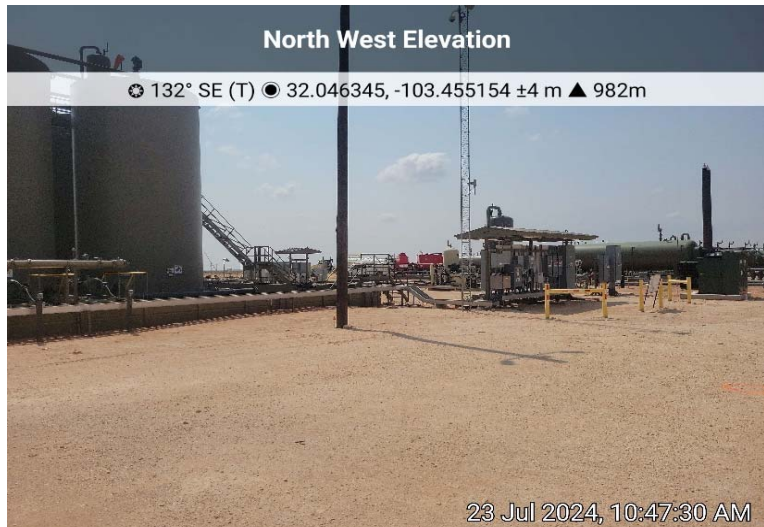
**Photograph No. 2**

**Description:**  
Area of Concern

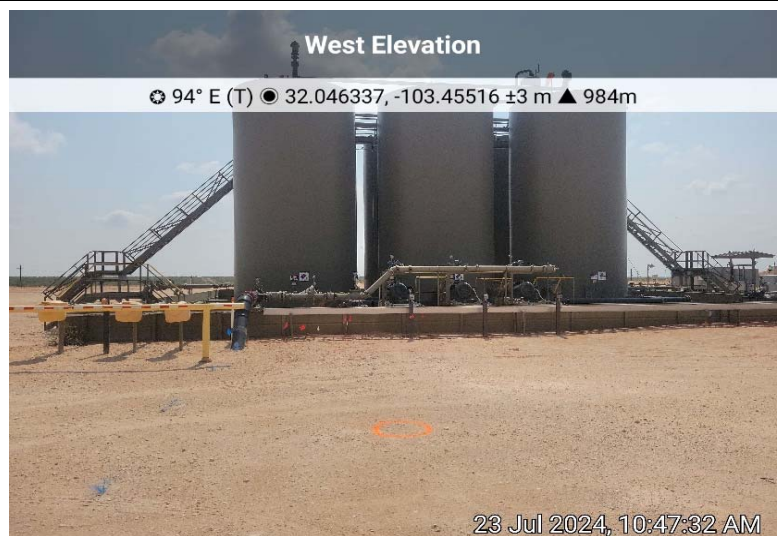
**Photograph No. 3**

**Description:**  
Area of Concern

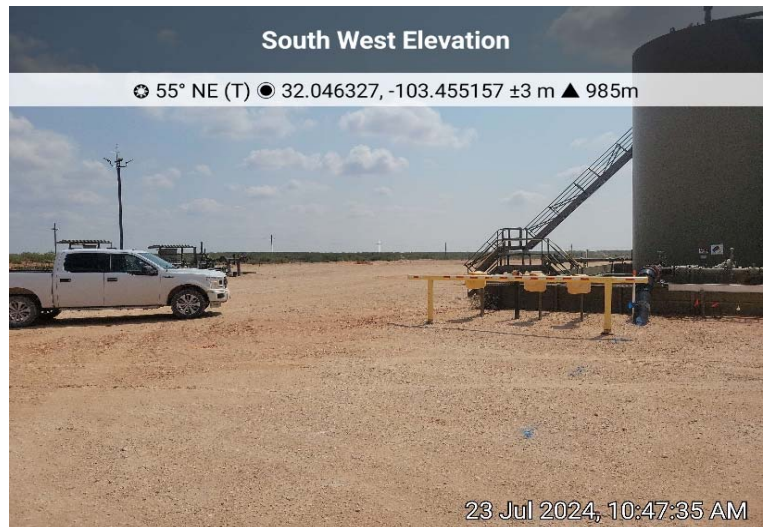
**Photograph No. 4**

**Description:**  
Area of Concern

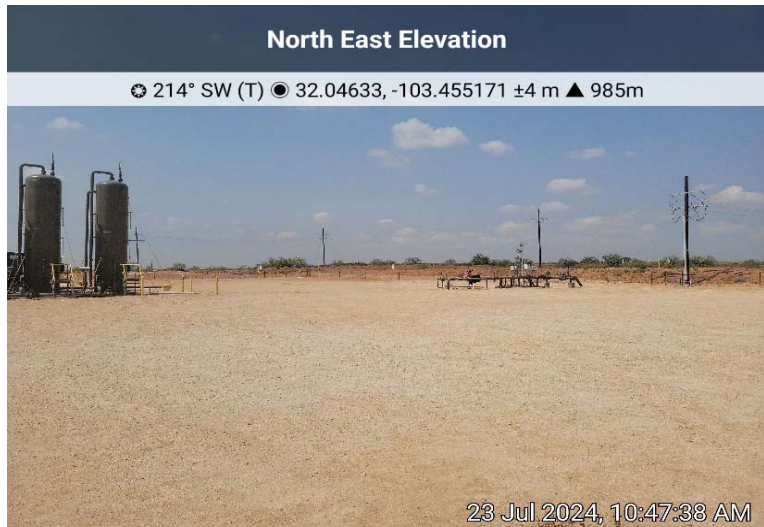
**Photograph No. 5**

**Description:**  
Area of Concern

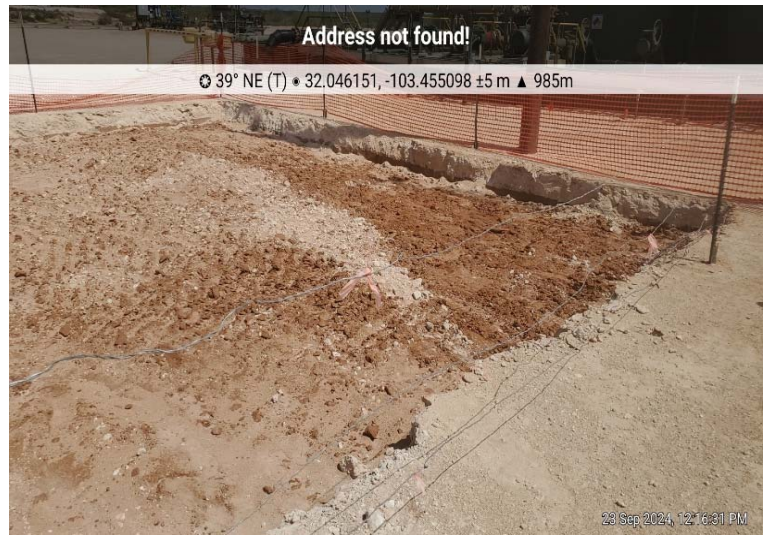
**Photograph No. 7**

**Description:**  
View of Excavation
