Team Operating – Remediation Closure Report

LMPSU Battery #2 Injection Line

Incident ID: nAPP2427552444 NMSLO

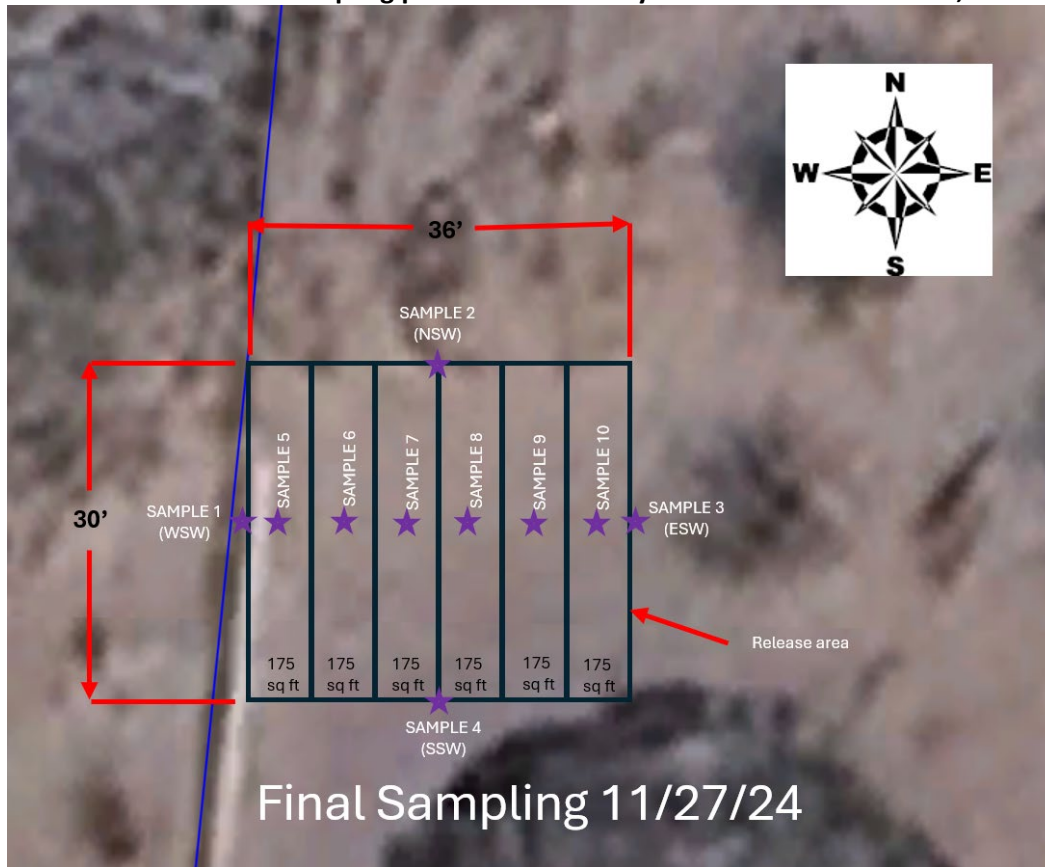
FIGURE 4: Diagrams of excavation and sampling points and summary table with nomenclature, and excavation photo:

All contaminated soil was removed, leaving an excavation with sidewalls of the following lengths: 36' (north wall) by 27' (east wall) by 36.5' (south wall) by 31' (west wall), for a total square footage of 1,085 sq ft.

A total of six (6) composite confirmation samples were taken from the excavation base (1,085 sq ft), and four (4) composite confirmation samples were taken from the excavation sidewalls (132 x 4.5 ft).

Confirmation soil samples were collected on 11/27/2024 and analyzed prior to backfilling. Confirmation 5- point composite samples were collected from the base and sidewalls of the remediation area in segments representative of no more than 200 square feet. Samples were submitted to a certified laboratory for analysis of benzene, toluene, ethylbenzene, and xylenes (BTEX), total petroleum hydrocarbons (TPH), and chlorides.

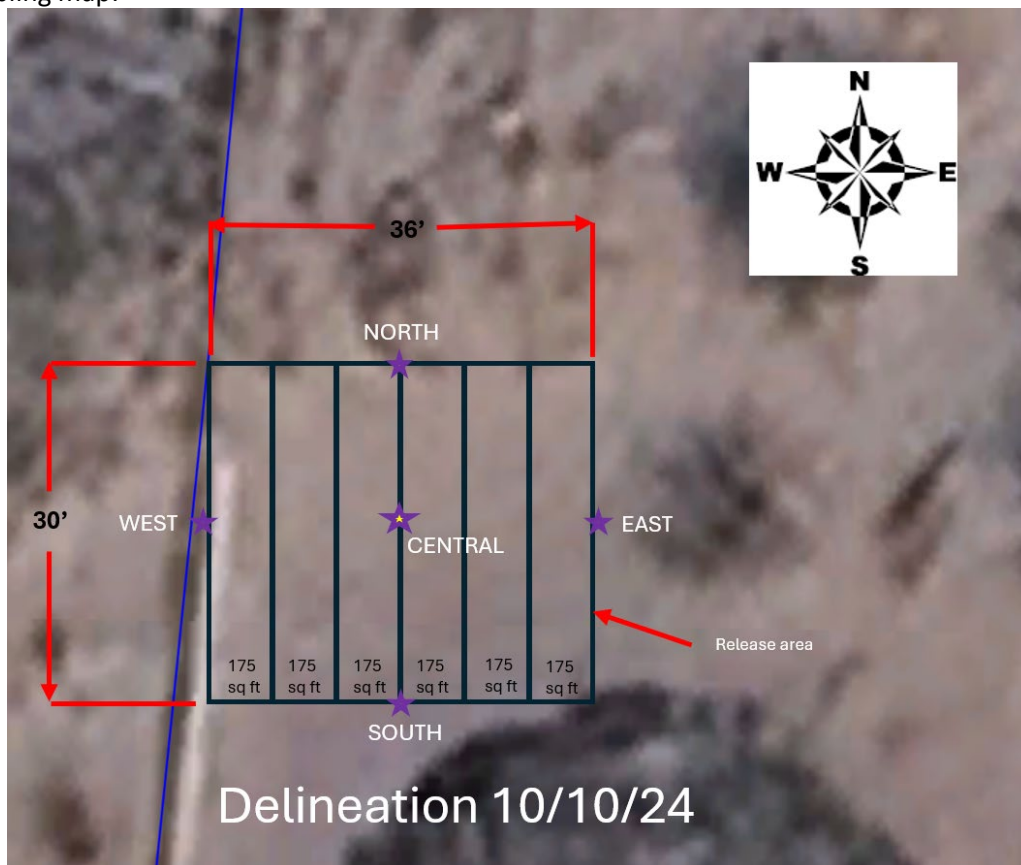
Delineation sampling map:

Delineation samples were taken on 10/10/2024 and are compiled in sample table along with final sample results. Delineation samples shows that the release area was properly delineated in all cardinal directions, and that higher chlorides found at deeper depths on sidewalls are due to background concentrations, and fall below the 10,000 mg/kg threshold.

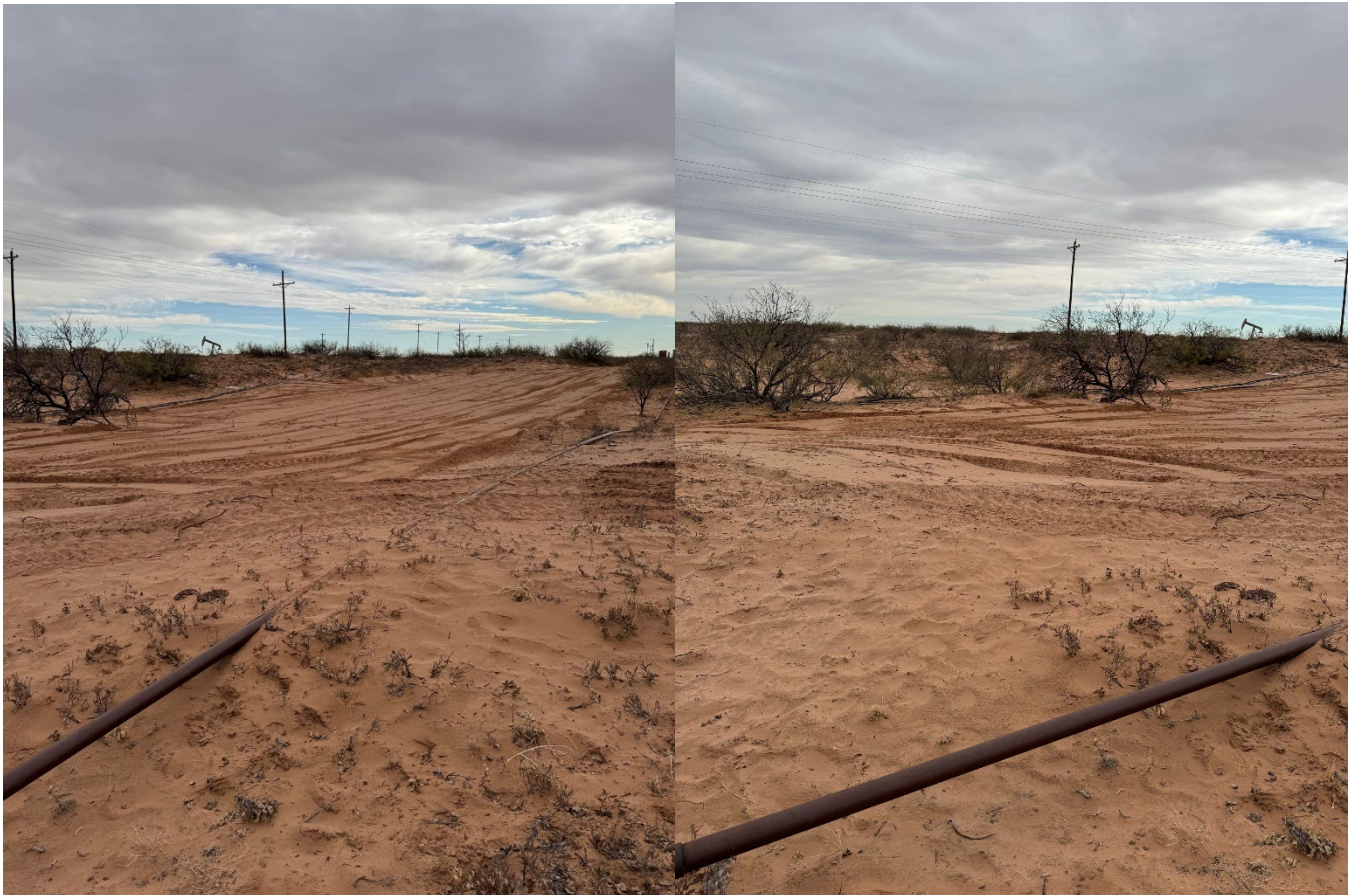
Figure 5: Post-closure photos

The areas that were subject to reclamation are the excavation area, lacking vegetation. After remediation the topsoil will be cross ripped to a minimum of eighteen (18) inches with a furrow spacing of two (2) feet. Site preparation will include ripping and tilling. The ripped areas will be re-contoured for initial seedbed preparation. The original landform will be restored, as near as possible, for all un-vegetated and/or disturbed areas from remedial action activities. Preparation of the seed bed will follow best practices. A certified weed-free seed mix designed by the NMSLO to meet reclamation standards will be used. Based on the soil complex (Pyote and Maljamar fine sands, Simona fine sandy loam, 0 to 3 percent slopes, and Wink fine sand) within and surrounding the Site, The NMSLO Seed Mixture Sandy (S) will be used for seeding and will be seeded at a rate of 16.0 pounds live seed (PLS) per acre (((Desired Stand in Plants per acre) / (1 - Expected Stand Loss)) / ((Seeds per lb.) x (% Germination))) to achieve a historic climax community. Seed mix species will include:

Based on contractor equipment availability, the seed mixture will be spread either by seed drill box or broadcast method. The seed mix will be purchased from a New Mexico Department of Agriculture (NMDA) licensed dealer. Following seeding operations, the seed tags will be made available to the NMSLO, along with a copy of the materials certification in a Reclamation Activities Report. Revegetation efforts will be completed in the first favorable growing season.

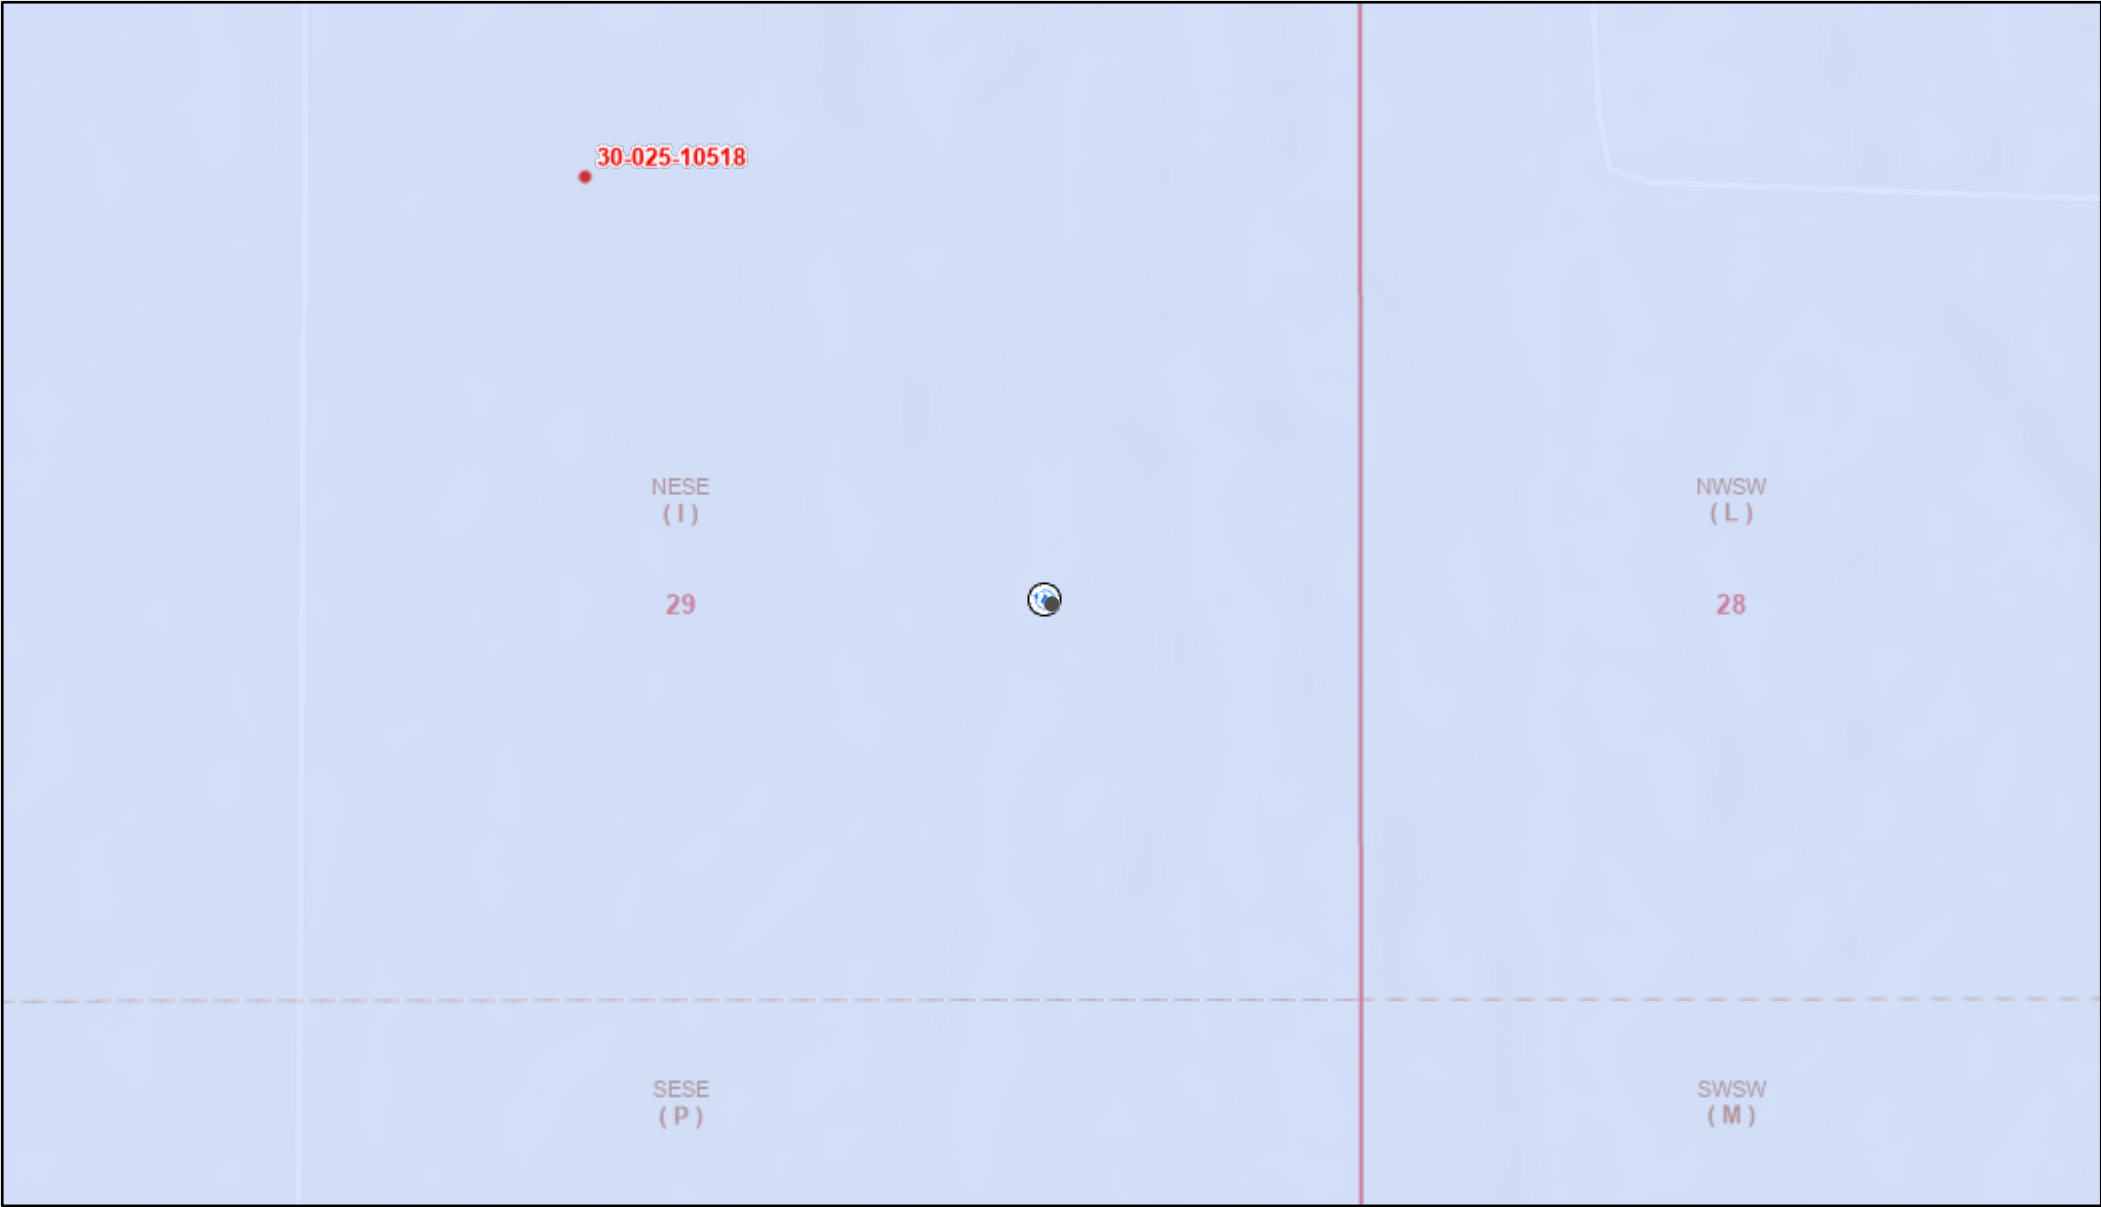
Karst Potential Map

Site Characterization	Average Groundwater Depth (ft)
Low Karst	60 ft
