**Re: Closure Request
PLU 20 BD West Battery
Incident Number nAPP2432726566
Eddy County, New Mexico**

Ensolum, LLC (Ensolum), on behalf of XTO Energy, Inc. (XTO), has prepared this *Closure Request* to document assessment, delineation, and soil sampling activities at the PLU 20 BD West Battery (Site). The purpose of the assessment and soil sampling activities was to assess for the presence or absence of impacts to soil following a produced water release onto the pad surface. Based on field observations, field screening activities, and soil sample laboratory analytical results, XTO is submitting this *Closure Request*, describing assessment and delineation activities that have occurred and requesting no further action for Incident Number nAPP2432726566.

Photographic Log
XTO Energy, Inc
PLU 20 BD West Battery
nAPP2432726566

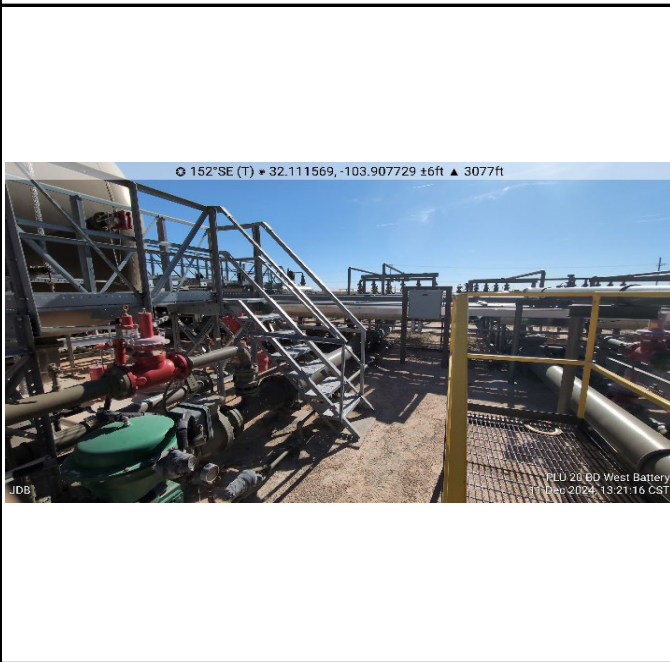
On December 11, 2024, Ensolum personnel visited the Site to evaluate the release extent based on information provided on the C-141 and visual observations. The release extent was mapped utilizing a handheld Global Positioning System (GPS) unit and is depicted on Figure 2. Photographic documentation was collected during the Site assessment and Photographic Log is included in Appendix B.

Photograph: 1 Date: 12/11/2024
Description: Assessment activities
View: Southeast

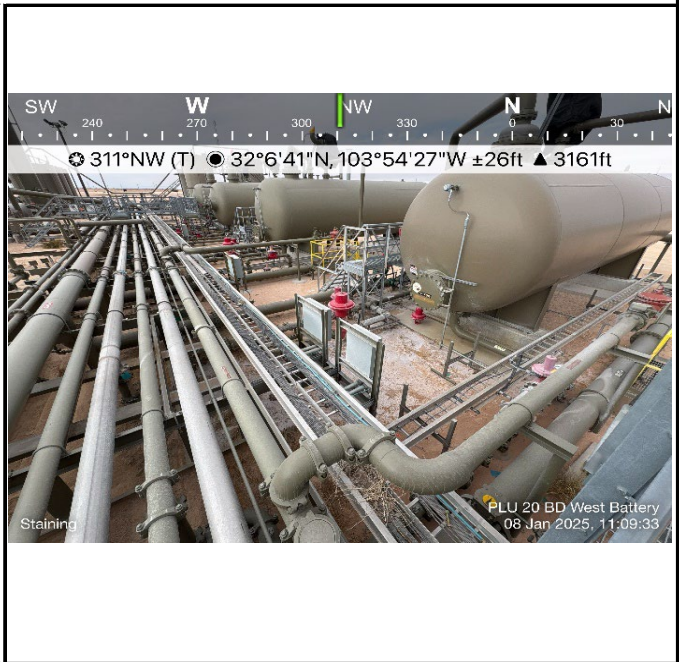
Photograph: 2 Date: 1/8/2025
Description: Delineation activities
View: Northwest

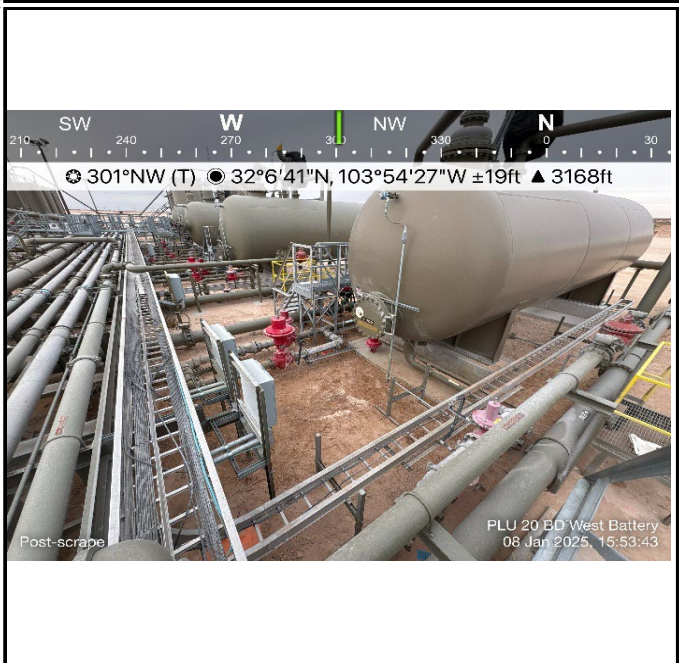
Photograph: 4 Date: 1/8/2025
Description: Surface scraping activities
View: Northwest

Following delineation activities, surface scraping of the release area was completed to the maximum extent practicable (MEP). Due to active production equipment and surface pipelines limiting the use of
