**Re: Liner Inspection and Closure Request
BTA Oil Producers, LLC
Rojo 10-13 CTB Release
Unit Letter A, Section 27, Township 25 South, Range 33 East
Lea County, New Mexico
Incident ID# NAPP2502447040**

Liner Inspection and Closure Request
February 21, 2025

**ROJO 10-13 CTB
APPROXIMATE RELEASE EXTENT AND LINER INSPECTION**

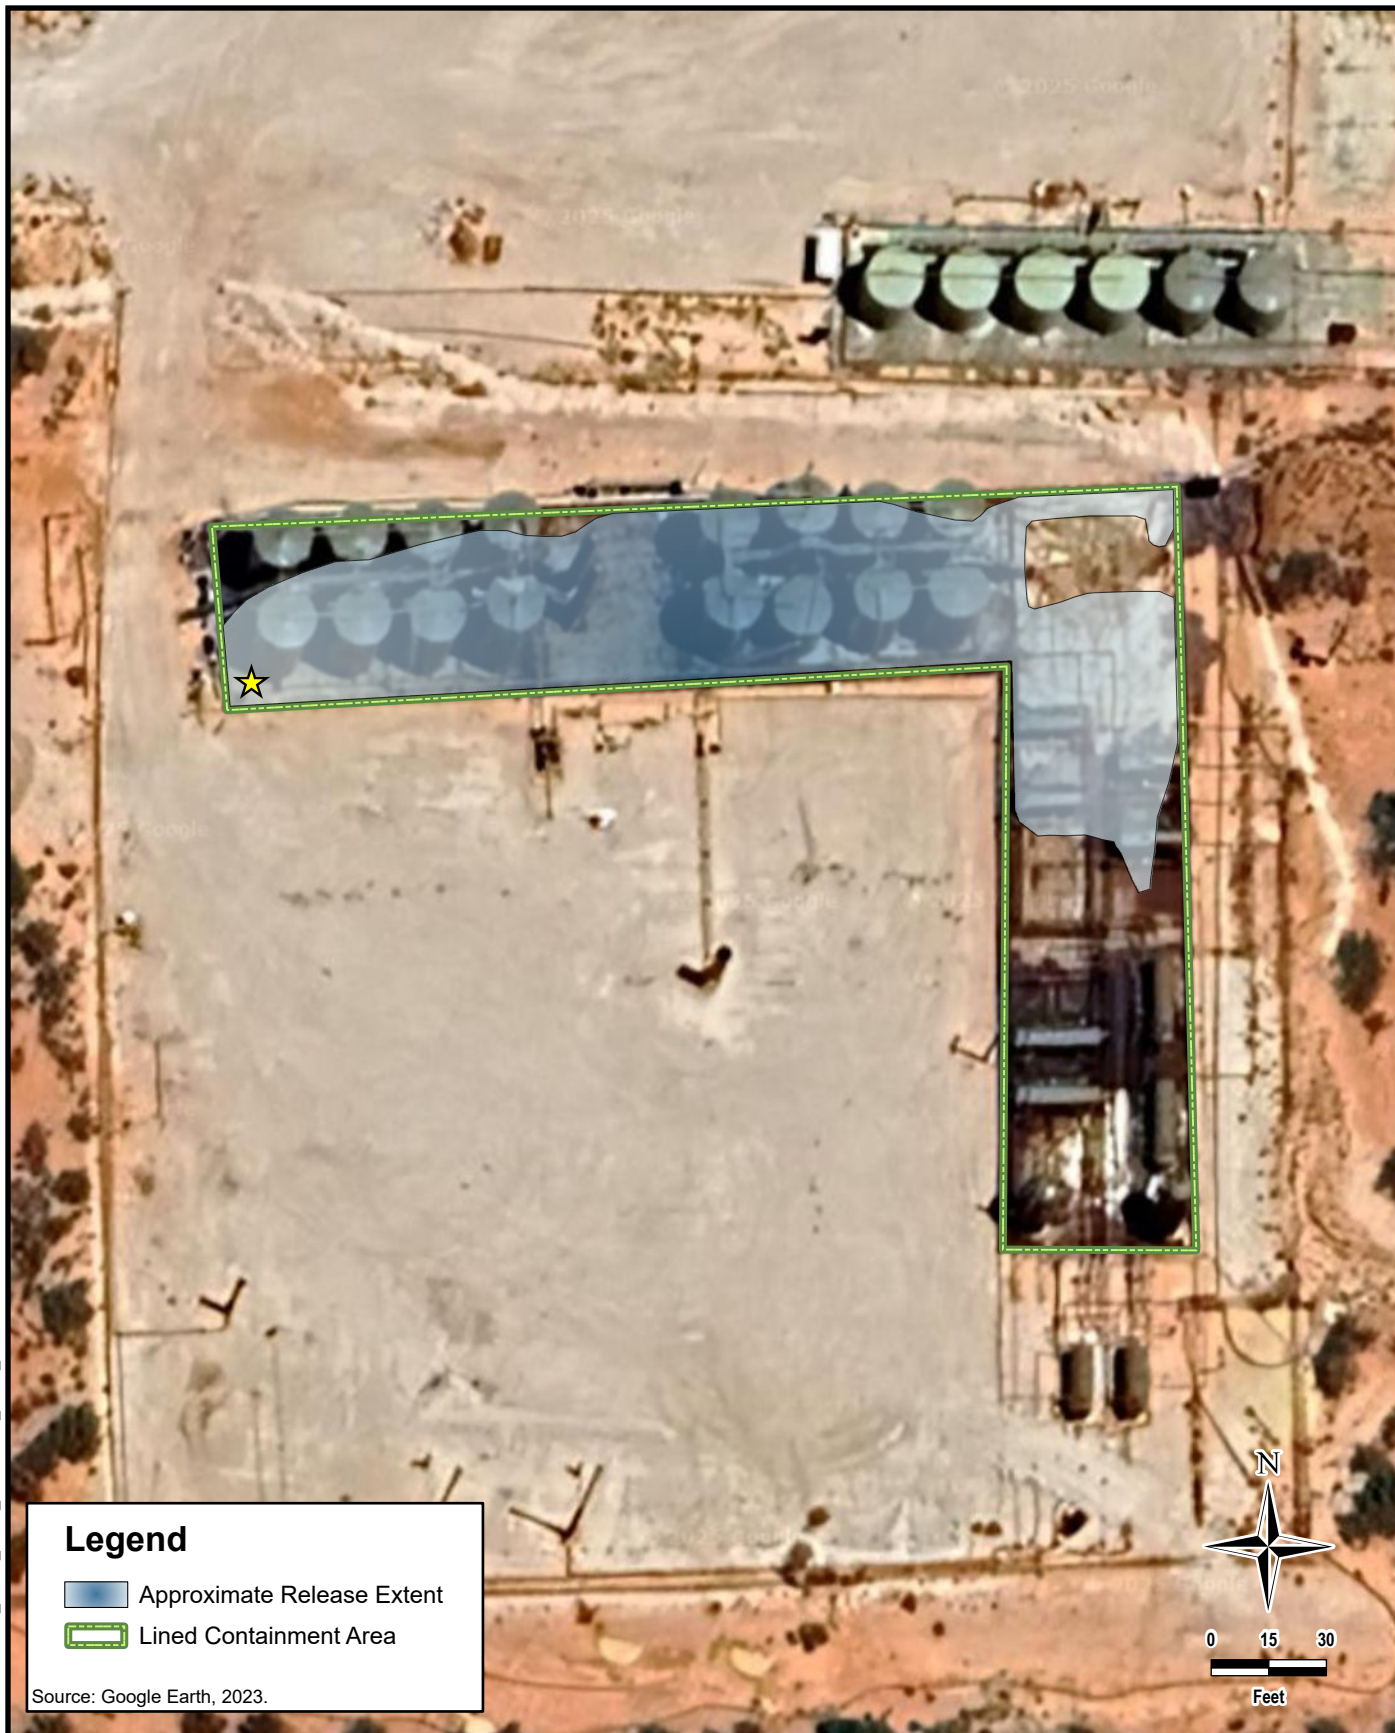
3

Legend

Approximate Release Extent
-

Lined Containment Area

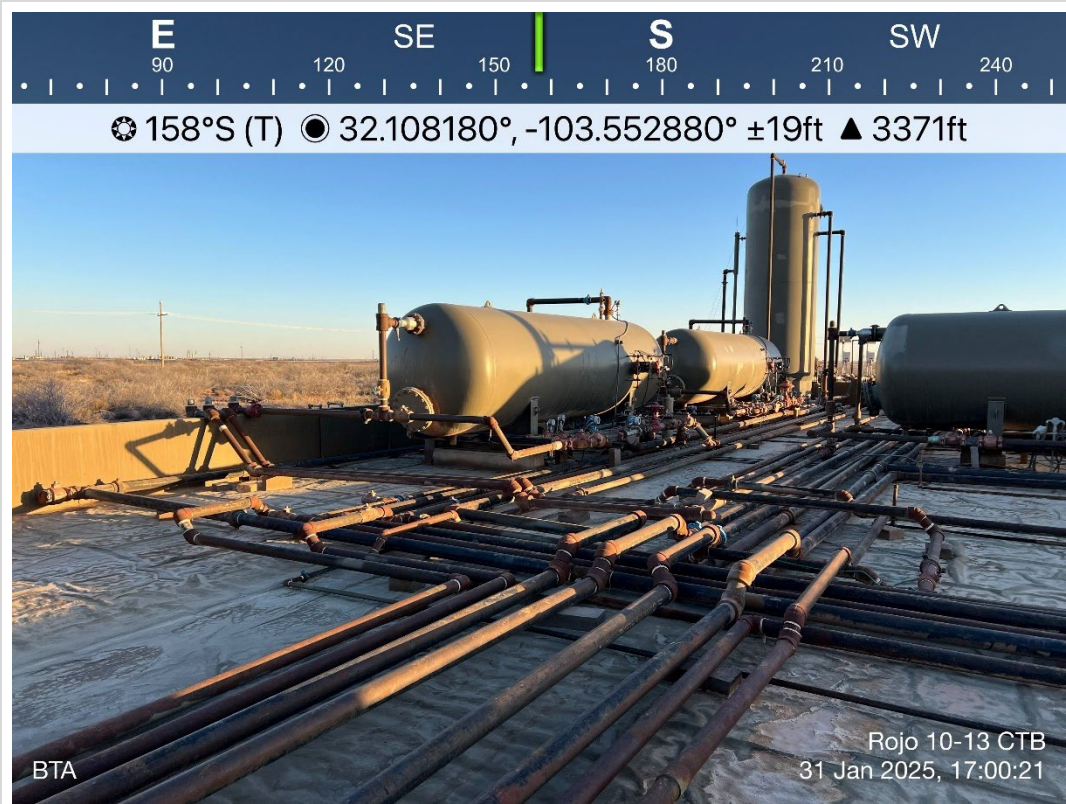
TETRA TECH, INC. PROJECT NO. 212C-MD-03766	DESCRIPTION	View south-southeast. Current lined containment area Conditions post-power wash: no rips, holes, or tears observed.	7
	SITE NAME	Rojo 10-13 Central Tank Battery Release	1/31/2025

On January 31, 2025, Tetra Tech personnel was on site to perform an inspection of the liner within the containment area of the Rojo 10-13 Battery. This work was completed to verify the integrity of the liner. The liner was observed to underlie the entirety of the tank battery containment area. The liner was intact with no visible rips or tears and encompassed by an approximately 2-foot-tall muscle wall. The liner was anchored on the interior. Photographic documentation of the liner inspection post-power wash is included in Appendix D.
