**Re: Liner Inspection and Closure Request
BTA Oil Producers, LLC
Ochoa CTB Release
Unit L, Section 7, Township 23 South, Range 29 East
Eddy County, New Mexico
Incident ID# nAPP2500641830**

Liner Inspection and Closure Request
February 14, 2025

**OCHOA CTB RELEASE
APPROXIMATE RELEASE EXTENT AND LINER INSPECTION**

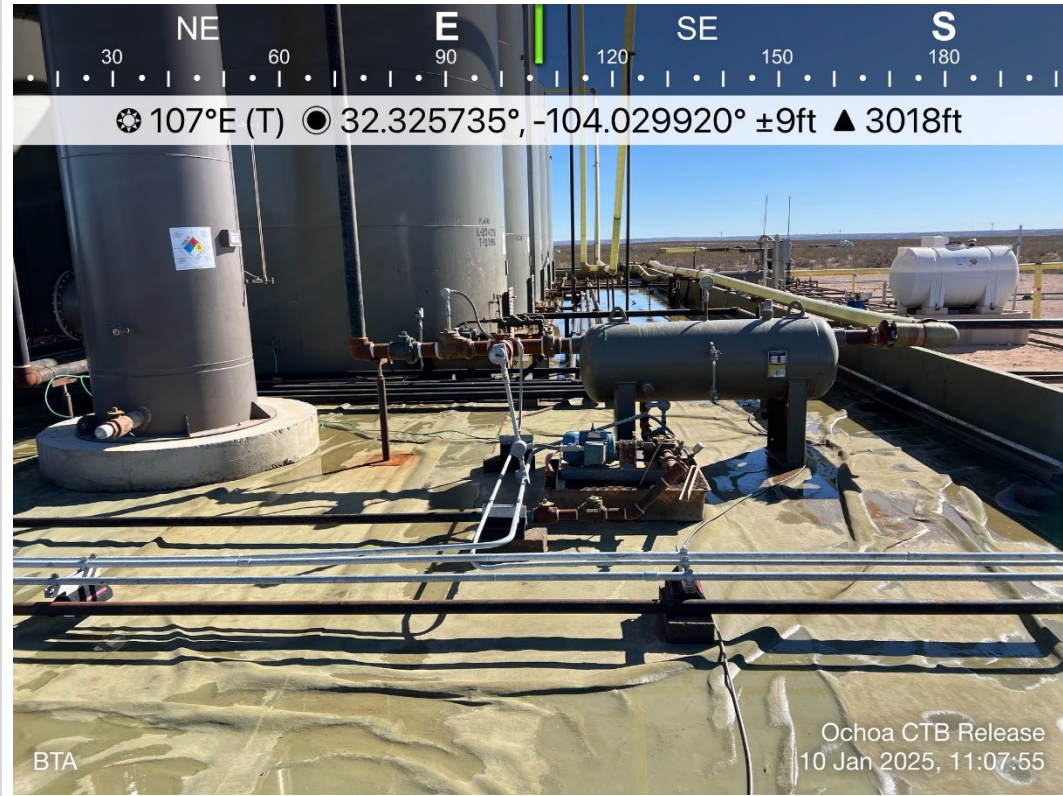
TETRA TECH, INC. PROJECT NO. 212C-MD-03746	DESCRIPTION	View east-southeast. Current lined containment area conditions post-winter mixed event: no rips, holes, or tears observed.	2
	SITE NAME	Ochoa CTB Release	1/10/2025

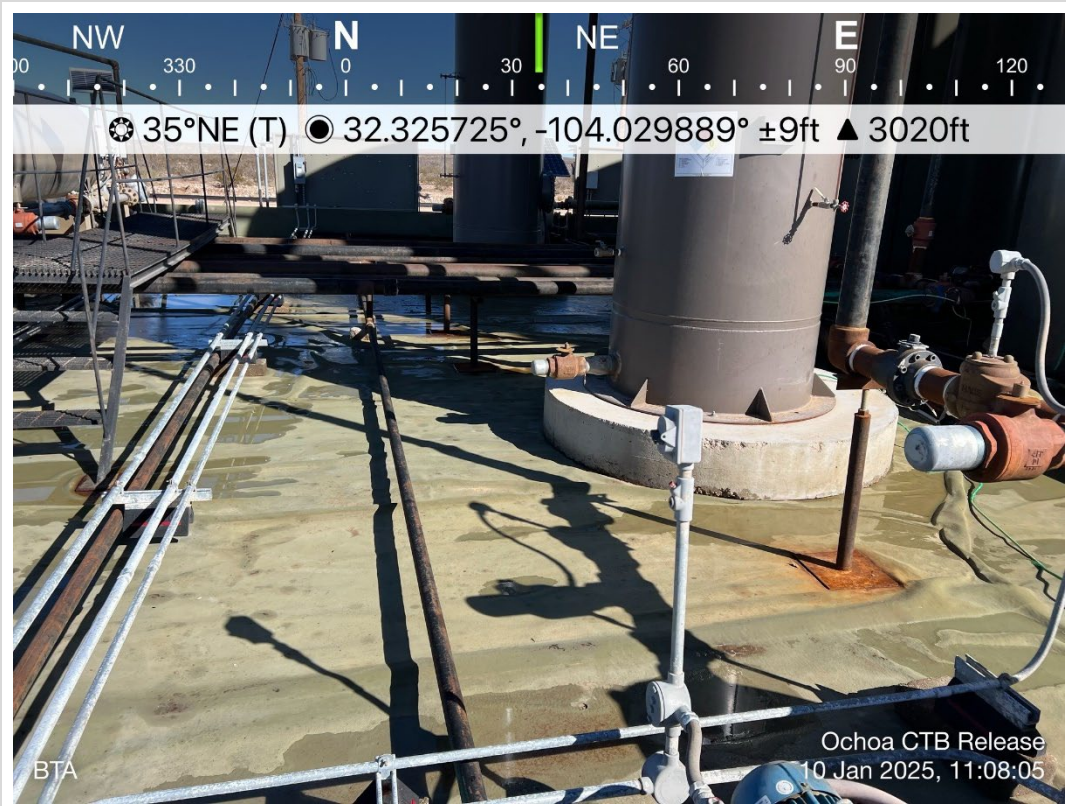
TETRA TECH, INC. PROJECT NO. 212C-MD-03746	DESCRIPTION	View northeast. Current lined containment area conditions post-winter mixed event: no rips, holes, or tears observed.	3
	SITE NAME	Ochoa CTB Release	1/10/2025

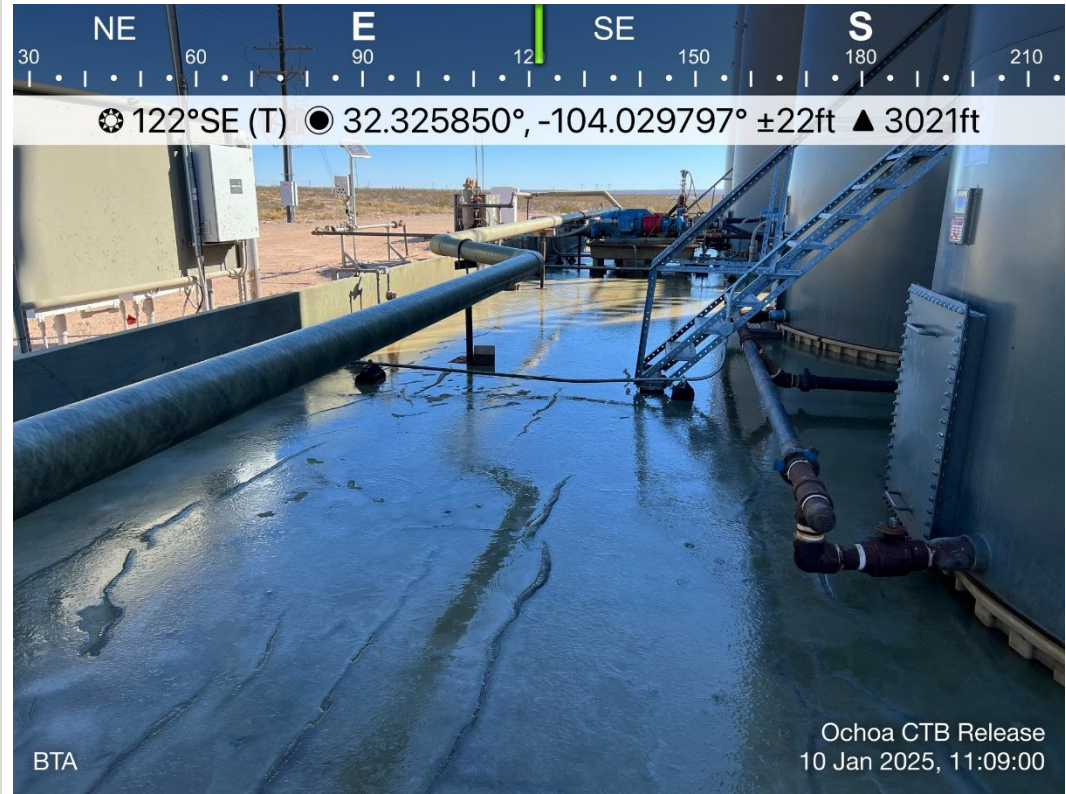
TETRA TECH, INC. PROJECT NO. 212C-MD-03746	DESCRIPTION	View east-southeast. Current lined containment area conditions post-winter mixed event: no rips, holes, or tears observed.	4
	SITE NAME	Ochoa CTB Release	1/10/2025

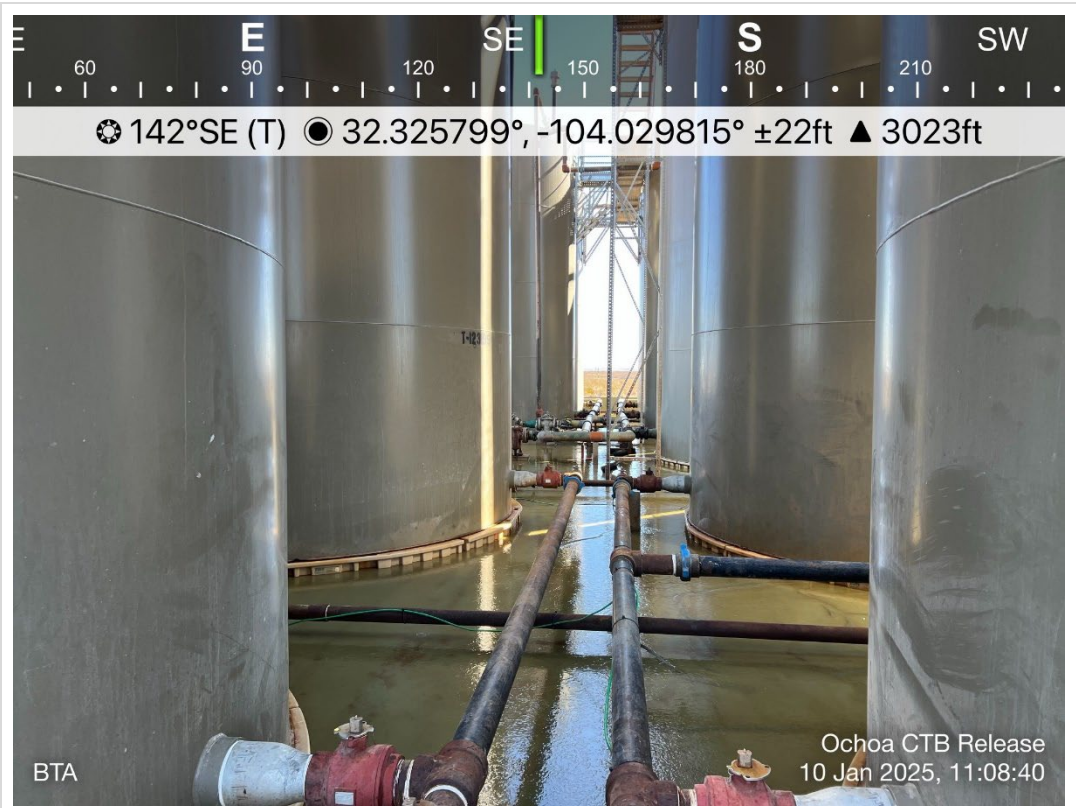
TETRA TECH, INC. PROJECT NO. 212C-MD-03746	DESCRIPTION	View southeast. Current lined containment area conditions post-winter mixed event: no rips, holes, or tears observed.	5
	SITE NAME	Ochoa CTB Release	1/10/2025

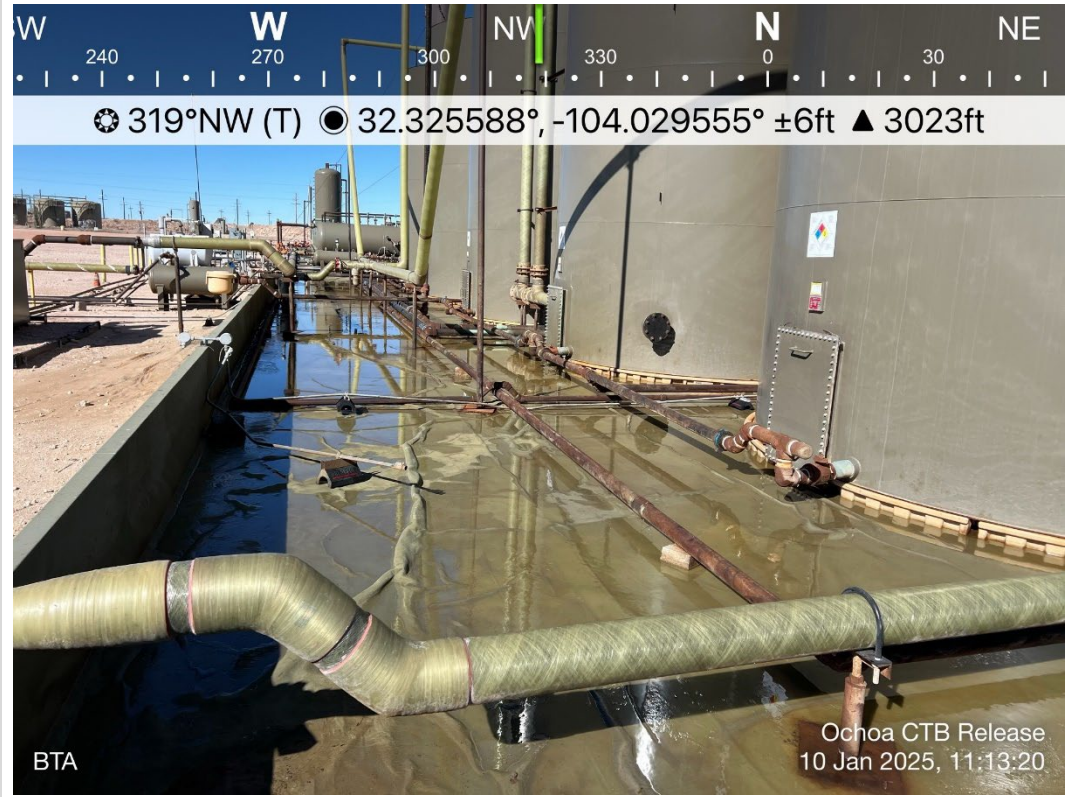
TETRA TECH, INC. PROJECT NO. 212C-MD-03746	DESCRIPTION	View northwest. Current lined containment area conditions post-winter mixed event: no rips, holes, or tears observed.	6
	SITE NAME	Ochoa CTB Release	1/10/2025
