Lee 3 Fee #1H SWD Line

PREPARED BY:
PIMA ENVIRONMENTAL SERVICES, LLC

PREPARED FOR:
Spur Energy

Site Assessment, Remediation,
Reclamation and Closure Report

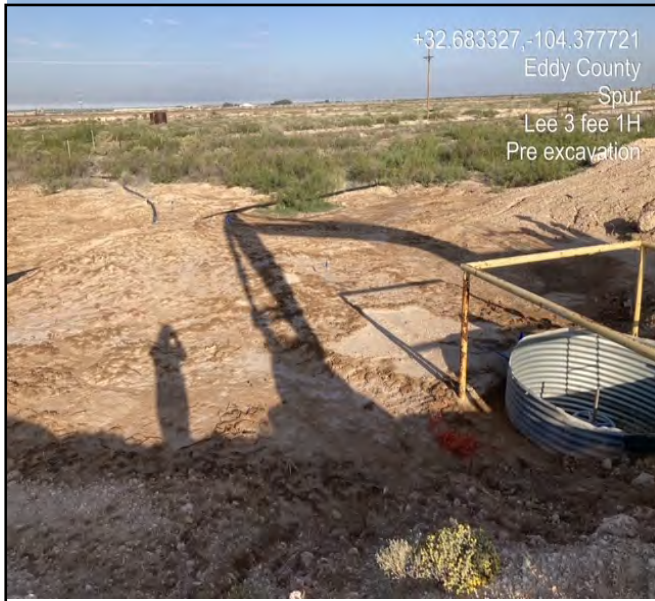
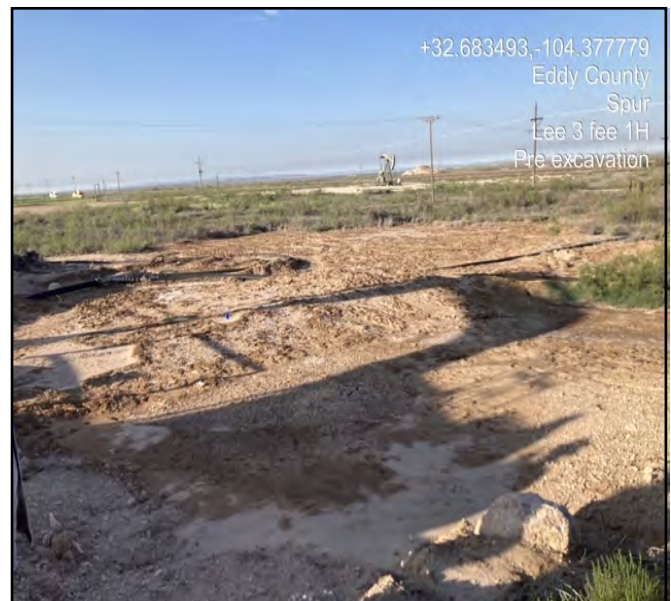
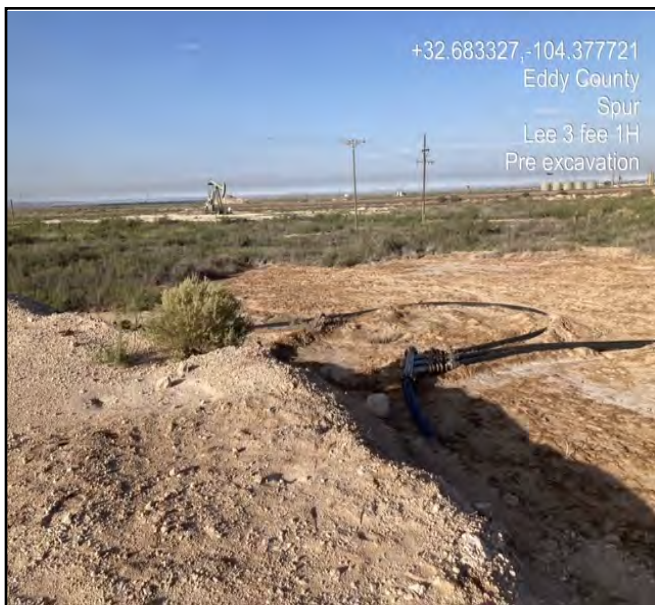
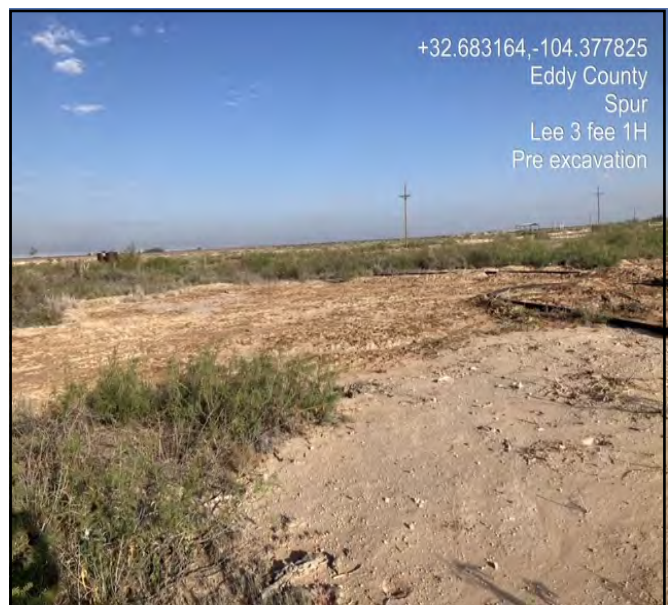
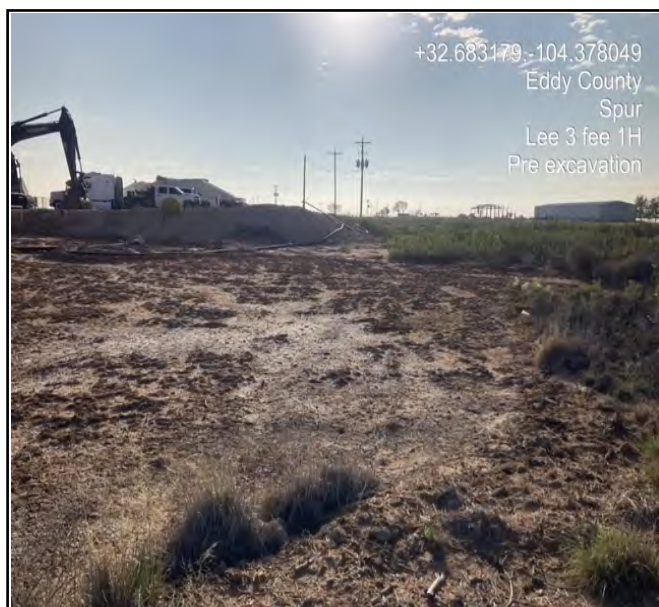
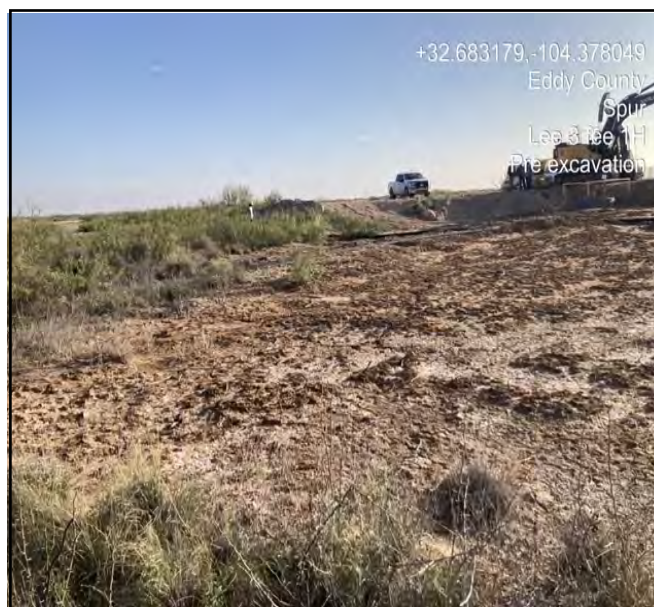
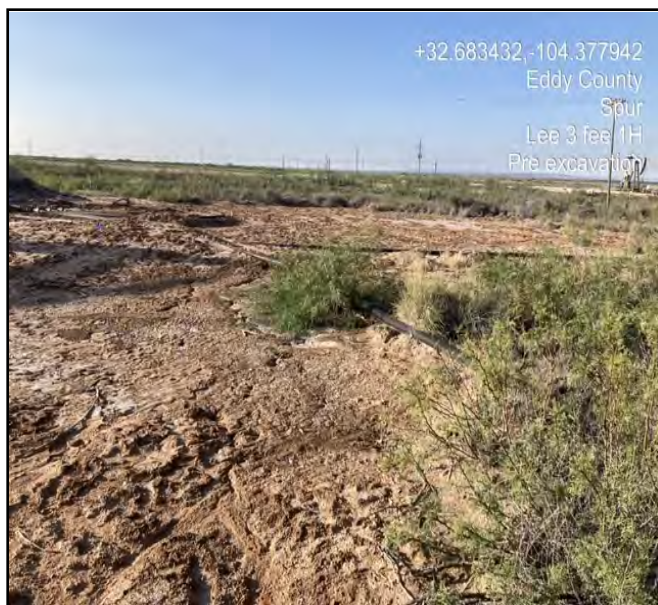
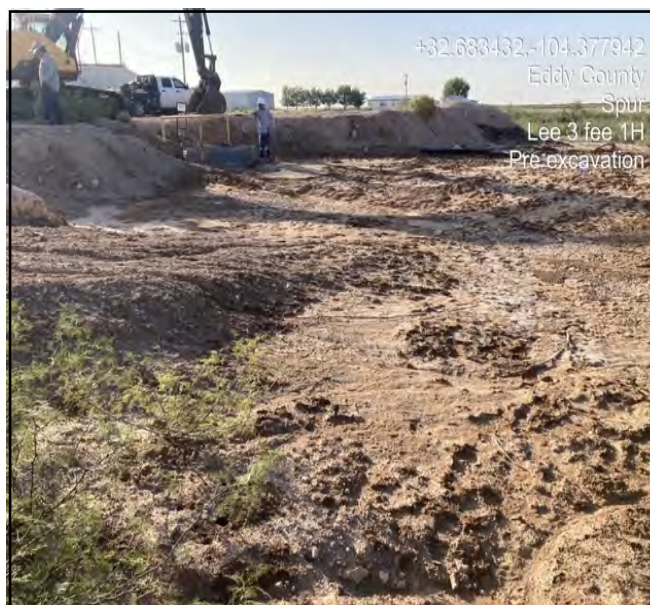
Photo of the site before the excavation process begins.

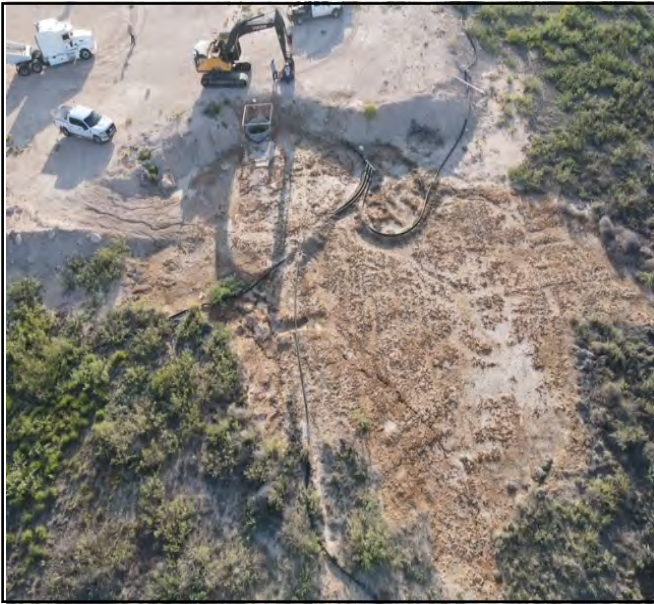
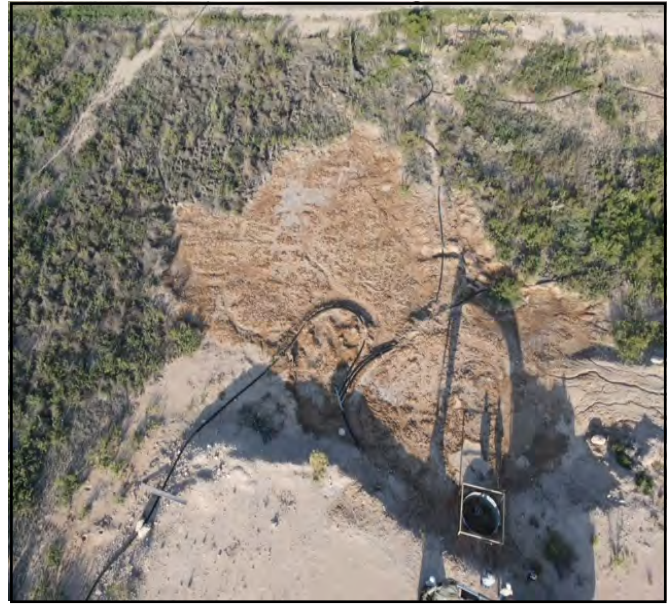
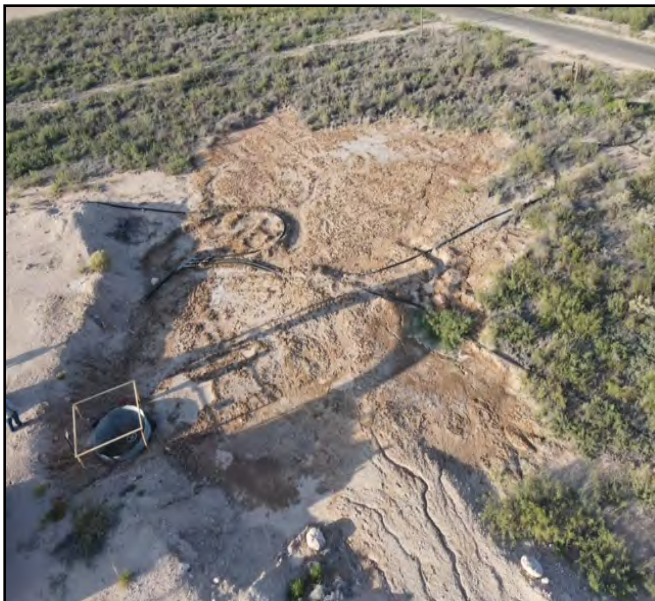
Photo taken by drone showing the release area from aerial view.

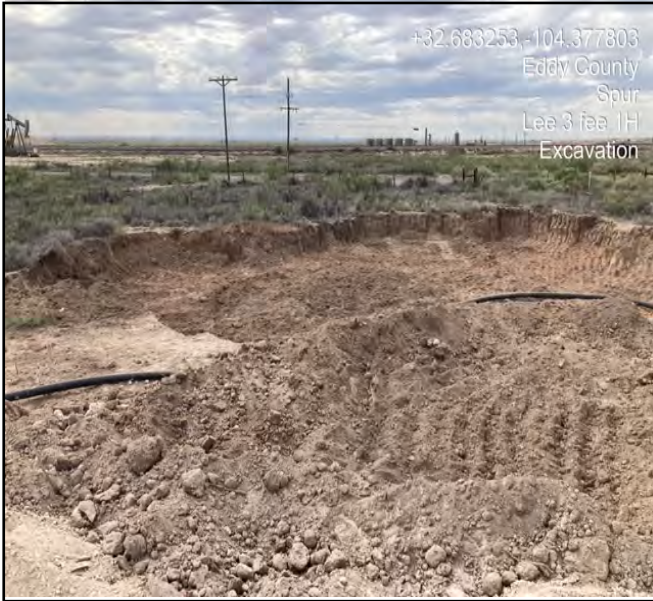
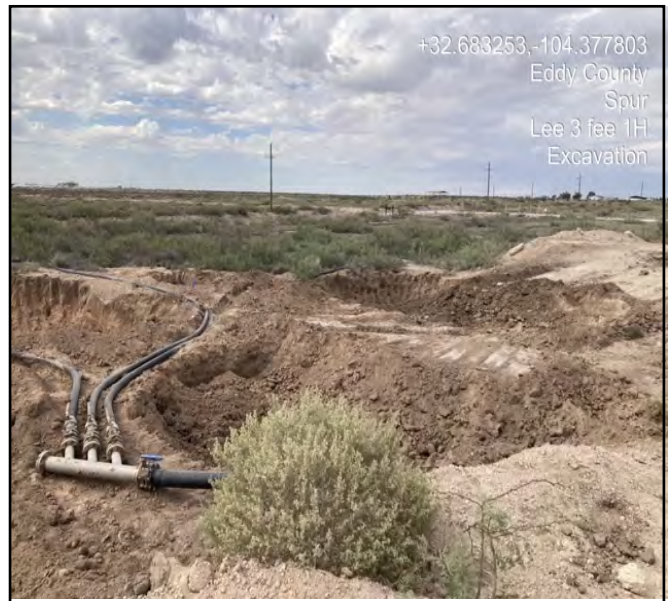
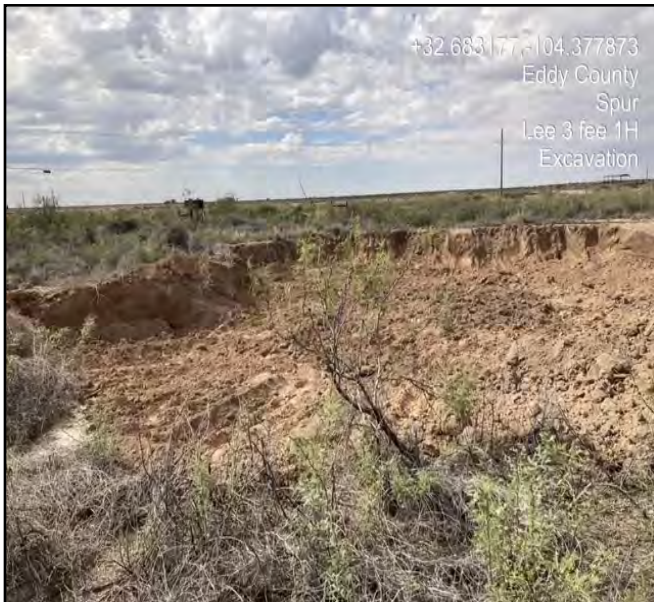
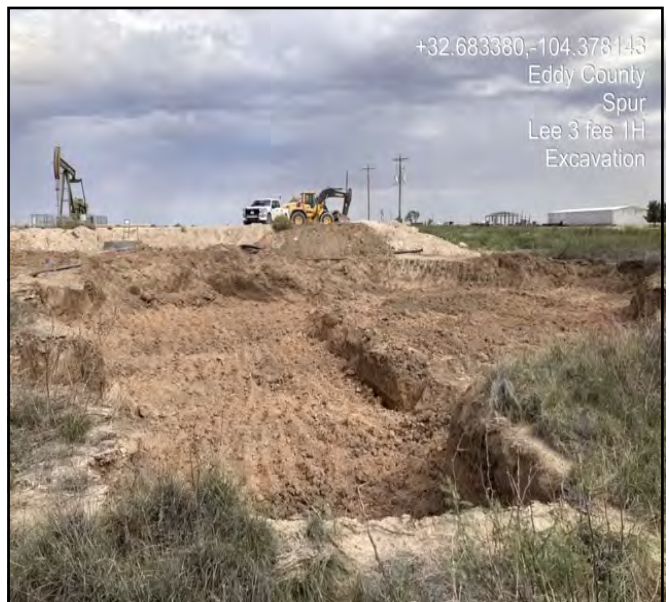
Photo of the site during the excavation process showing the depth of the excavation.

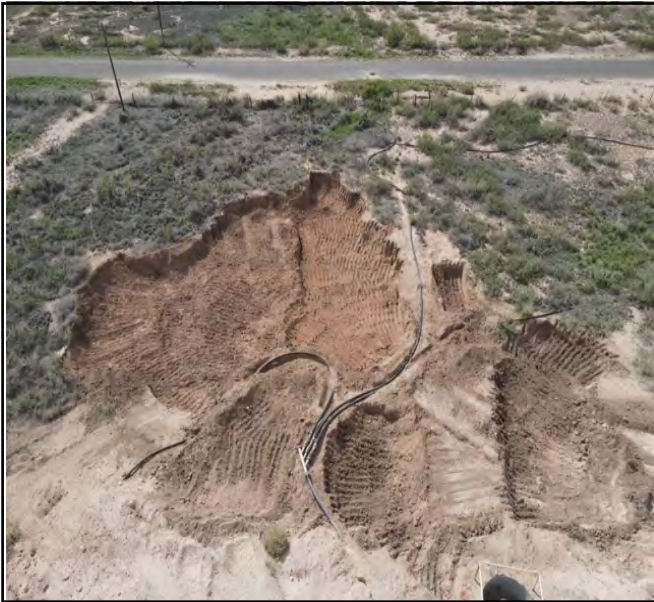
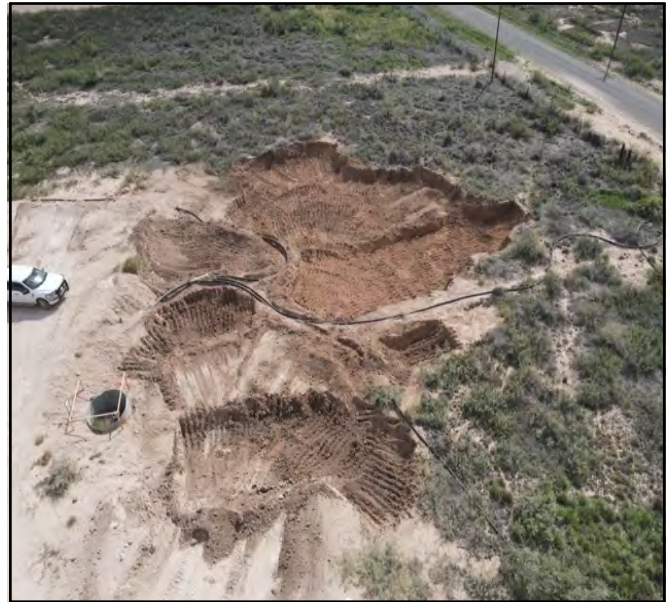
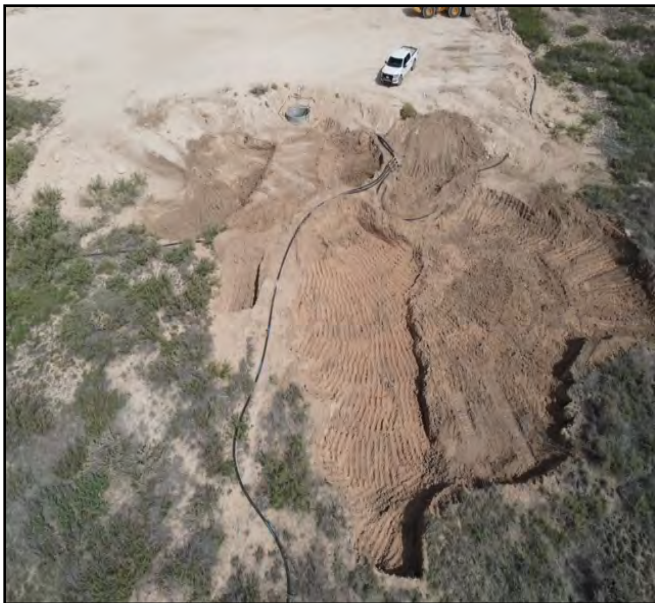
Photo of the site during the excavation process taken from drone

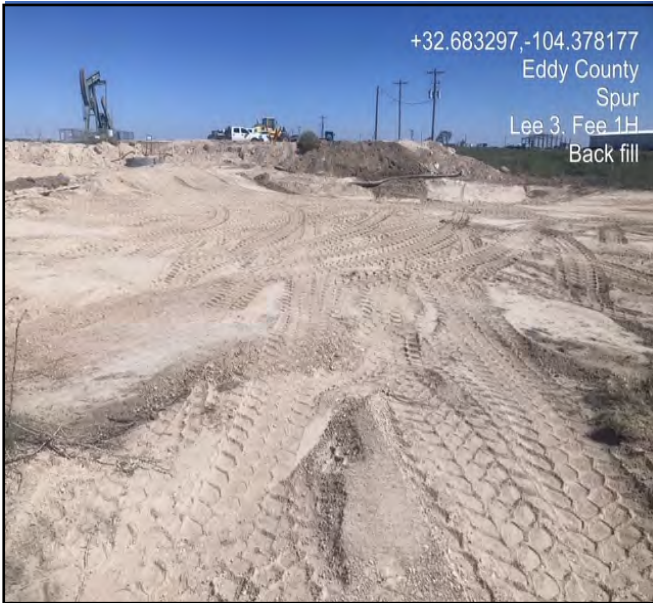
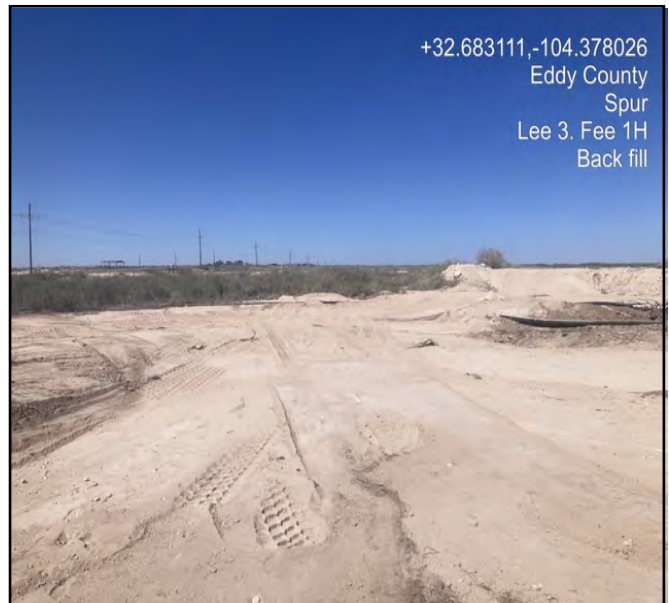
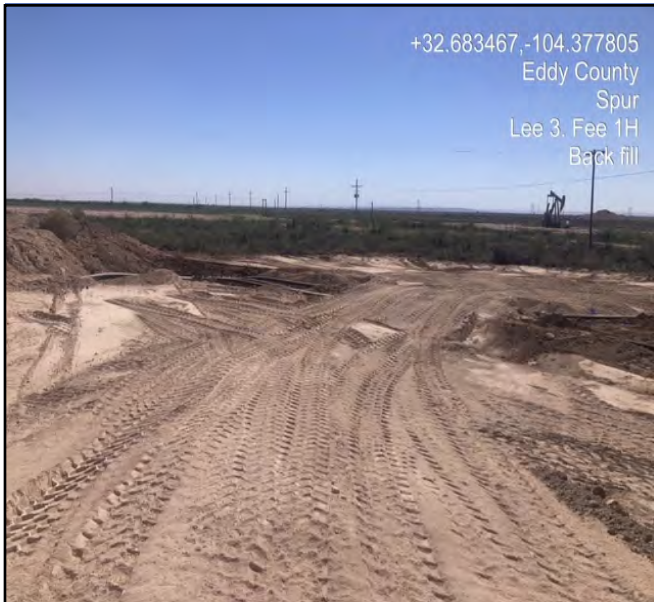
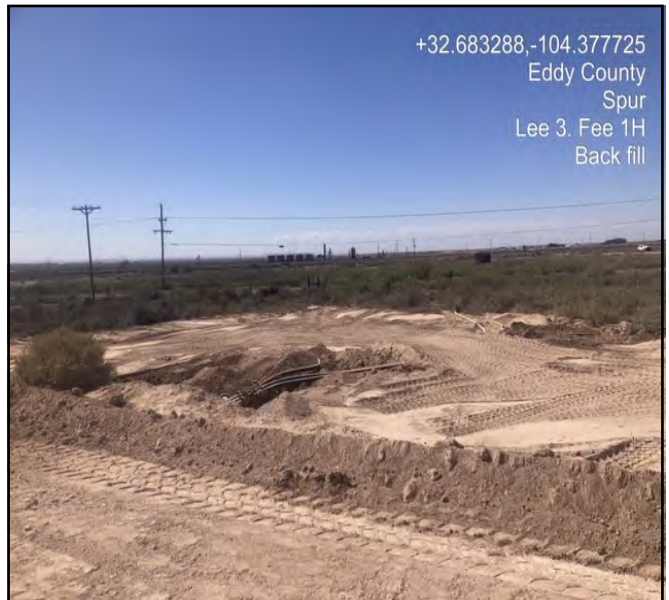
Photograph of the excavation being backfilled and completed prior to seeding.

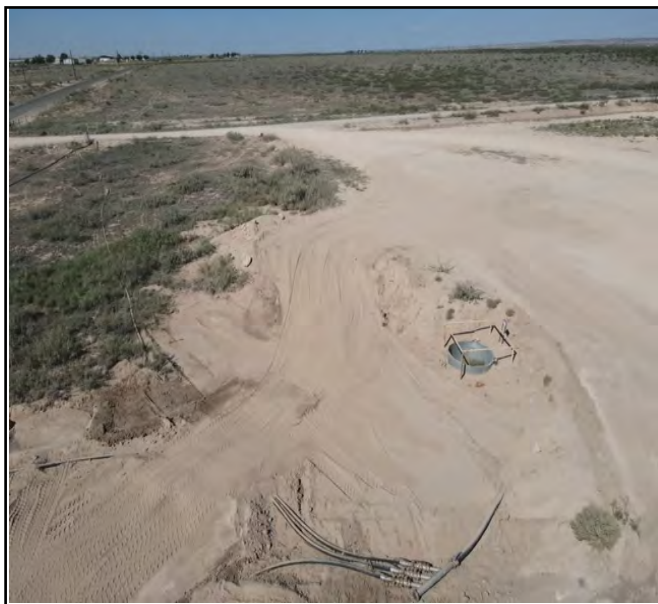
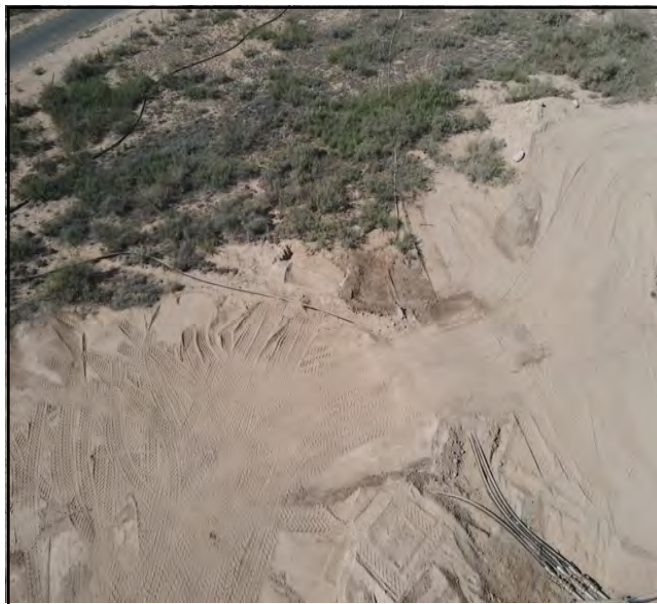
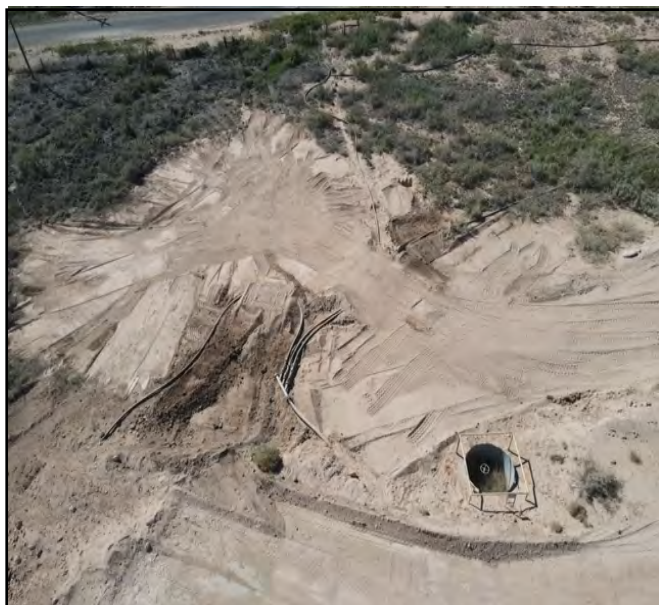
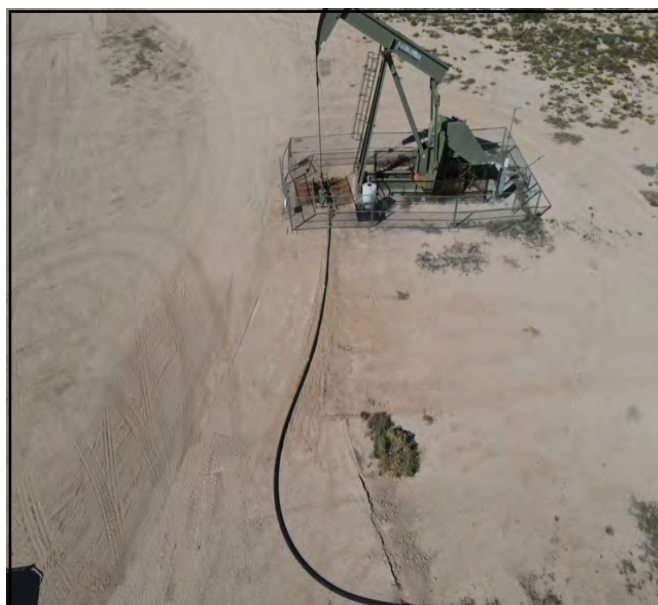
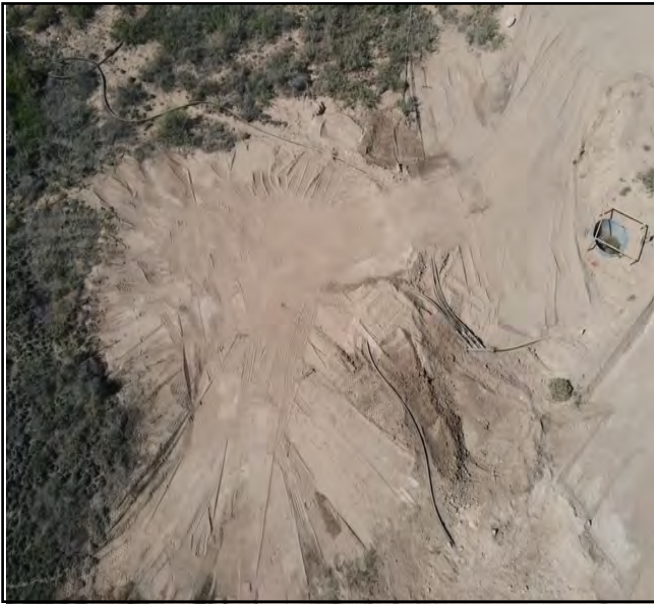
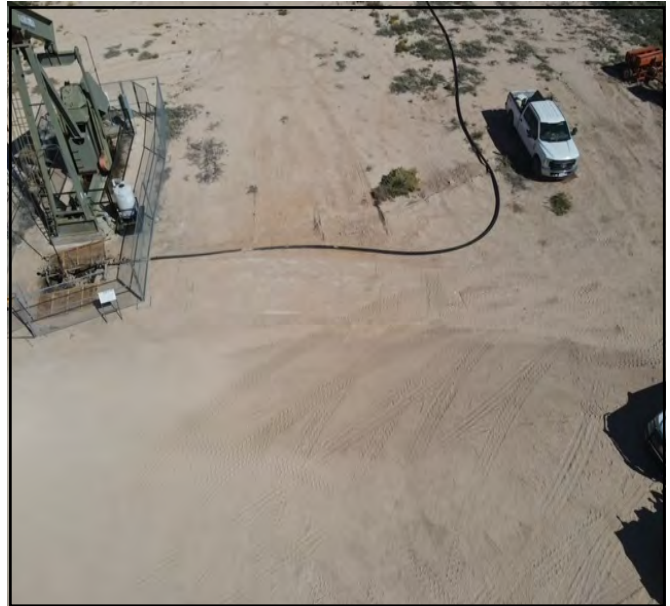
Photograph taken from a drone of the excavation being backfilled and completed prior to seeding.

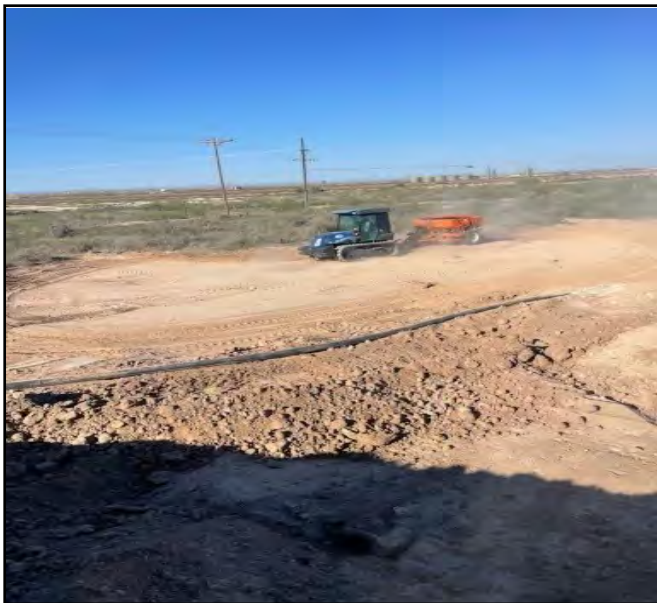
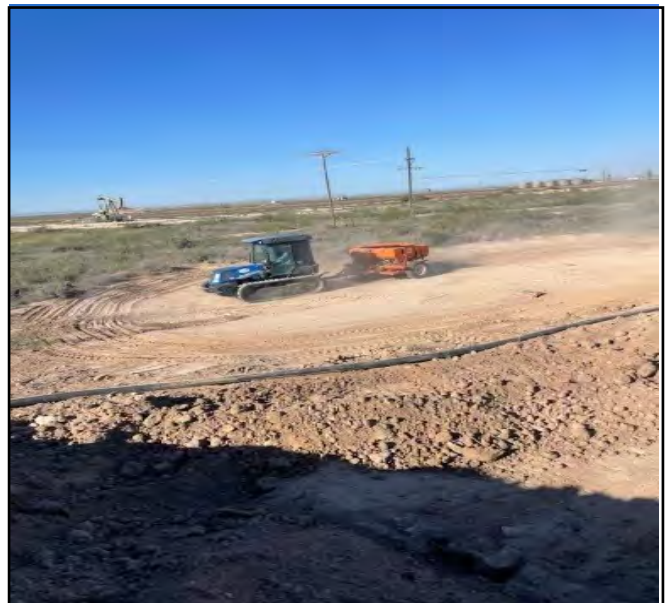
Photo of the seeding process to the whole excavated site.

surrounding area. Approximately half an acre of seed was used to reseed the location. Given the expected lack of moisture in the later months of the year, it was determined that seeding at this time would offer the best chance for sustainable growth in the area impacted by the Lee release. A picture of the seeding blend is included in Appendix D, and a detailed site map showing the seeded area is provided in Figure 6.
