RE: Closure Request Addendum Cover Letter  
Devon Energy Production Company, LP  
Black Mamba 15 State Com 8H  
Incident Number nJXK1534548184  
Lea County, New Mexico

Etech Environmental & Safety Solutions, Inc. (Etech), on behalf of Devon Energy Production Company, LP (Devon), presents the following Closure Request Addendum Cover Letter (CRACL) that requests No Further Remedial Action (NFRA) for an inadvertent release of produced water assigned Incident Number (nJXK1534548184) at the Black Mamba 15 State Com 8H (Site) (**Figure 1 in Appendix A**), based on previous remediation efforts and additional backfill soil samples collected as requested.

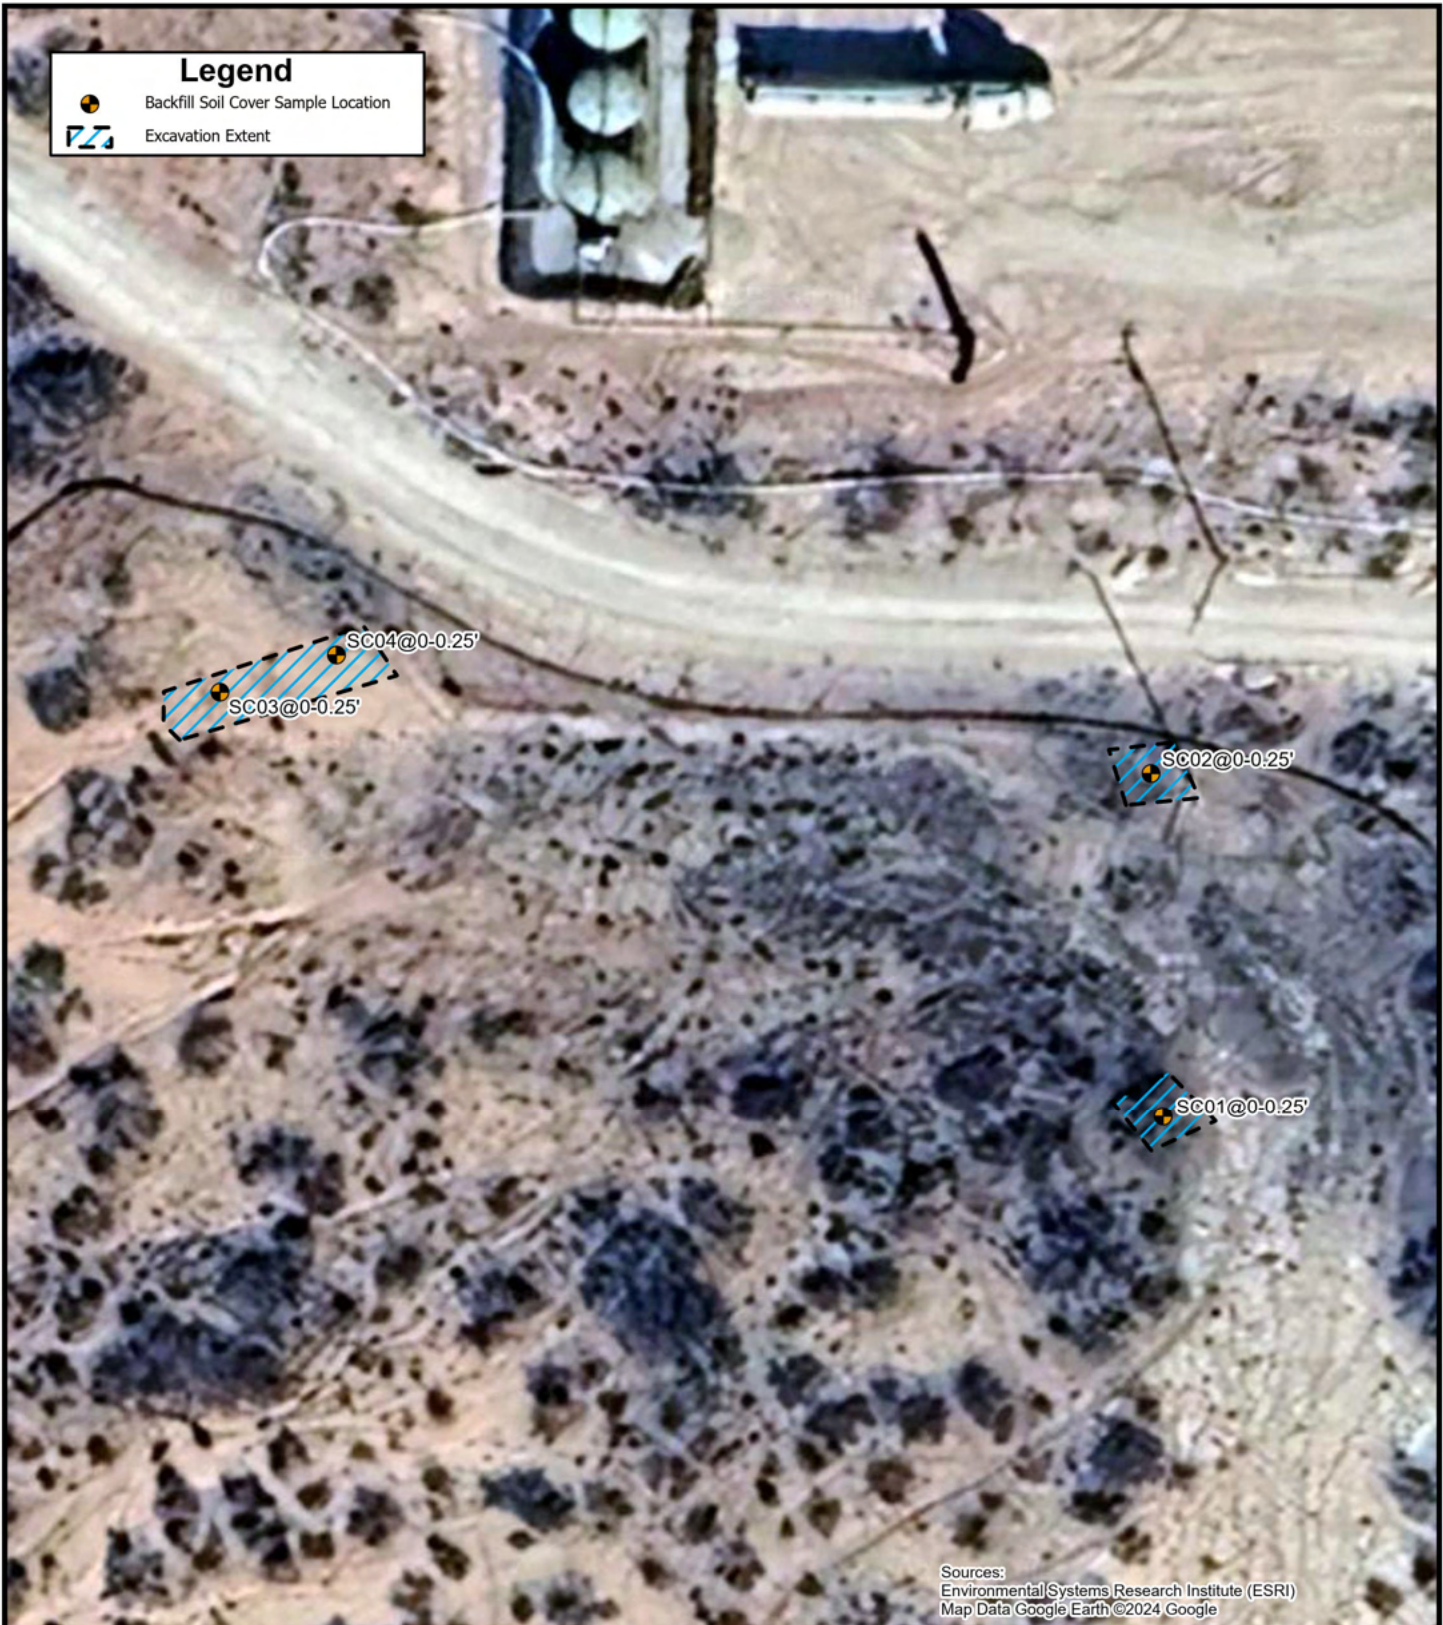
FIGURE 2

On January 15, 2025, Etech collected via hand shovel four (4) 5-point composite soil samples of the backfill soil cover (SC01 through SC04) from each of the backfilled excavations from approximately ground surface to 0.25-foot below ground surface (bgs). The 5-point composite soil samples were comprised of five equivalent aliquots homogenized in a 1-gallon, resealable plastic bag. The samples were then placed into lab provided pre-cleaned glass jars, packaged with minimal void space, labeled, and immediately placed on ice. The soil samples were transported under strict chain-of-custody procedures to Envirotech, Inc. (Envirotech) in Farmington, New Mexico, for analysis of the constituents of concern (COC) listed in Table I, Closure Criteria for Soils Impacted by a Release, of Title 19, Chapter 15, Part 29, Section 12 (19.15.29.12) of the New Mexico Administrative Code (NMAC): Benzene, Toluene, Ethylbenzene, Total Xylenes (BTEX) by Method Environmental Protection Agency (EPA) 8260B; TPH (Total Petroleum Hydrocarbon) - Gasoline Range Organics (GRO), TPH-Diesel Range Organics (DRO), and TPH-Oil Range Organics (ORO) by Method EPA 8015D; and chloride by Method EPA 300.0. The locations of the backfill soil cover samples are shown in **Figure 2 in Appendix A**. Photographic documentation is included in **Appendix B**.

## Backfill Soil Sample Locations

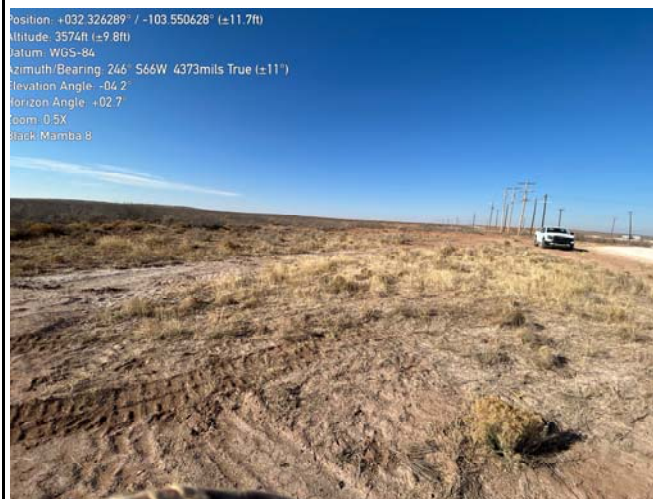
**Photograph 1**

Description: Western view of completed restoration.

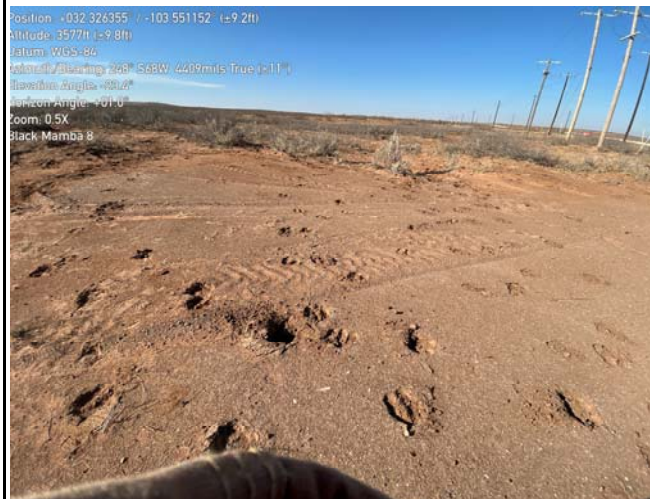
**Photograph 2**

Description: Southwestern view of completed restoration.

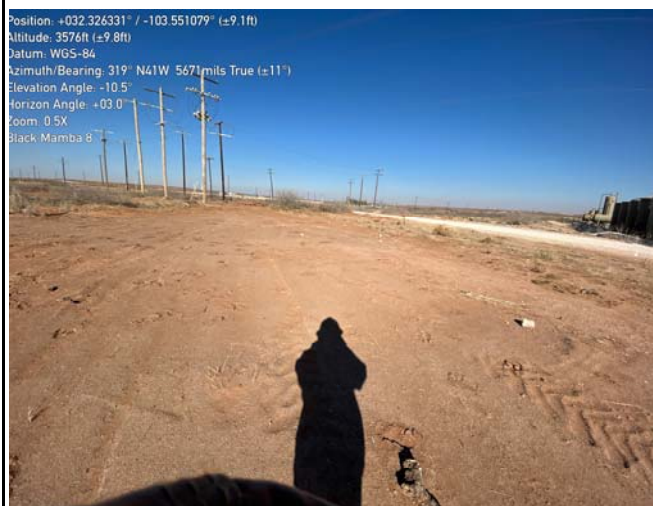
**Photograph 3**

Description: Northwestern view of completed restoration.

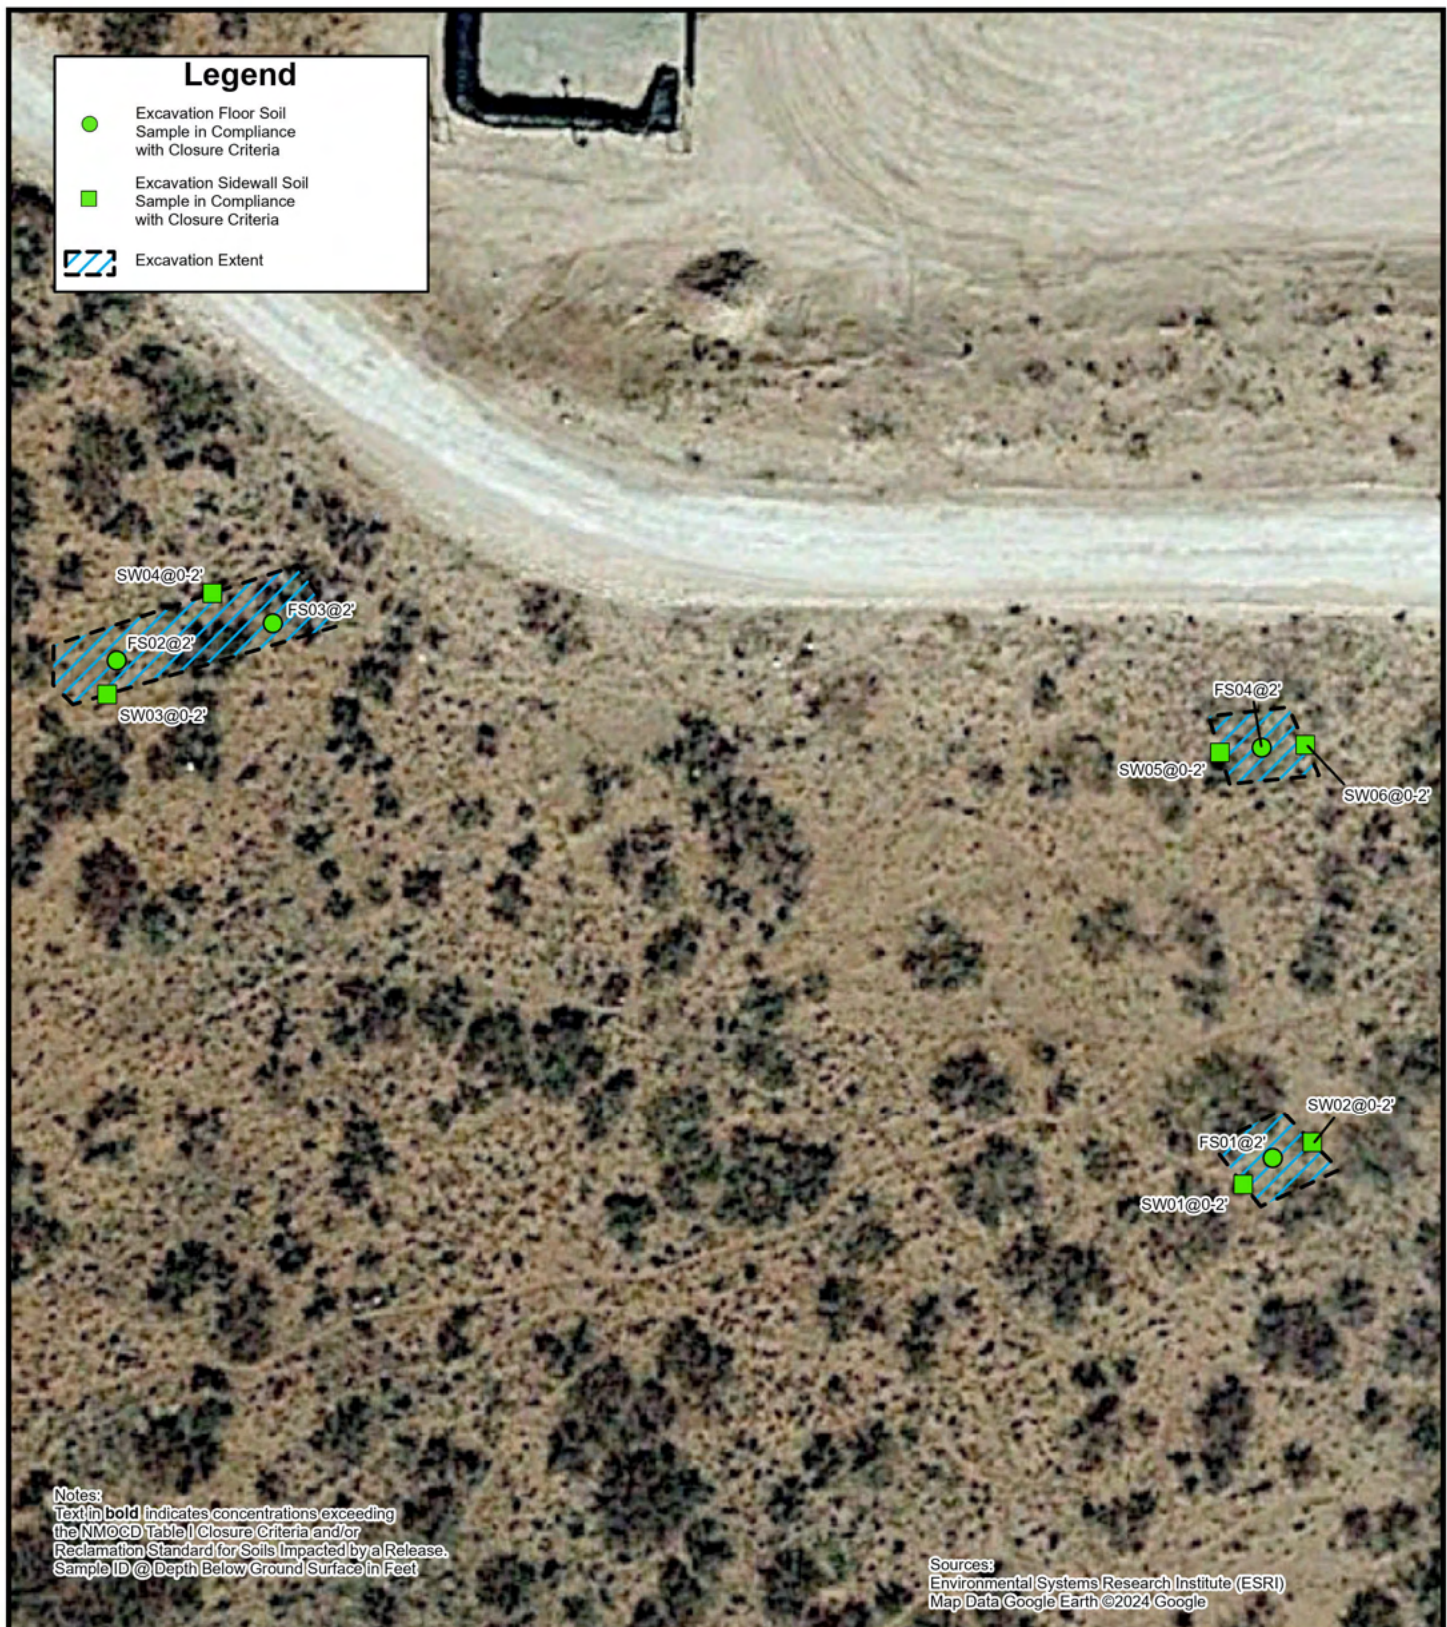
FIGURE 5

## Excavation Soil Sample Locations

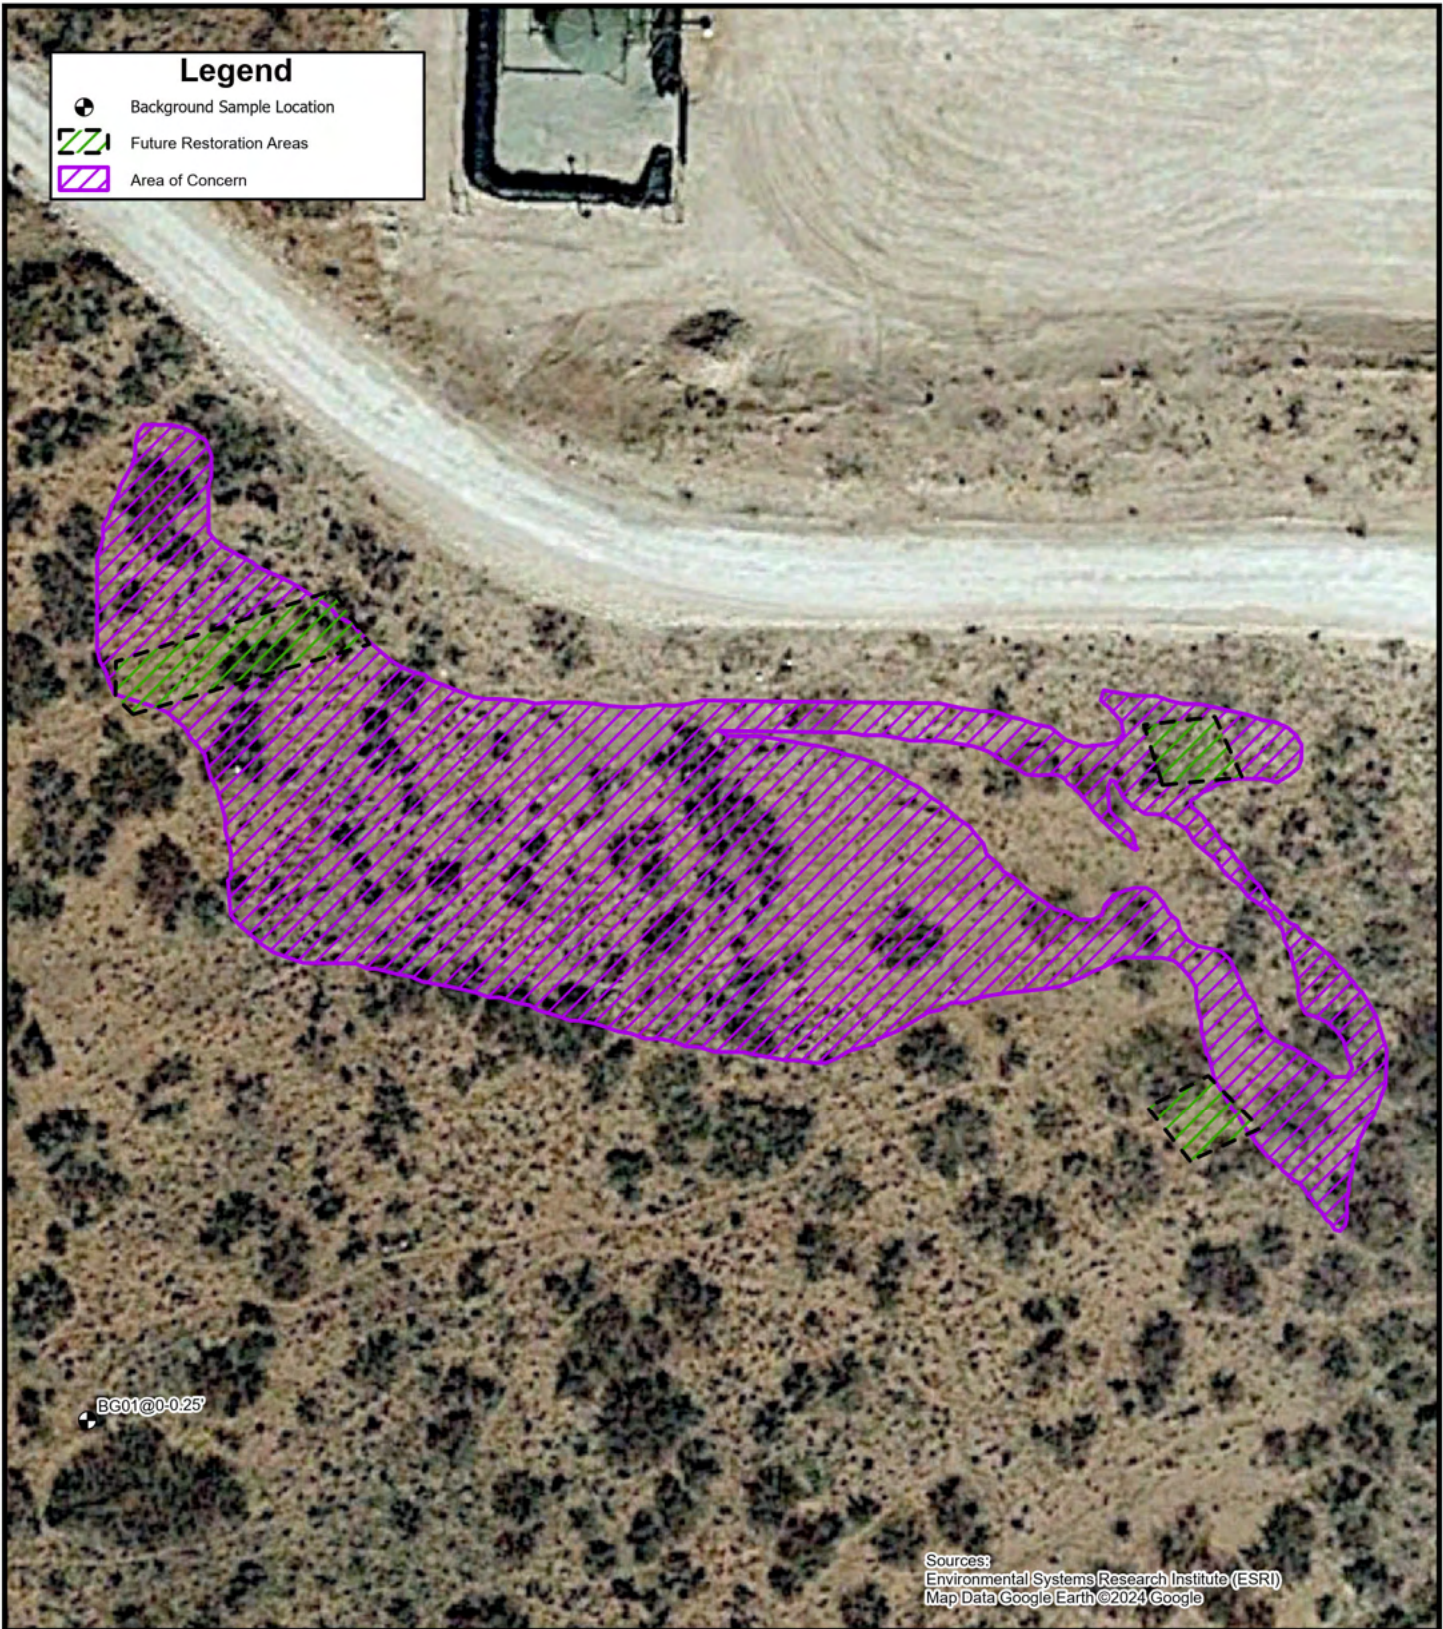
FIGURE 6

**Future Restoration Areas**

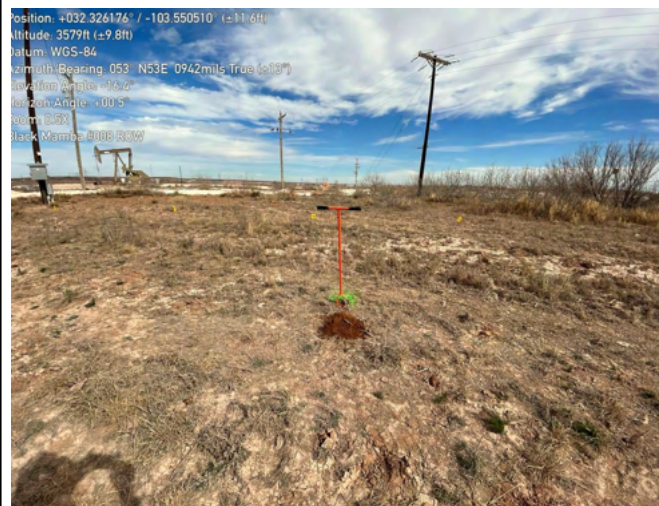
**Photograph 1****Date: 02/01/2024**

Description: Northeastern view of delineation activities.

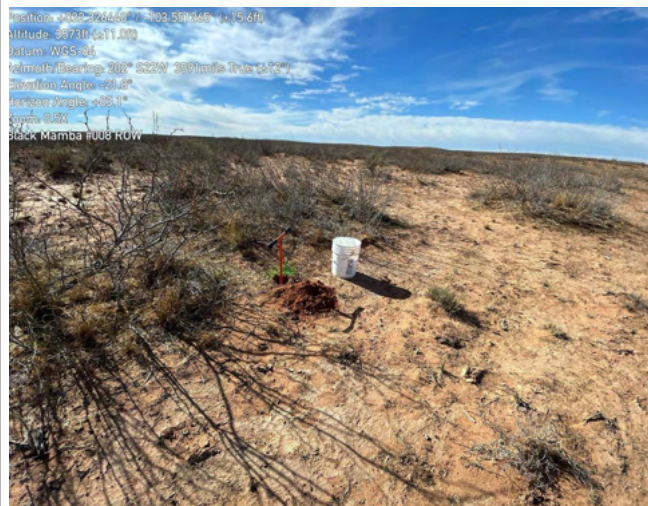
**Photograph 2****Date: 02/01/2024**

Description: Southwestern view of delineation activities.

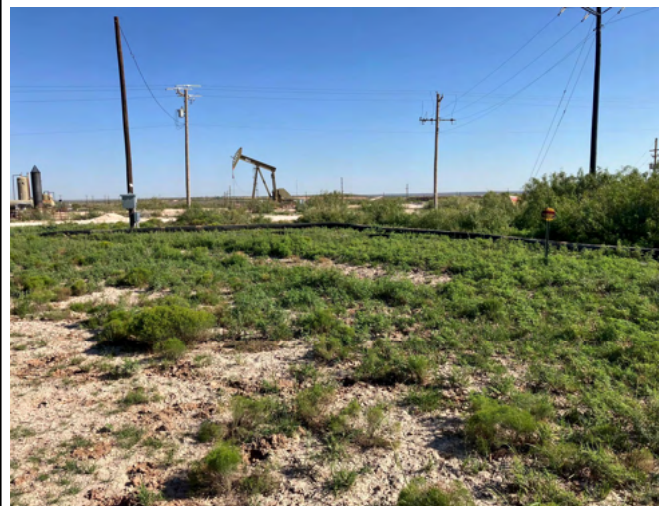
**Photograph 3****Date: 09/11/2024**

Description: Northeastern view of confirmation activities.

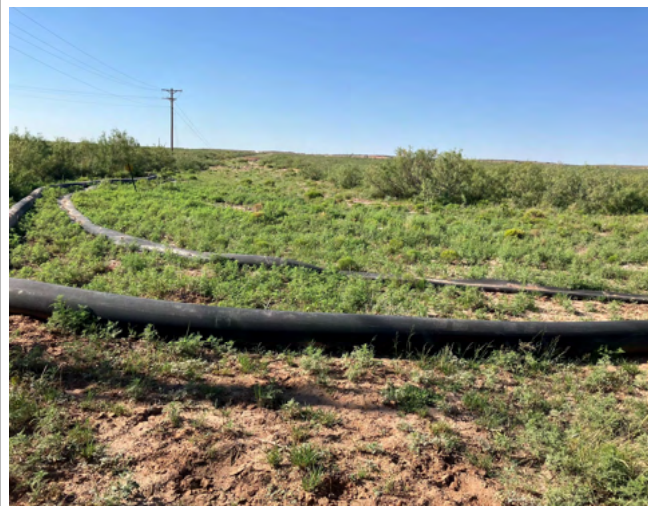
**Photograph 4****Date: 09/11/2024**

Description: Southwestern view of confirmation activities.

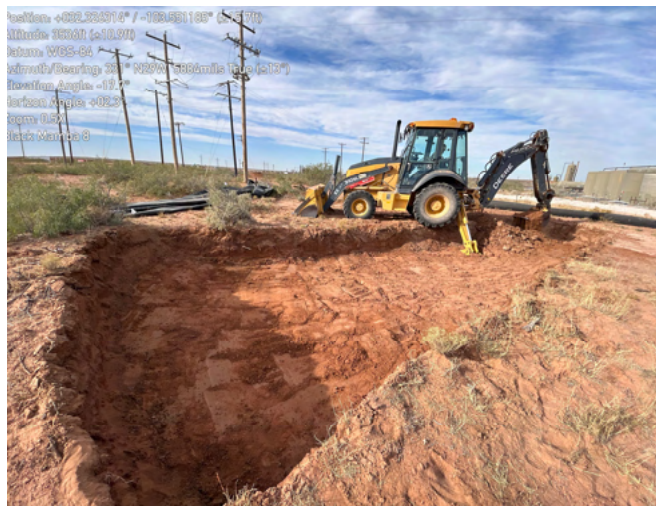
**Photograph 5**

Description: Northwestern view of excavation activities.

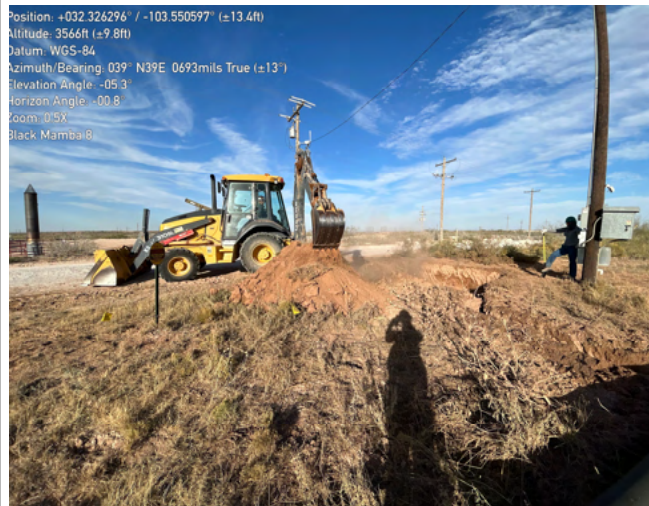
**Photograph 6**

Description: Northeastern view of excavation activities.

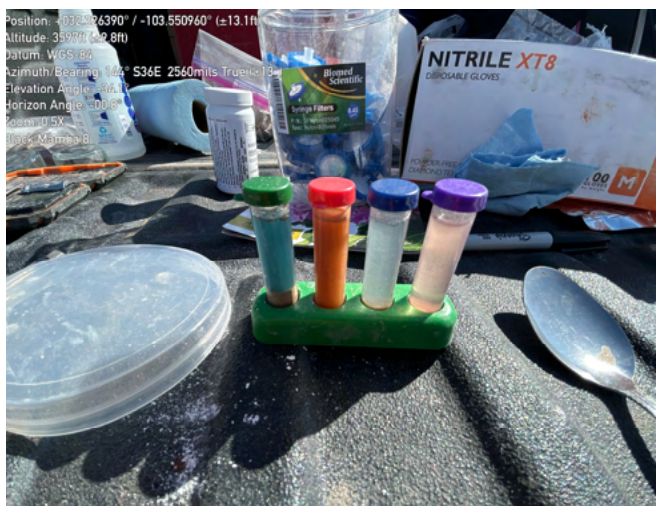
**Photograph 7**

Description: Southeastern view of nutrient testing results for backfill material SC02.

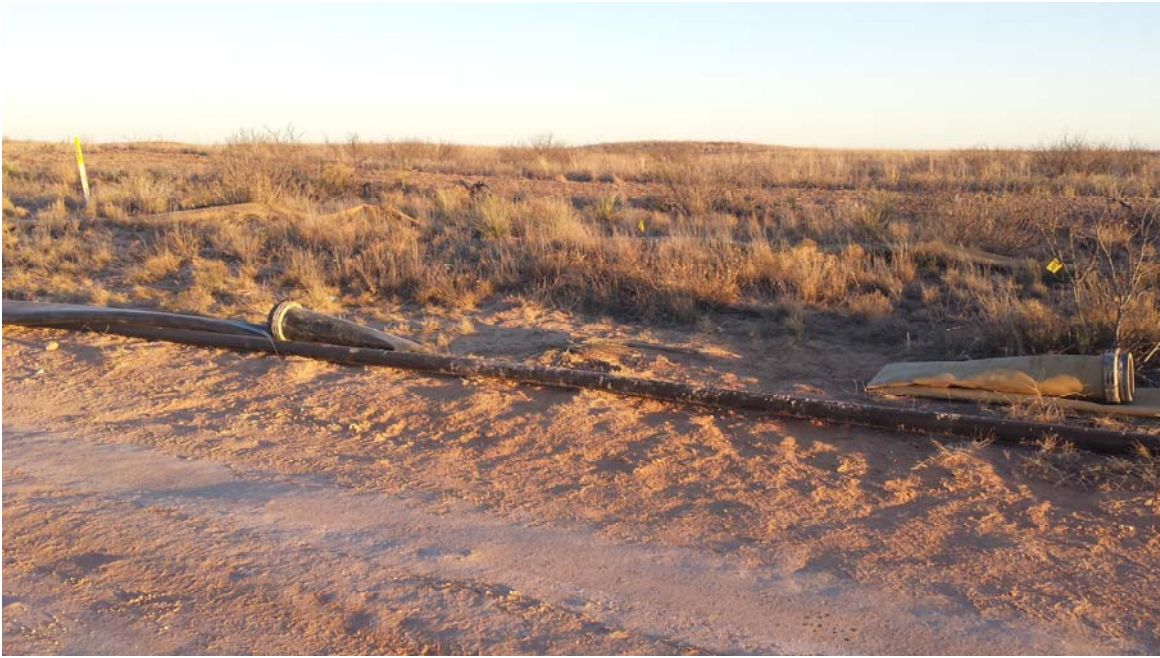
Devon Energy - Carlsbad	Project Name:	Black Mamba 15 State COM #008	Reported:
6488 7 Rivers Hwy	Project Number:	01058-0007	
Artesia NM, 88210	Project Manager:	Haleigh Blume	1/23/2025 1:16:14PM

View of release area at Site 1 looking southeast.

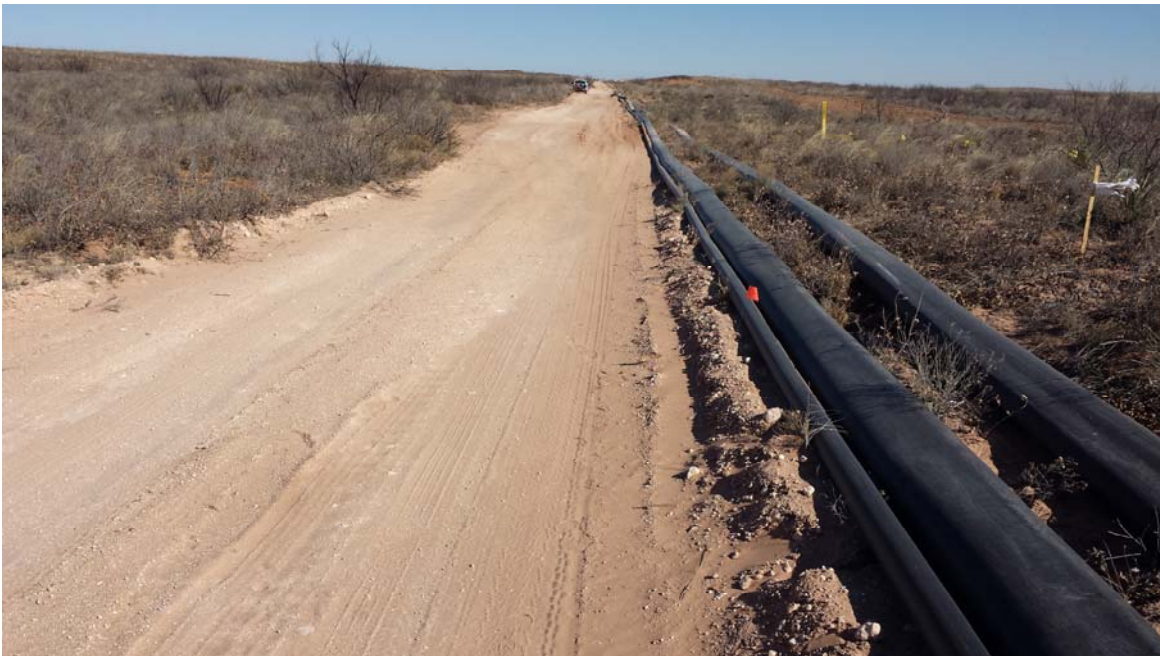
View of end of release area at Site 1 looking northeast.

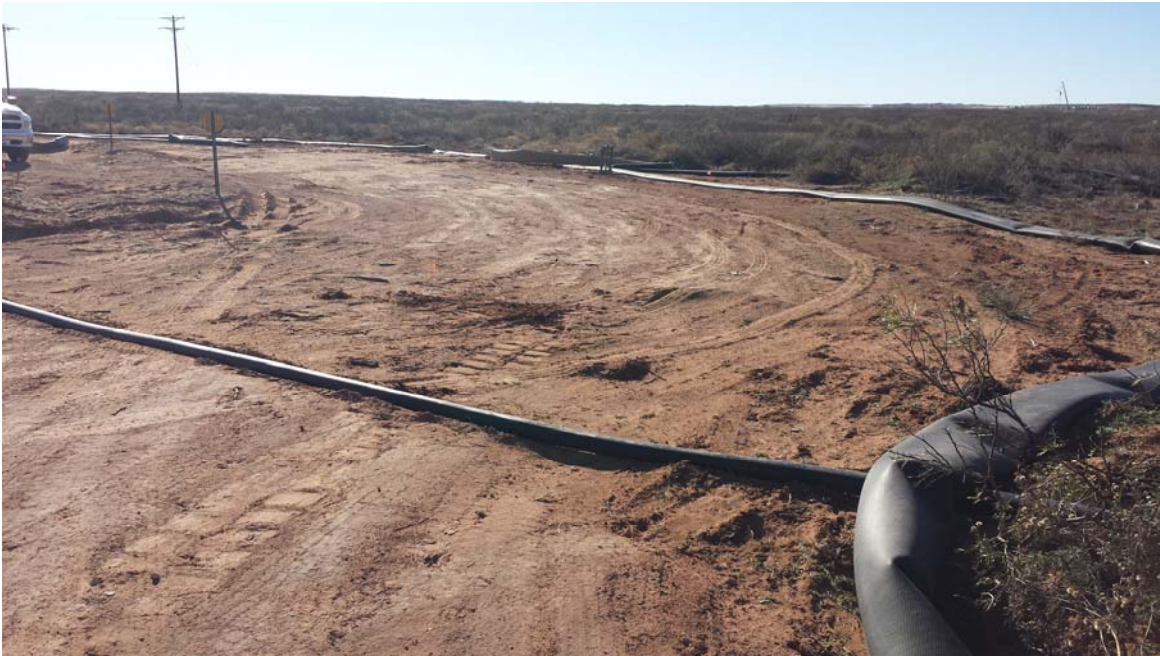
View across release area at Site 2 looking southwest.

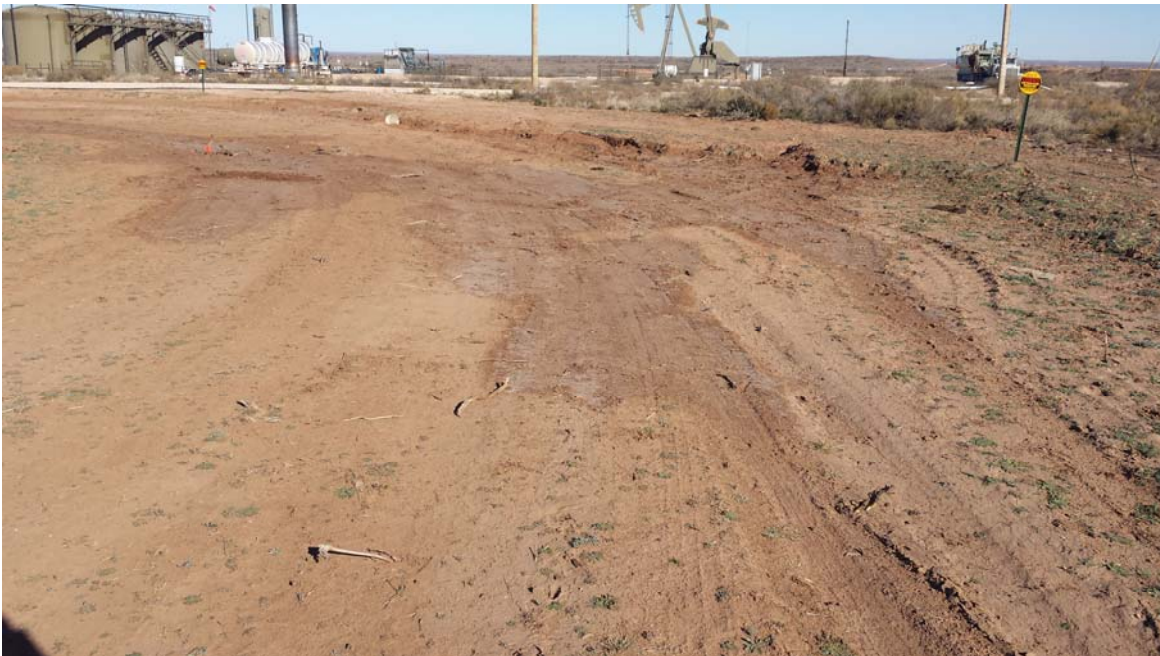
View of end of release area at Site 2 looking north-northwest.

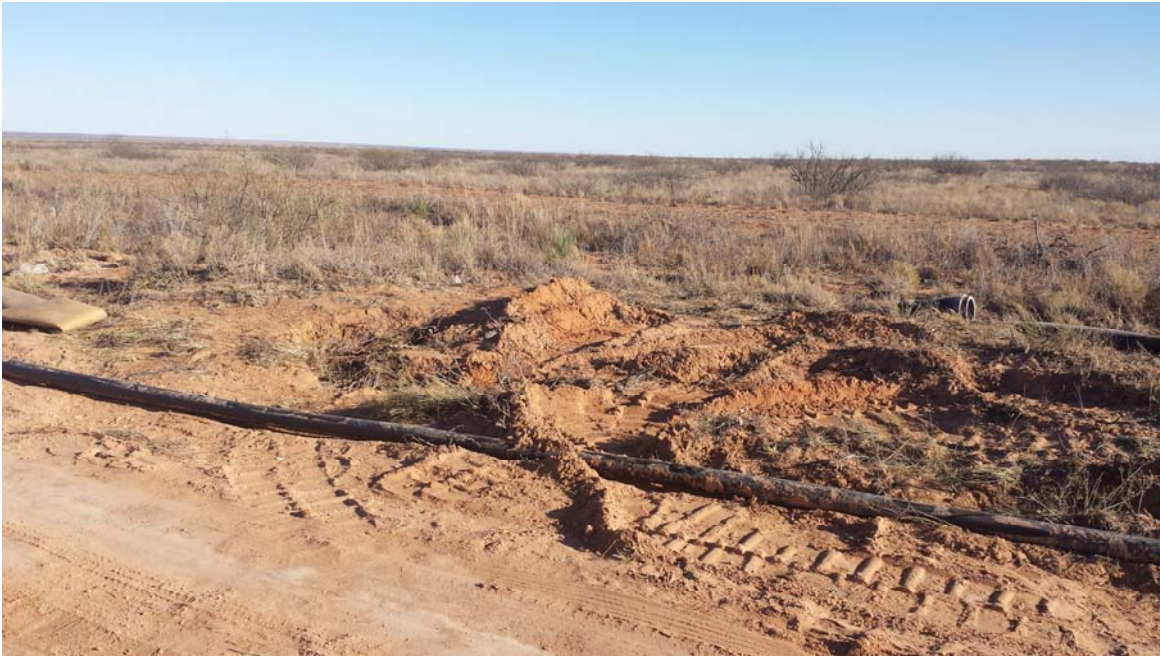
View of release location at Site 3 looking east.

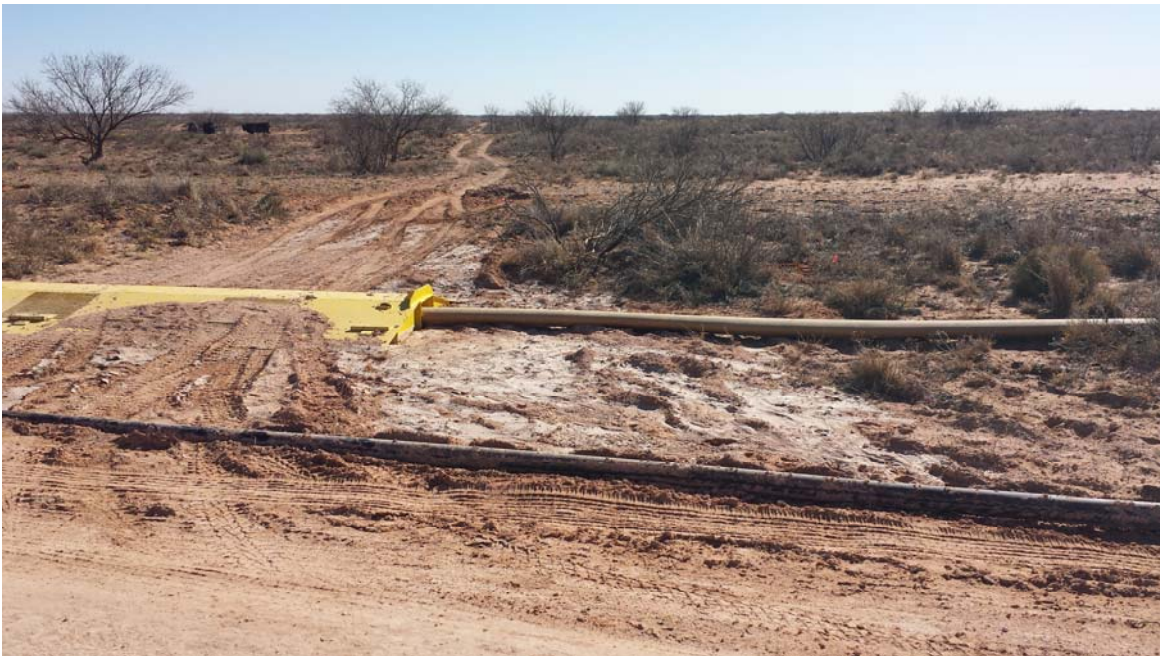
View of end of release in low lying area adjacent to lease road at Site 3, looking southeast.
