November 22, 2024

**Re: Closure Report
ConocoPhillips (COG Production, LLC)
Windward Federal #006H Flowline Release
Unit Letter D, Section 30, Township 24 South, Range 32 East
DOR: 8/27/2024
Lea County, New Mexico
Incident ID: NAPP2425330502**

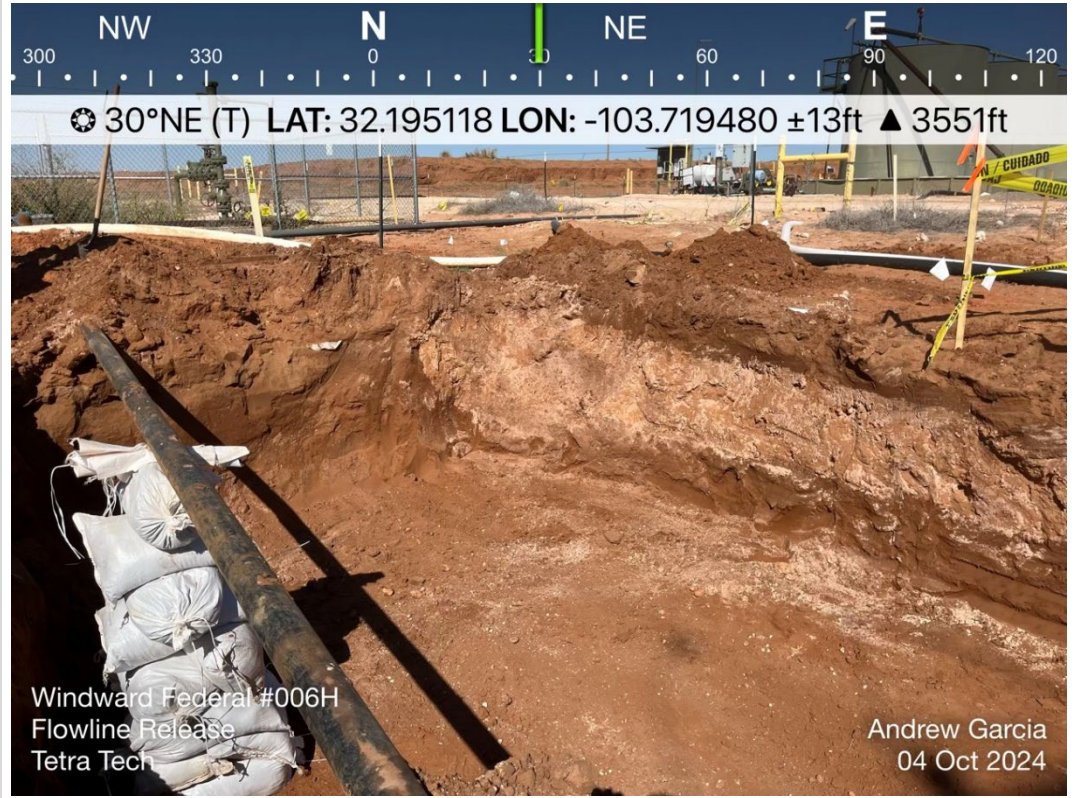
TETRA TECH, INC. PROJECT NO. 212C-MD-03643	DESCRIPTION	View northeast of release area. View of remedial activities.	2
	SITE NAME	Windward Federal #006H Release	10/4/2024

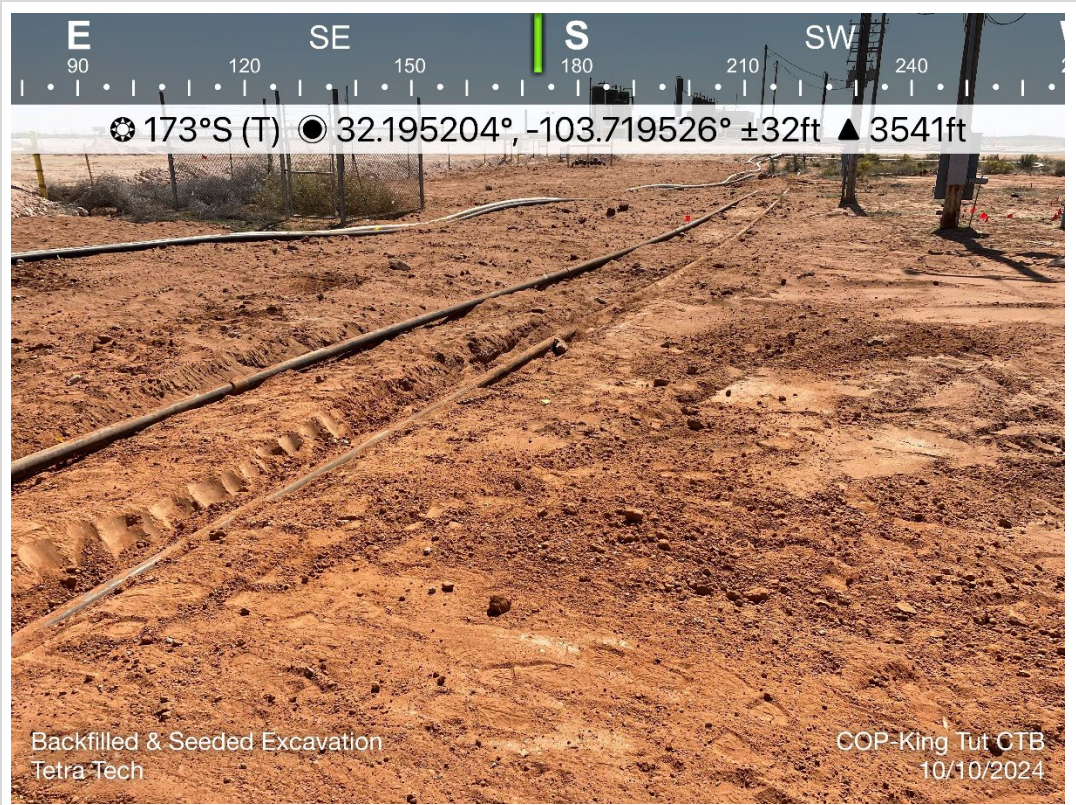
TETRA TECH, INC. PROJECT NO. 212C-MD-03643	DESCRIPTION	View south of backfilled and seeded excavation.	6
	SITE NAME	Windward Federal #006H Release	10/10/2024
