Incident Report: nAPP2325041967

Facility Name: WO Hughes #007

API Number: 30-039-23464

Subject: Incident Report and Compliance with 19.15.29 NMAC

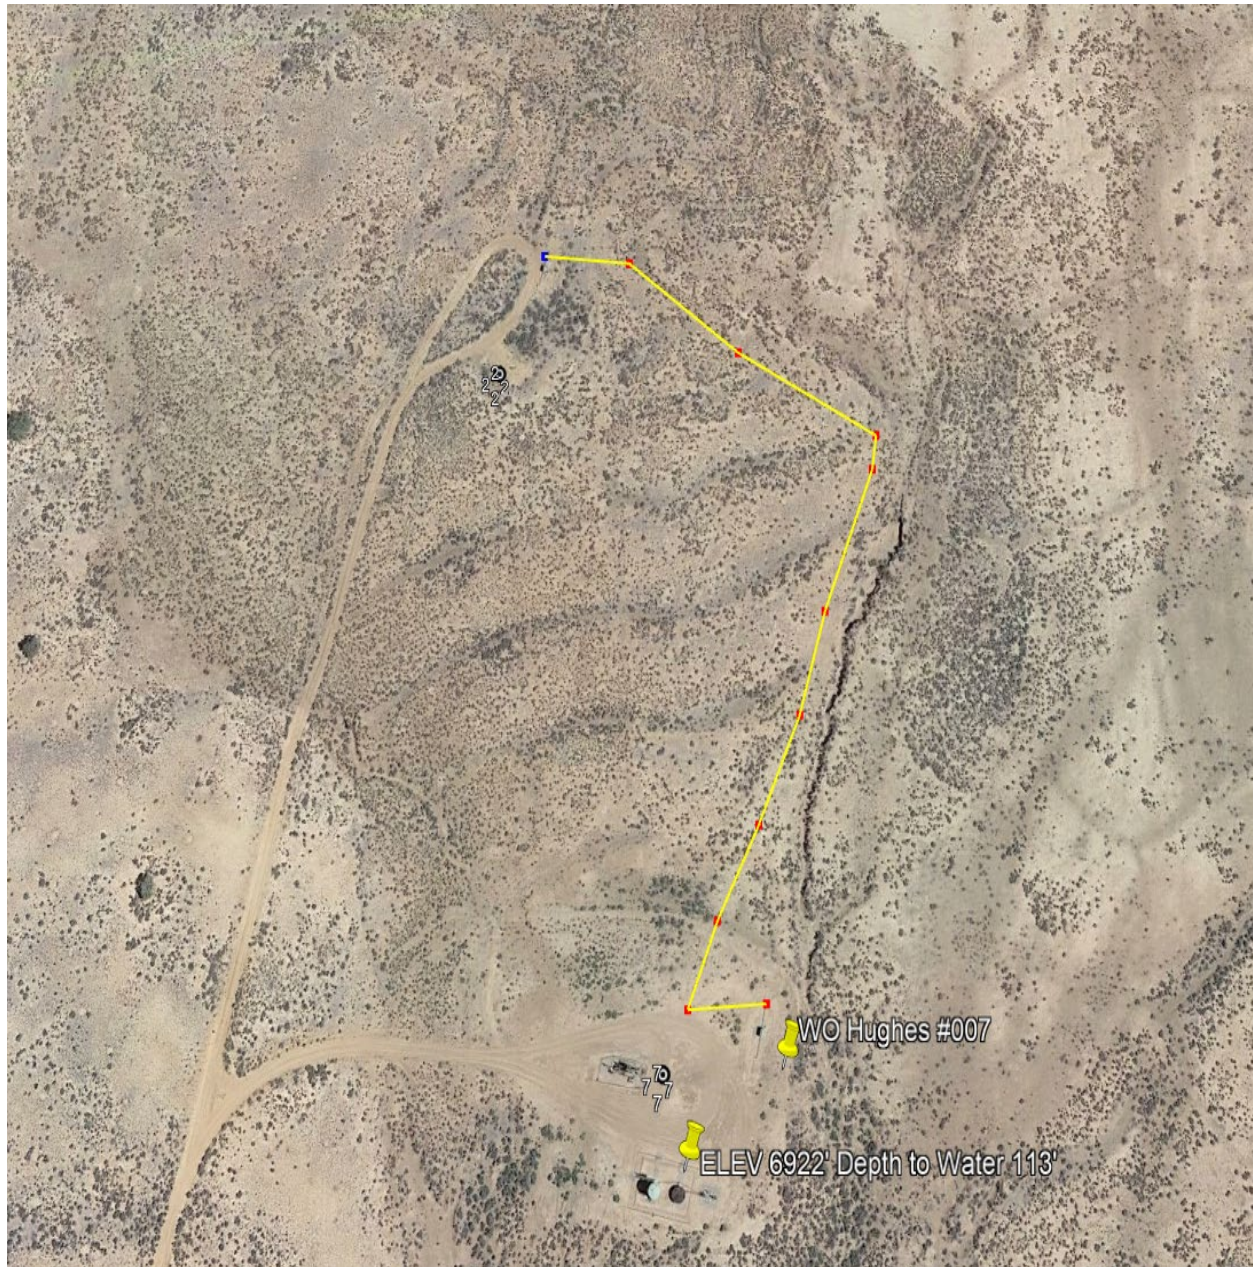
Release Area**Pipeline Area:**

Based off the El Paso Pipeline books, LOGOS has the pipeline takeaway ties into LOGOS WO Hughes #002 which is roughly 0.22 miles from the WO Hughes #007. No other pipelines are referenced in the WO Hughes #007 vicinity.

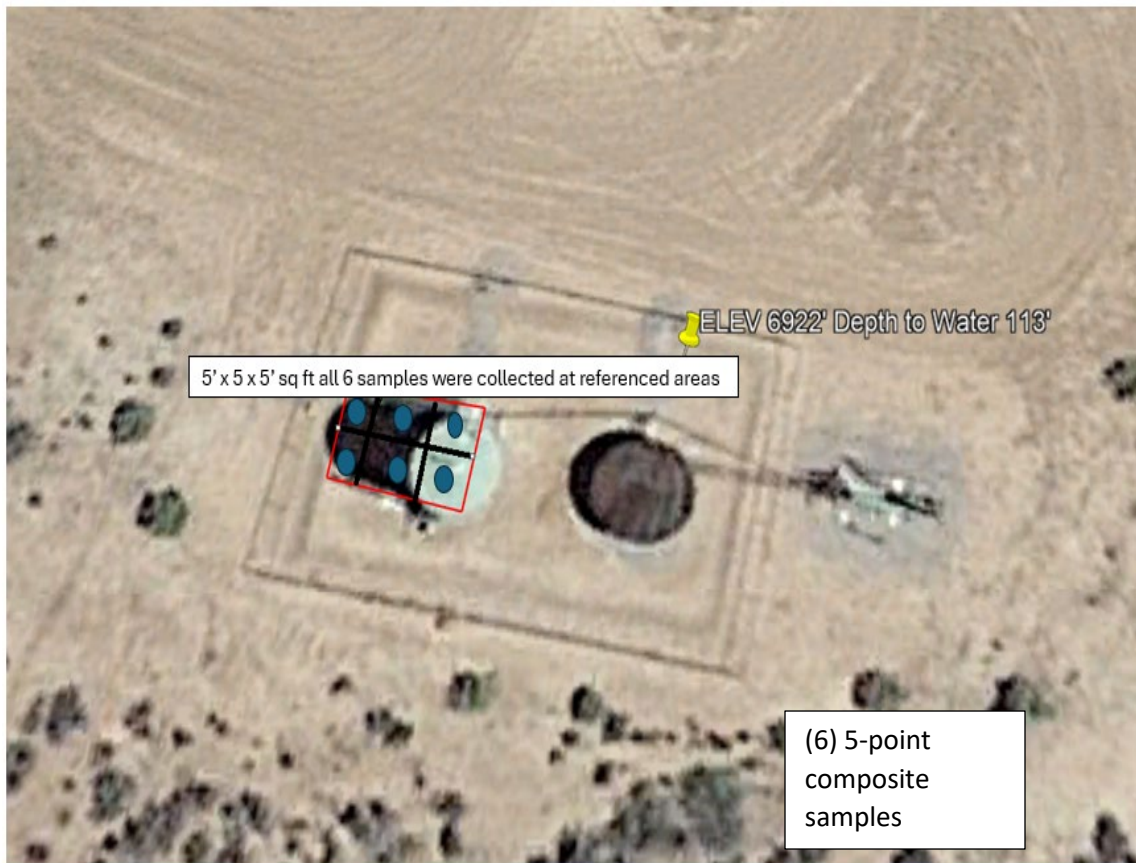
Sample Area

5 -point composite sample area on March 12, 2024 samples SB 1,SB2, SB3,SB4,SB5 and SB 6 at a depth of 4' below ground surface. Samples were collected at 200' sections

Sample SB-5 was over the regulatory requirements. LOGOS further remediated another foot in the reference area of SB-5. (One) 1 -5-point composite sampling consisting of 200sgft was collected based on the referenced photos below. A new sample was collected in the area of SB 5, and we are below regulatory requirements. Once the sample results were determined to be below regulatory requirements LOGOS backfilled the excavation area.

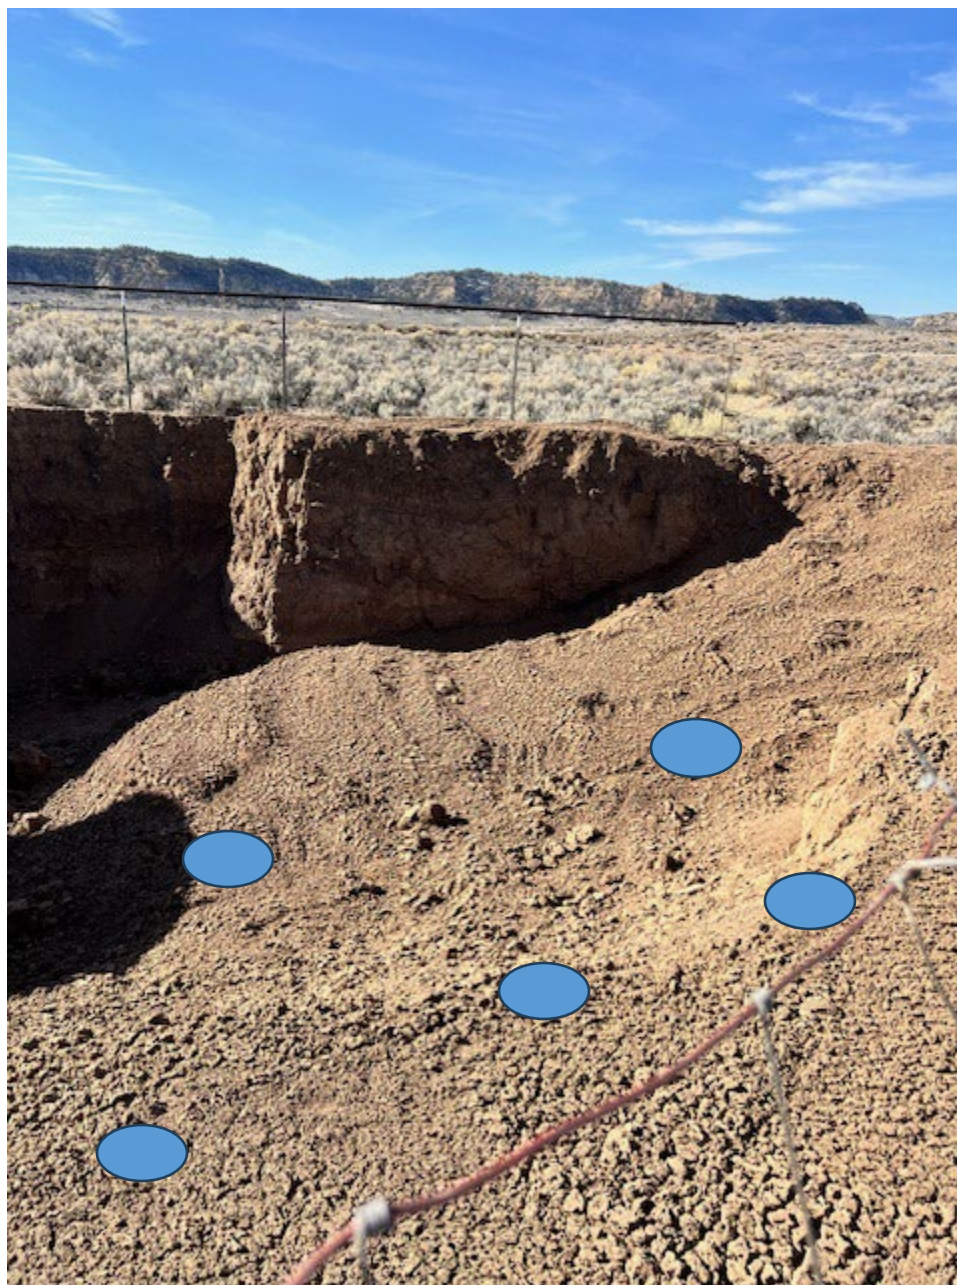
SB 6 5-point
composite sampling

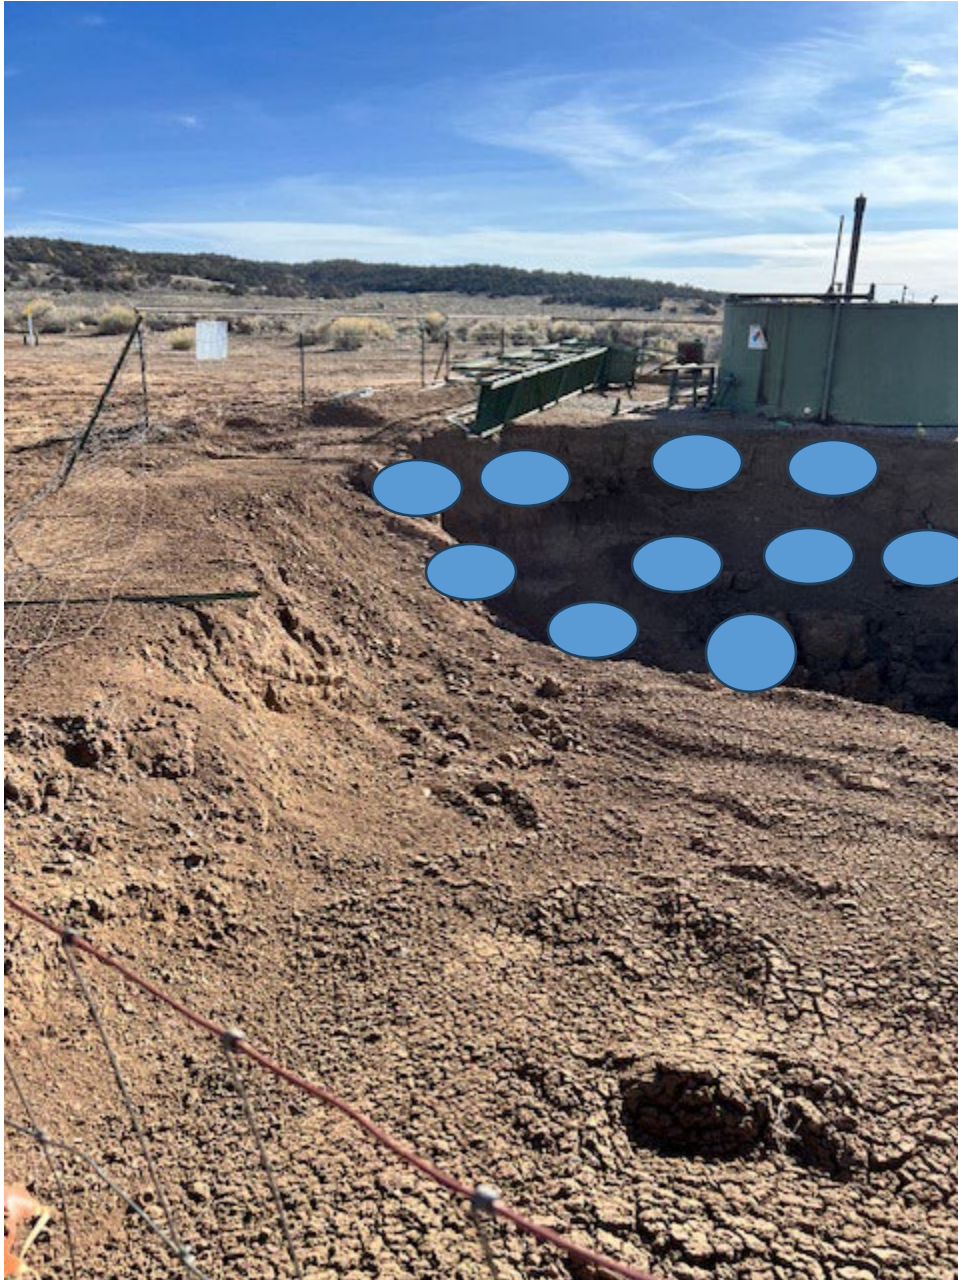
SB 3, 4 & 5 5-point
composite samples

SB 1, 2 5 5-point composite samples

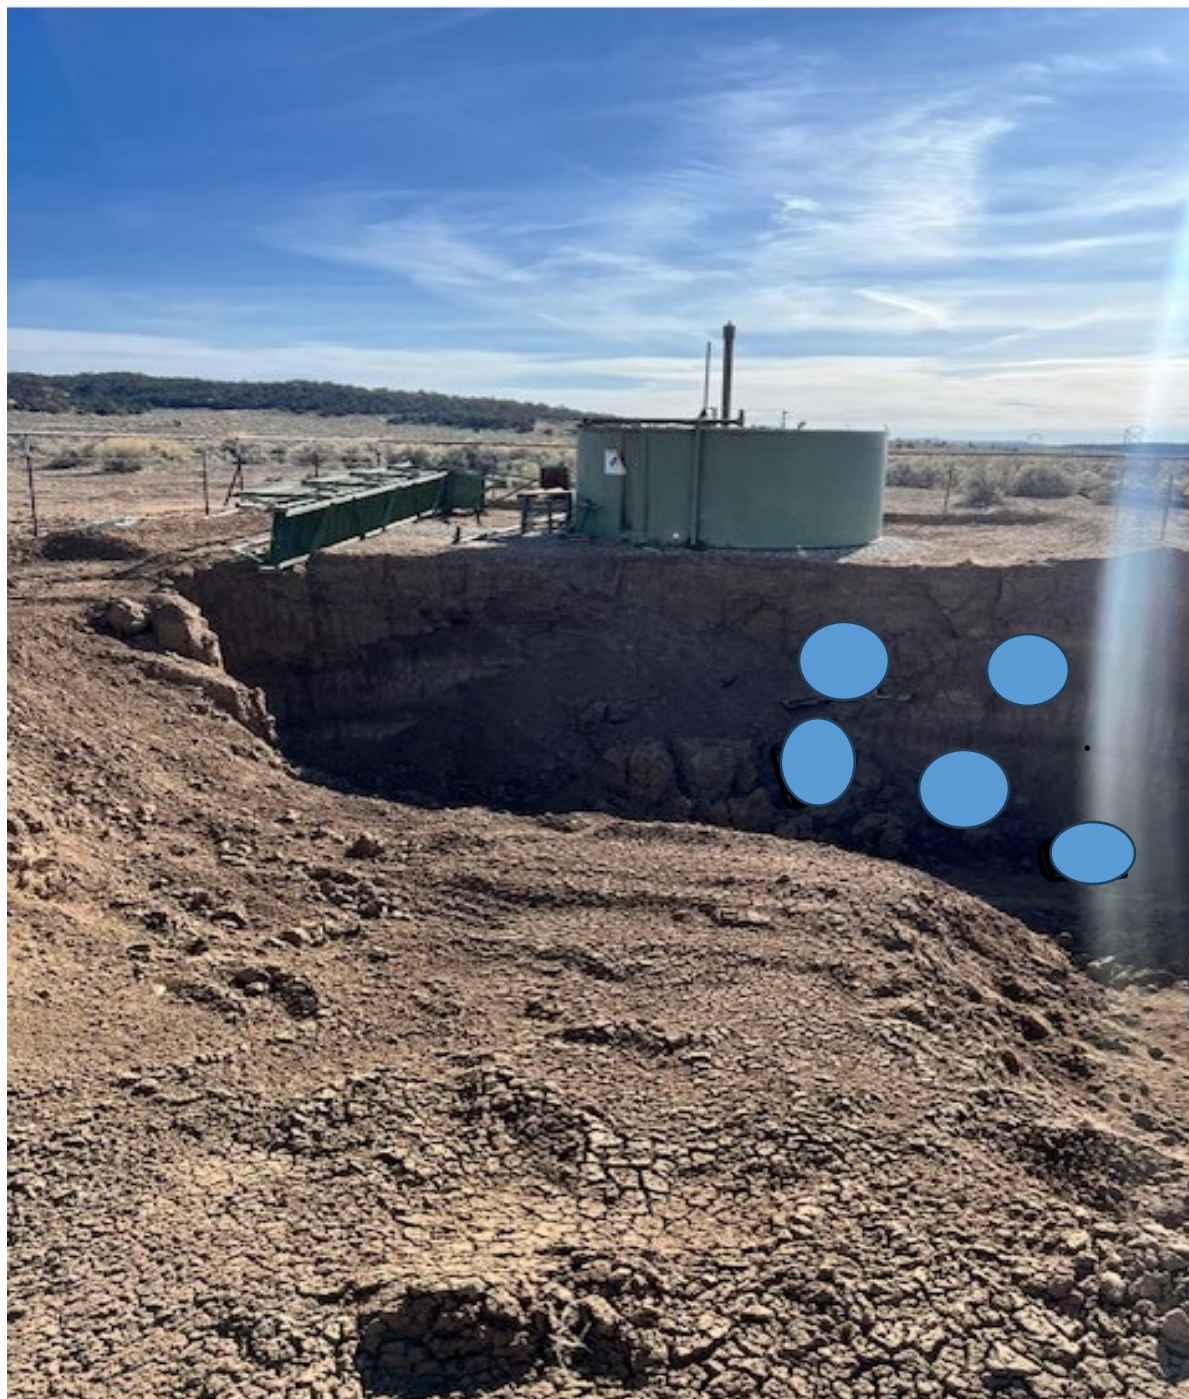
Final clean up Area

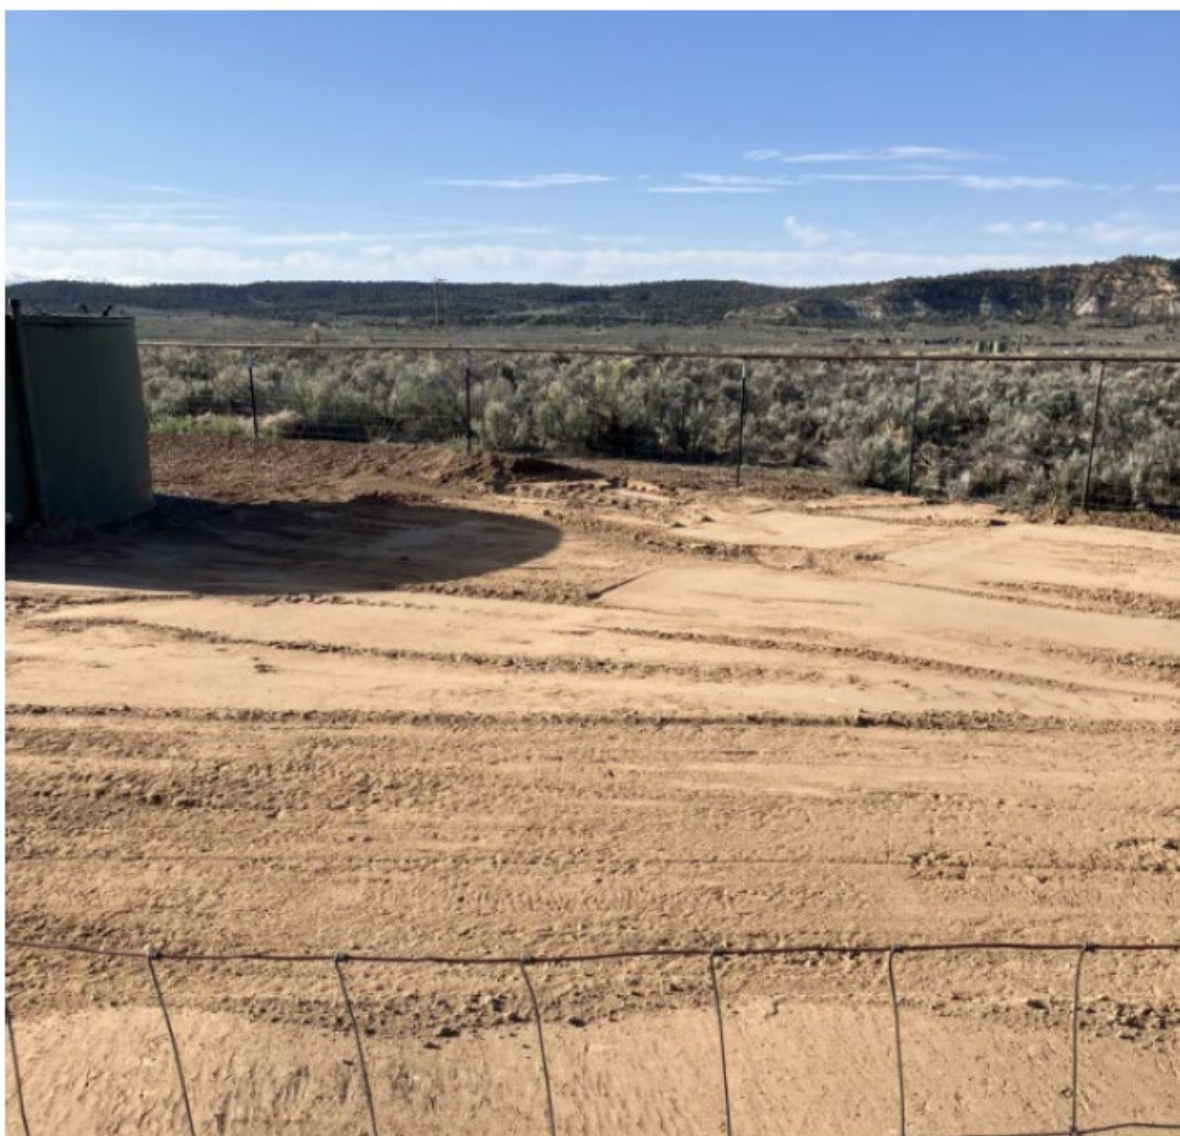
WO Hughes #007 Backfill

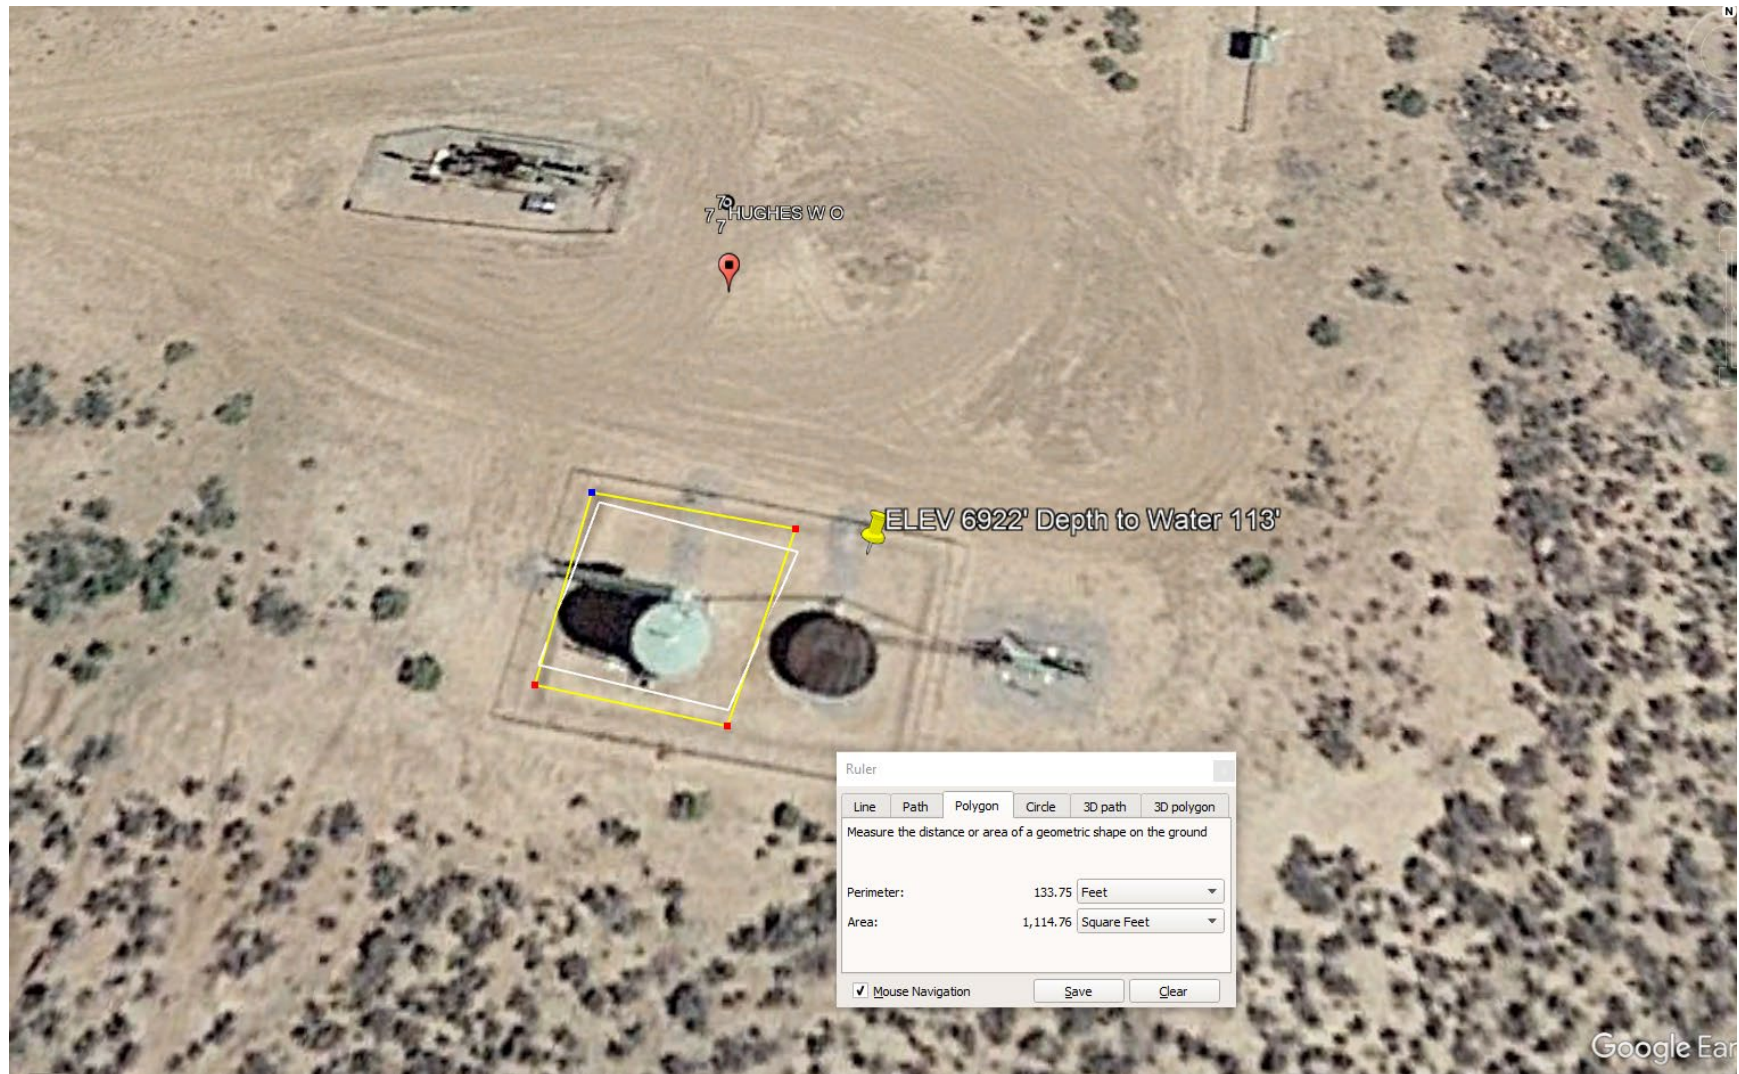
WO Hughes Depth to water 113'

- **Floodplain and Wetlands:** The site is not 300' within a floodplain or wetland.
- **Depth to Groundwater:** Jillison Federal SWD #001 Depth to groundwater is 110' below ground surface with an elevation of 6919'. The WO Hughes #007 is approximately 0.40 miles upgradient from the Jillison Federal SWD # 001 6922' making the estimated depth to groundwater at the WO Hughes #007 of 113' below ground surface.
- **Karst Features:** The area is not located above karst terrain.
- **Spring of Private Domestic Well:** The site is located 687' from a sinkhole
- **Municipal Boundaries:** The site is located more than 5 miles from a municipal boundary

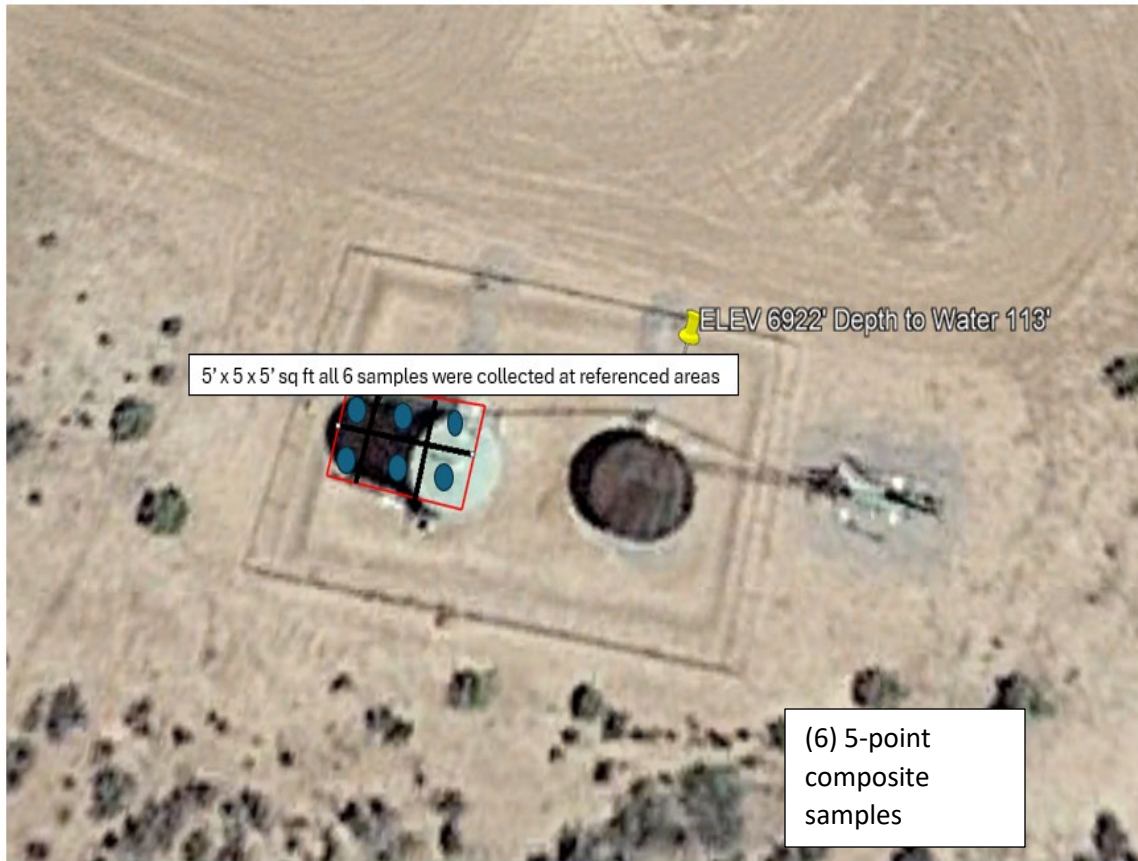
Sample Area

5 -point composite sample area on March 12, 2024 samples SB 1,SB2, SB3,SB4,SB5 and SB 6 at a depth of 4' below ground surface. Samples were collected at 200' sections

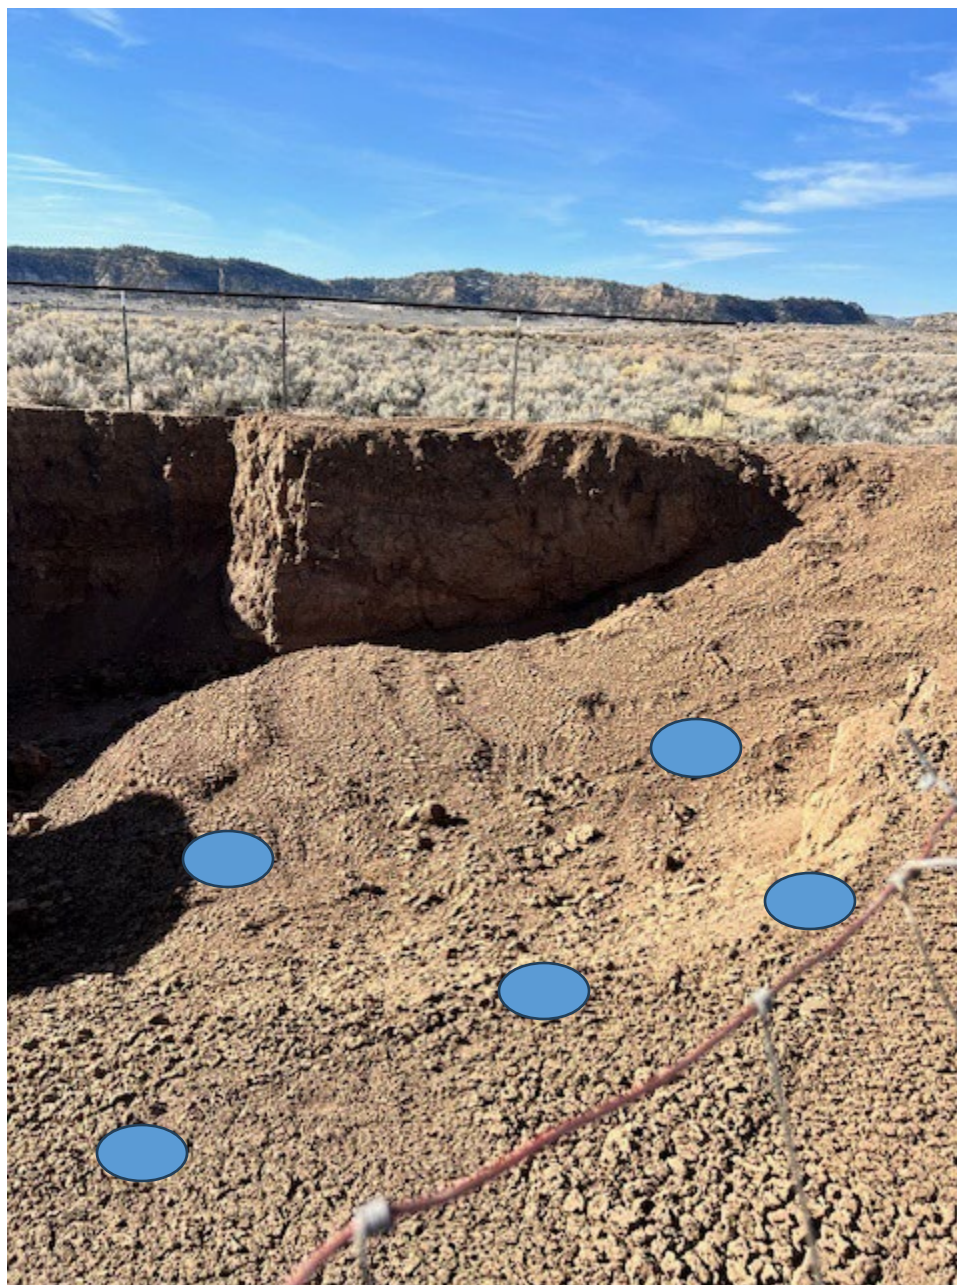
SB 6 5-point
composite sampling

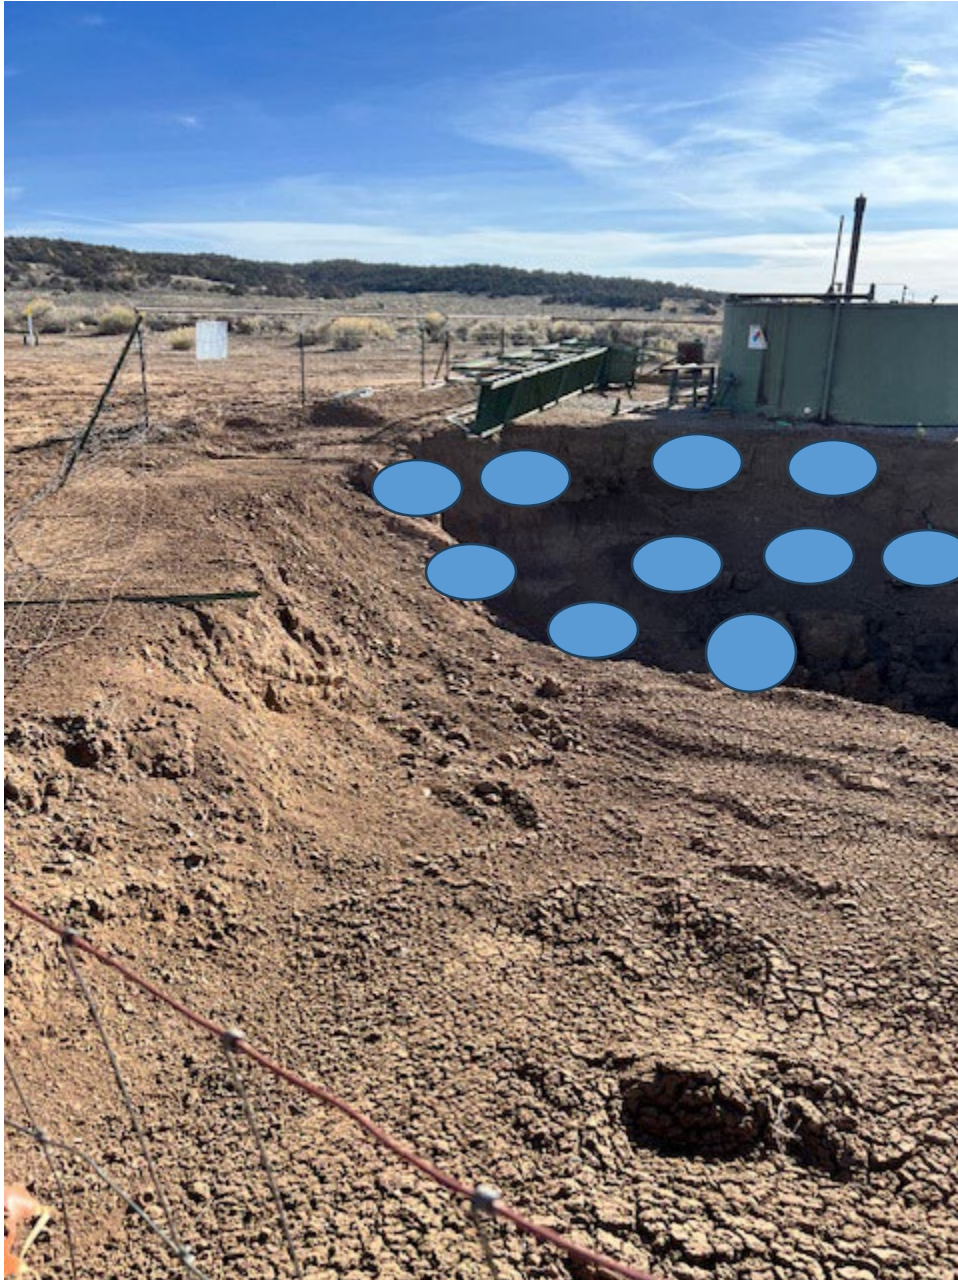
SB 3, 4 & 5 5-point
composite samples

SB 1, 2 5 5-point composite samples

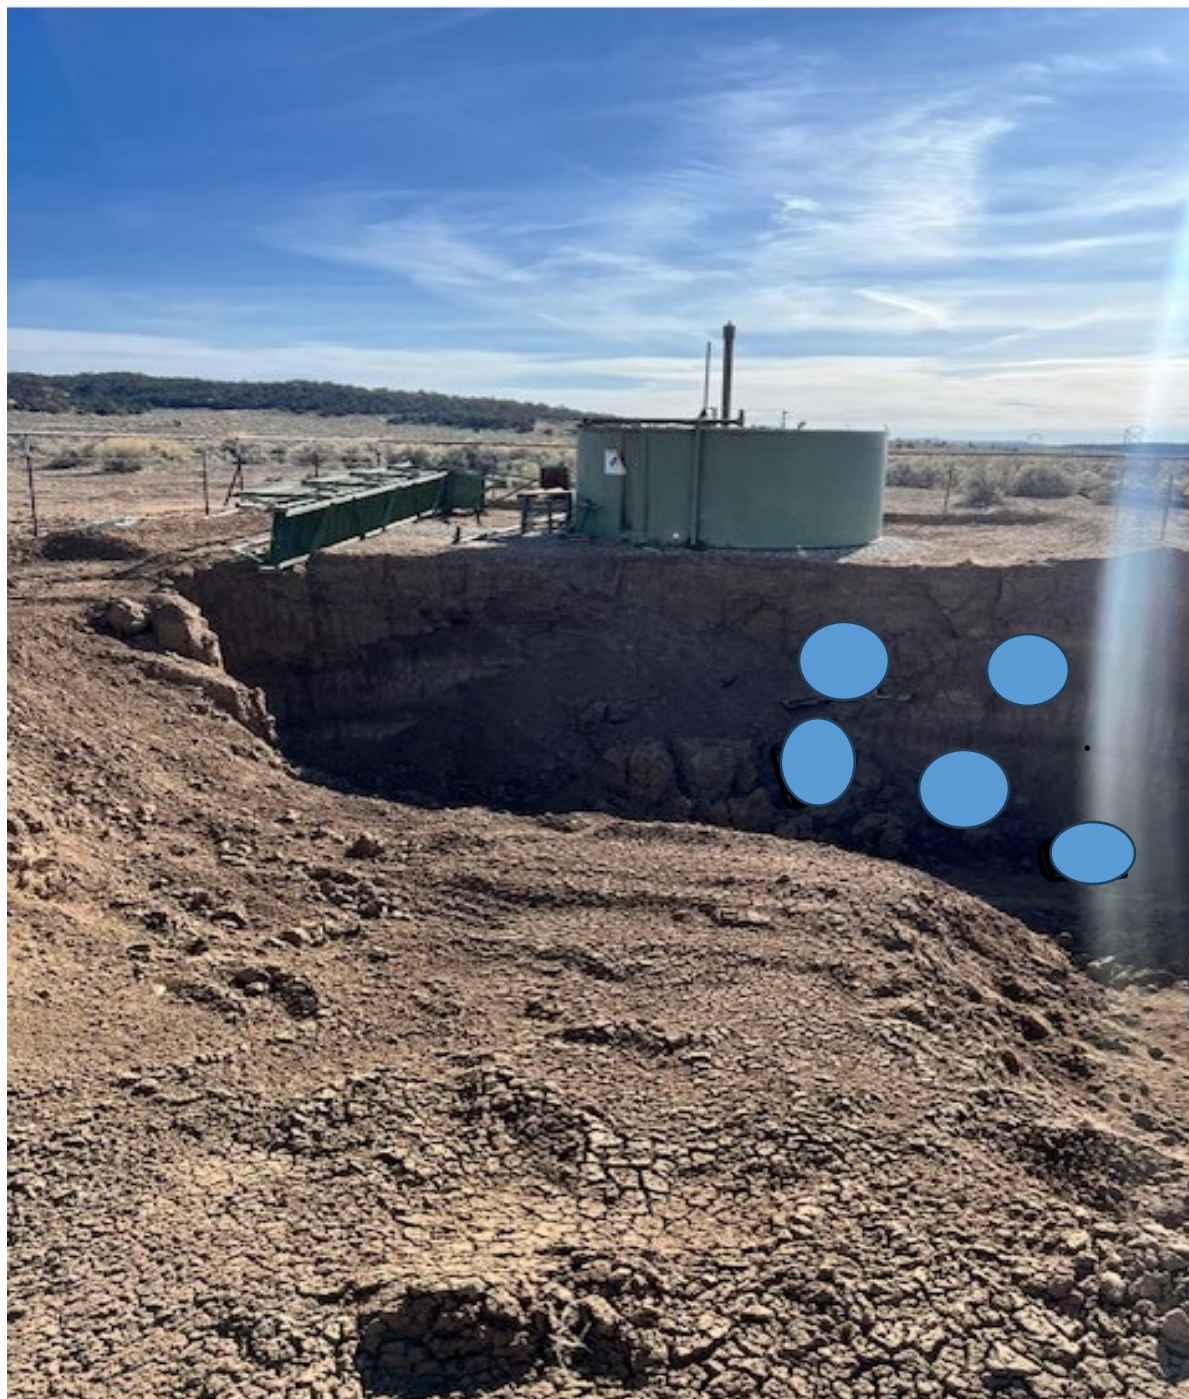
Final clean up Area

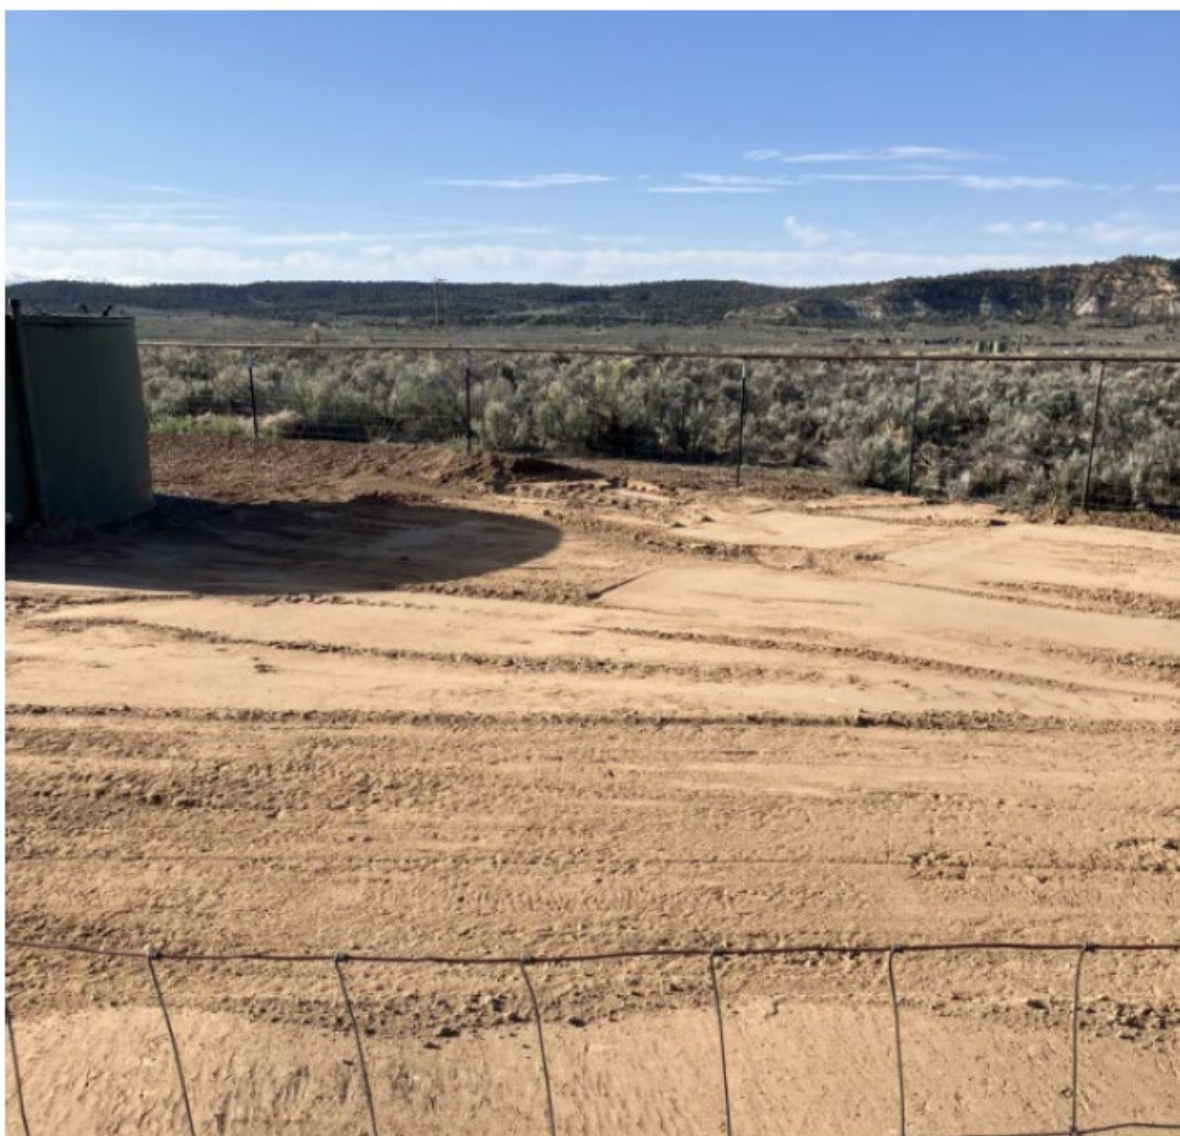
WO Hughes #007 Backfill

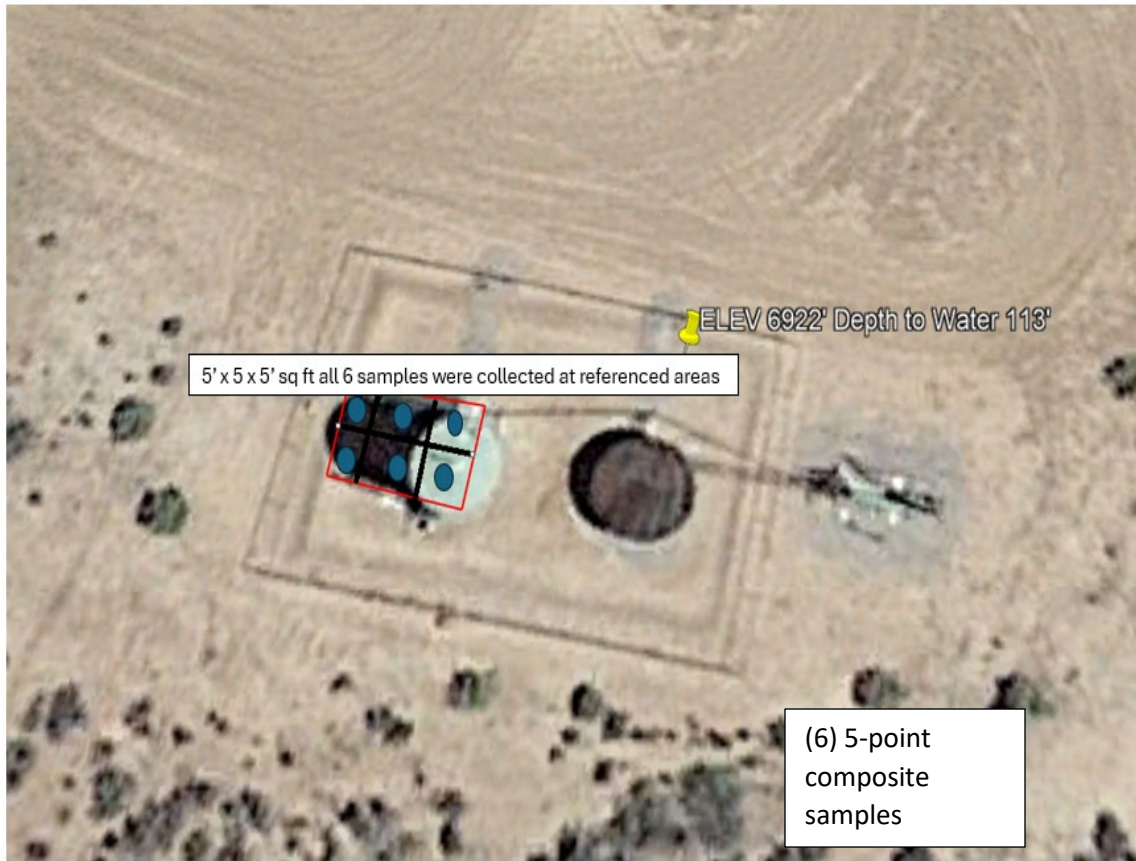
Sample Area

5 -point composite sample area on March 12, 2024 samples SB 1,SB2, SB3,SB4,SB5 and SB 6 at a depth of 4' below ground surface. Samples were collected at 200' sections

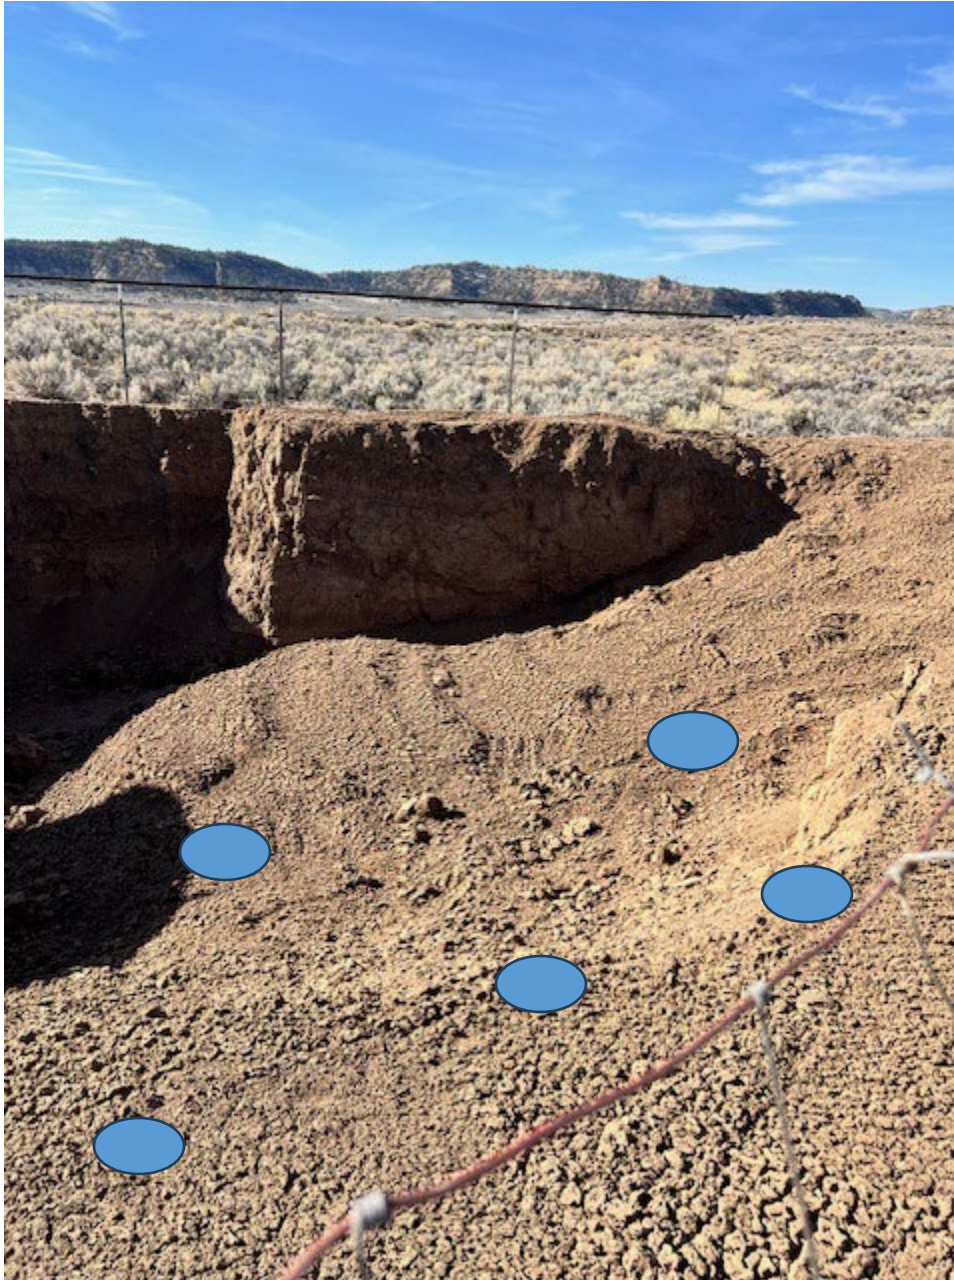
SB 6 5-point
composite sampling

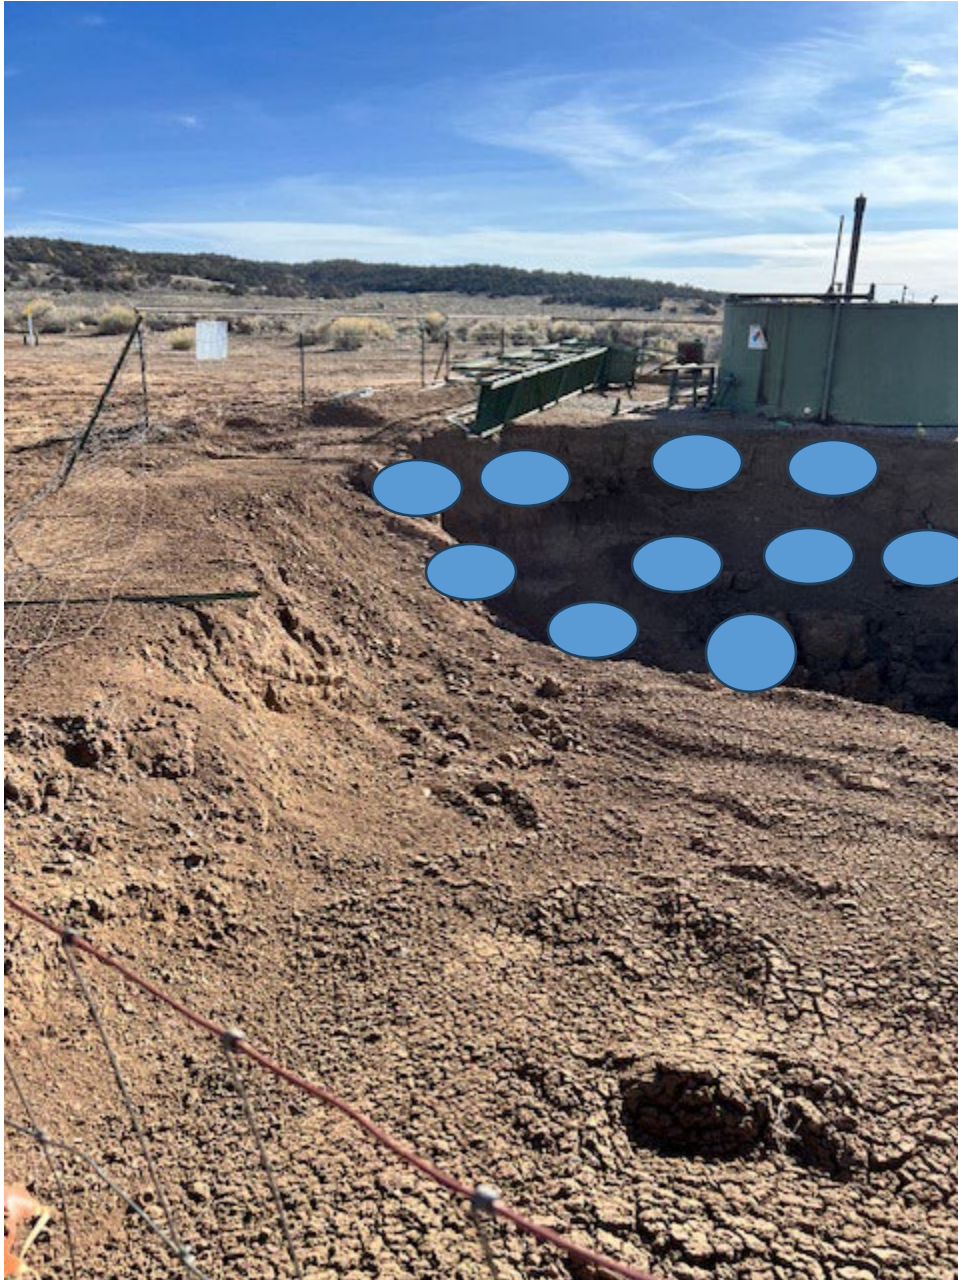
SB 3, 4 & 5 5-point
composite samples

SB 1, 2 5 5-point composite samples

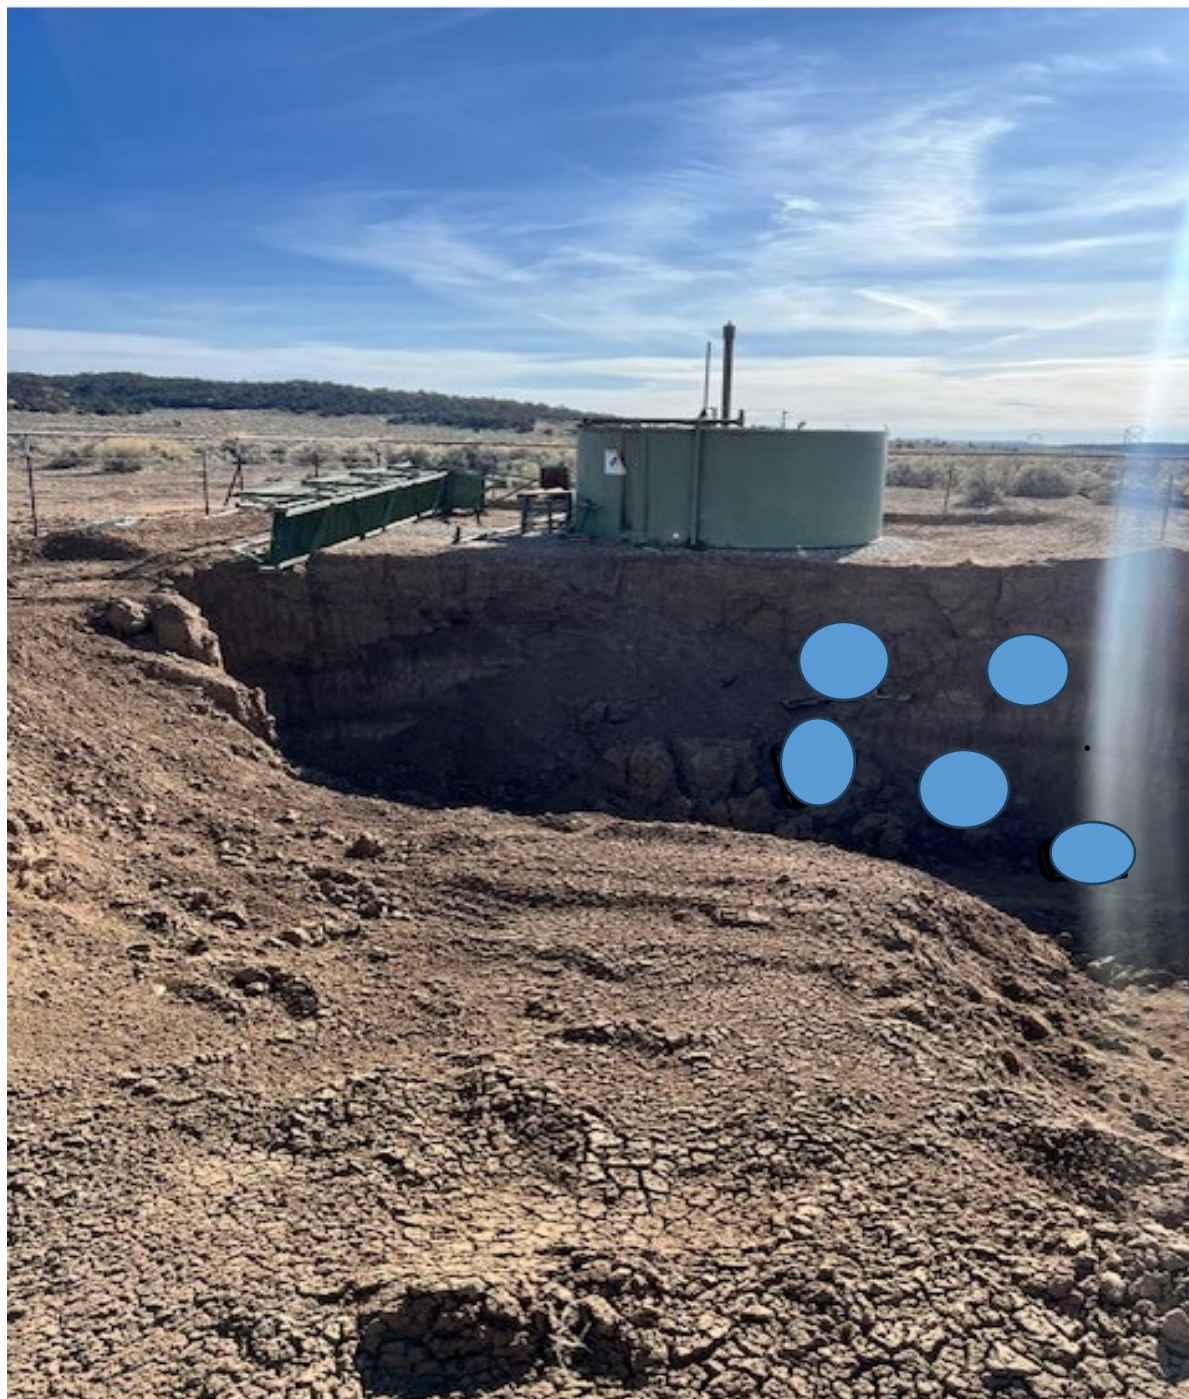
Final clean up Area
