Incident Report: nAPP2325041967

Facility Name: WO Hughes #007

API Number: 30-039-23464

Subject: Incident Report and Compliance with 19.15.29 NMAC

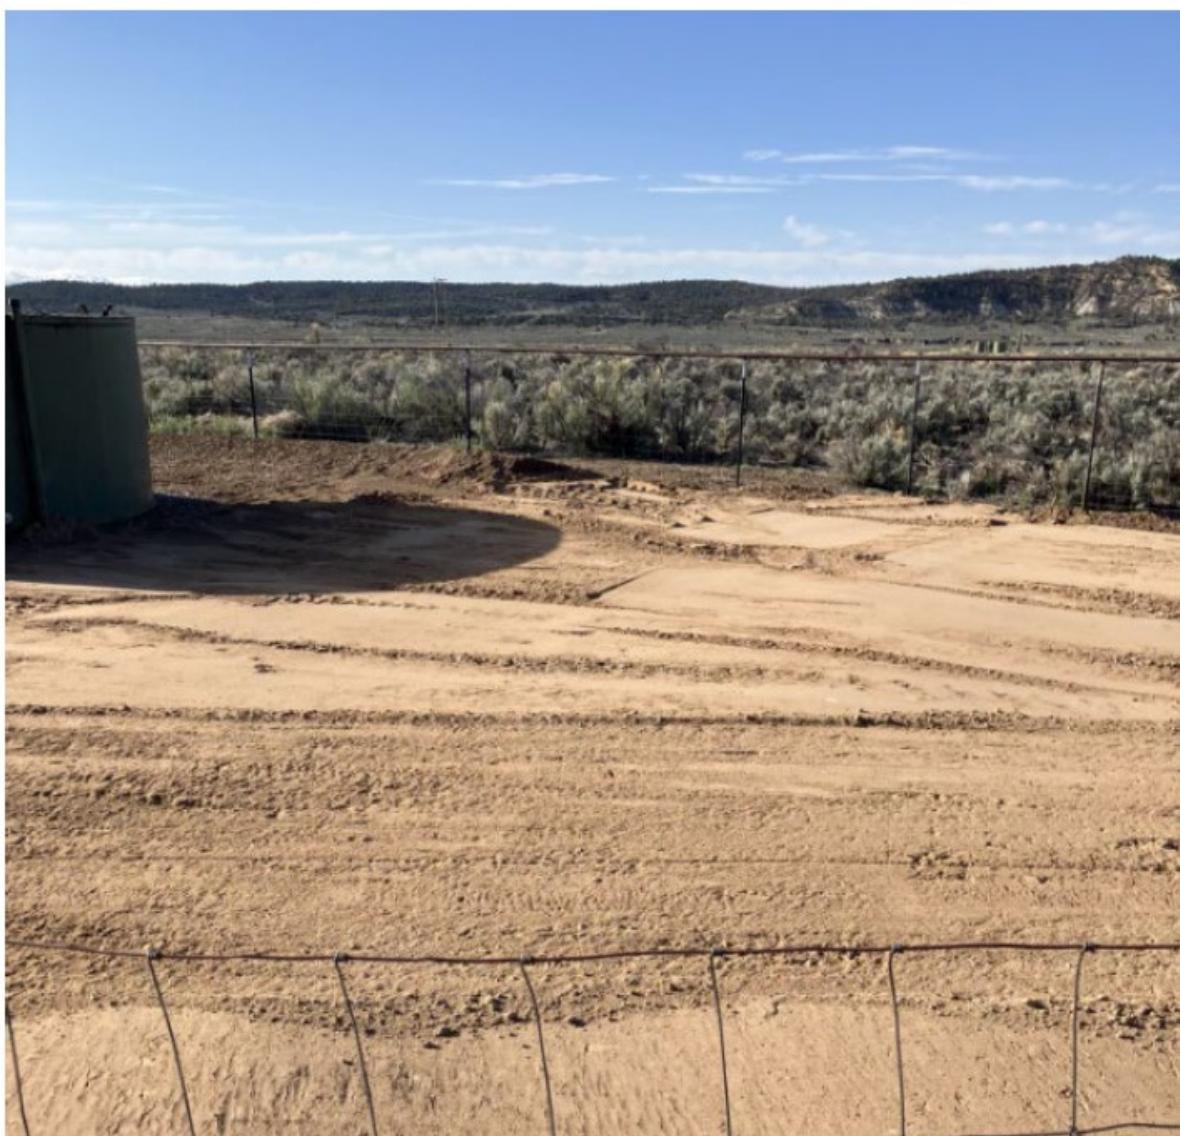
WO Hughes #007 Backfill
