CLOSURE REPORT

Gallegos Canyon Unit #55 (08/26/24)
Unit Letter G, S35 T28N R12W
San Juan County, New Mexico

New Mexico EMNRD OCD Incident ID No. NAPP2423945301

Ensolum Project No. 05A12263331

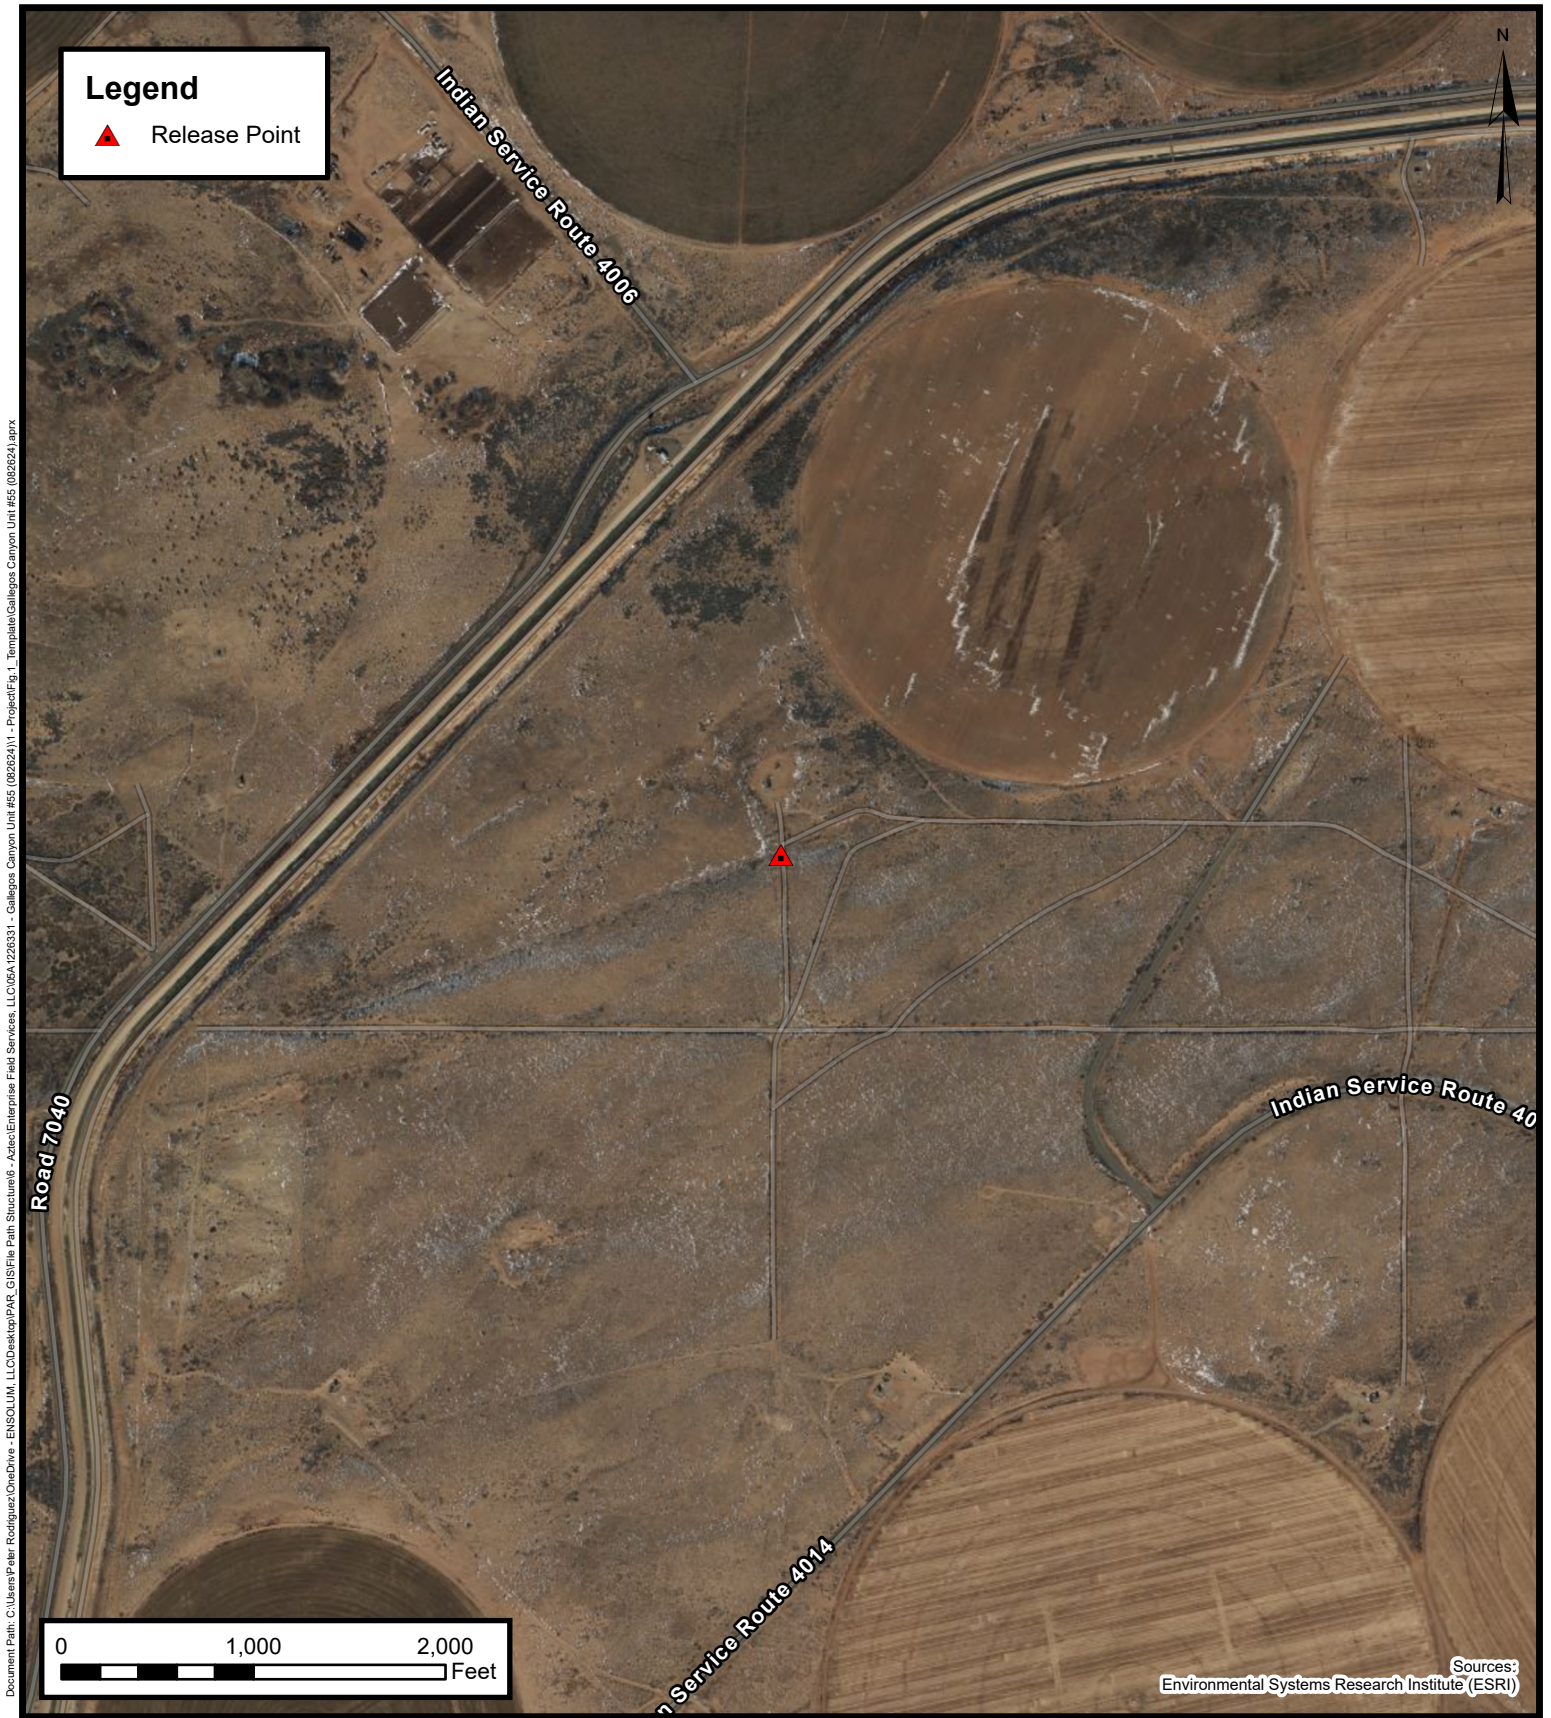
Site Vicinity Map

A **Topographic Map** depicting the location of the Site is included as **Figure 1**, and a **Site Vicinity Map** is included as **Figure 2** in **Appendix A**.

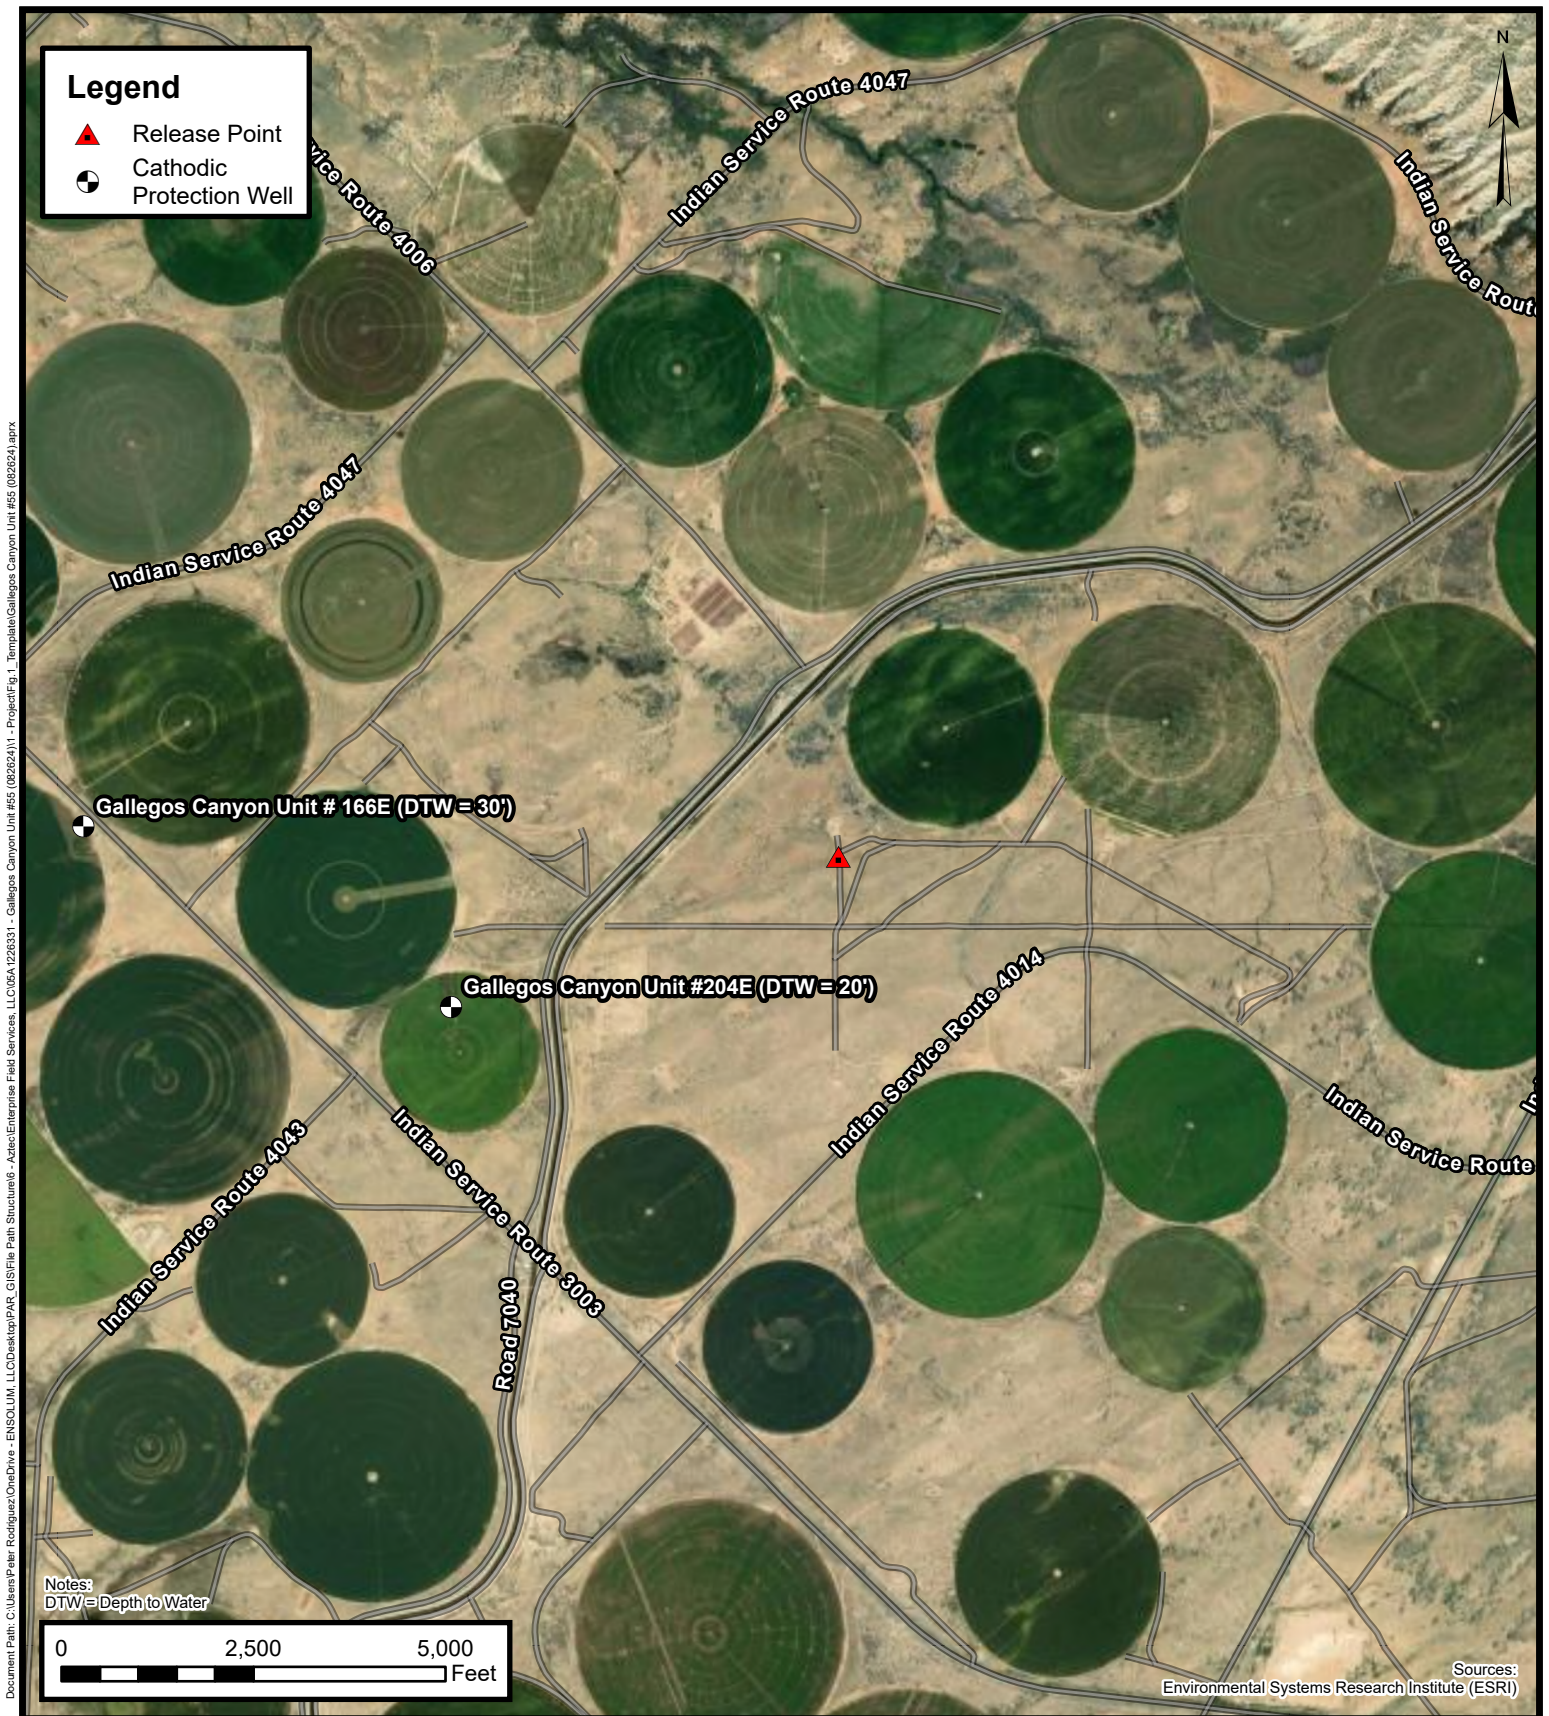
FIGURE
B

Cathodic Protection Well Recorded Depth to Water

same PLSS section as the Site. These CPWs are depicted on **Figure B (Appendix B)**. Documentation for the closest CPW, located near the Gallegos Canyon Unit #204E production pad, indicates a depth to water of 20 feet below grade surface (bgs). This CPW is located approximately 0.82 miles west of the Site and is approximately 82 feet lower in elevation than the Site. Documentation for the CPW located near the Gallegos Canyon Unit #166E production pad indicates a depth to water of 30 feet bgs. This CPW is located approximately 1.49 miles west of the Site and is approximately 170 feet lower in elevation than the Site.

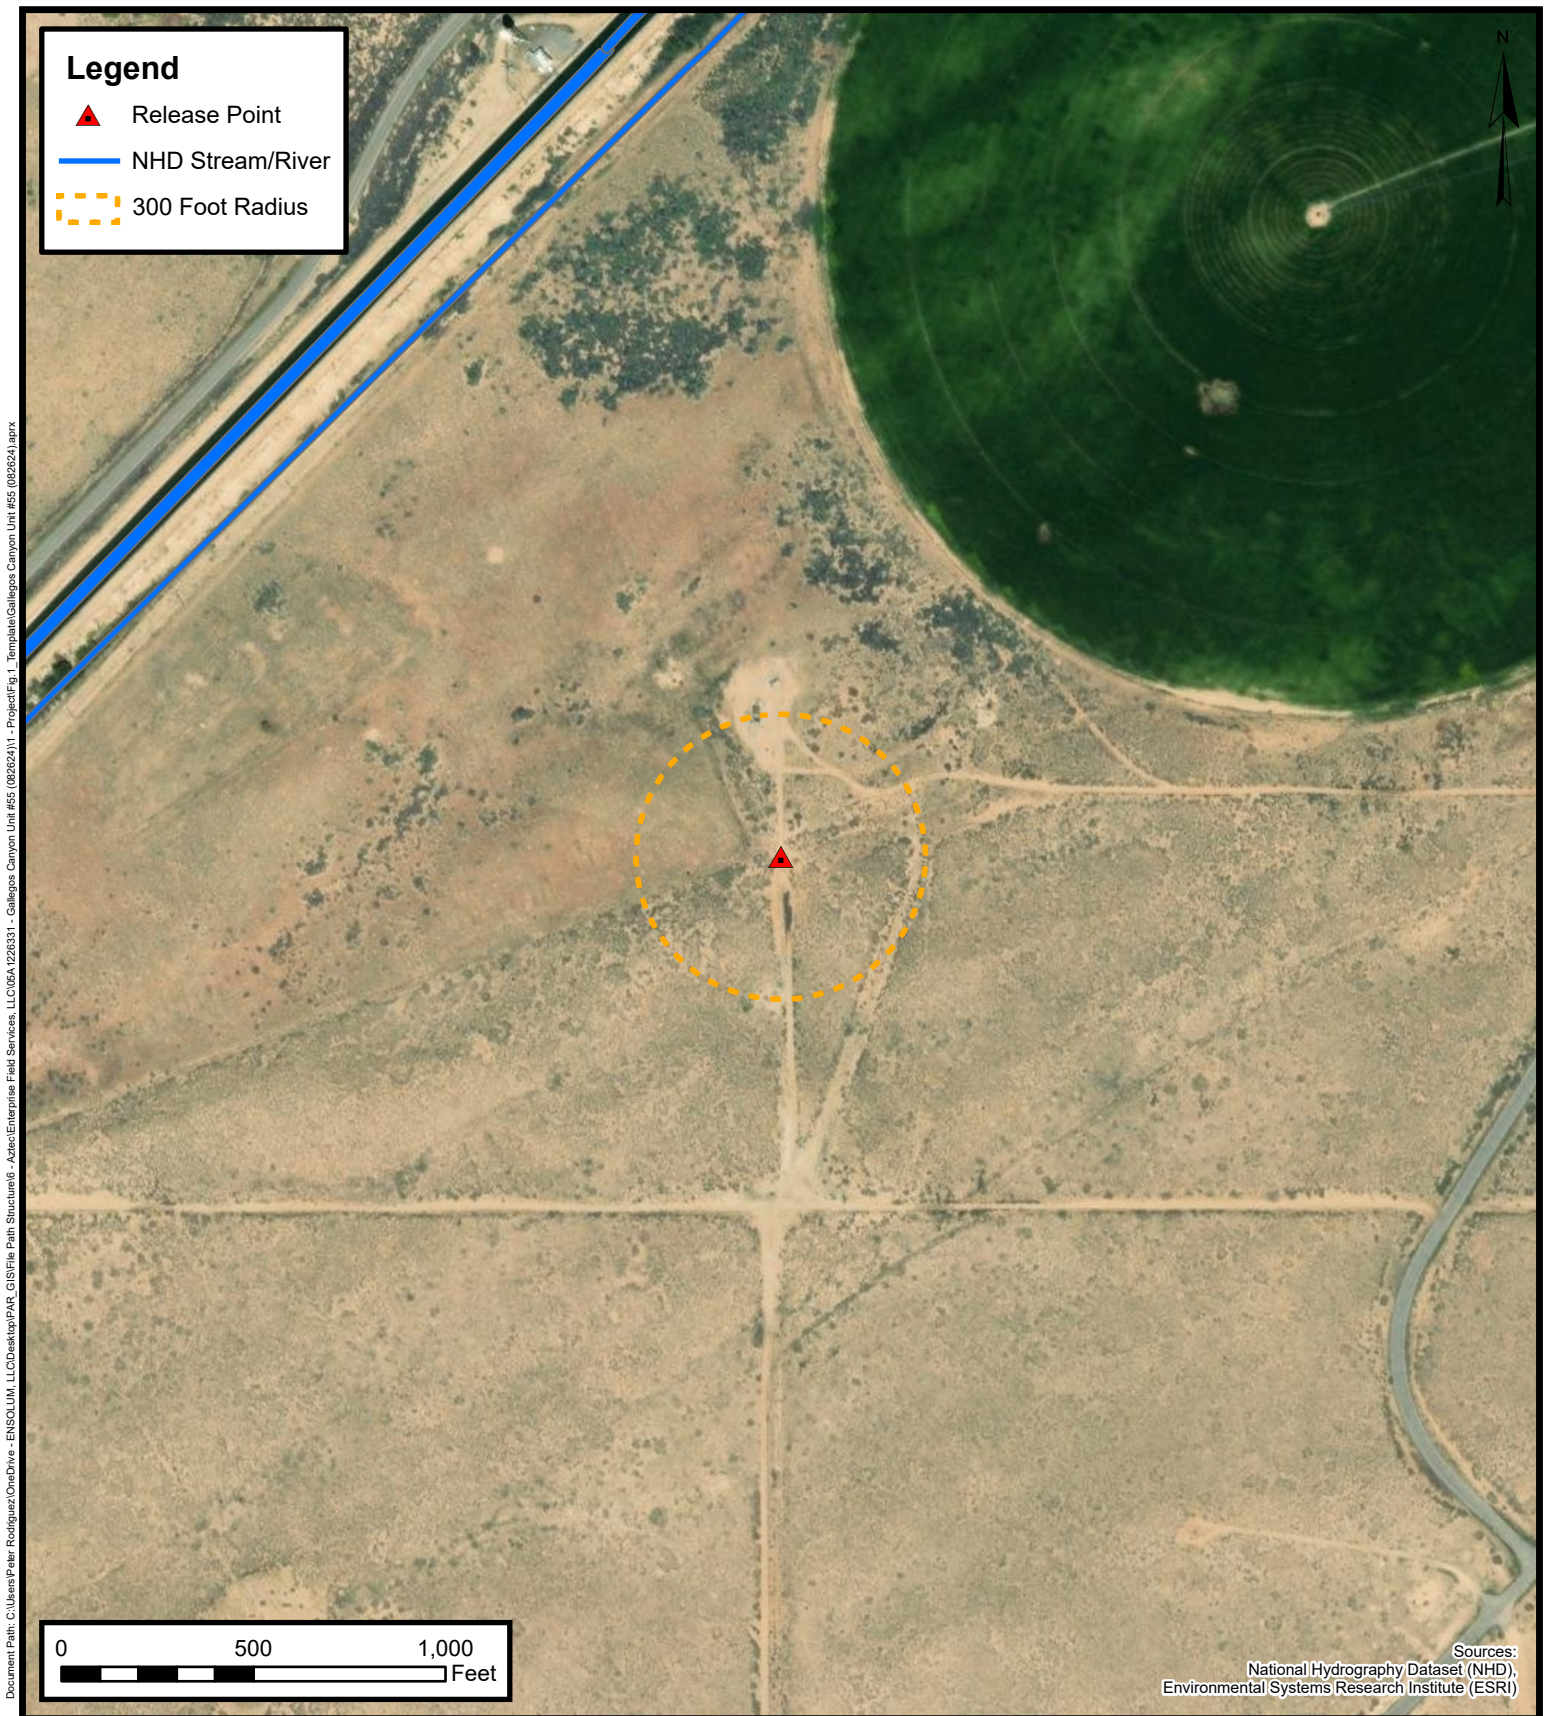
FIGURE
C

300 Foot Radius Watercourse and Drainage Identification

- The Site is not located within 300 feet of a NM EMNRD OCD-defined significant watercourse (**Figure C, Appendix B**).
- The Site is not located within 200 feet of a lakebed, sinkhole, or playa lake.

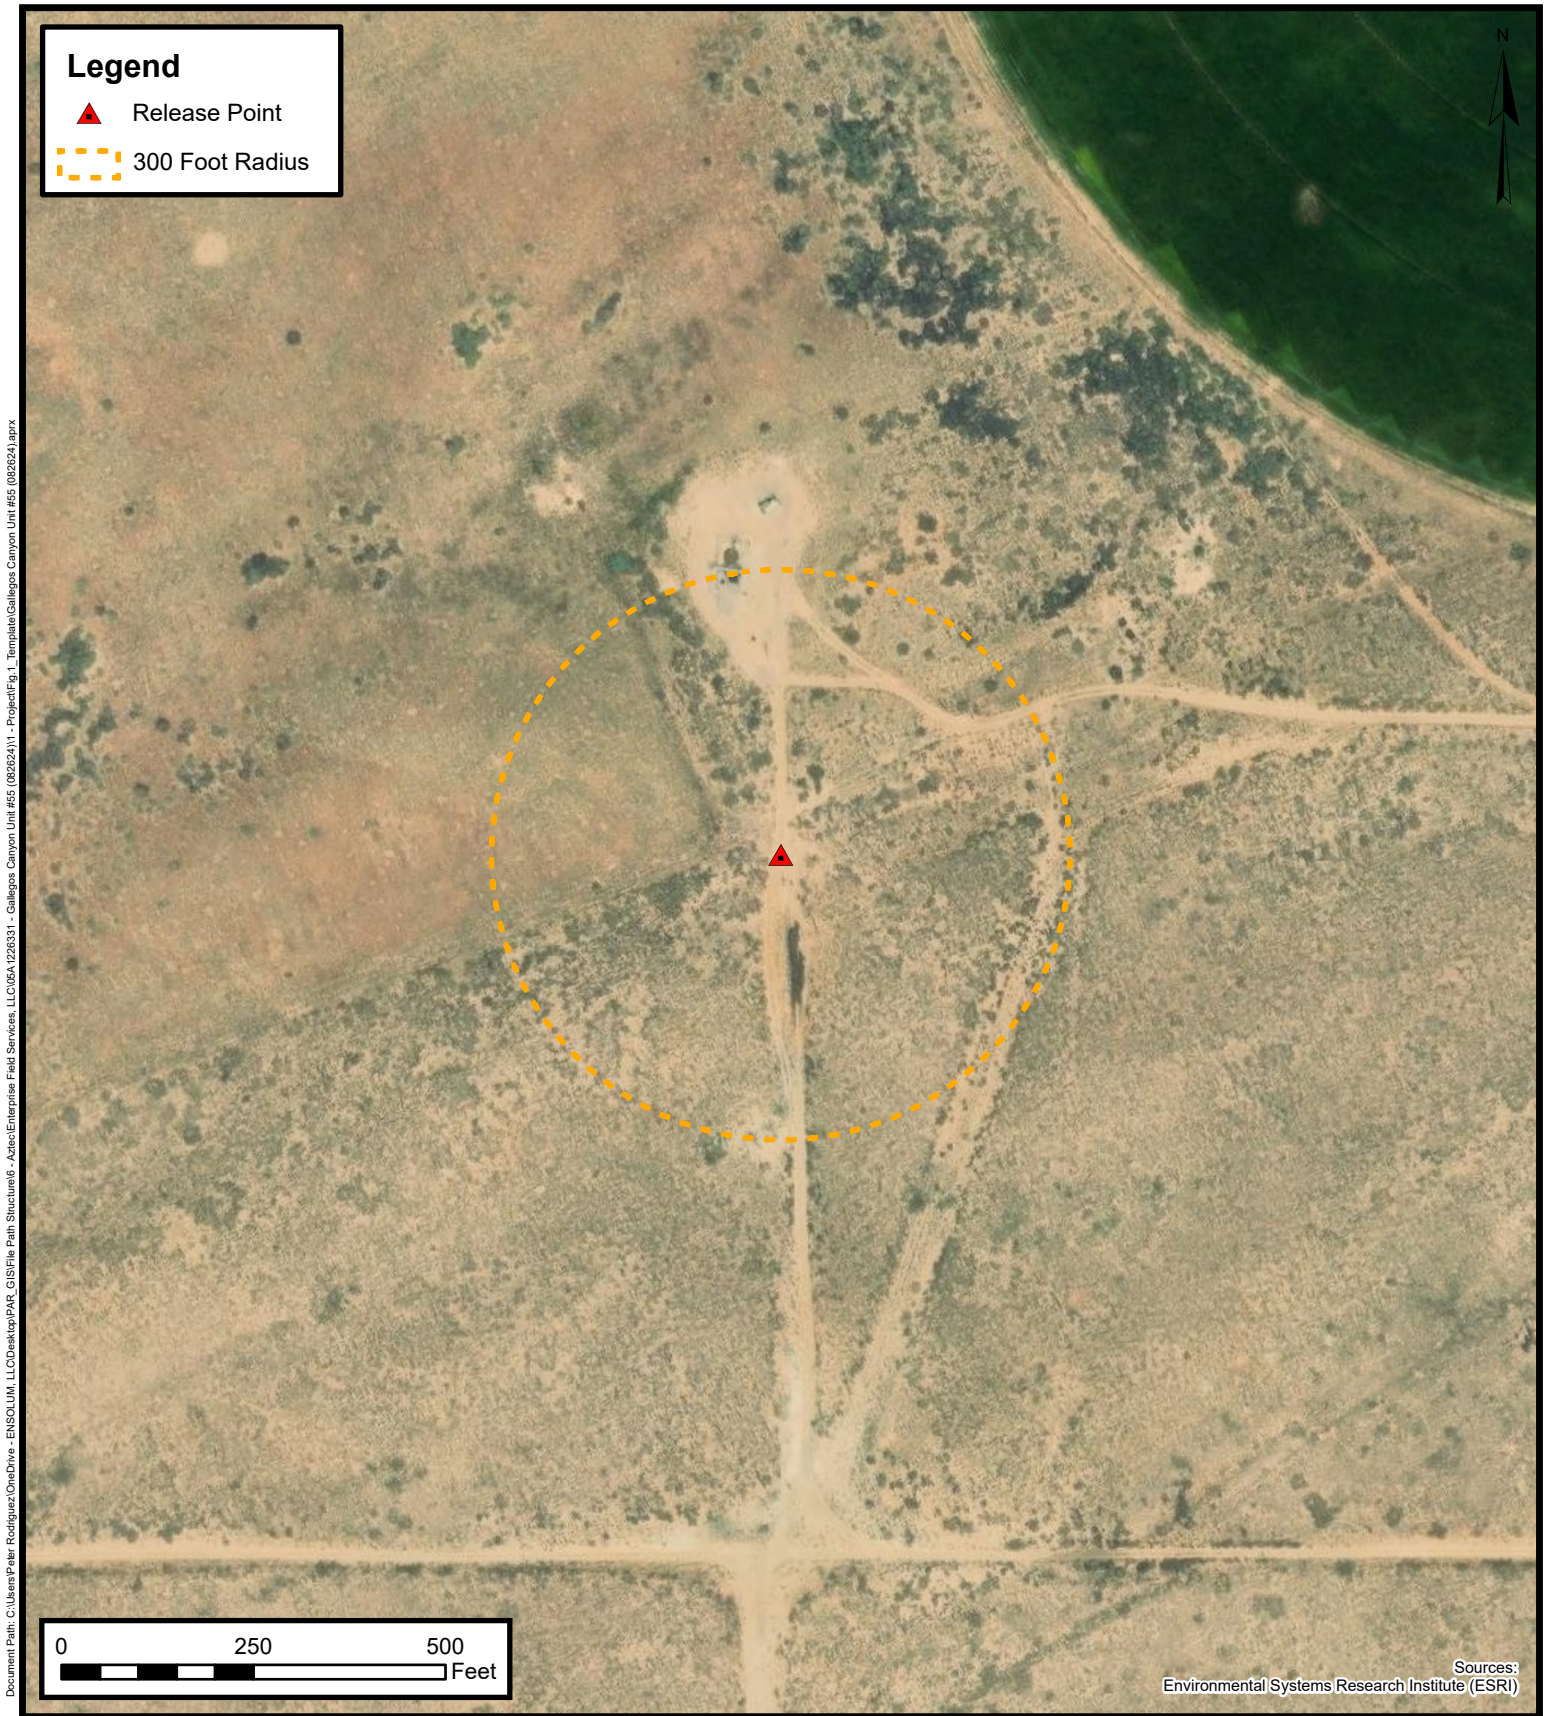
**FIGURE
D**

**300 Foot Radius Occupied
Structure Identification**
Enterprise Field Services, LLC
Gallegos Canyon Unit #55 (08/26/24)
Project Number: 05A1226331

- The Site is not located within 300 feet of a permanent residence, school, hospital, institution, or church (**Figure D, Appendix B**).
- No springs, or private domestic freshwater wells used by less than five households for domestic or stock watering purposes were identified within 500 feet of the Site (**Figure E, Appendix B**).

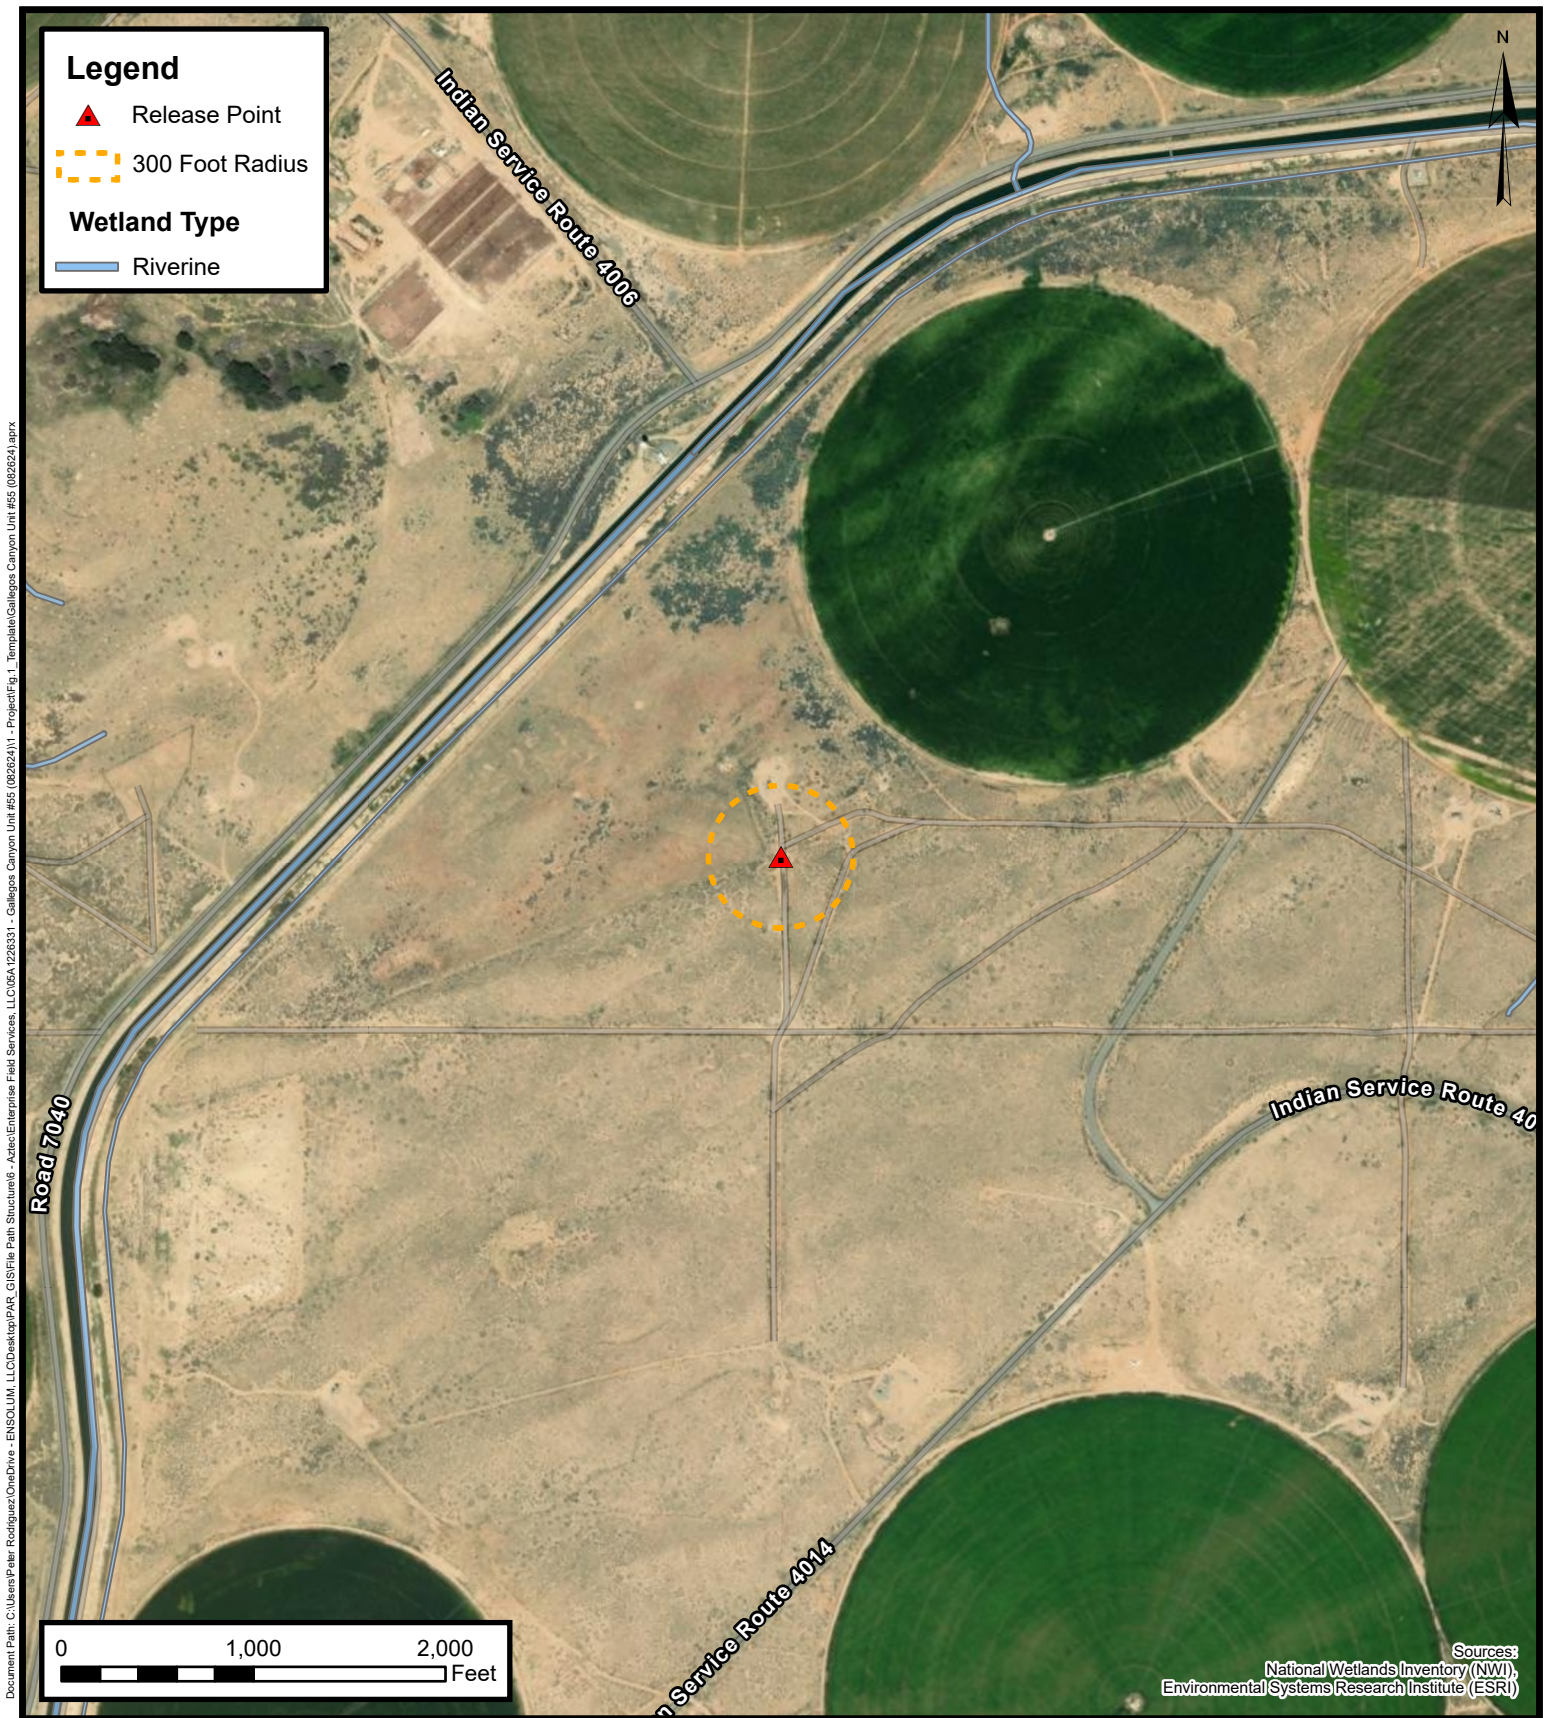
F

Wetlands

- Based on information identified in the U.S. Fish & Wildlife Service National Wetlands Inventory Wetlands Mapper, the Site is not within 300 feet of a wetland (**Figure F, Appendix B**).

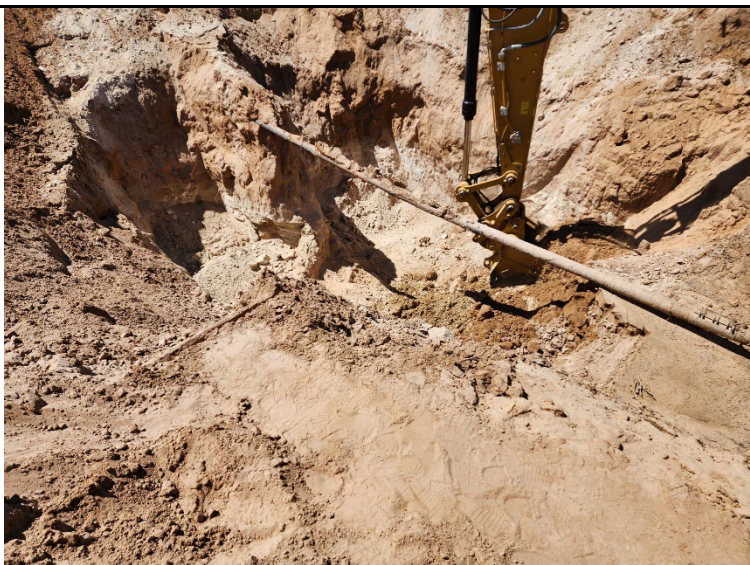
**Photograph 1**

Photograph Description: View of the in-process excavation activities.

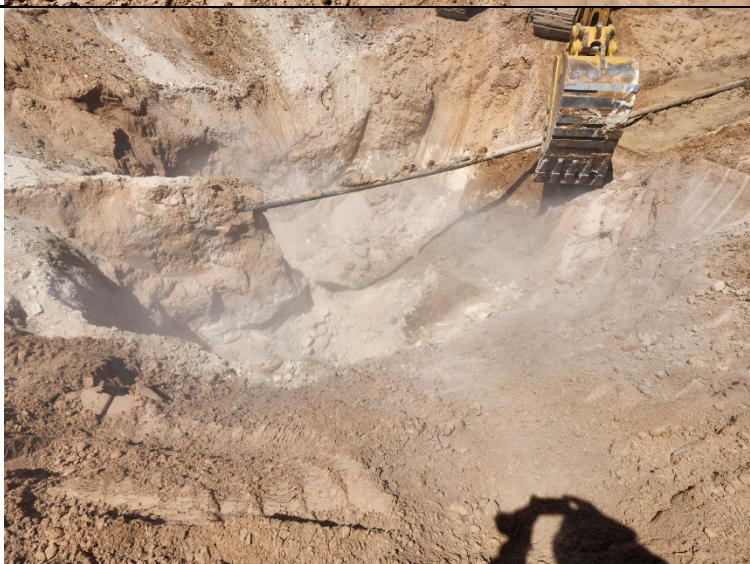
**Photograph 2**

Photograph Description: View of the in-process excavation activities.

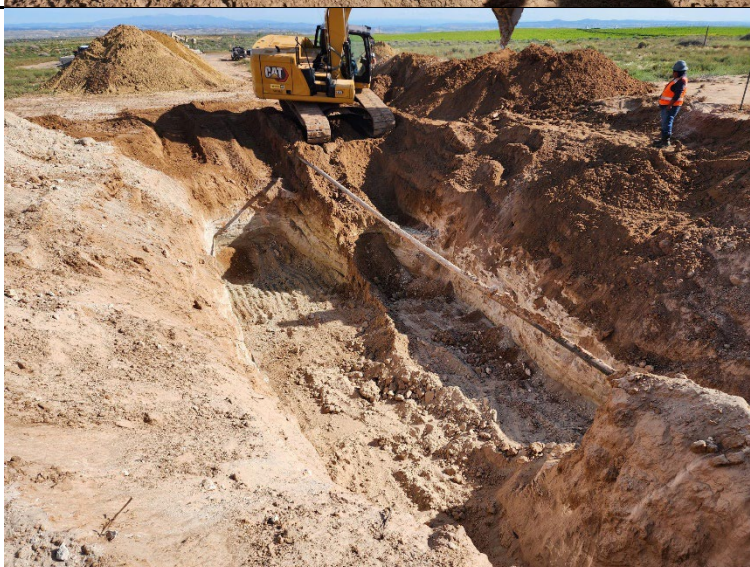
**Photograph 3**

Photograph Description: View of the in-process excavation activities.

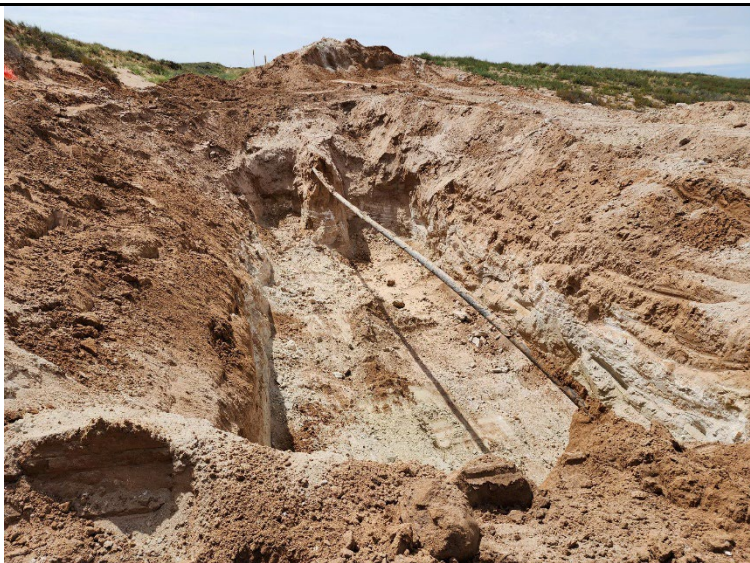
**Photograph 4**

Photograph Description: View of the excavation prior to the second sampling event.

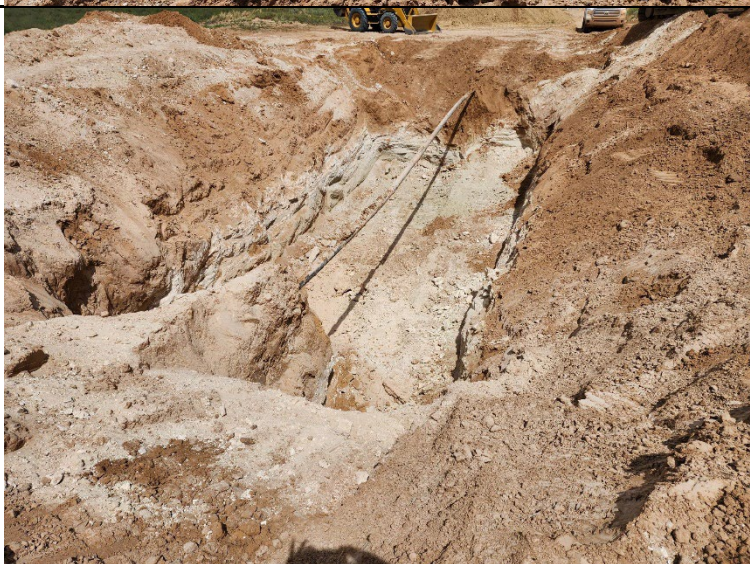
**Photograph 5**

Photograph Description: View of the excavation prior to the second sampling event.

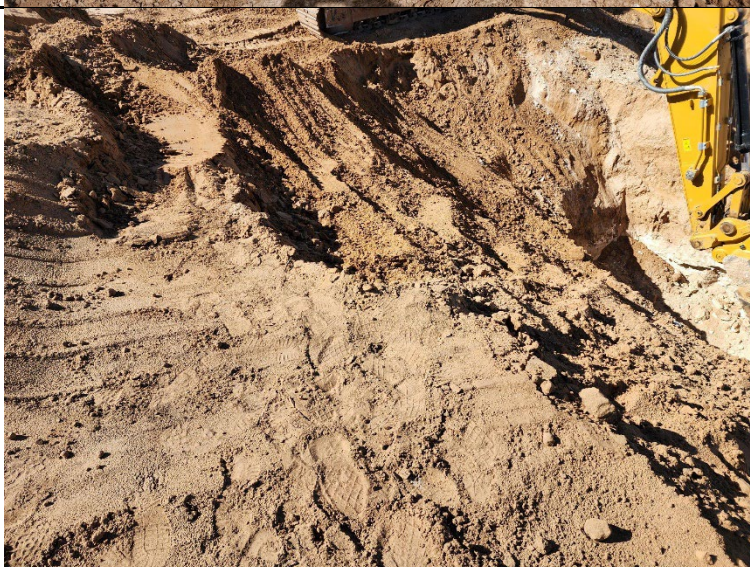
**Photograph 6**

Photograph Description: View of the in-process excavation of S-9 soils.

On August 30, 2024, a third sampling event was performed at the Site. Composite soil sample S-13 (0' to 15') was collected to replace sample S-9 after additional soil was removed from the side wall (**Figure 3, Appendix A**).

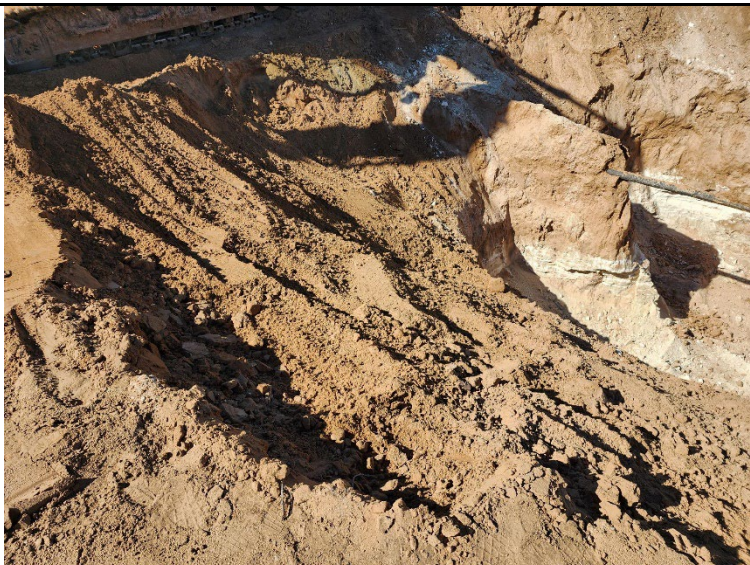
**Photograph 7**

Photograph Description: View of the excavation in the area of S-13 after removal of soils associated with S-9. The remainder of the excavation remained unchanged from Photographs 4 and 5.

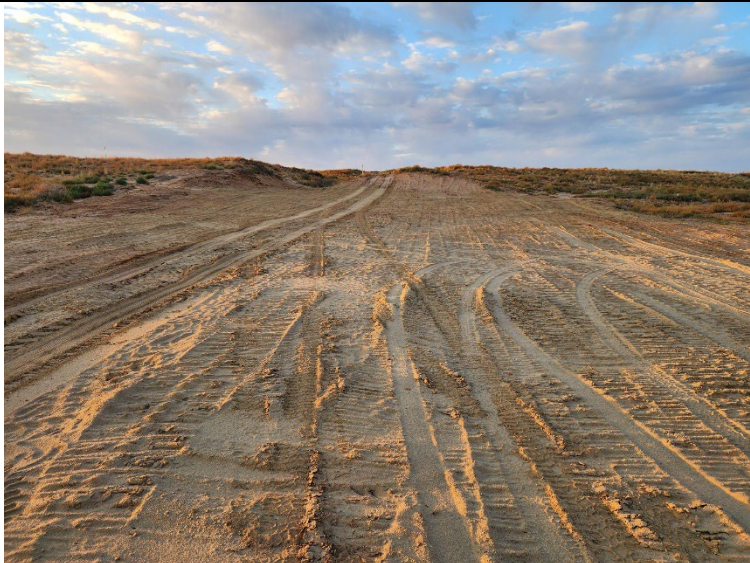
**Photograph 8**

Photograph Description: View of the site after initial restoration.

The excavation was backfilled with imported fill and then contoured to the surrounding grade. Once the Site is no longer being used for oil and gas production, final reclamation and revegetation will be addressed in accordance with 19.15.29.13 NMAC.
