RE: **Black Marlin CTB - Closure Request Report**

Incident Number: nAPP2503639050

Project No. 2838

Earth Systems Response and Restoration (ESRR), presents the following Closure Request Report (CRR) to document the findings during a recent liner inspection conducted at the Black Marlin CTB (Site) following an inadvertent release of a hydrogen sulfide chemical within a lined secondary containment (LSC). Based on initial release response and liner inspection activities, Civitas Resources (Civitas) is requesting No Further Action (NFA) at the Site.

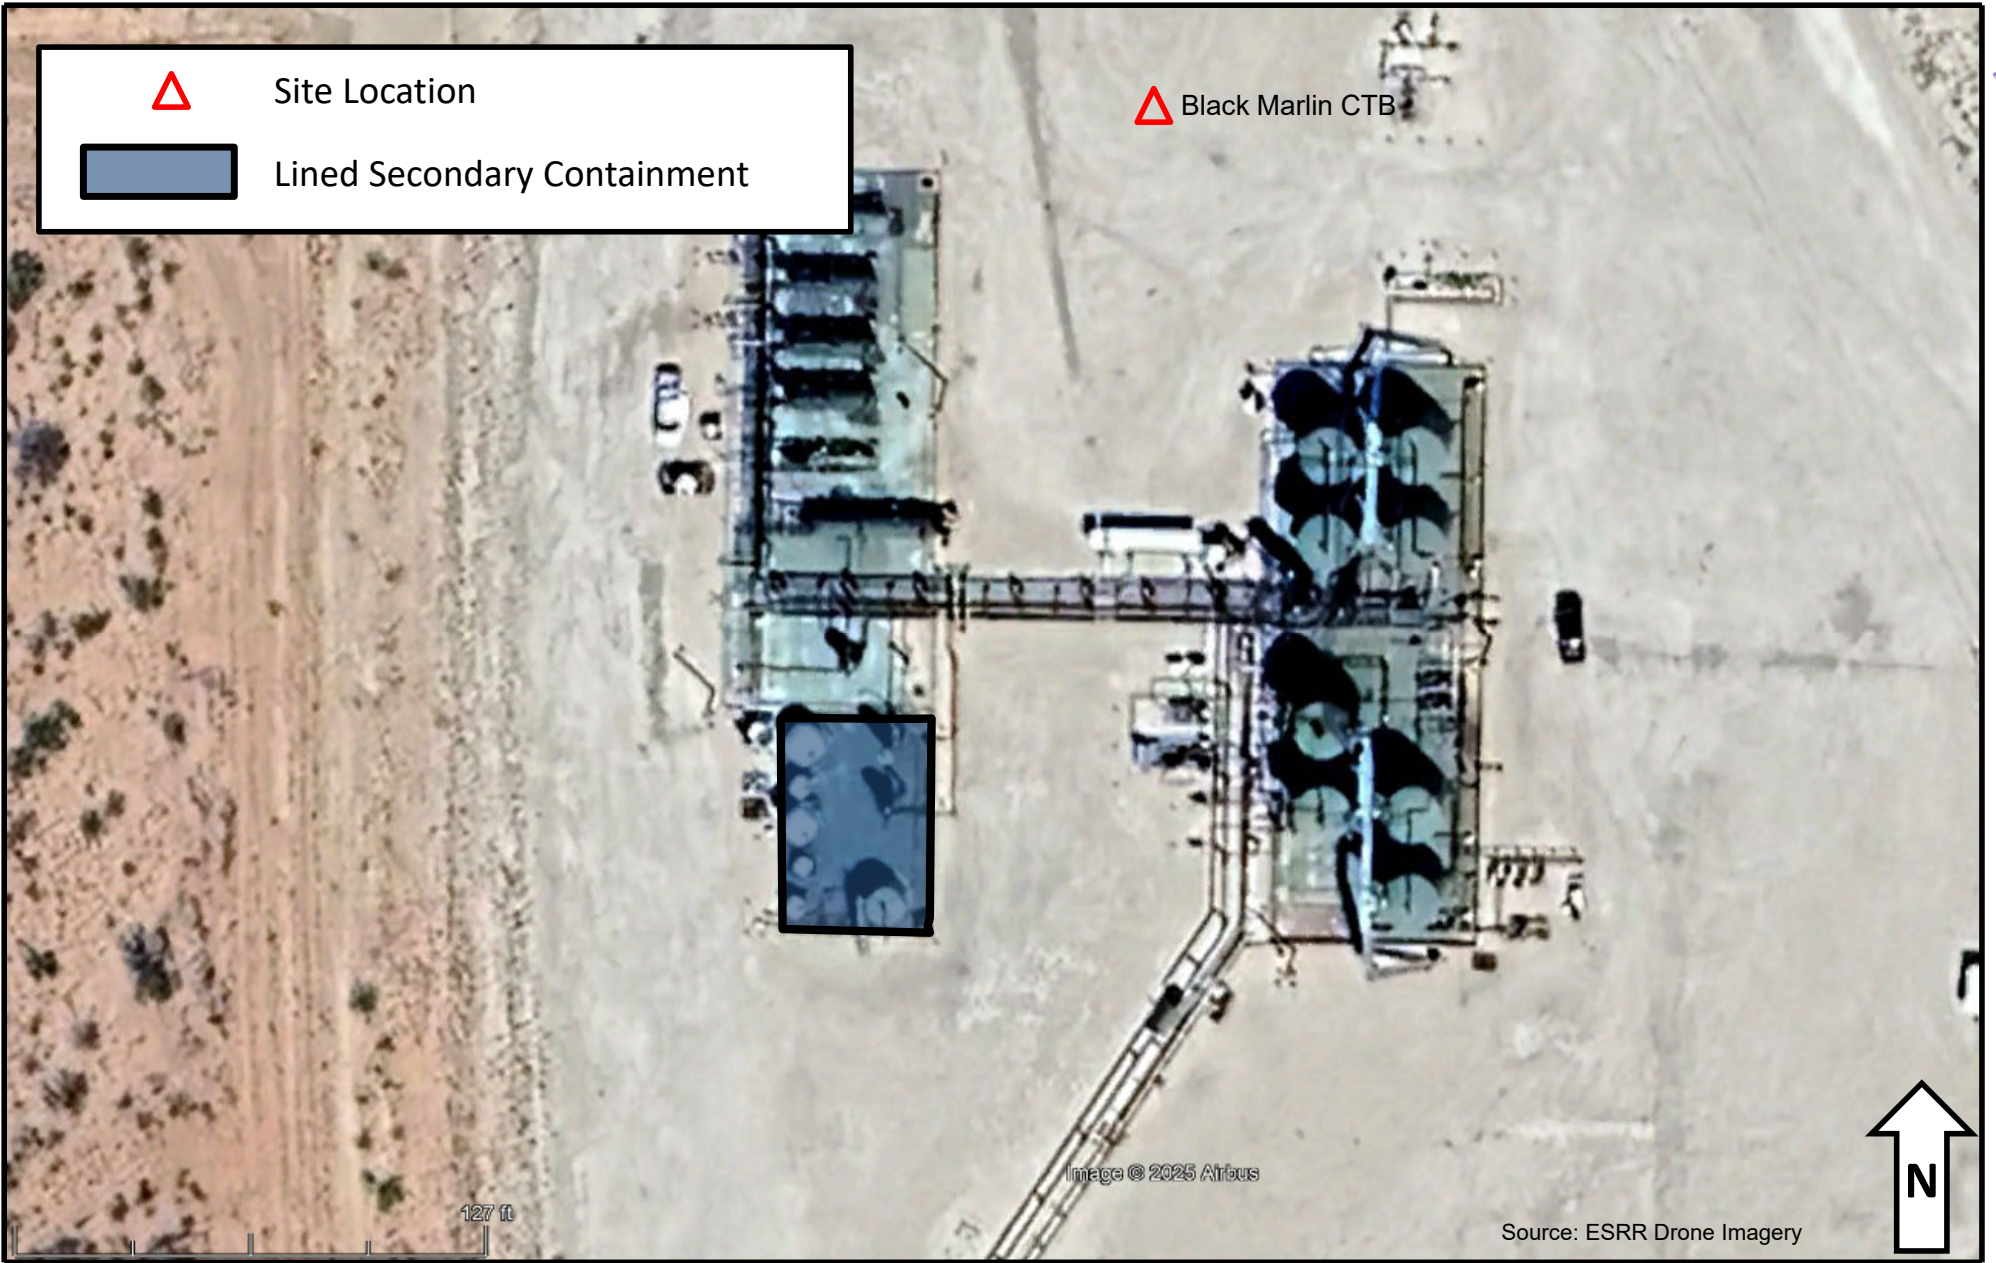
Figure 2 – Release Extent

On February 4, 2025, a faulty drain valve on an H₂S scavenger tote failed, releasing approximately 2,800 gallons of a hydrogen sulfide chemical within a LSC (**Figure 2**). The release was fully contained within the LSC with no fluids escaping to the production pad or adjacent native soils. A vacuum truck was immediately dispatched to the Site recovering the 2,800 gallons of fluids.

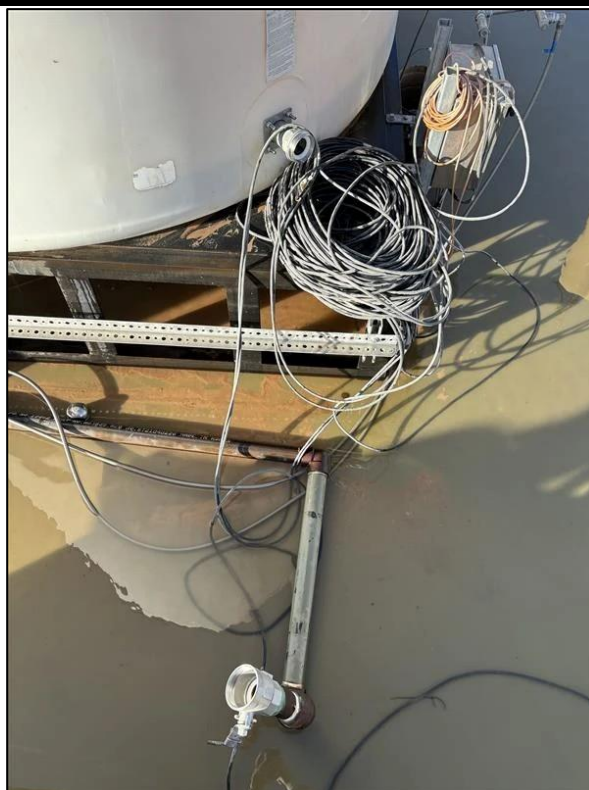
PHOTO 1: Civitas provided image of release extent. 02/04/2025

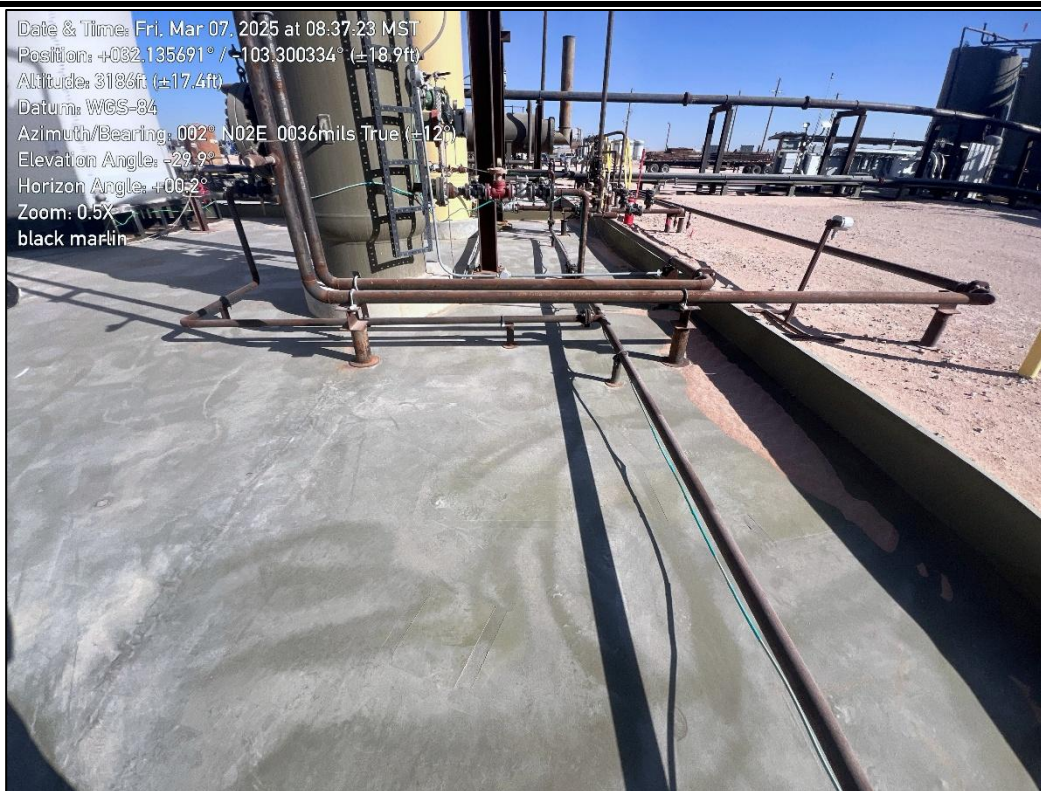
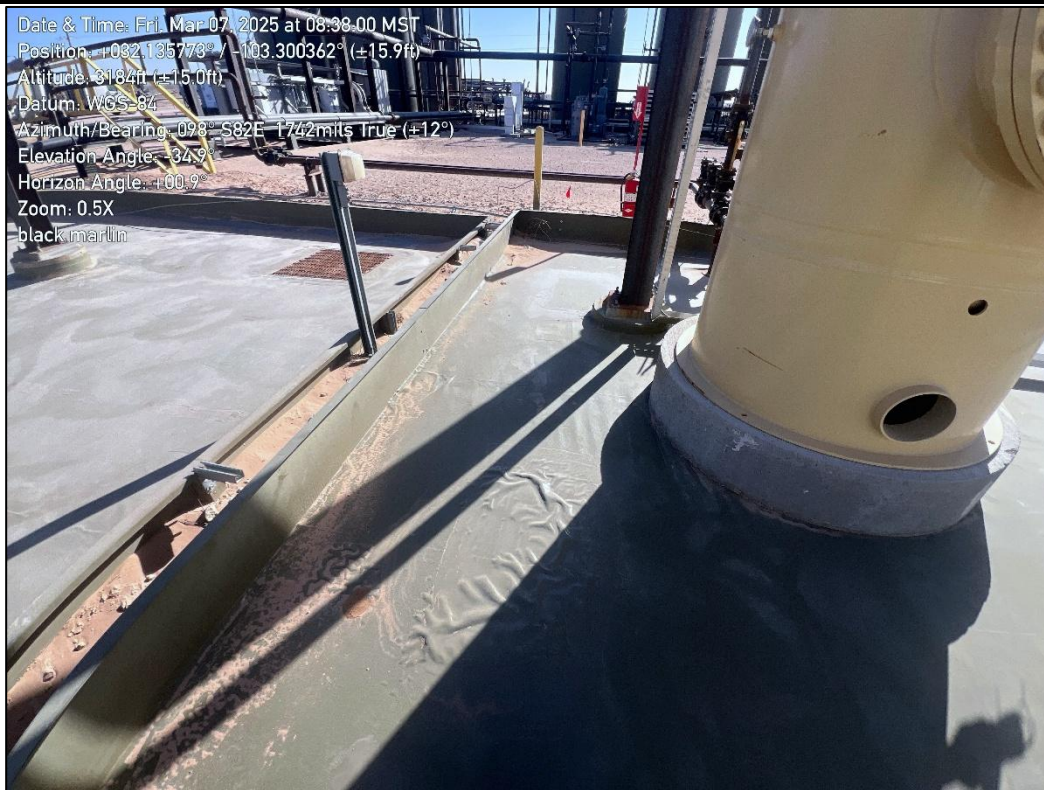
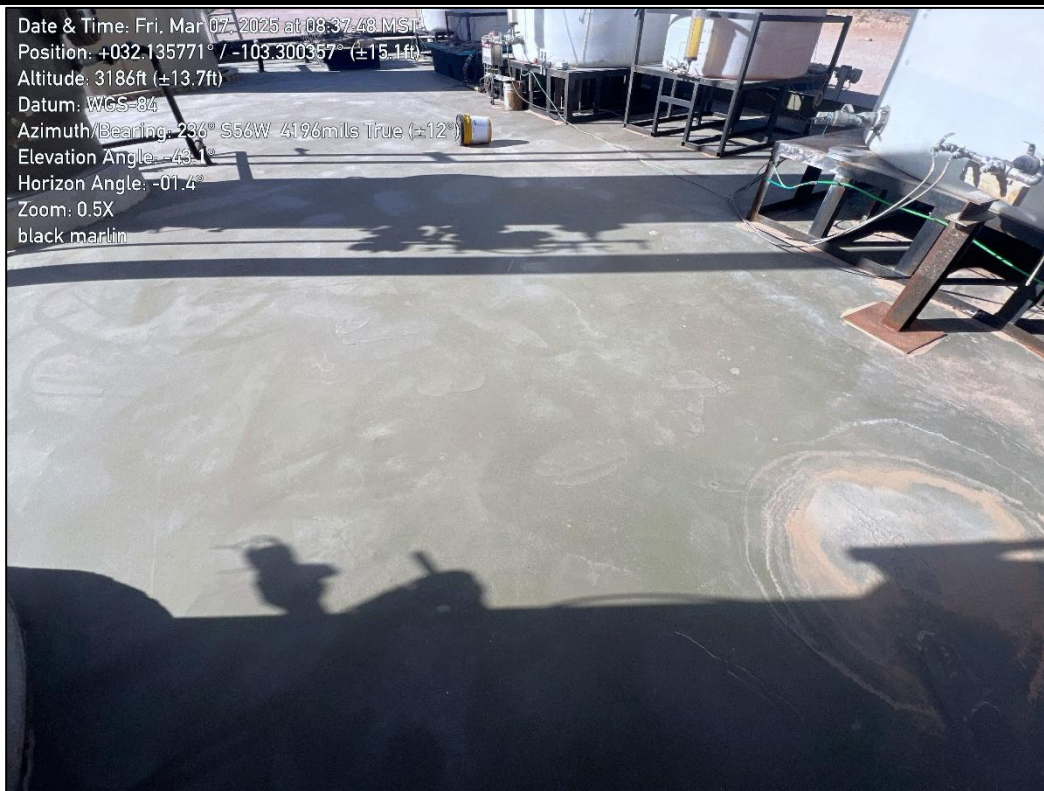
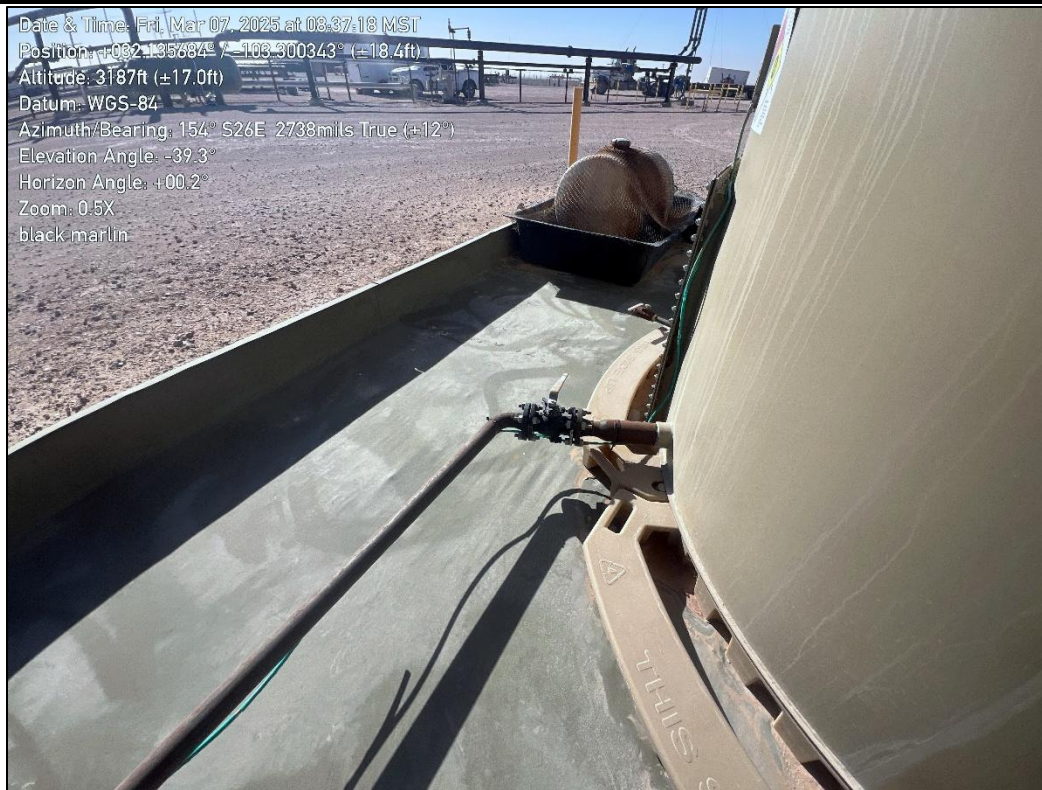
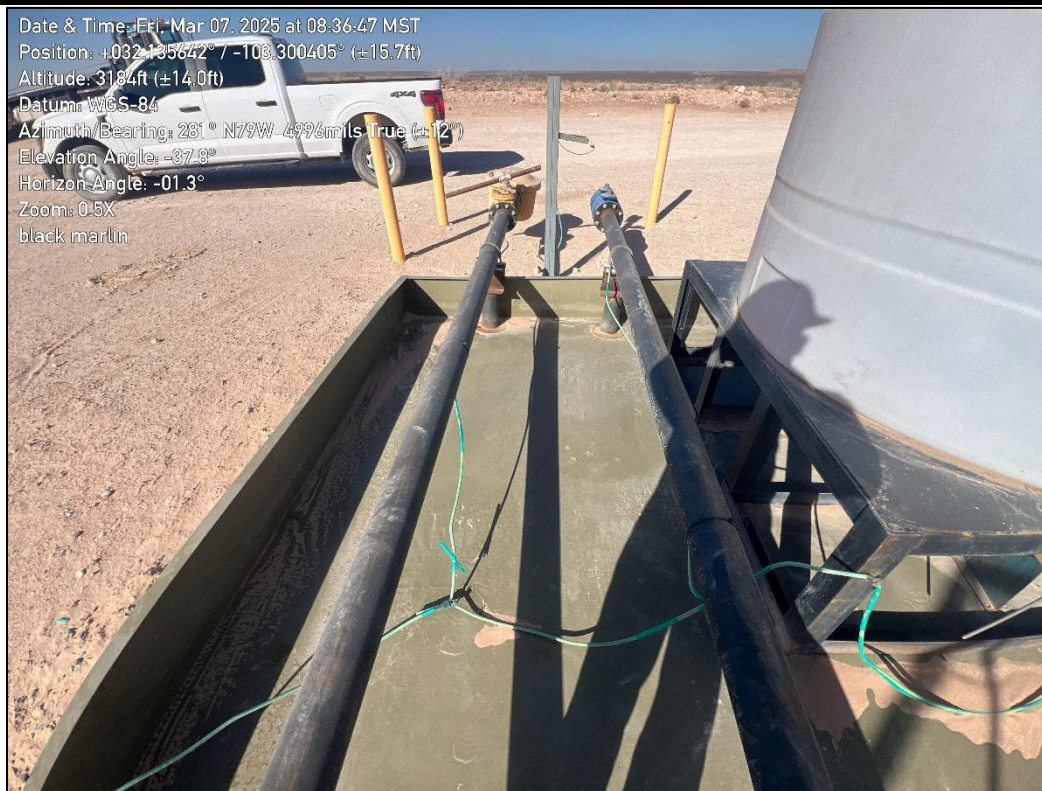
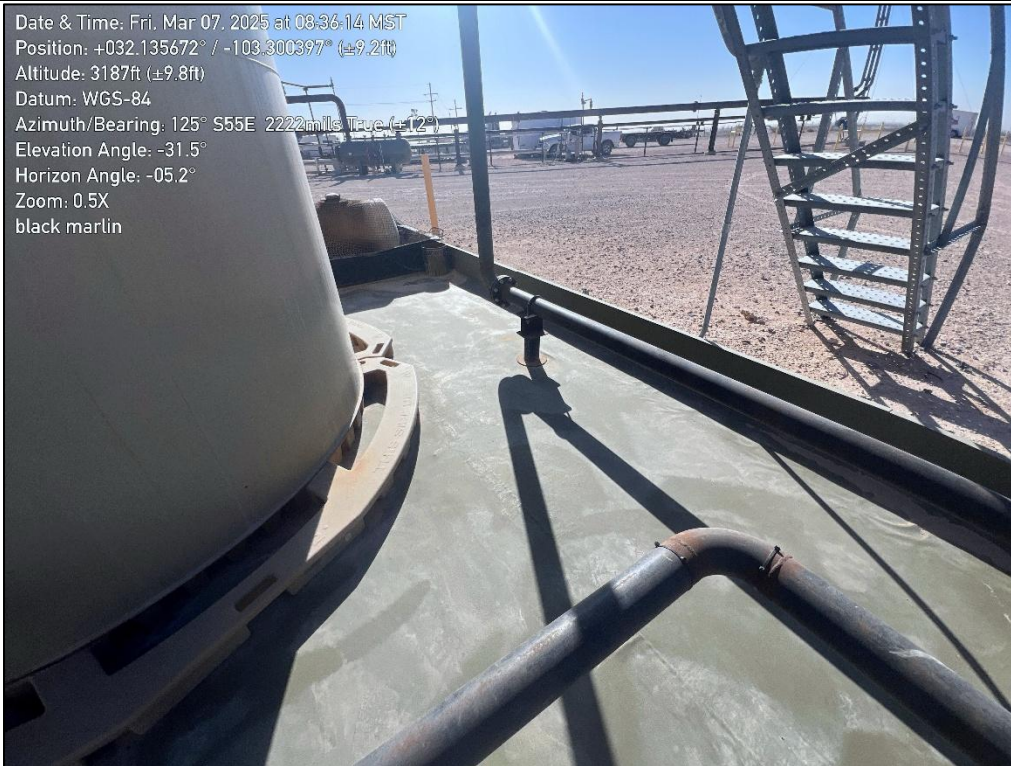
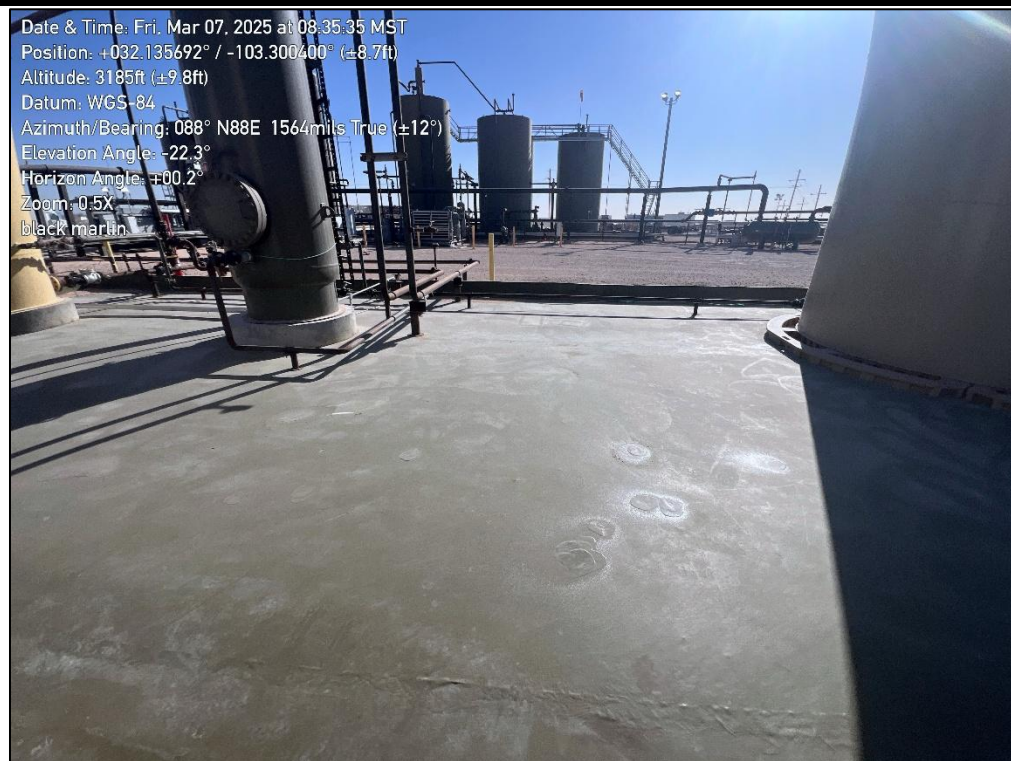
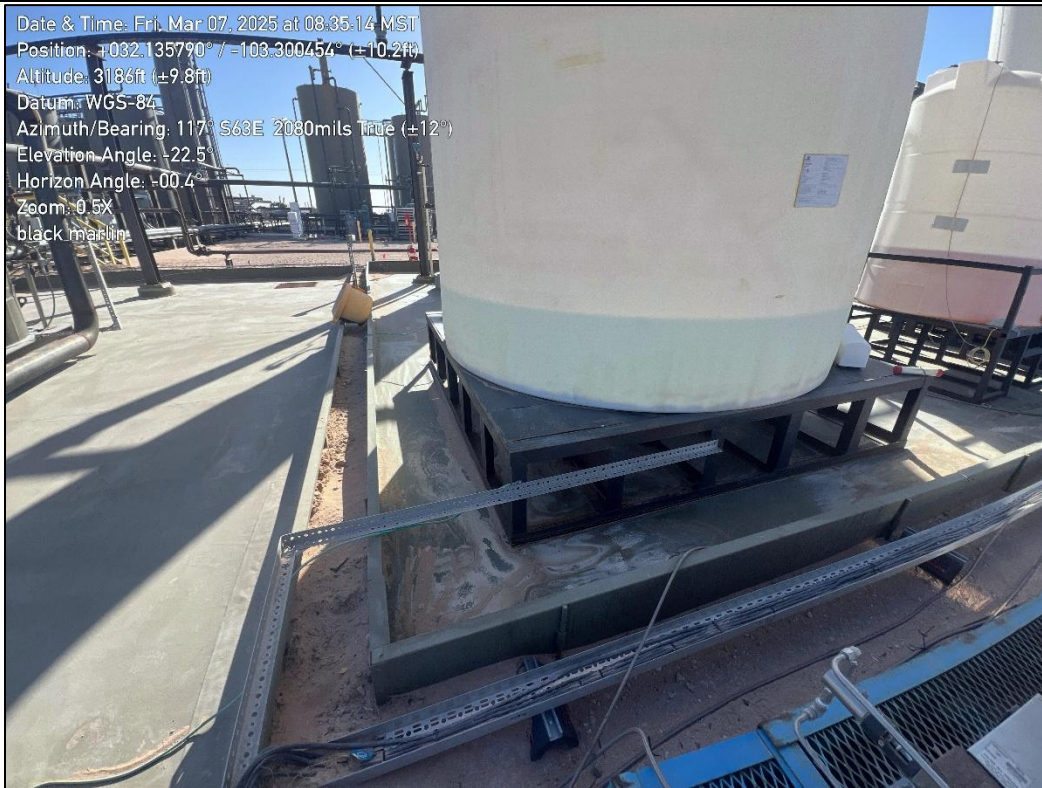
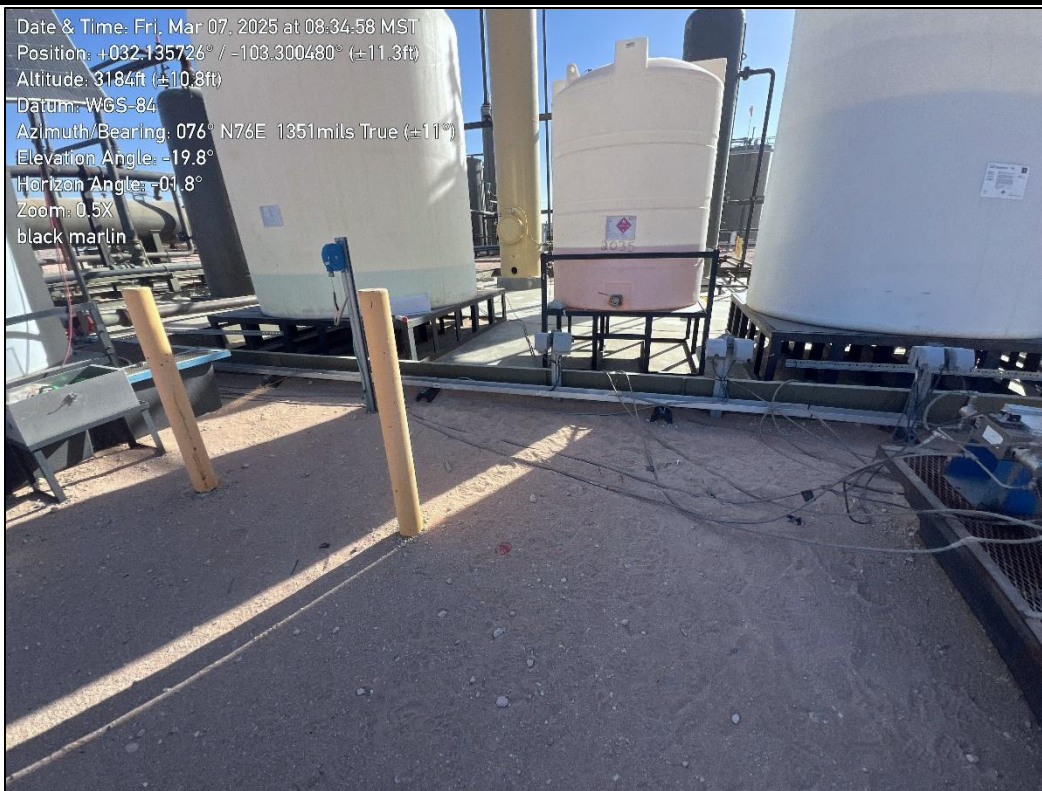
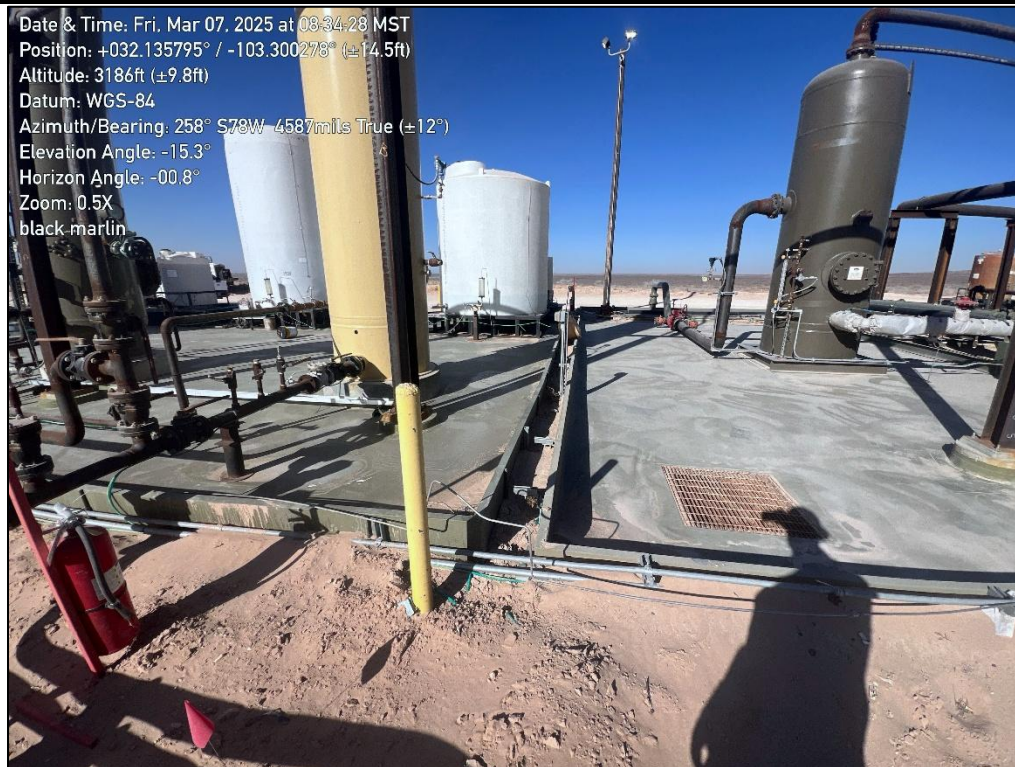
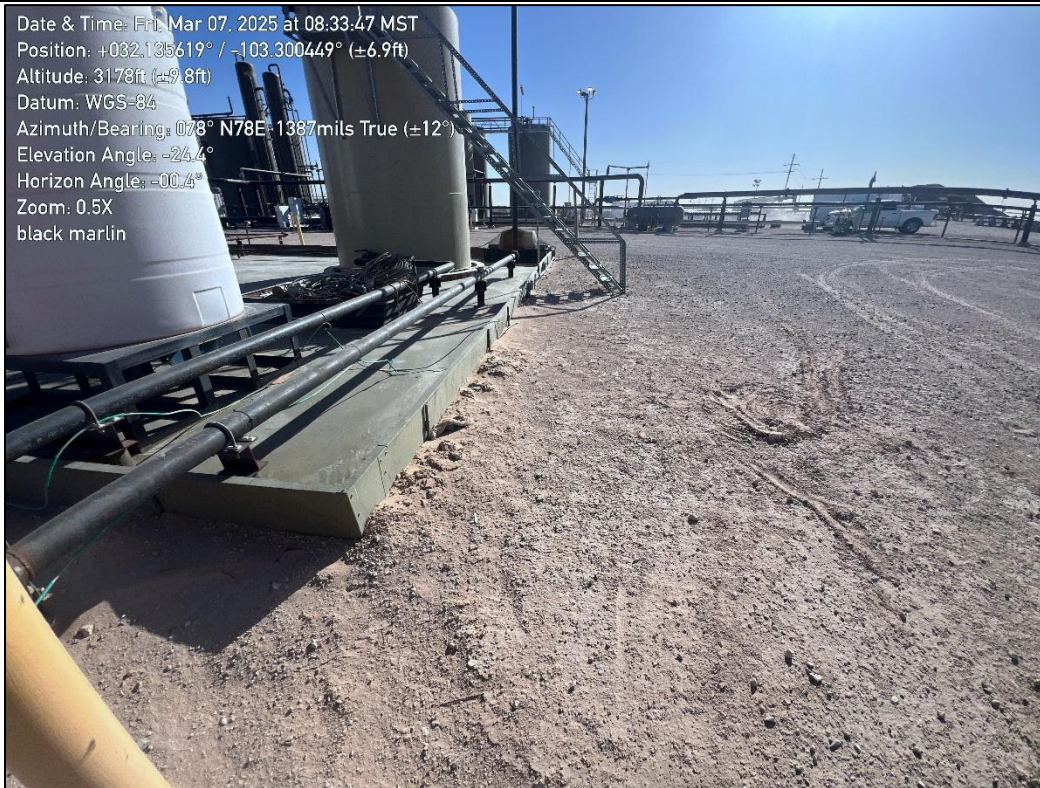
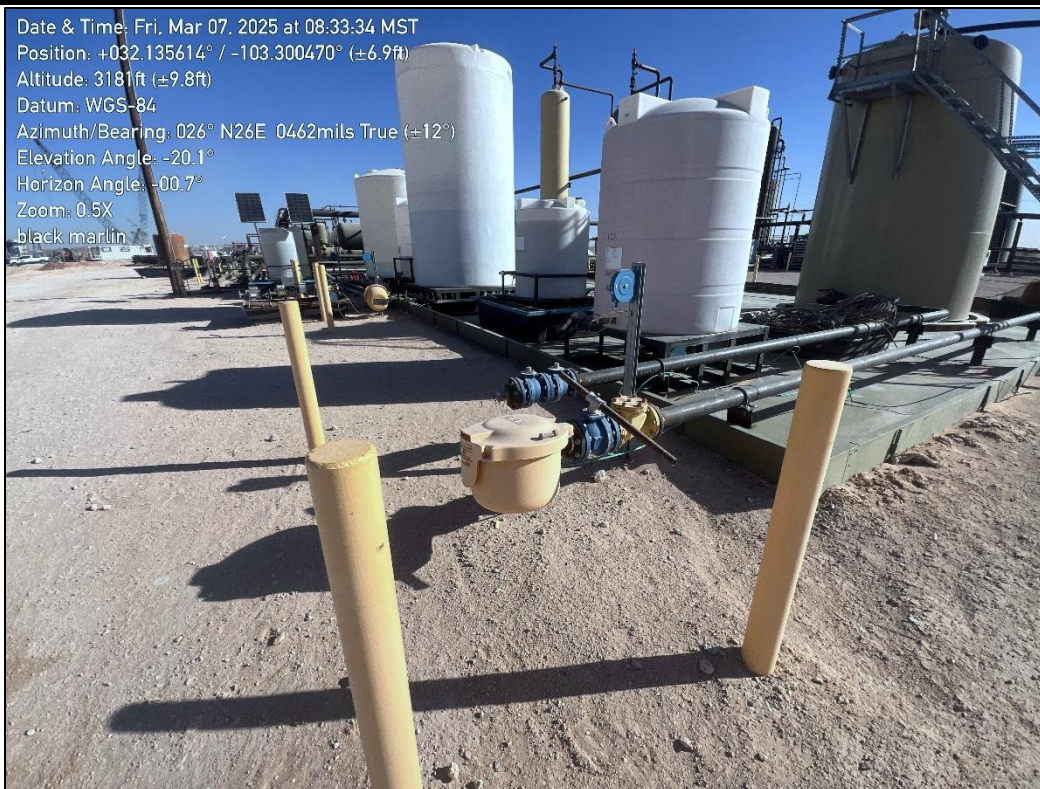
On March 7, 2025, ESRR conducted a thorough visual inspection of the LSC and found no tears, cracks, cuts, breaks, or other signs of damage, confirming no evidence of a breach to the LSC. The liner appears to be in good condition and is performing as designed. **Photographic Documentation** of liner inspection activities is attached.
