**RE: Final Closure Plan – East Puerto Chiquito Mancos Unit #012 (API #30-039-06863)  
Benson-Montin-Greer Drilling Corporation  
Latitude/Longitude: 36.5394936/-106.8624573  
Rio Arriba County, New Mexico**

**EPCMU #012**  
**Project Map**  
**Benson-Montin-Greer**  
**Drilling Corporation**

**EPCMU #012**  
**Photographic Log**  
**Besnon-Montin-Greer Drilling Corporation**

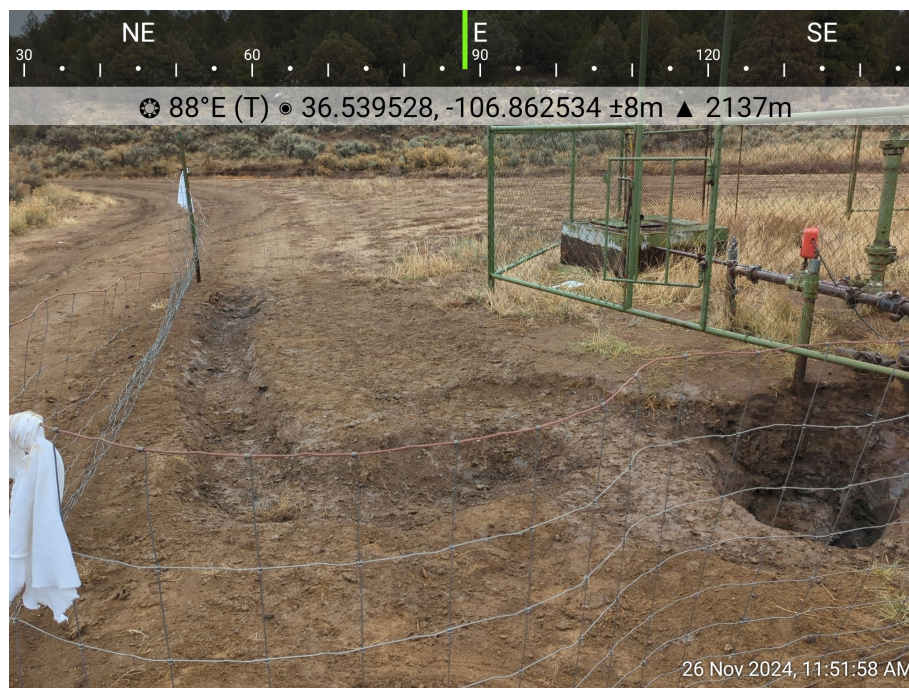
Photo 2: Overall release area and flowpath.

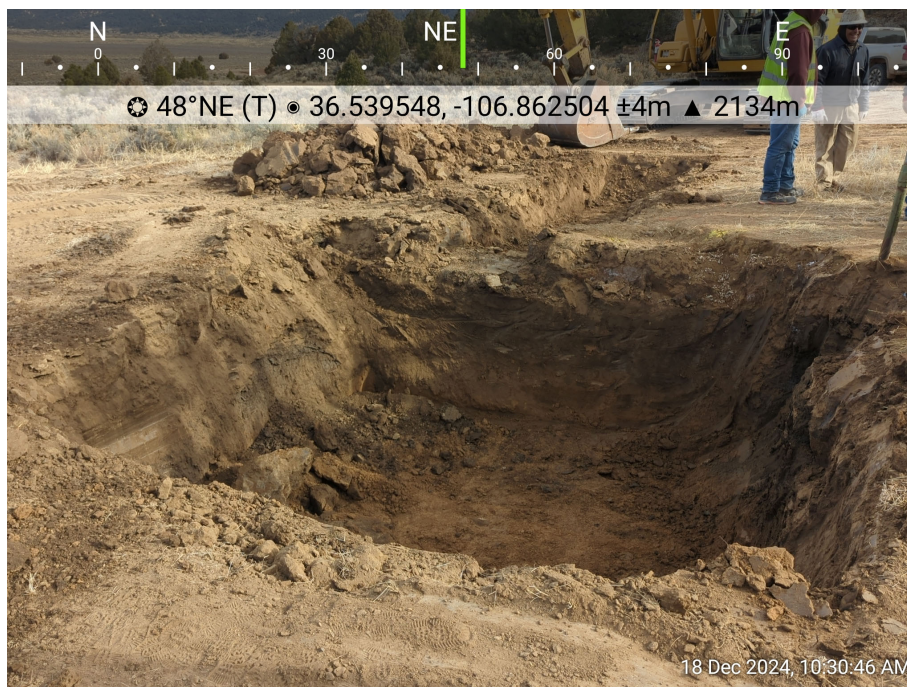
Photo 5: Wellhead excavation and new release excavation.

On December 18, 2024, approximately 50 yards of additional material was removed from the historical release area to a depth of approximately 4 feet bgs. An additional 2 yards of material was removed from the new release area. Five 5-point composite soil samples (SS03-SS07) were collected from the sidewalls and base of the historical release area. One 5-point composite soil sample (SS08) was collected from the new release area. It was determined that the east sidewall, south sidewall, and new release area indicated TPH levels in exceedance of the JAN-EPO total TPH limit at concentrations of 450 mg/kg, 15,839 mg/kg, and 179 mg/kg respectively. Following the sampling event, the entire south sidewall of the excavation was treated with 20 gallons of Micro-Blaze® Emergency Liquid Spill Control (Micro-Blaze®). The Micro-Blaze® solution was applied at a minimum concentration of 10 percent (%) (10 parts Micro-Blaze® to 90 parts water). The north sidewall, west sidewall, and base of the excavation area were below the JAN-EPO limit for total TPH and non-detect for BTEX.

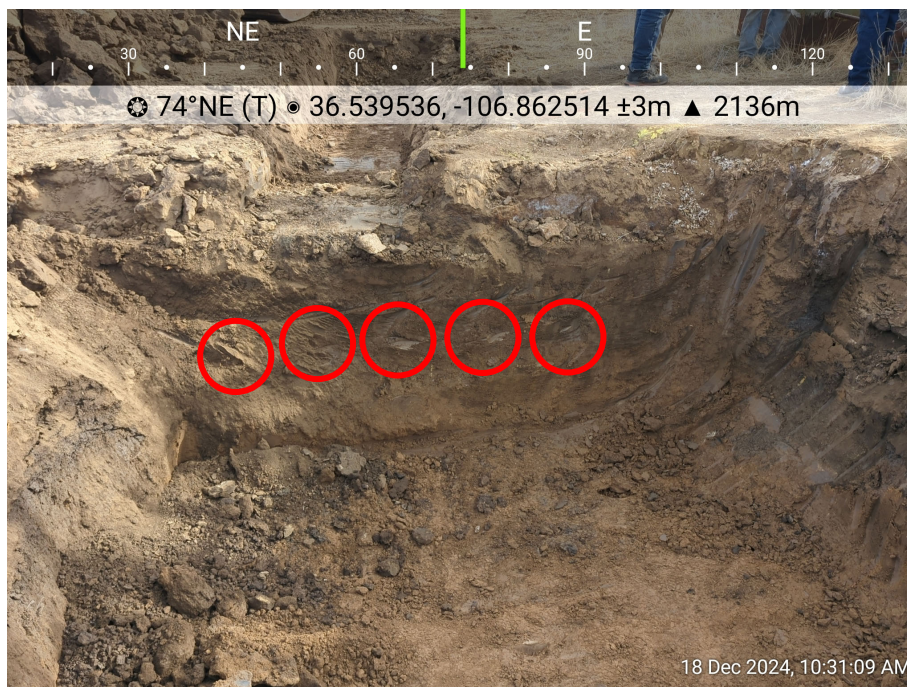
Photo 7: SS04 collected as a 5-point composite sample from east sidewall of wellhead excavation area.

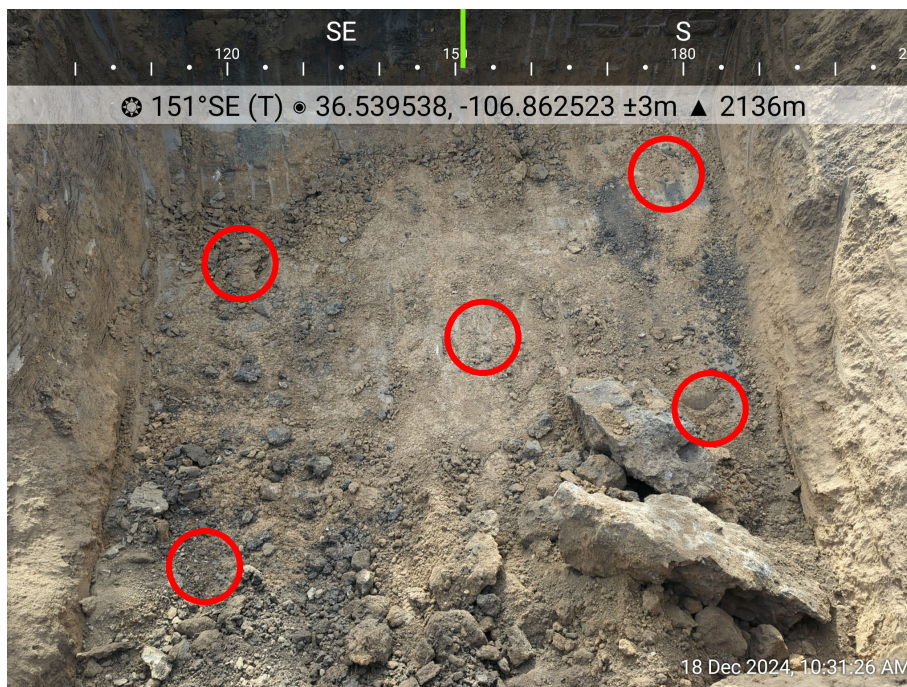
Photo 9: SS06 collected as a 5-point composite sample from the base of wellhead excavation area.

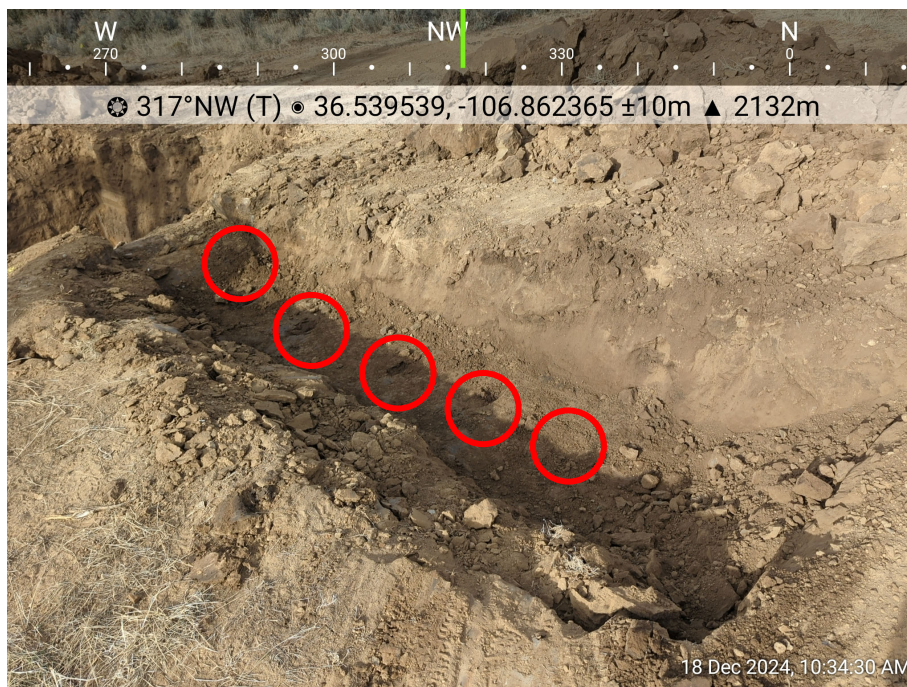
Photo 11: SS08 collected as a 5-point composite sample from new release excavation area.

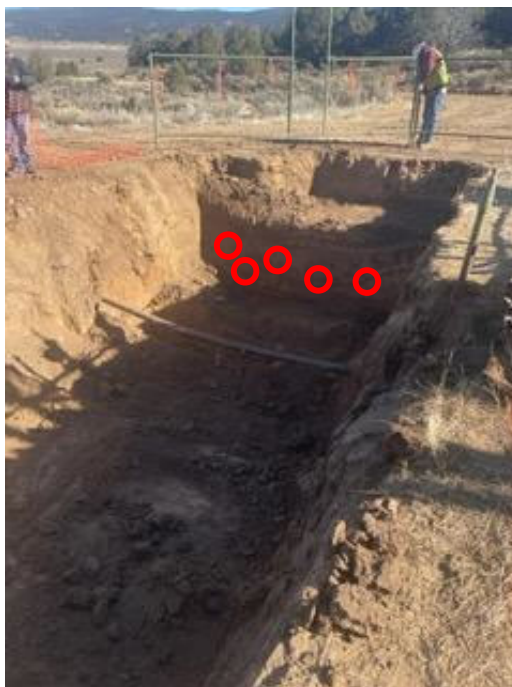
Photo 13: SS09 collected as a 5-point composite from east sidewall of wellhead excavation area 12/23/2024.

On December 23, 2024, approximately 40 yards of additional material was removed from the eastern portion of the historical release excavation. An additional 4 yards of material was removed from the new release excavation. Two 5-point composite samples (SS09/SS11) were collected from the east sidewall and south sidewall of the historical release excavation. One 5-point composite sample (SS10) was collected from the new release excavation. All samples collected were below the JAN-EPO limit for total TPH and non-detect for BTEX. The south sidewall of the excavation was treated with an additional 15 gallons of Micro-Blaze® and the entire new release excavation was treated with 5 gallons of Micro-Blaze®. The Micro-Blaze® solution was applied at a minimum concentration of 10%.

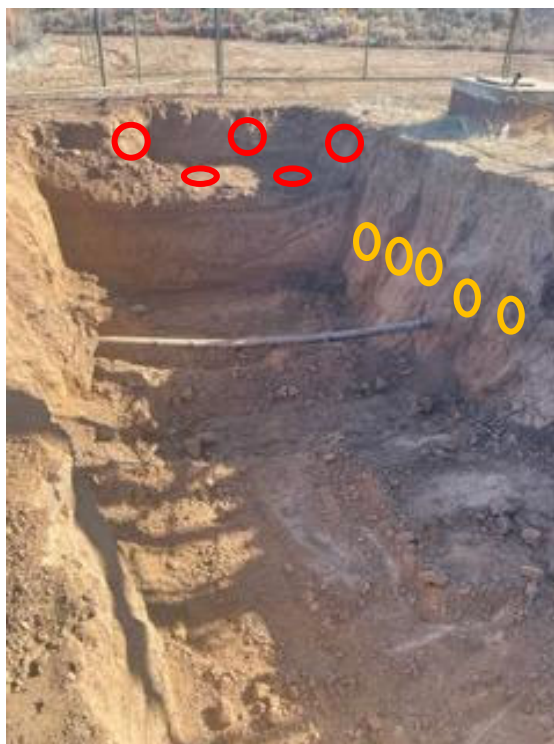
Photo 14: SS10 (red) collected as a 5-point composite from new release excavation area and SS11 (yellow) collected as a 5-point composite from south sidewall of wellhead excavation area, 12/23/2024.

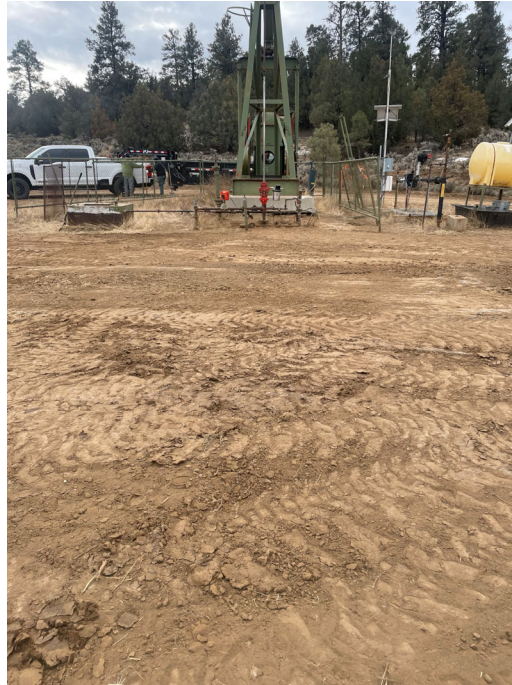
Photo 15: Excavated areas have been backfilled with clean material, 1/6/2025.

On December 26, 2024, the JAN-EPO approved BMG to backfill the excavation with clean soils. On December 27, 2024 and January 6, 2025, BMG backfilled the historical release and new release excavations with clean soils sourced from nearby native soils provided by the JAN-EPO.

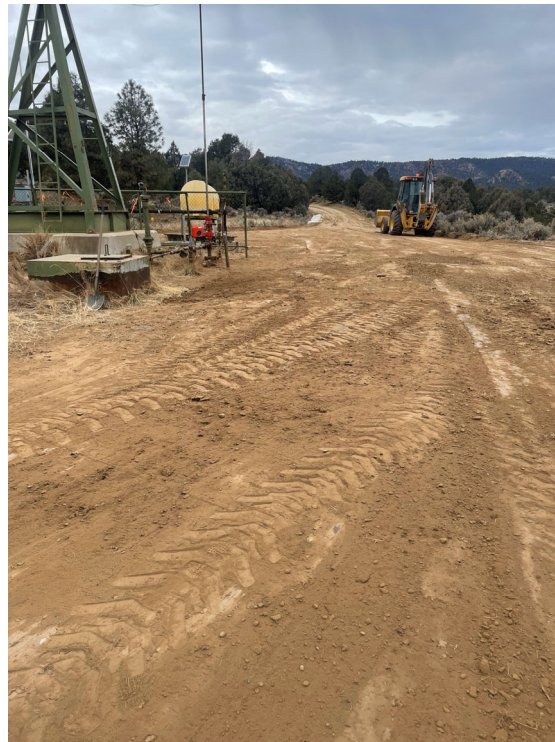
Photo 16: Excavated areas have been backfilled with clean material, 1/6/2025.
