# **CLOSURE REPORT (FINAL)**

**NORTH MONUMENT GRAYBURG  
SAN ANDRES UNIT (NMGSAU) #603**

**NMOCD 1RP# 1019**

**JULY 2007**

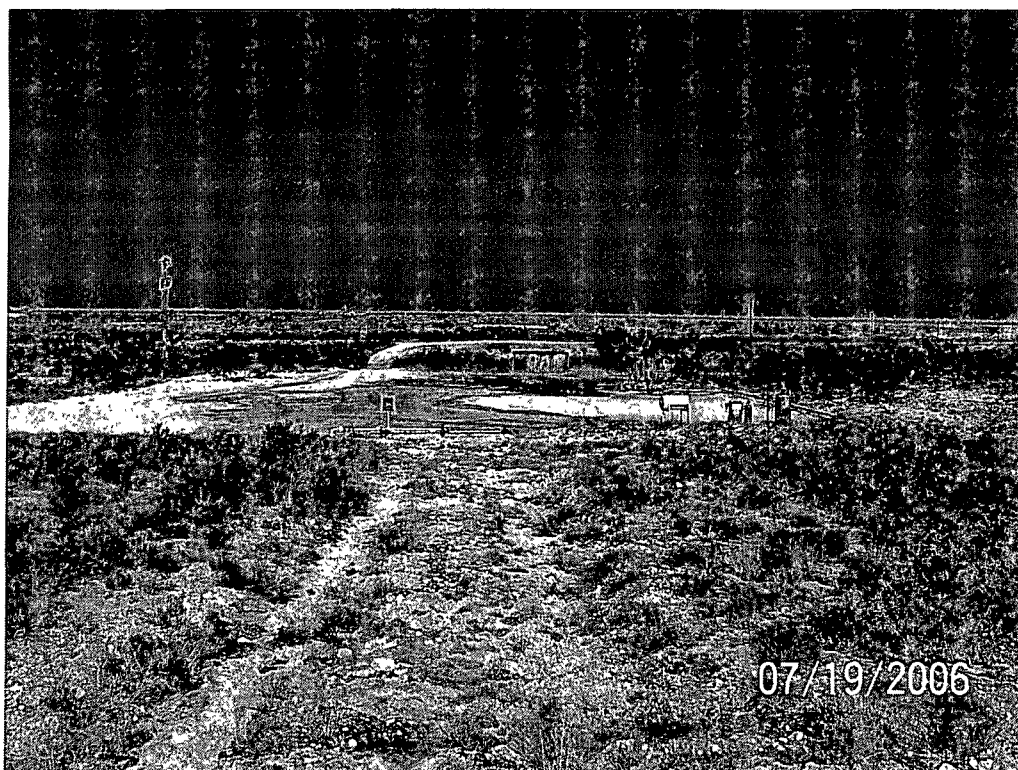
**Photo #4:** Looking westerly from point of release at Lanexco well pad. Dark stained soil indicates contamination.

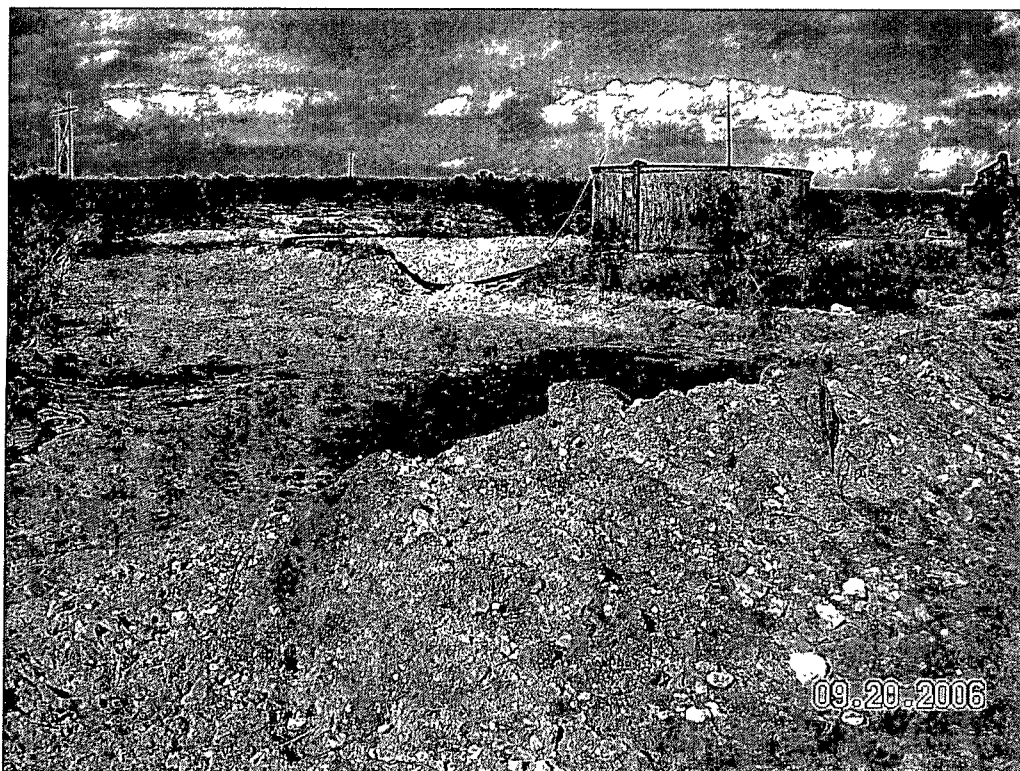
**Photo #9:** Looking northeasterly at pooling area west of Lanexco caliche well pad (i.e., location of soil boring SB-1).

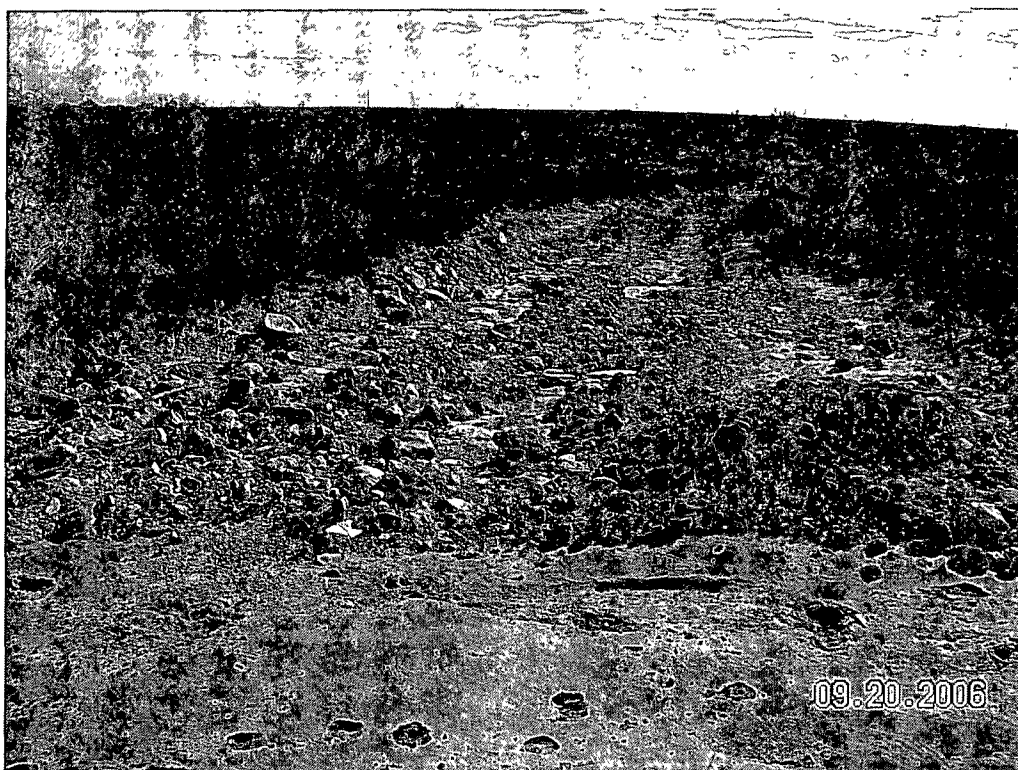
*Photo #11:* Looking southerly across release area at center berm in southern portion of excavation.
