SITE ASSESSMENT & REMEDIATION WORK PLAN

RE: SITE ASSESSMENT AND REMEDIATION WORK PLAN

LOCATION: Ice Dancer 30 Fed Com 2H

NMOCD REF. NO. NAB1834553041

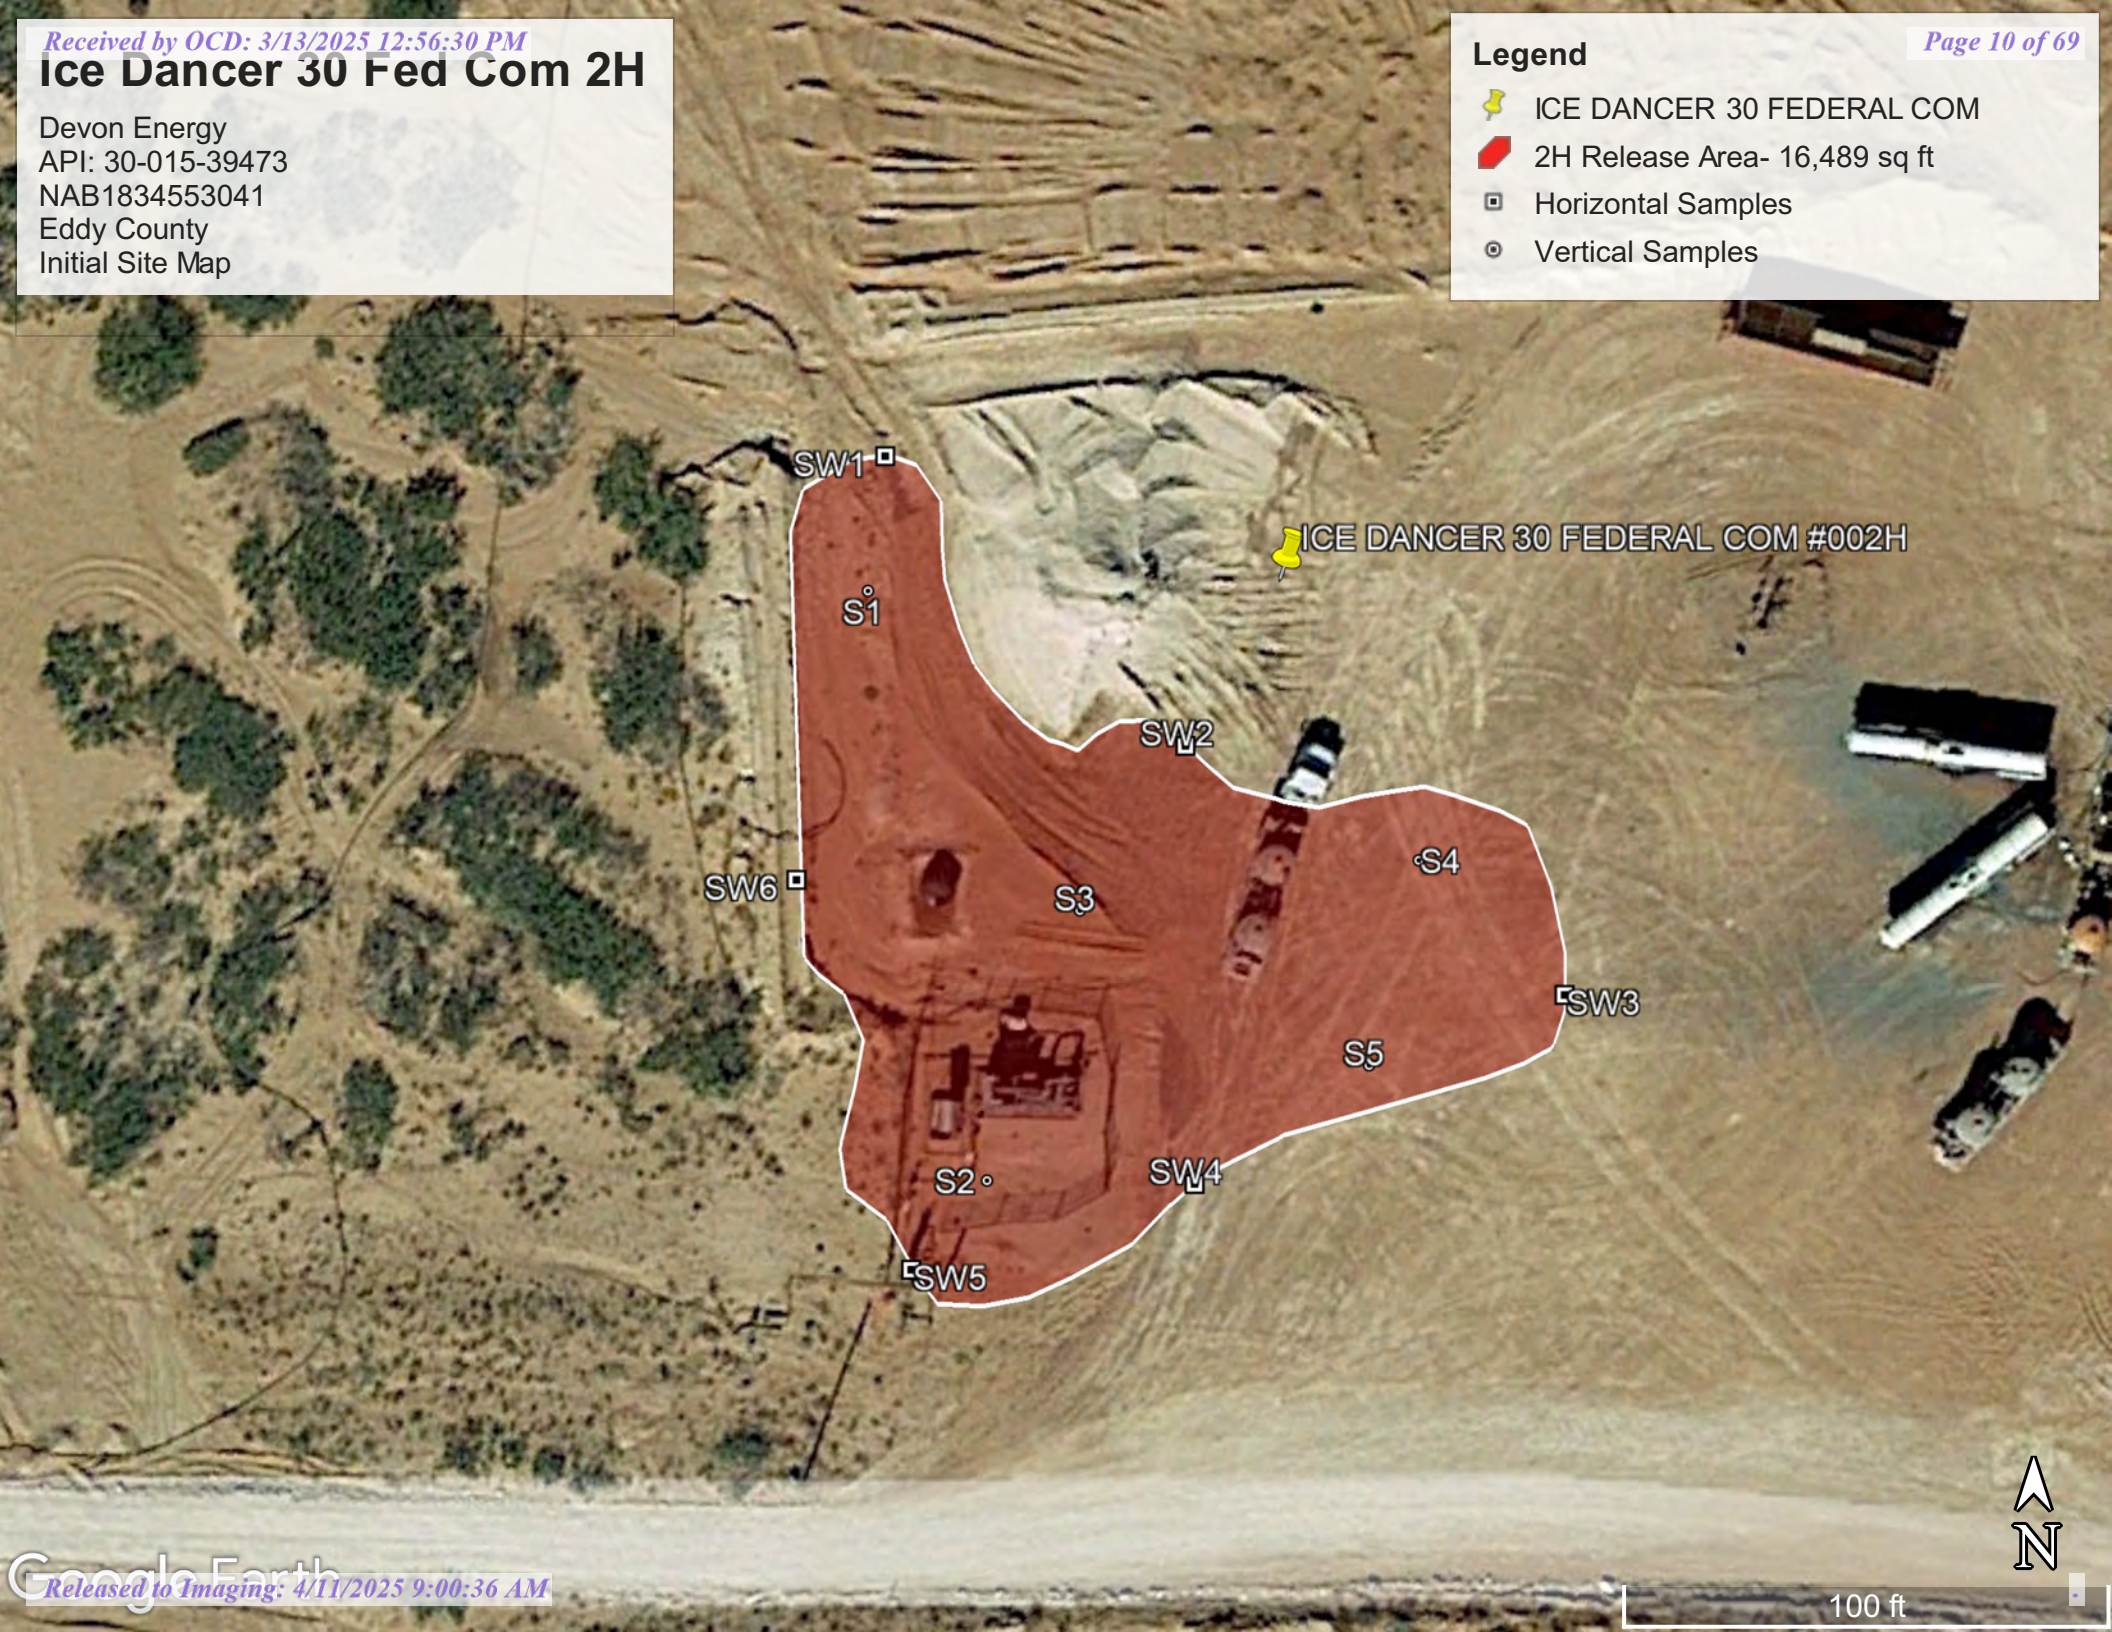
Devon Energy
API: 30-015-39473
NAB1834553041
Eddy County
Initial Site Map

On February 7, 2023, Pima Environmental mobilized personnel to the site to assess the impacted area. Pima collected samples around the impacted area in an effort to delineate the extent of the contamination. Five (5) vertical samples labeled S1-S5 were collected at depth intervals of 1' and 3'. Five (5) horizontal samples labeled SW1-SW5 were collected at 6" and one (1) sample labeled BG1 was collected from the pasture to serve as a background sample. An Initial Site Map can be found in Figure 5. A data table can be found in Figure 4. A complete Laboratory Report can be referenced in Appendix E.

2H Release Area- 16,489 sq ft
-
